Statens vegvesen
Region vest
Bergen distrikt

Report

Fire in the Fløyfjell tunnel on the 10th of November 2003

Bergen, the 21st of December 2003

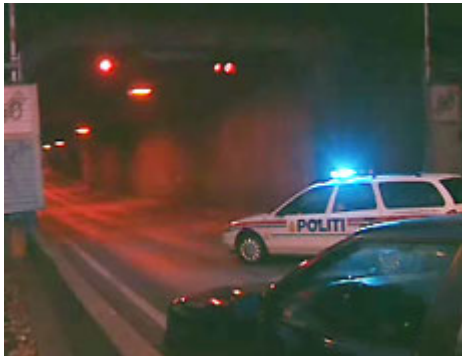
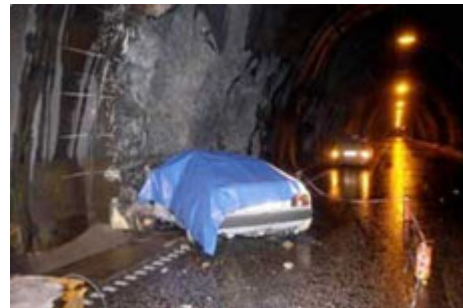
- One emergency cabinet with a fire extinguisher and an emergency telephone and a distribution box for 4 other emergency cabinets were destroyed as a result of the impact.
- As a cause of the fire, 2-3 m² of the watertight sealing material – PE – was damaged.
- The air hose for the sprinkler system was damaged and had to be replaced for 20 meters.
- 10 sprinkler heads were used (melted) and had to be replaced.
- The sprinkler system was dismantled and prepared for reinstallation.
- The tunnel was cleaned.
- Estimated total expenses for repairs was NOK 200.000,-
