Intern rapport nr. 1910

**Long-term behaviour of a 13 m high
reinforced steep soil slope. Paper
presented at Euro Geo 1 Maastricht.**

LONG-TERM BEHAVIOUR OF A 13M HIGH REINFORCED STEEP SOIL SLOPE

Jan Vaslestad, Nils Fjeldheim, Anne Braaten and Tor Helge Johansen.

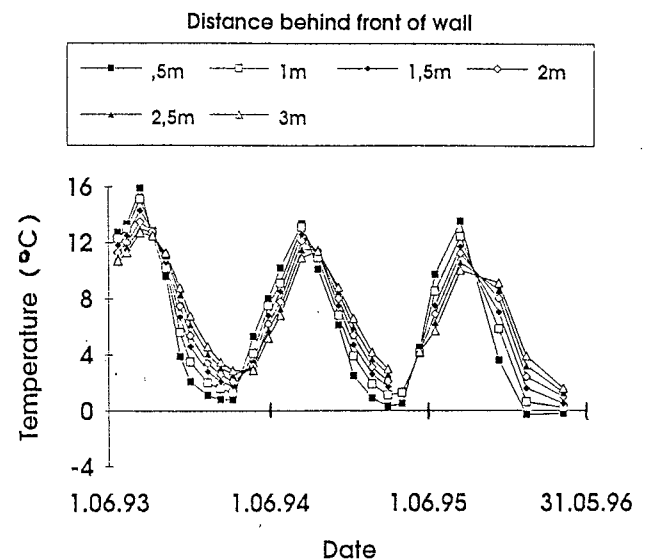
Fig. 9 Temperature measured in the soil in the reinforced structure

A maximum temperature of 16°C was measured in the summer 1993 and a minimum temperature of -0,5°C in the winter 1996.

In the summer the difference in temperature is about 4°C from 0,5 m to 3,0 m behind the front. The difference in temperature in the winter is about 3°C from 0,5 m to 3,0 m behind the front.

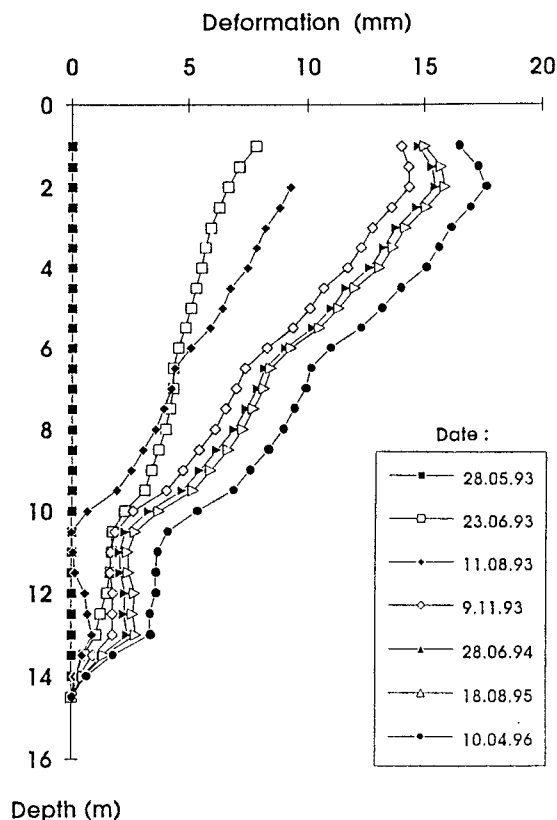
Fig. 10 Horizontal deformation after the end of construction

A maximum horizontal deformation of 18 mm is measured 1 m below the top of the wall.

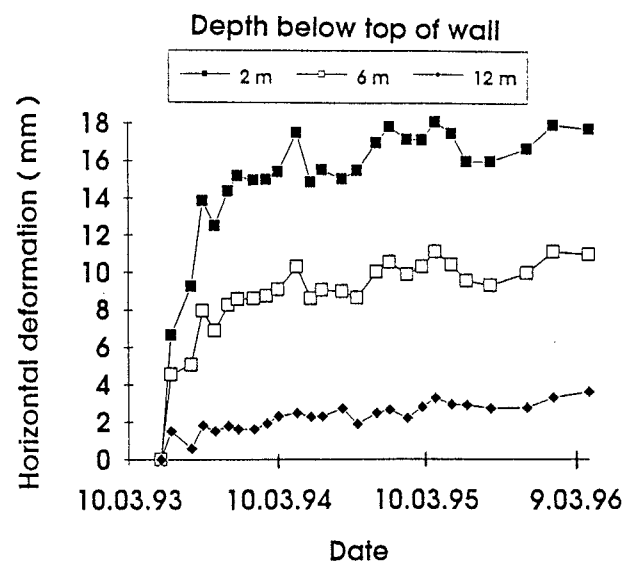
The major part of the deformations in the top of the wall (14 mm) occur within the first 6 months after the end of construction, see figure 11.

The horizontal deformation also show an annual cyclical pattern as shown on figure 11.

Fig. 11 Horizontal deformations, annual variation

The horizontal deformations are largest in the

spring time (the thawing period) and smallest in the summer and autumn.

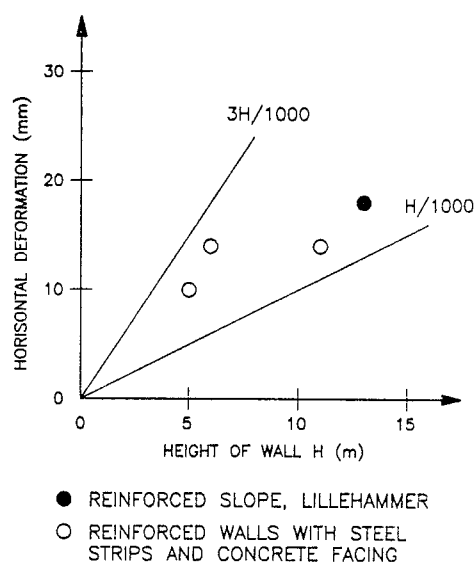
Fig. 12 Long-term post-construction horizontal deformations on reinforced earth walls in Norway

Fig. 12 shows that the long-term deformation of the reinforced slope and walls lies between $H/1000$ and $3H/1000$.

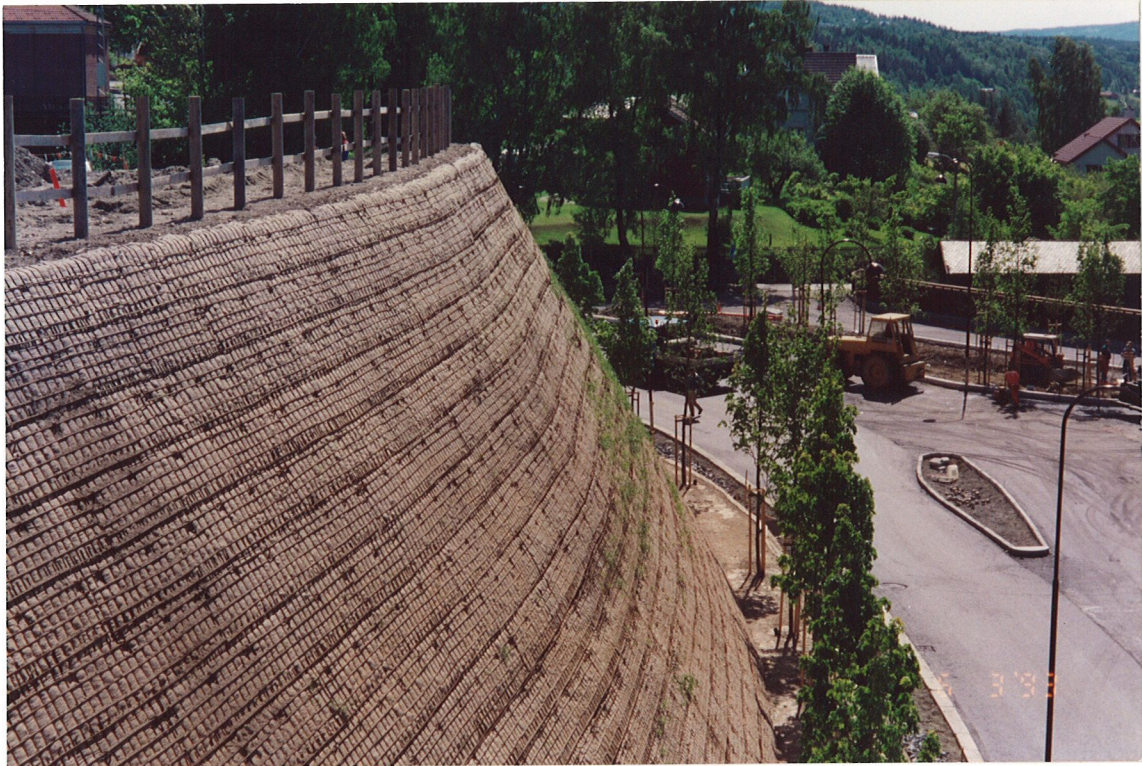
Fig. 9 Vegetation is coming

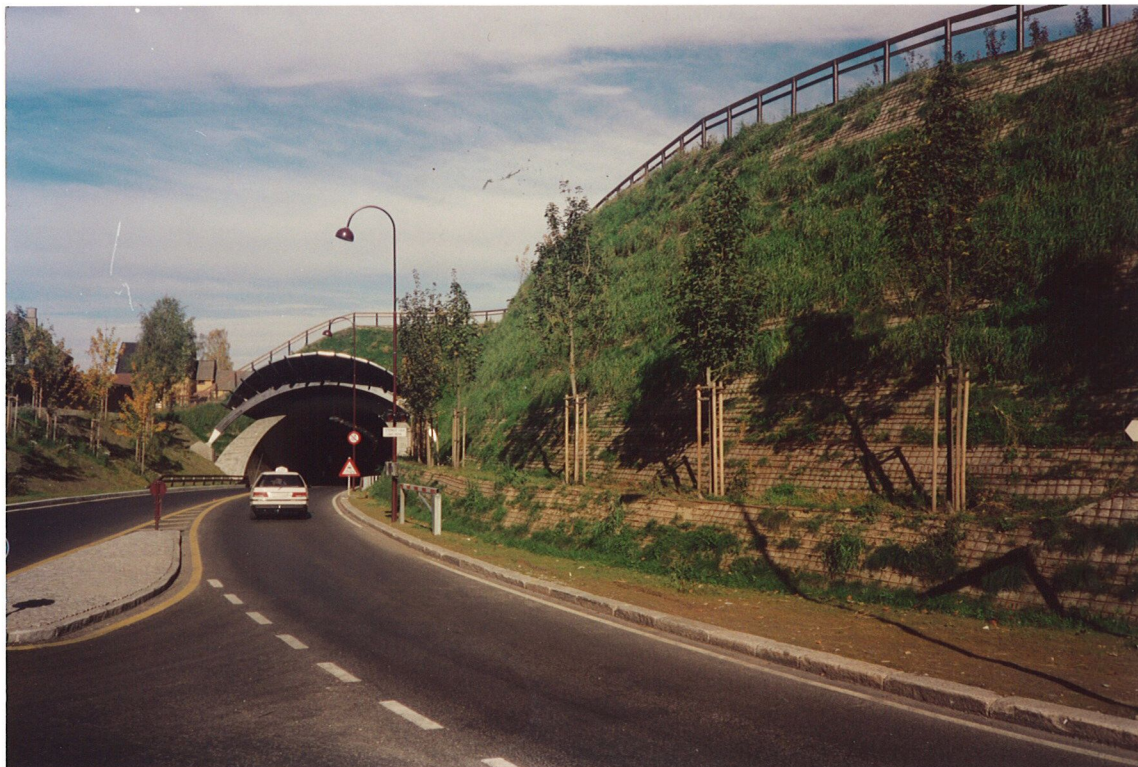
Fig. 12 Vegetation proceeds
