Long-term performance of cathodic protection (CP) of marine bridge, inspection of Sortlandsbrua 27 years after CP installation

An investigation of performance and damages on the installation.

Master's thesis in Experience-based Part-time Master
programme Road and Railway Engineering
Supervisor: Mette Rica Geiker
May 2019

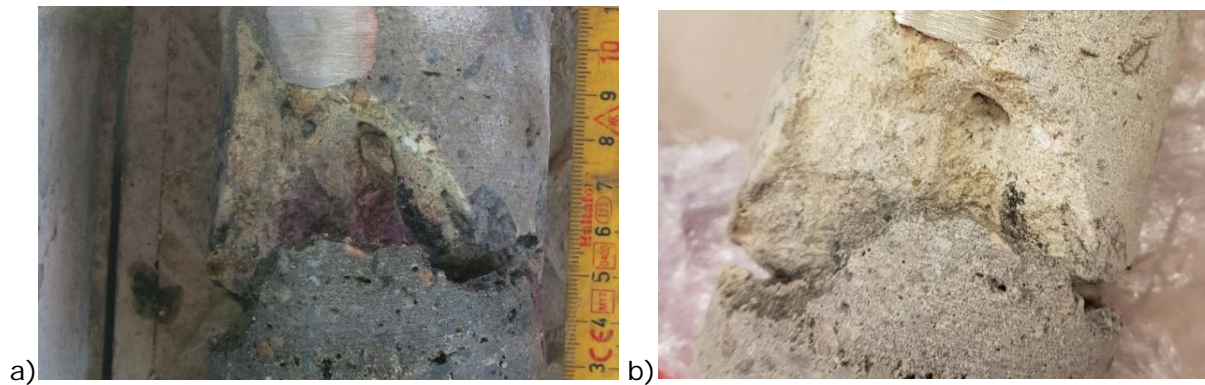
While studying the cores it was discovered that some of them had developed a white puss where the connection between repair mortar and ordinary concrete was. This might indicate that the concrete has dried somewhat out over the months. A crack was discovered in M6 seen in Figure 4-15 it was decided to cut through it as it could be of interest regarding the study of chloride ingress or other elements in the cracked mortar.

Figure 4-14 Delamination in core M8 a) from before wrapping, b) from after 4 months in storage.

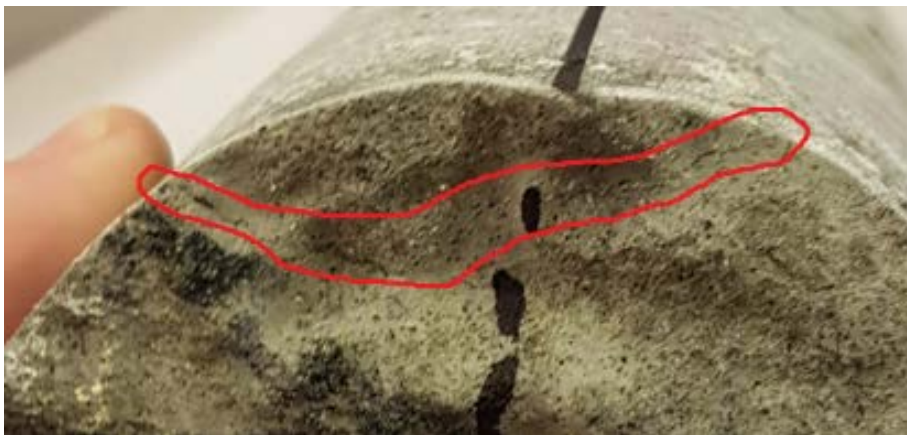
Figure 4-15 Core M6 with a crack

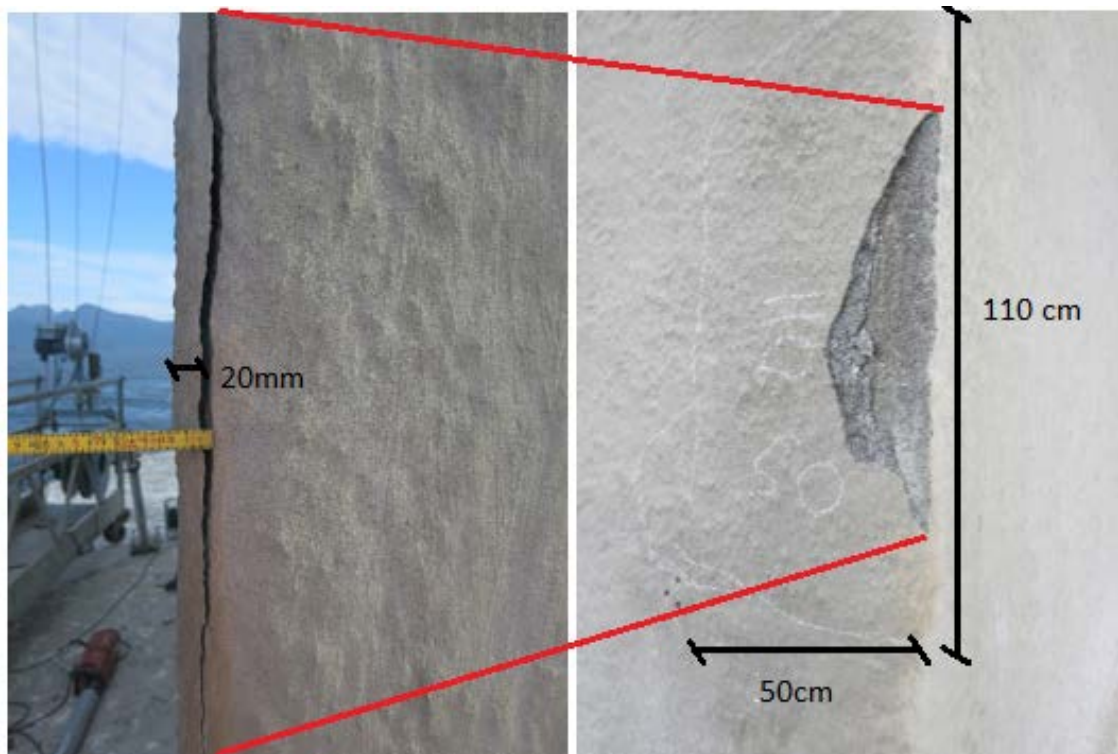
Figure 5-1 Delamination on pillar 11, north eastern corner. On the left the crack is shown before removing the delaminated mortar.

The thickness of this area of shotcrete can be considered small (<20mm) see Figure 5-1, and a possible reason for the lack of bond could be the low thickness.

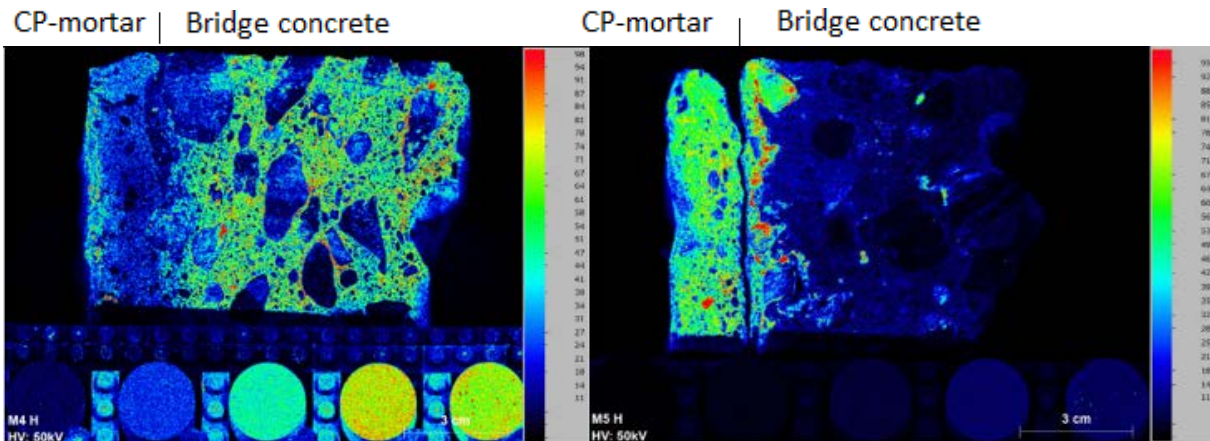
Figure 5-16 Core M4 and M5 with different levels of chloride ingress

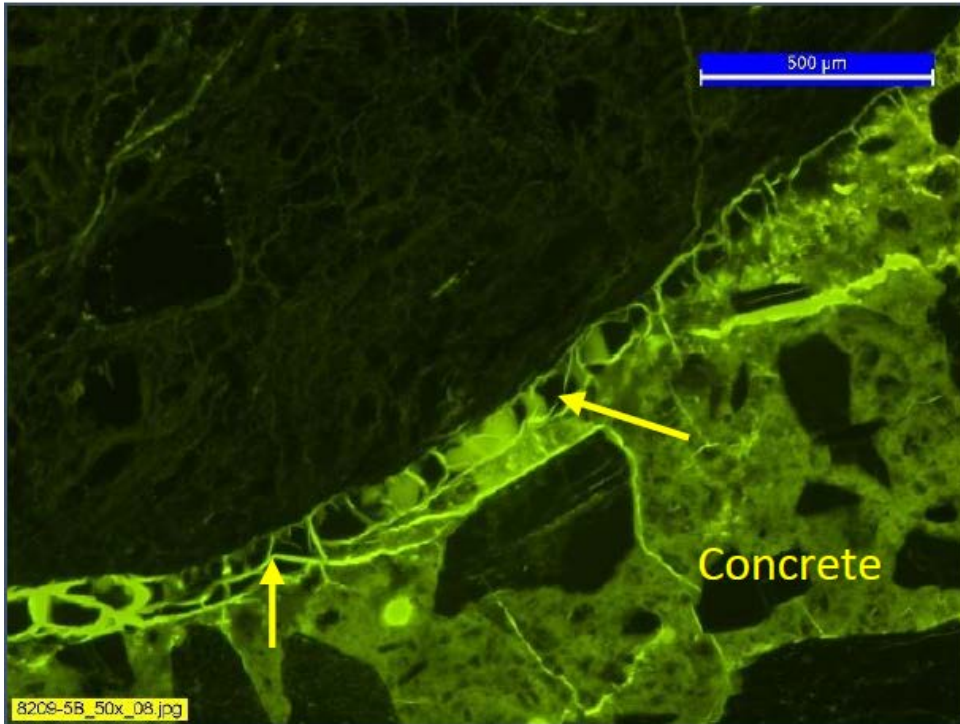
Several cracks near an corroded rebar in the bottom of the core is filled with alkali silica gel. Her gel is present around an gneissic aggregate.

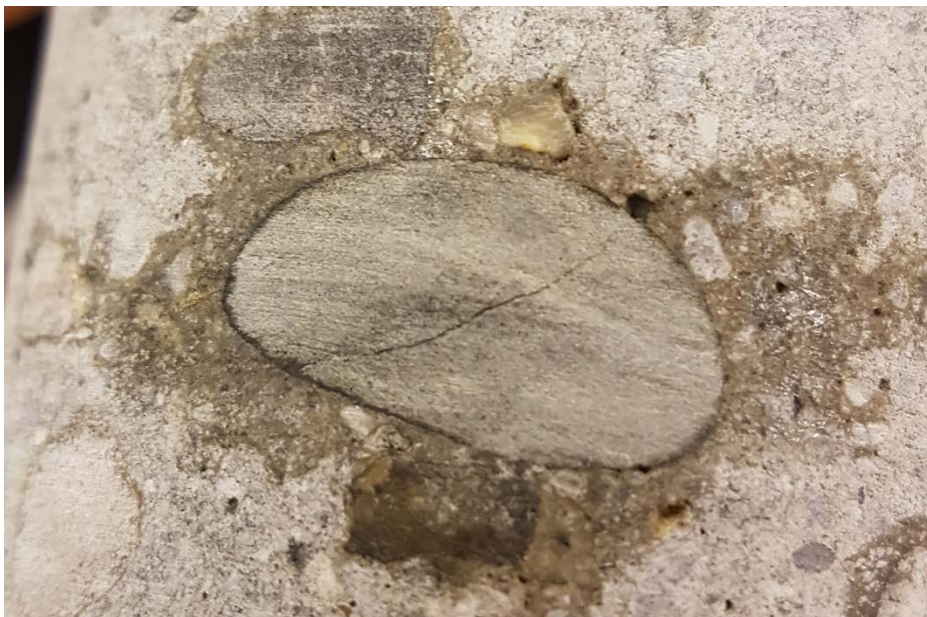
Figure 5-29 closeup of reactive aggregate in core M6.

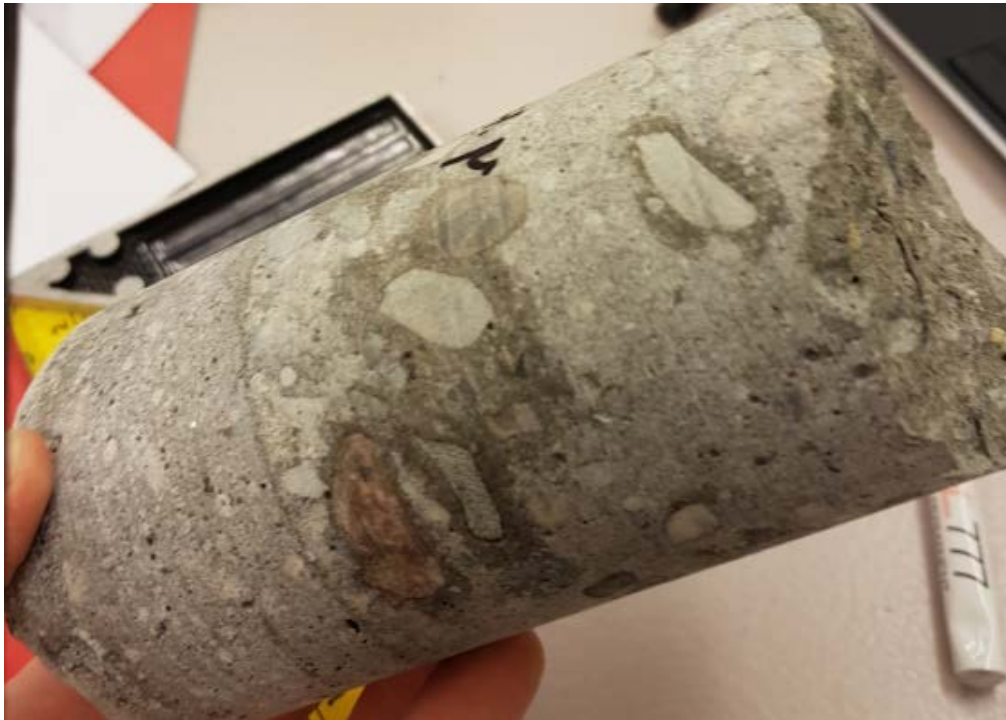
Figure 5-30 M6 showing several potential reactive aggregates, with surrounding moisture

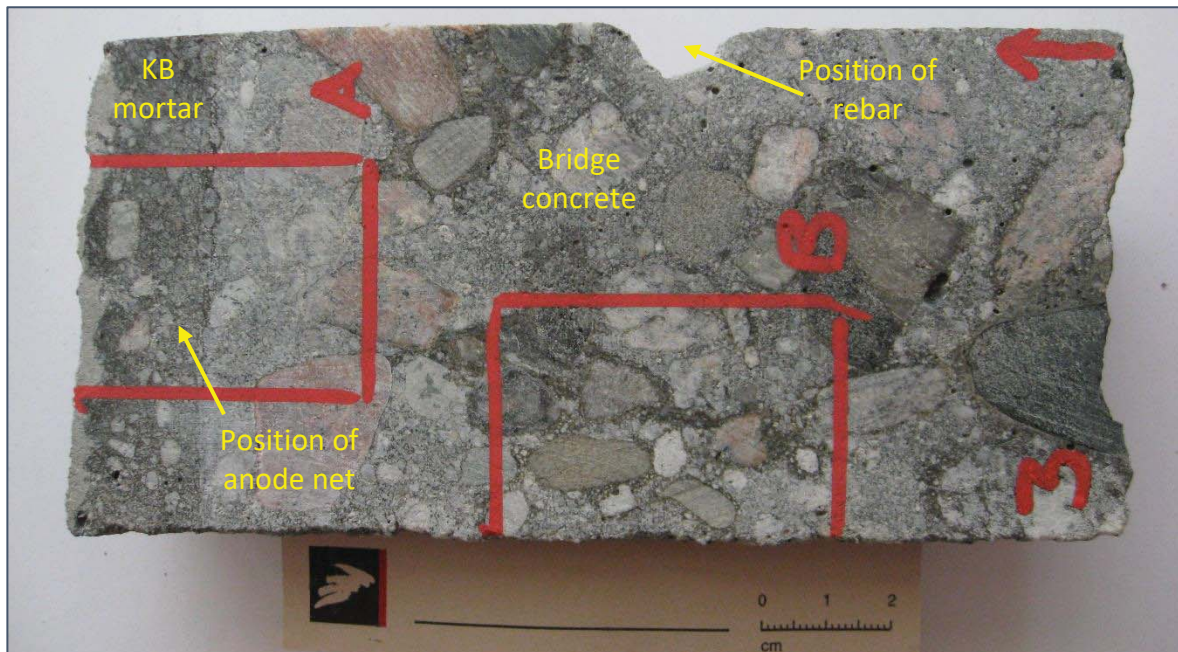
Core M3: Powered anode. Rusty appearance is seen on the upper surface of the rebar (on the other side of the core).

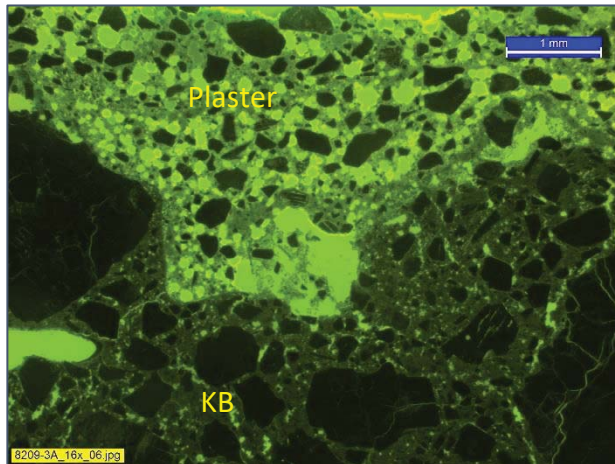
Interface between relative porous plaster and dense KB mortar, in an area with few micro-cracks in the KB paste.

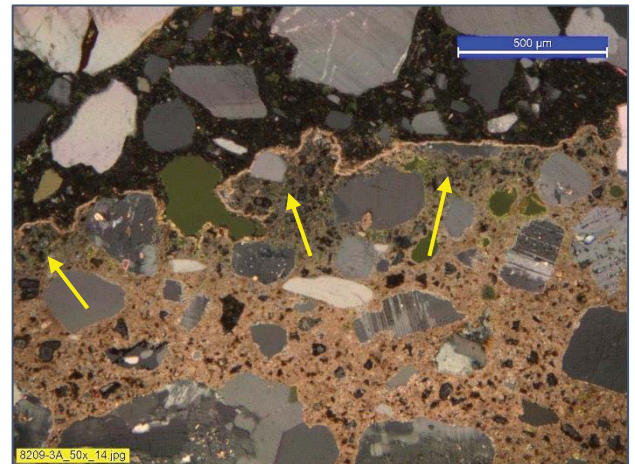
Interface between KB mortar and the carbonated, very uneven concrete surface. The upper 0,4mm of the concrete is somewhat de-carbonated.

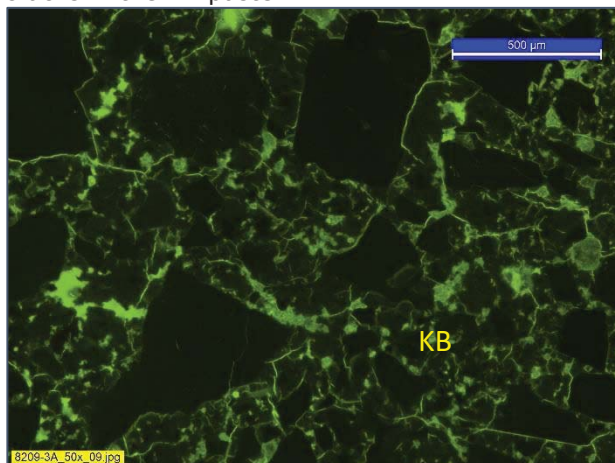
Generally, the paste of the KB mortar is highly dense and typically contains a lot of micro-cracks. Irregular shaped voids are frequent in the mortar.

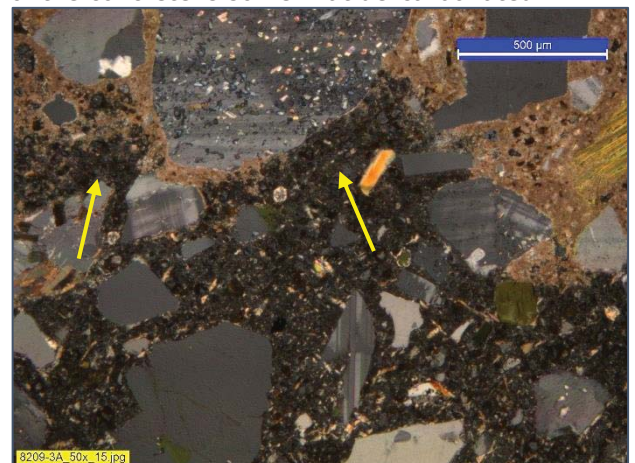
Interface between carbonated and non-carbonated paste in the concrete. CH is depleted in front of the carbonated paste (black paste).

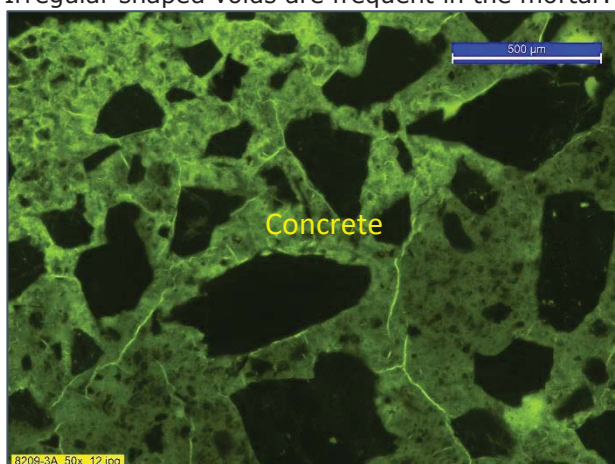
The paste of the concrete has a much higher capillary porosity compared to the KB paste. Micro-cracks are abundant. Fluorescent light mode.

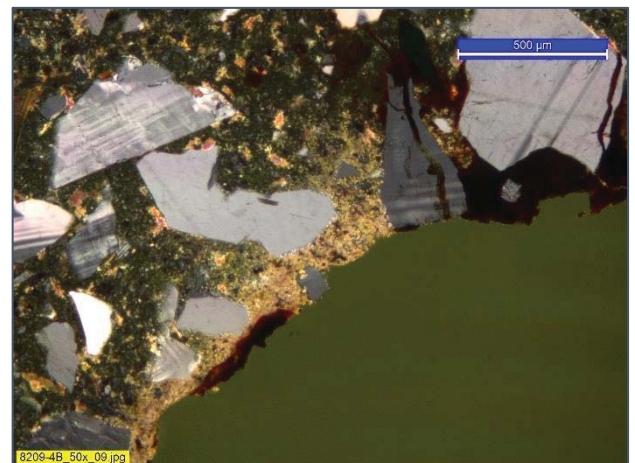
Bottom of section -B with rust lining imprint after rebar. Carbonated paste is seen along the imprint as well as along the fracture zone.

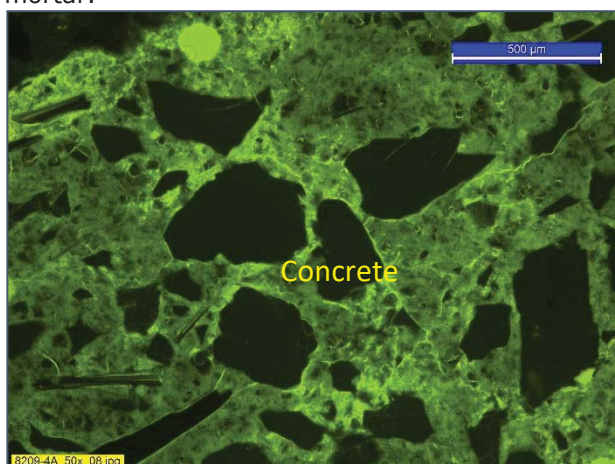
The paste of the concrete has a much higher capillary porosity compared to the KB paste. Micro-cracks are abundant. Fluorescent light mode.

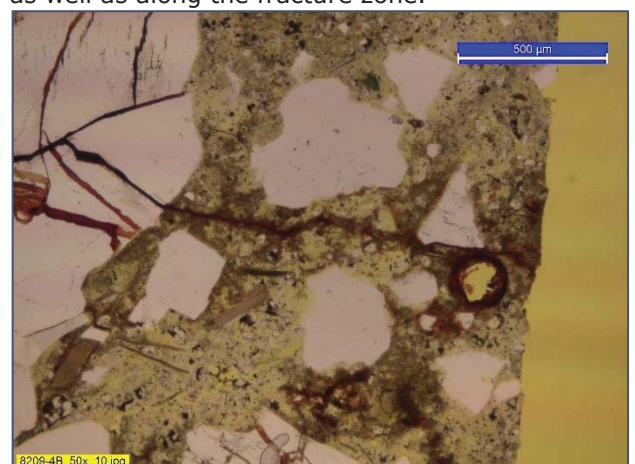
Cracks close to the rebar is more or less filled with rust. The paste in this area appears somewhat leached.

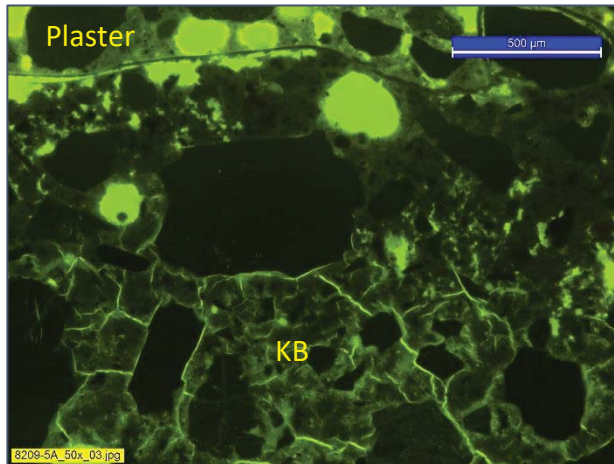
Interface between relative porous plaster and dense KB mortar. The KB paste contains a very high number of micro-cracks. Surface is dense.

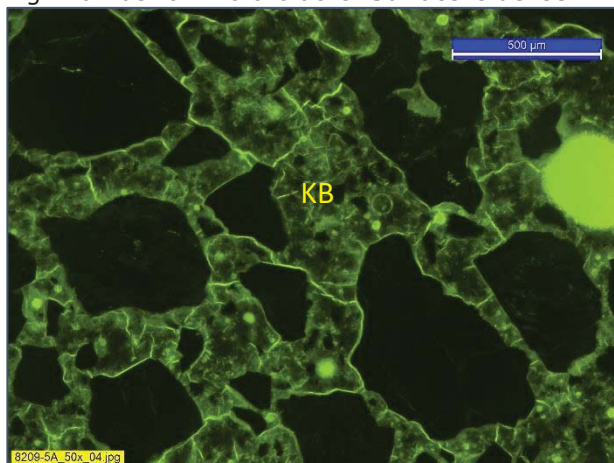
Generally, the paste of the KB mortar is dense and typically contains a lot of micro-cracks.

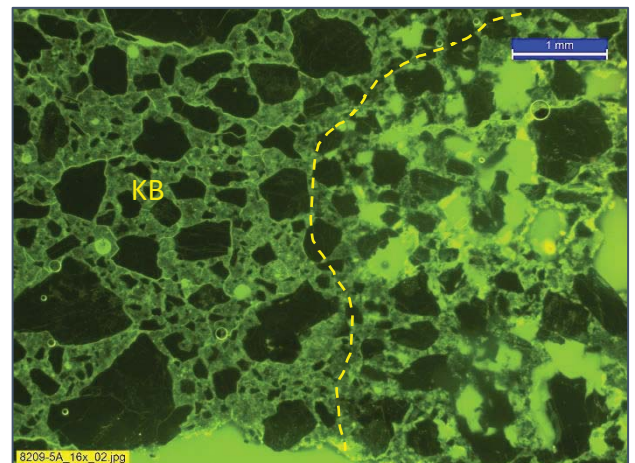
Porous area in the KB mortar (to the right), positioned near an anode. The dense paste is cracked.

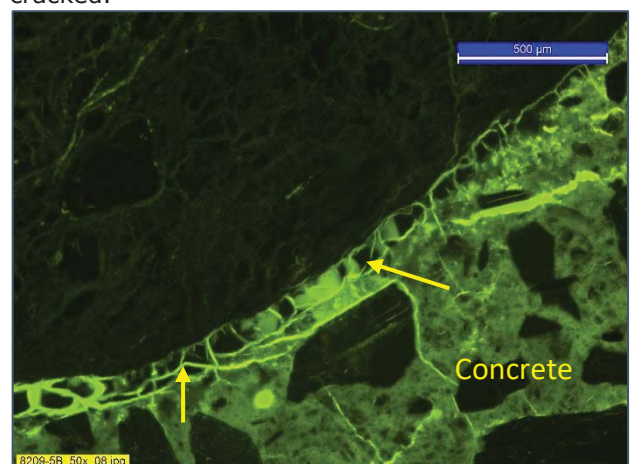
Several cracks near an corroded rebar in the bottom of the core is filled with alkali silica gel. Her gel is present around an gneissic aggregate.

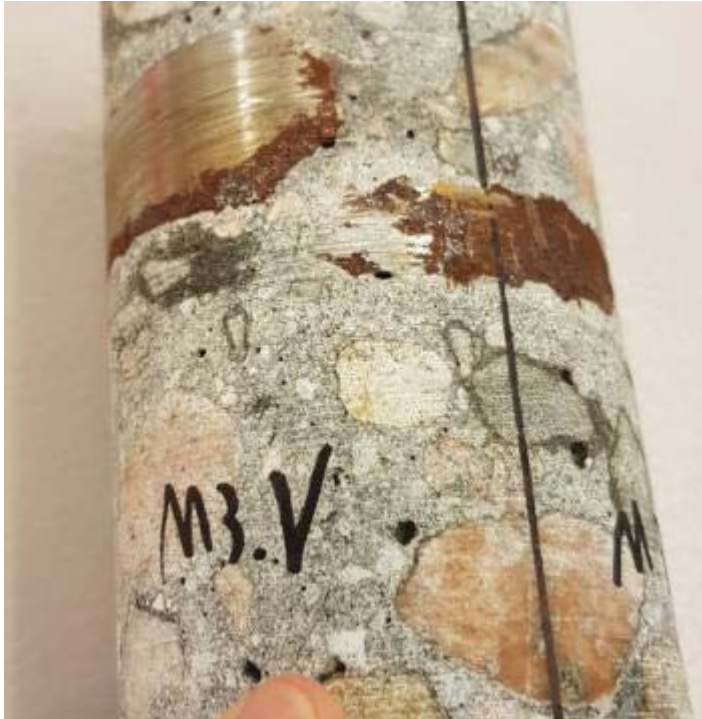
Figur 1 M3 etter 5 måneder pakket i plast på kjøll. Fukt rundt flere tilslag som antageligvis er ASR.

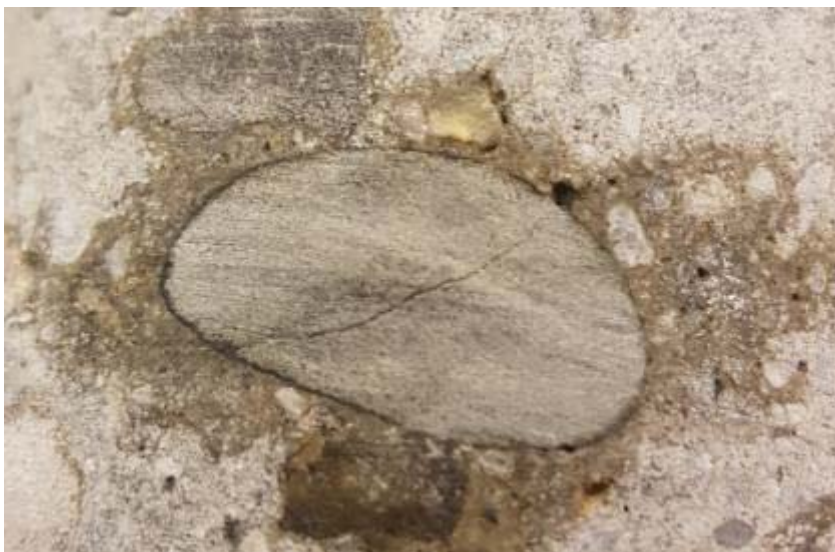
Figur 2 sprukket tilslag med tilsynelatende ASR rundt (dette bildet er av kjerne M6 som ikke ble sendt inn til tynnslip). **Ligner ASR men revnen går undersliggt på tværs af bjergartensstruktur. Kan du se revner ud i pasta?**

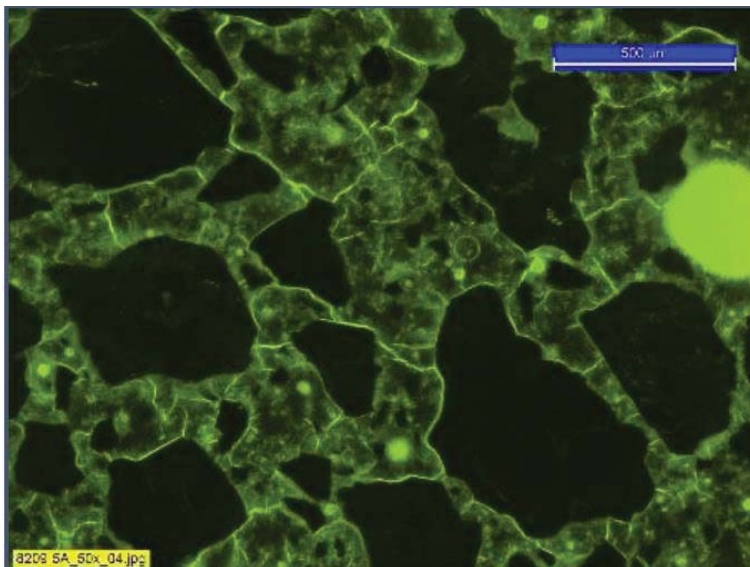
Figur 4 mulig frostskafe fra figur 1.
