Antonia Menga
Terje Kanstad
Daniel Cantero

Corrosion induced failures of post-tensioned bridges

Trondheim – May – 2022

Report

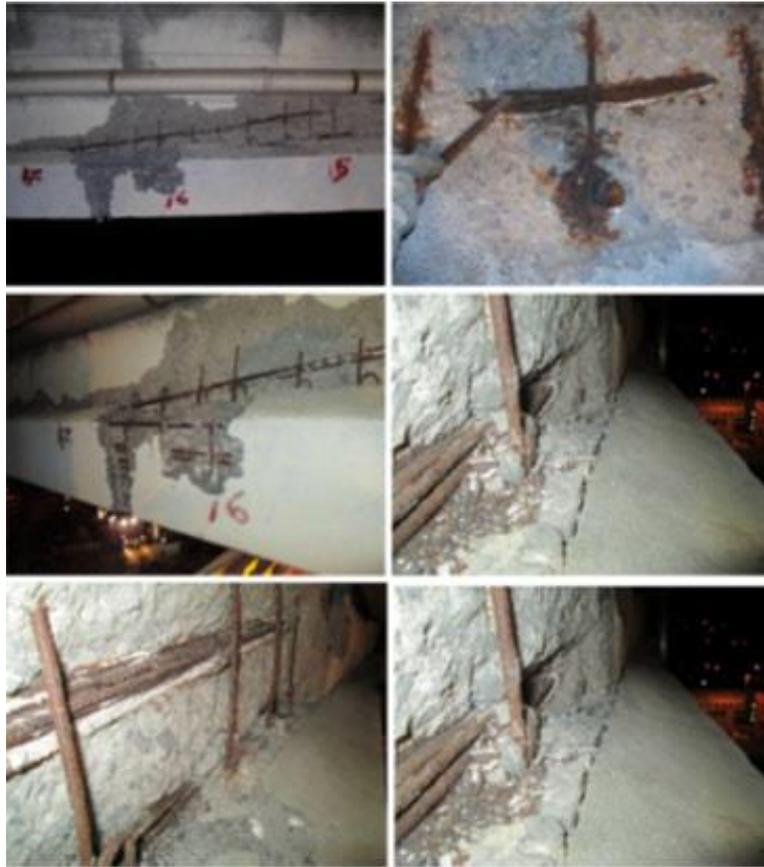
Figure 3.1.18. Polcevera Bridge (ID-6). View of cables toward the support in 2011 (top) and 2013 (middle). Zoom of the cables in 2013 (bottom) where corrosion and partial pitting can be observed (Nutti et al, 2020).

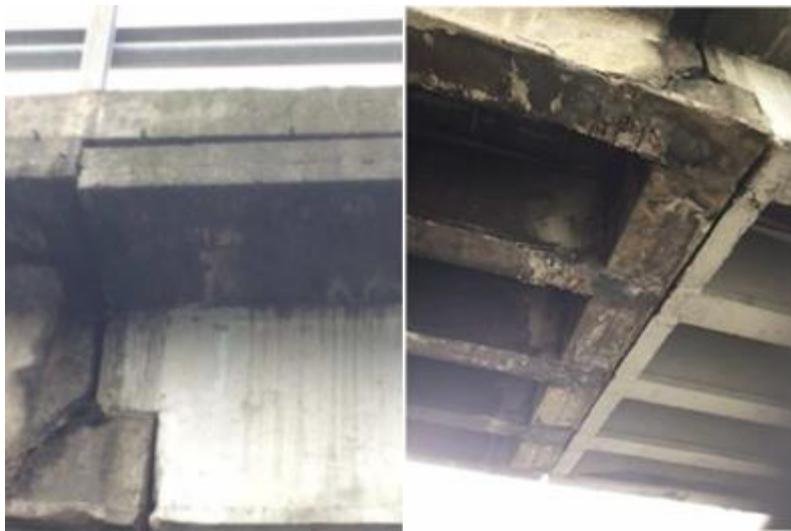
Figure 3.1.20. Annone Overpass (ID-21). Critical Gerber joint view before the collapse (Di Prisco et al, 2018).

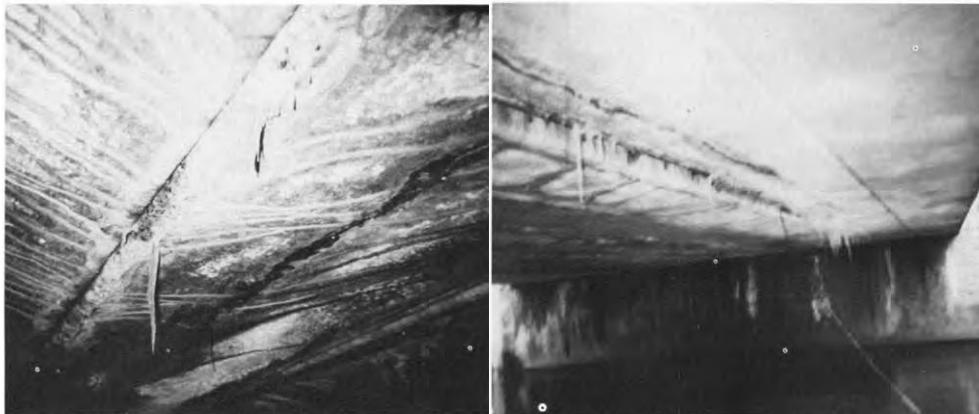
In Walnut Street Bridge (ID-31, see Section 2.2) stains were observed on the sides of the beams (Figure 3.1.22). The stains indicated that water had been seeping through the shear key joints between all beams. In addition, some of the beams were badly deteriorated with holes through the top flanges, crumbling concrete, and exposed strands (Murray and Frantz, 1992).

Figure 3.1.22. Walnut Street Bridge (ID-31). Stains on beams and ruptured strand hanging down into the river (Murray and Frantz, 1992).

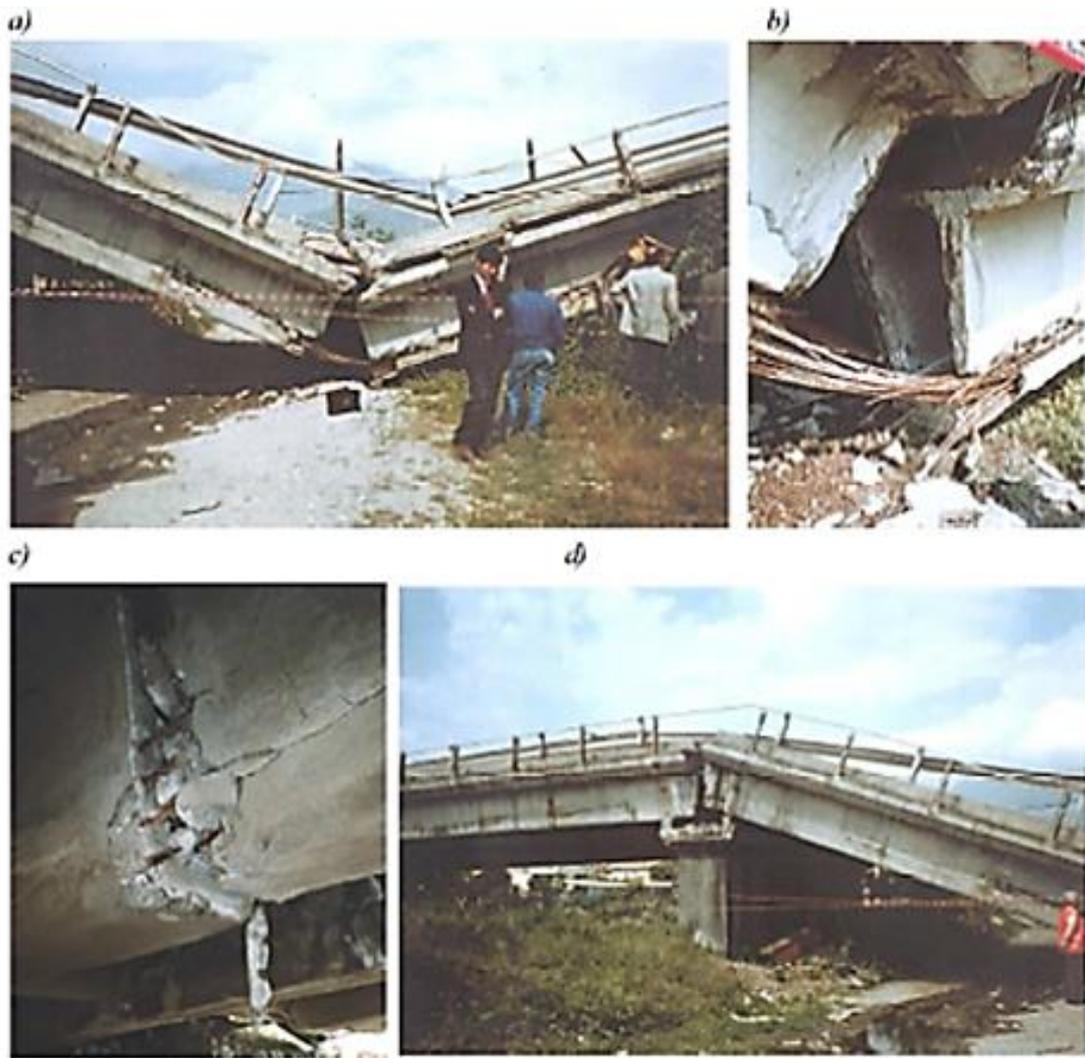
Figure 3.3.4. S. Stefano Viaduct (ID-2): a) collapse of the viaduct; b) slippage of cables; c) opening of joints; and d) rotation of the deck (Colajanni et al, 2016).

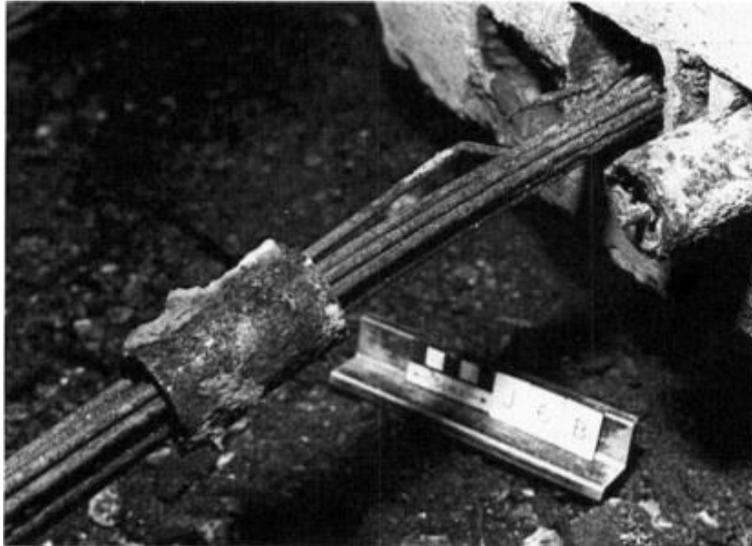
ID-1.4. Metal sleeve over longitudinal tendon: corrosion of tendons at joints (Woodward and Williams, 1988).

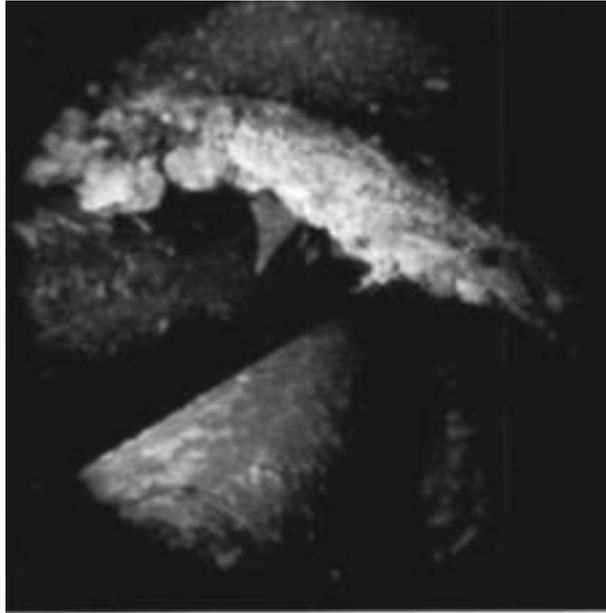
ID-1.7. Void at top of longitudinal duct: patches of cement paste on exposed wires (Woodward and Williams, 1988).

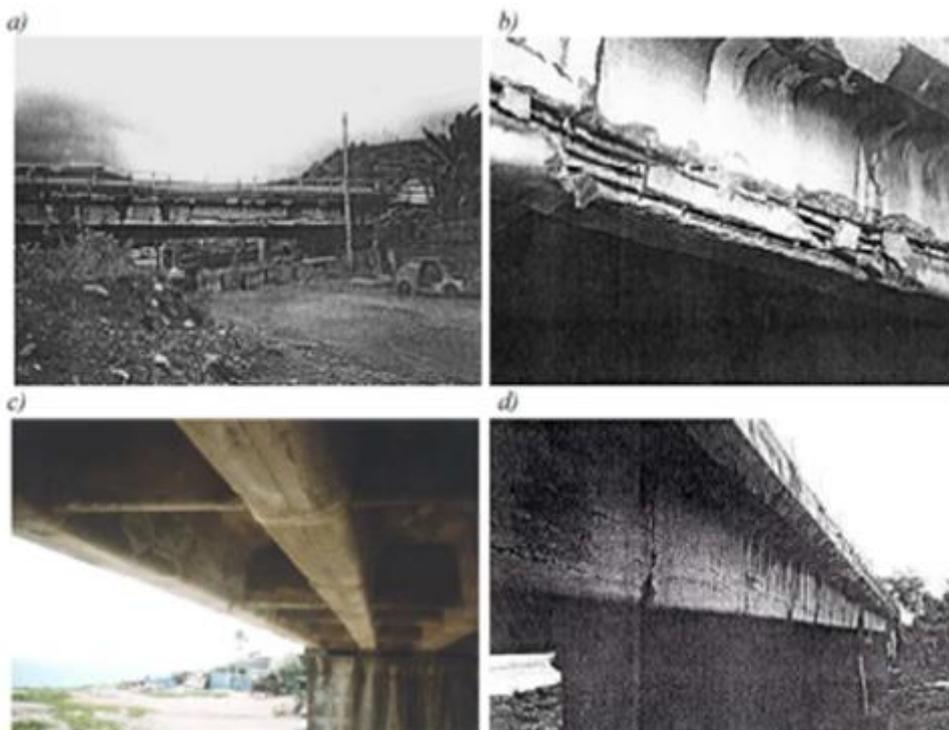
ID-2.2. S. Stefano Viaduct: a) beam shore side; b) details of corrosion phenomena on the shore side beam; c) bottom view of the deck; and d) damage on the beam mount side beam (Colajanni et al, 2016).

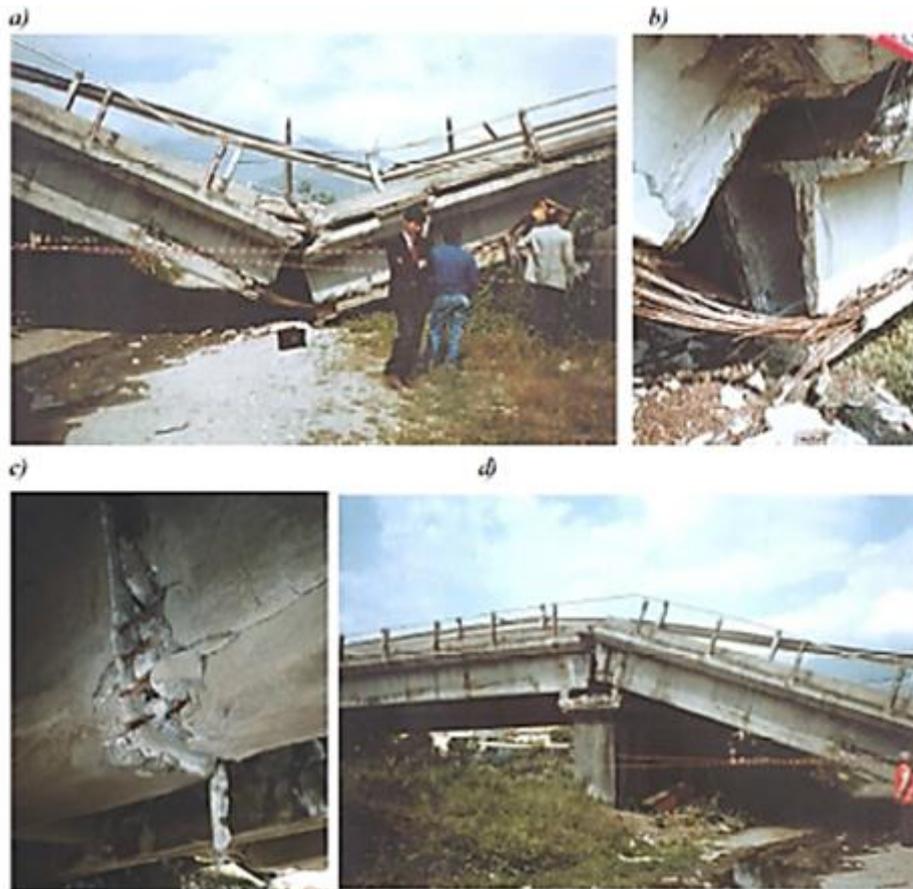
ID-2.3. S. Stefano Viaduct: a) collapse of the viaduct; b) slippage of cables; c) opening of joints; and d) rotation of the deck (Colajanni et al, 2016).

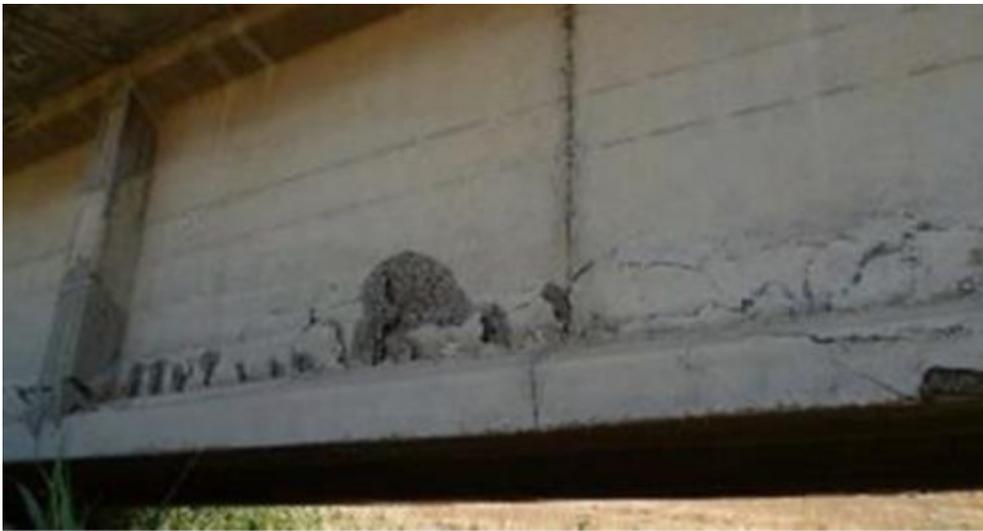
ID-4.8. Cracking in the other bridge spans (Anania et al, 2018).

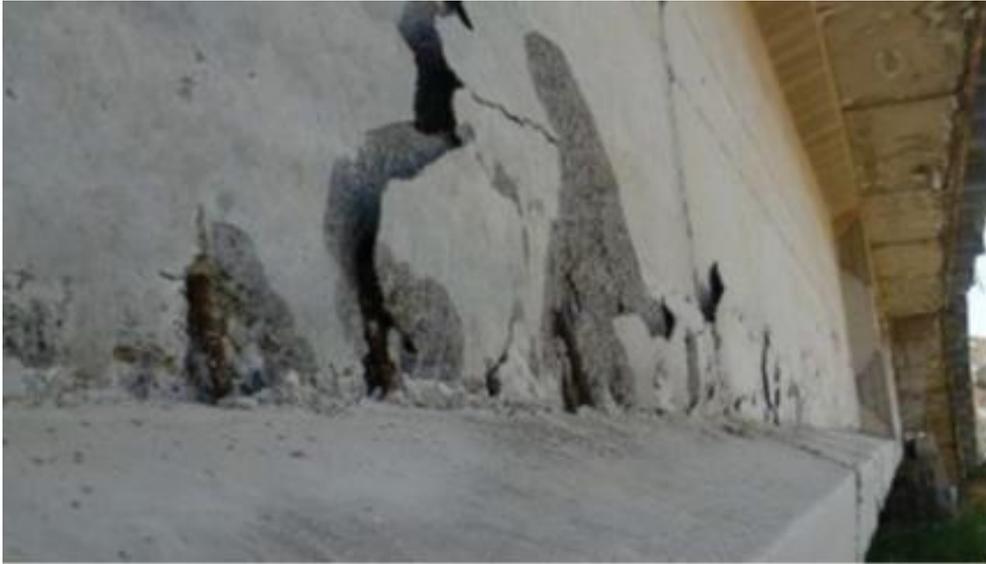
ID-4.10. Cracking on the bridge span due to tensile stress and to the expulsion of the stirrups (Anania et al, 2018).

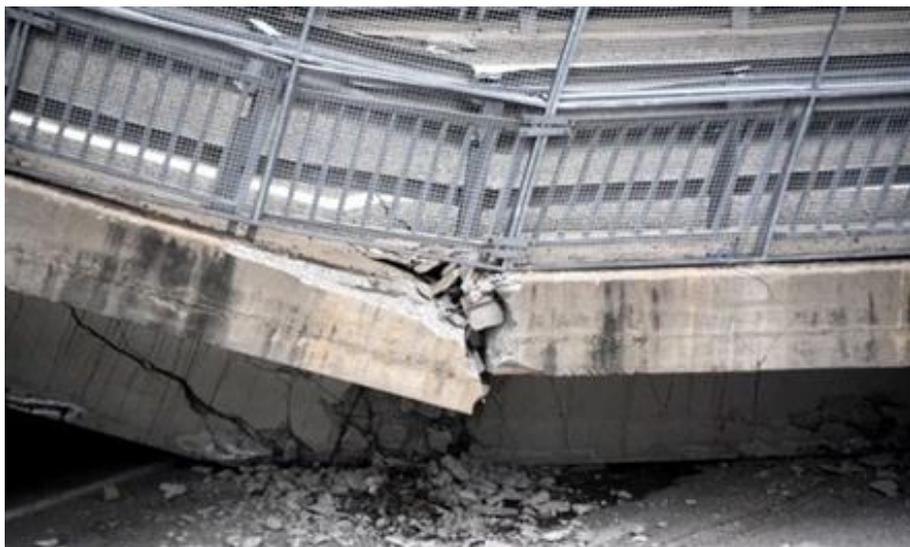
ID-5.2. Bridge beam: mid span fracture

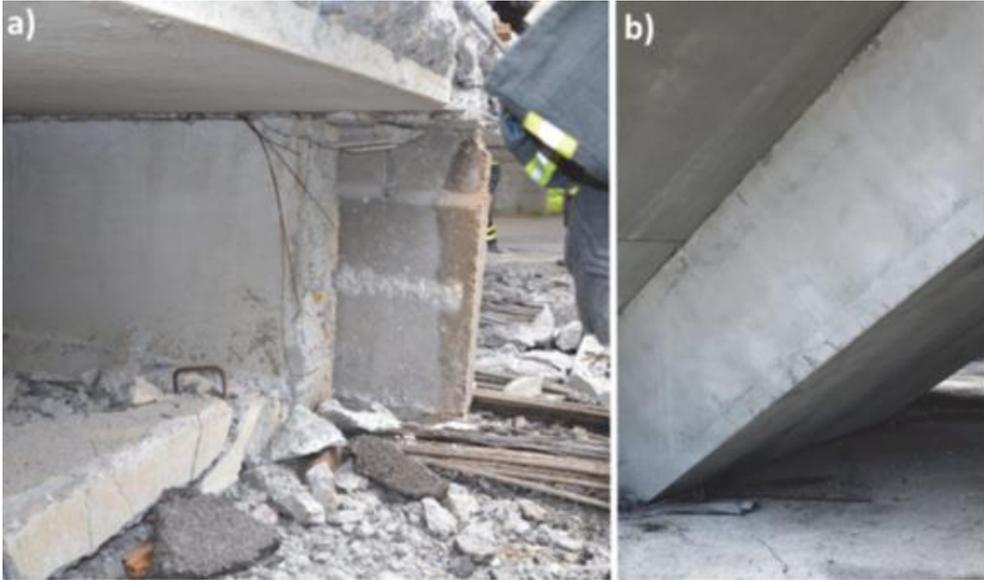
ID-5.4. Prestressing cables in the collapsed joint area (a); external concrete conditions (b) (Bazzucchi et al, 2018).

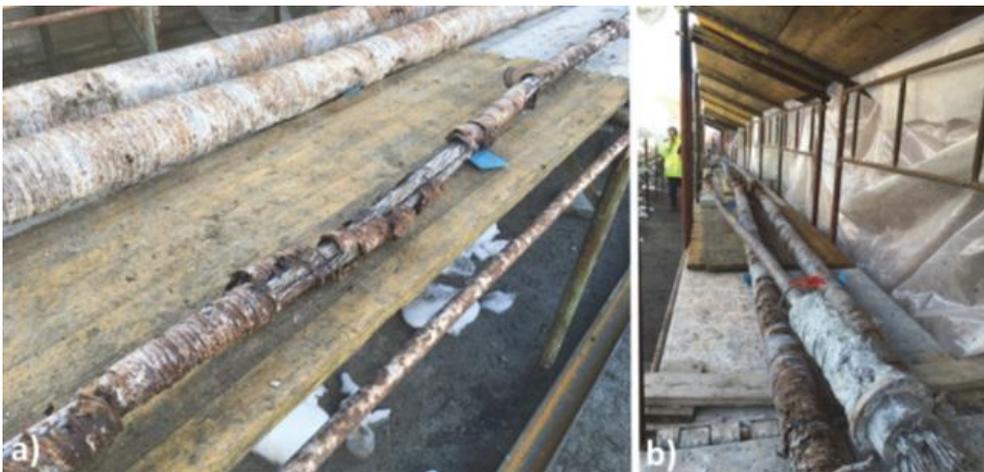
ID-5.5. Prestressing cables extracted and analysed. It is possible to note the direct correlation between grout content and oxidation rate of both sheathing and strands (Bazzucchi et al, 2018).

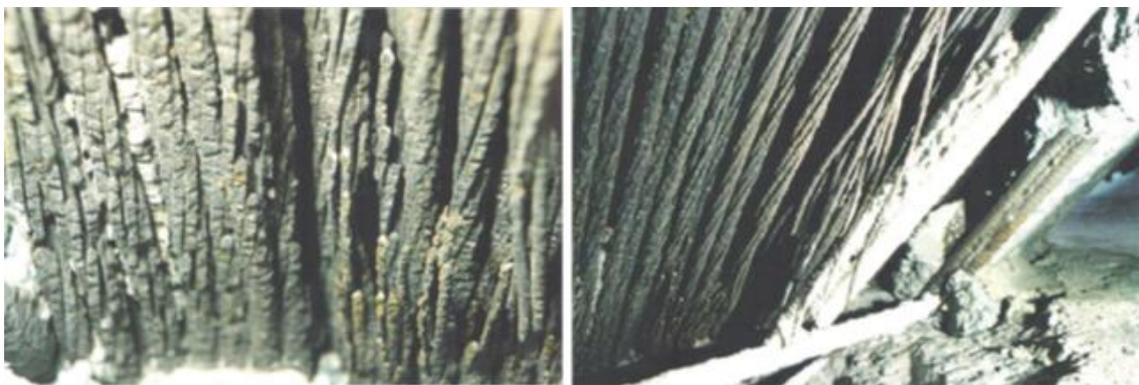
ID-6.6. Details of top part of the suspension cables, strongly corroded in 1991 (Nuti et al, 2020).

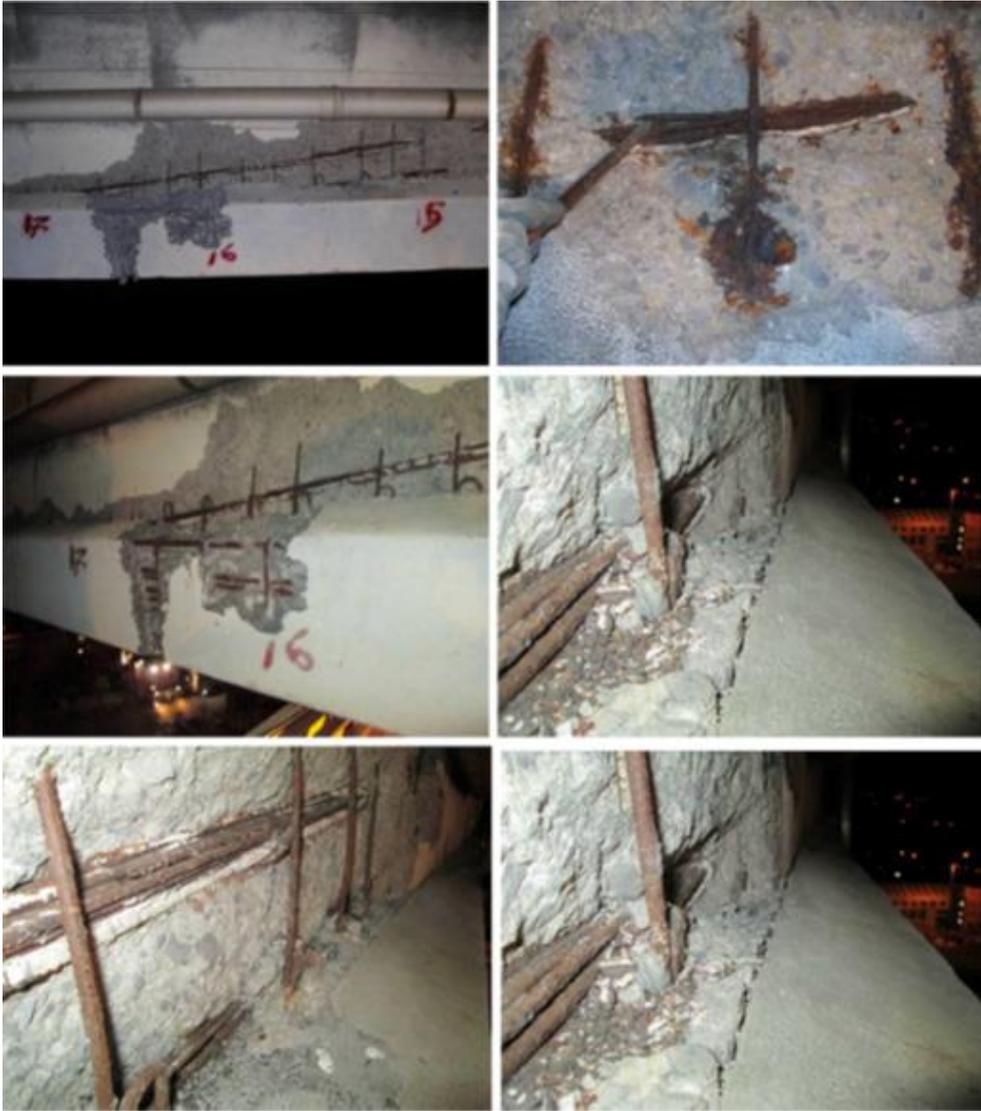
ID-6.7. View of cables toward the support in 2011 (top) and 2013 (middle). Zoom of the cables in 2013 (bottom) where corrosion and partial pitting can be appreciated (Nutti et al, 2020).

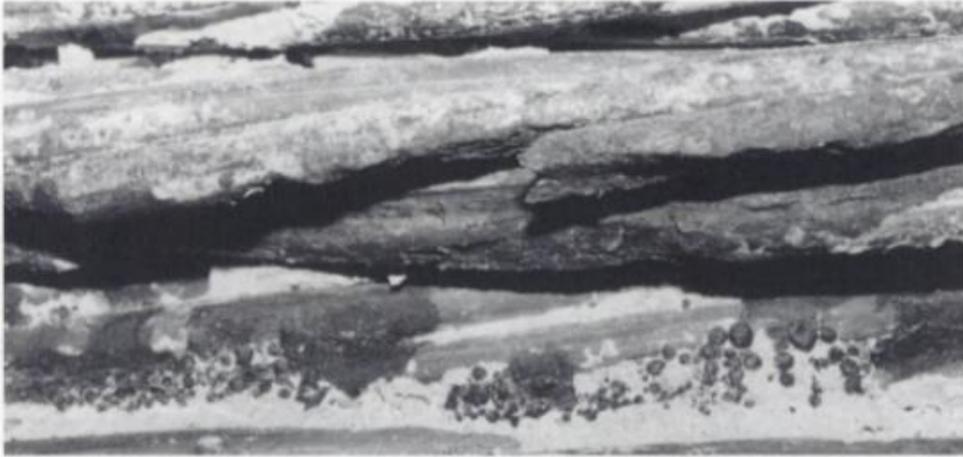
ID-7.4. Broken wire in one of the strands of Tendon 2 of Span 40-A (Venugopalan and Powers, 2003).

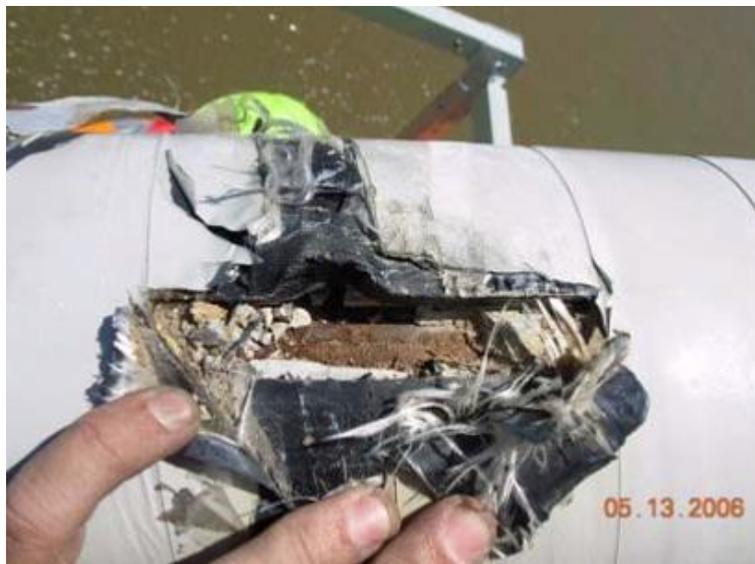
ID-10.2. Corrosion of wires at PE split (Mehrabi, 2009).

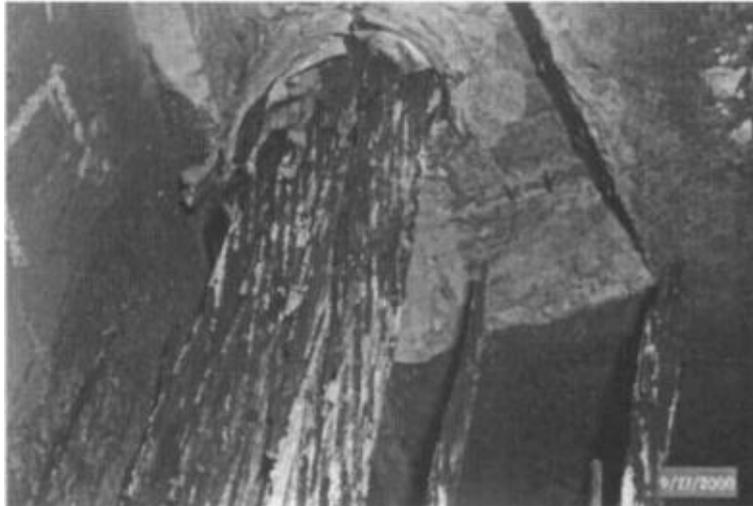
ID-11.5. Severe corrosion and failure just below the cap on the SE tendon in column 133 NB (Theryo et al, 2011).

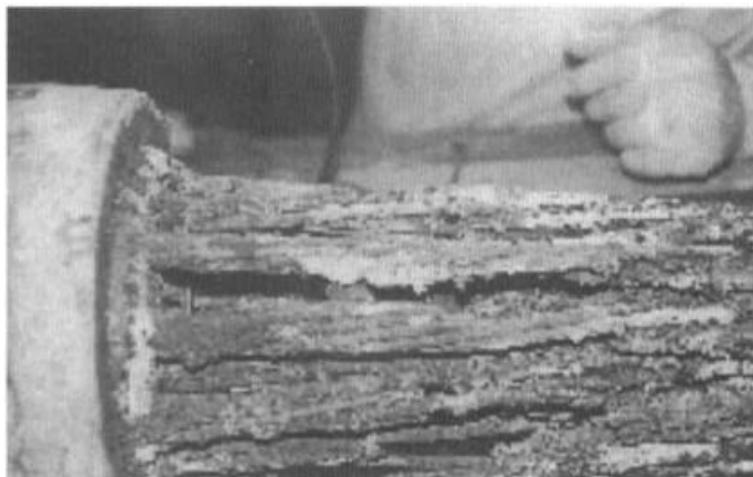
ID-11.6. Condition of strand inside the trumpet (Theryo et al, 2011).

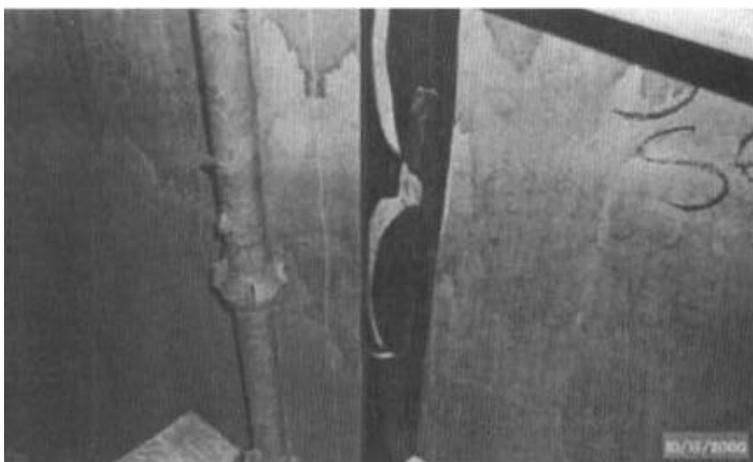
ID-11.7. Cracked PE duct (Theryo et al, 2011).

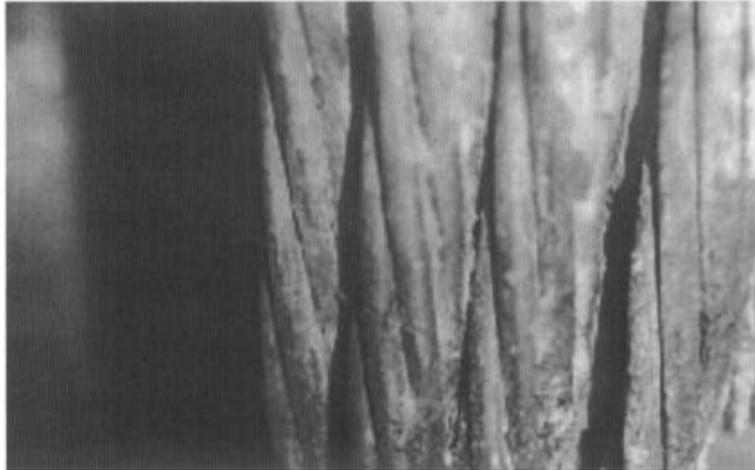
ID-11.8. Severe corrosion and strand failure in the NE tendon recess area at the bottom of segment 1 in column 131 SB (Theryo et al, 2011).

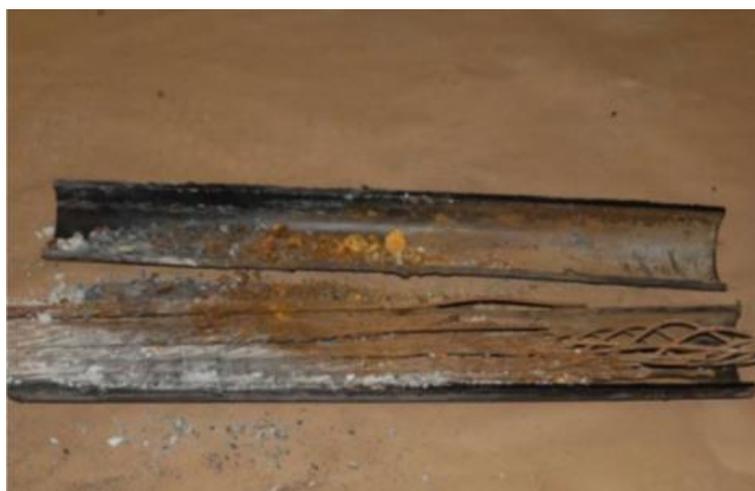
ID-15.3. Segment of failed tendon discovered in January 2011 with evidence of corrosion damage. Duct opened in laboratory during investigation (Ahern et al, 2018).

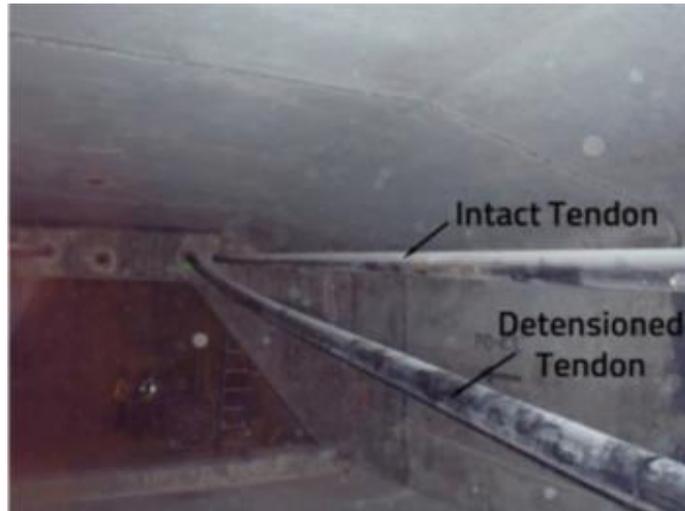
ID-15.4. Detentioned PT Tendon discovered in July 2011 (Ahern et al, 2018).

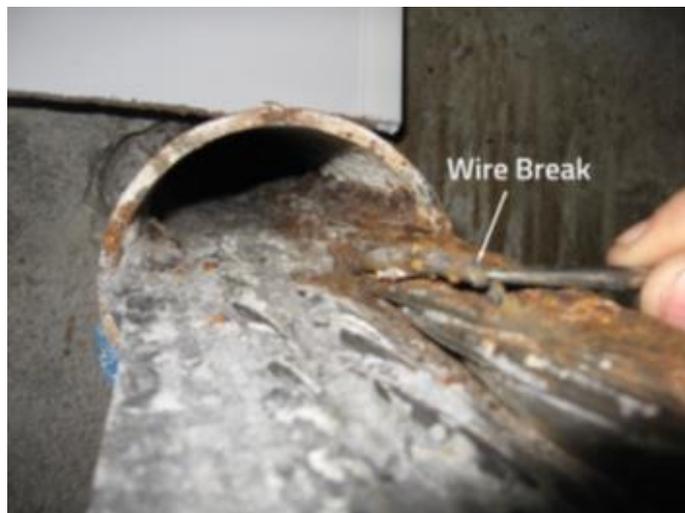
ID-15.4. Corrosion of strands and wire breaks identified in other external PT tendons (Ahern et al, 2018).

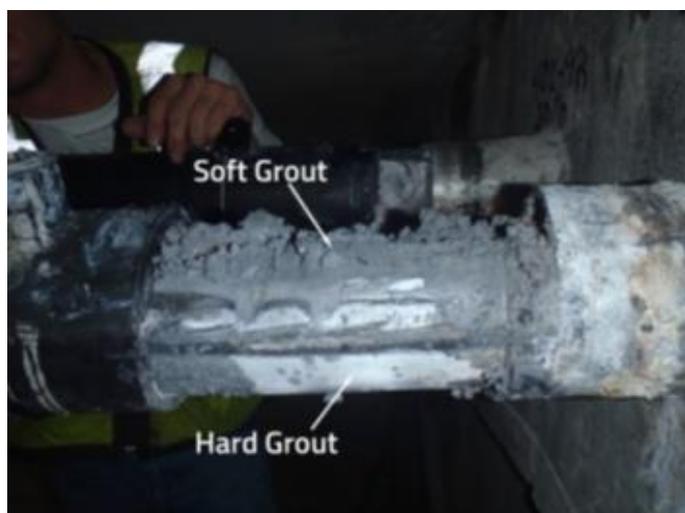
ID-15.5. Segregation of the grout material observed near the high points of the tendon profile (Ahern et al, 2018).

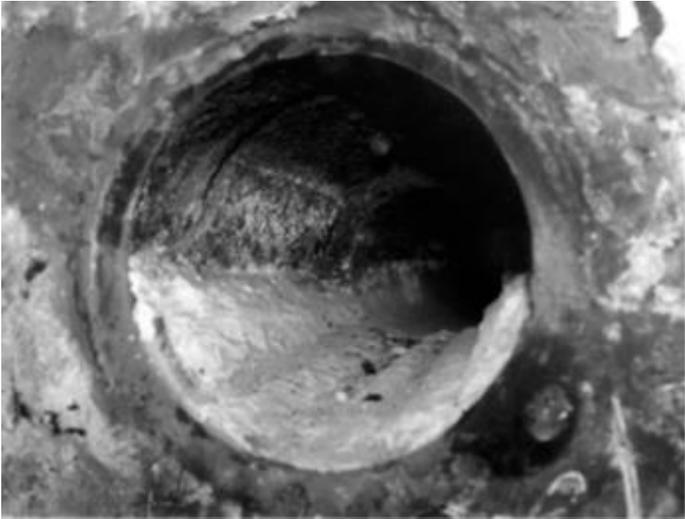
ID-17.2. Anchor at failed tendon showing chalky grout, partial grout filling and heavy corrosion (Powers et al, 2002).

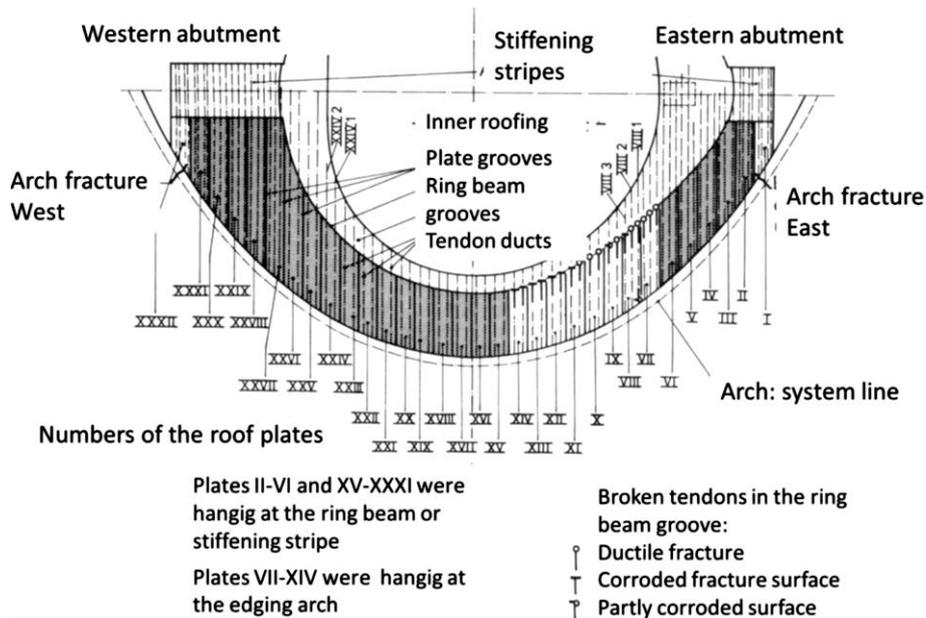
ID-19.4. Ground view with the location of corroded and broken tendons (Helmerich and Zunkel, 2014).

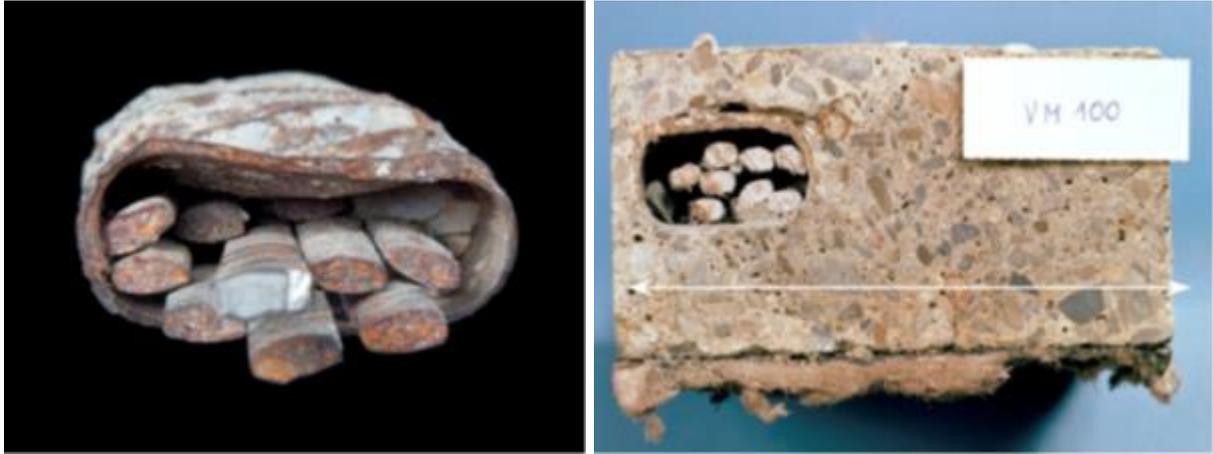
ID-19.7. Prestressing wires are almost not embedded in the protective grout (left) or insufficient grouted (right). Only one broken wire (left) shows a non-corroded brittle broken fracture surface. (Helmerich and Zunkel, 2014).

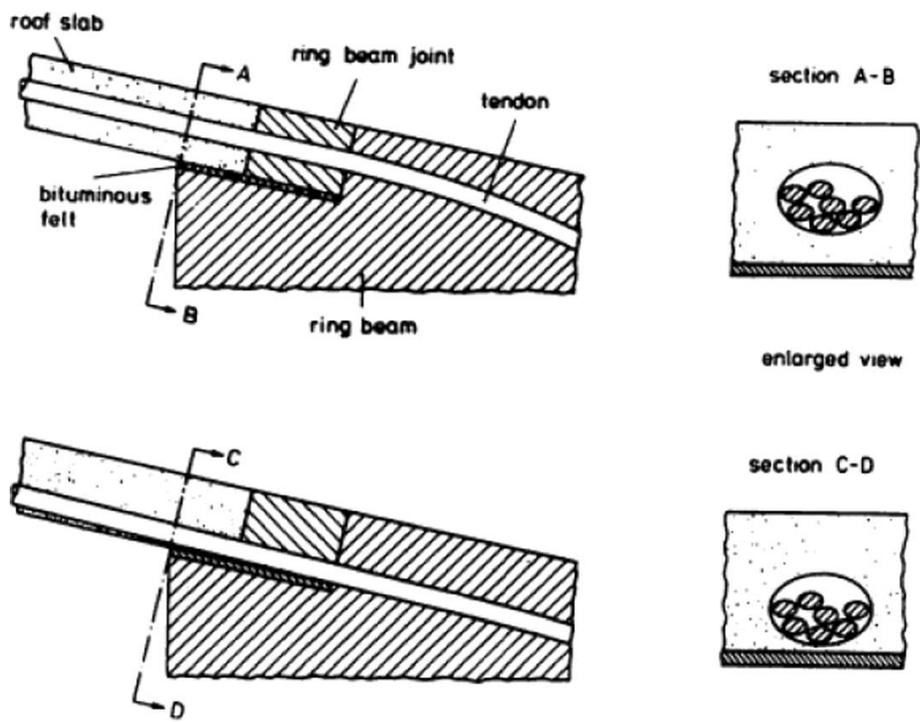
ID-19.8. Intended (upper) and real location (lower) of tendons (left) and wires in the tendon duct (right) (Helmerich and Zunkel, 2014).

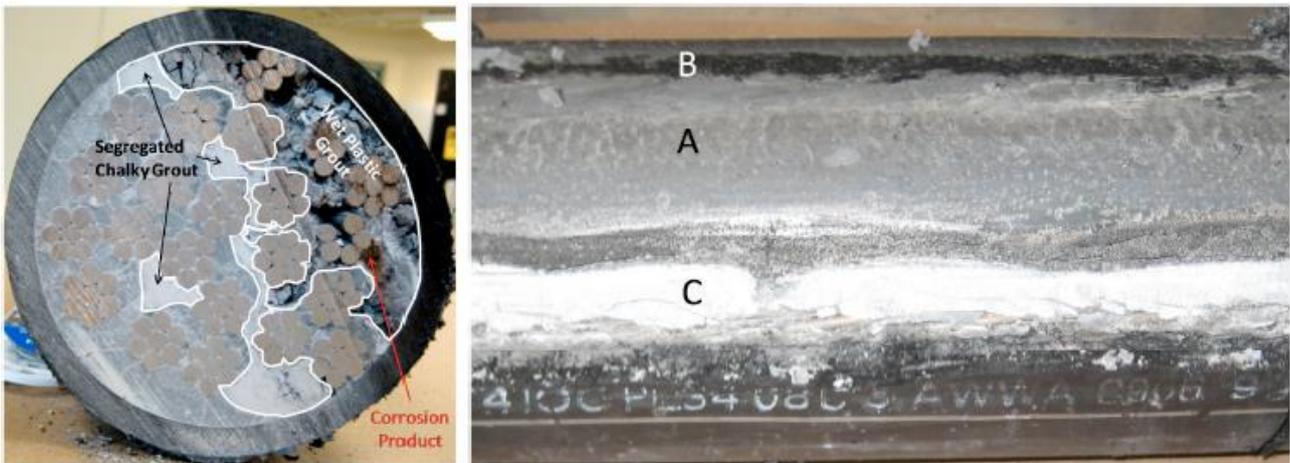
ID-20.3. Grout segregation appearance. (A) Wet plastic grout. (B) Dark band of sedimented silica fume. (C) White chalky grout (Permeh et al, 2016).

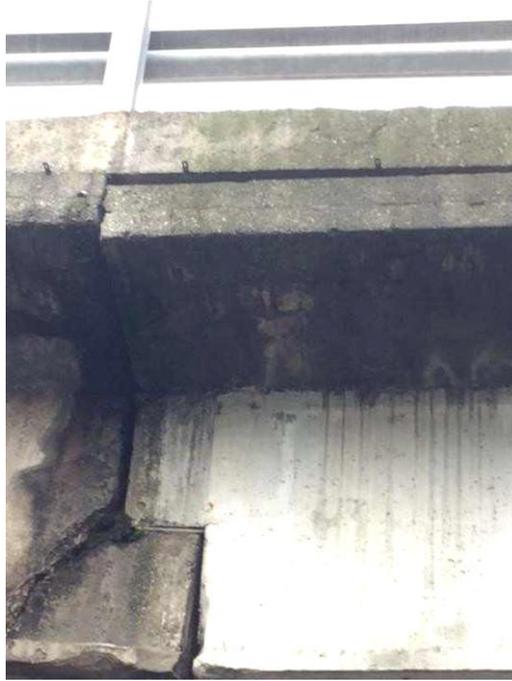
ID-21.7. Critical dapped-end joint view before the collapse: side view (Di Prisco et al, 2018).

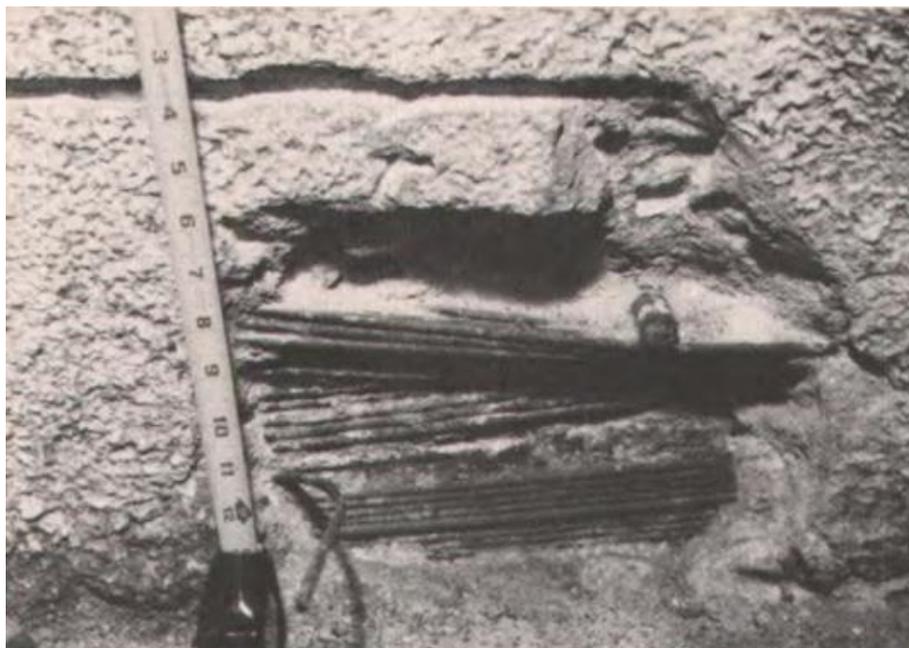
ID-42.1. Corroded wires bundled around a pipe. Shotcrete protection did not penetrate bundle and was not bonded to tank wall (Schupack and Suarez, 1982).
