Korrosjonsforsøk på bolter i Vardøtunnelen

Etatsprogrammet Varige konstruksjoner 2012-2015

Nr. 464

Corrosion test on rock bolts in the Vardø tunnel

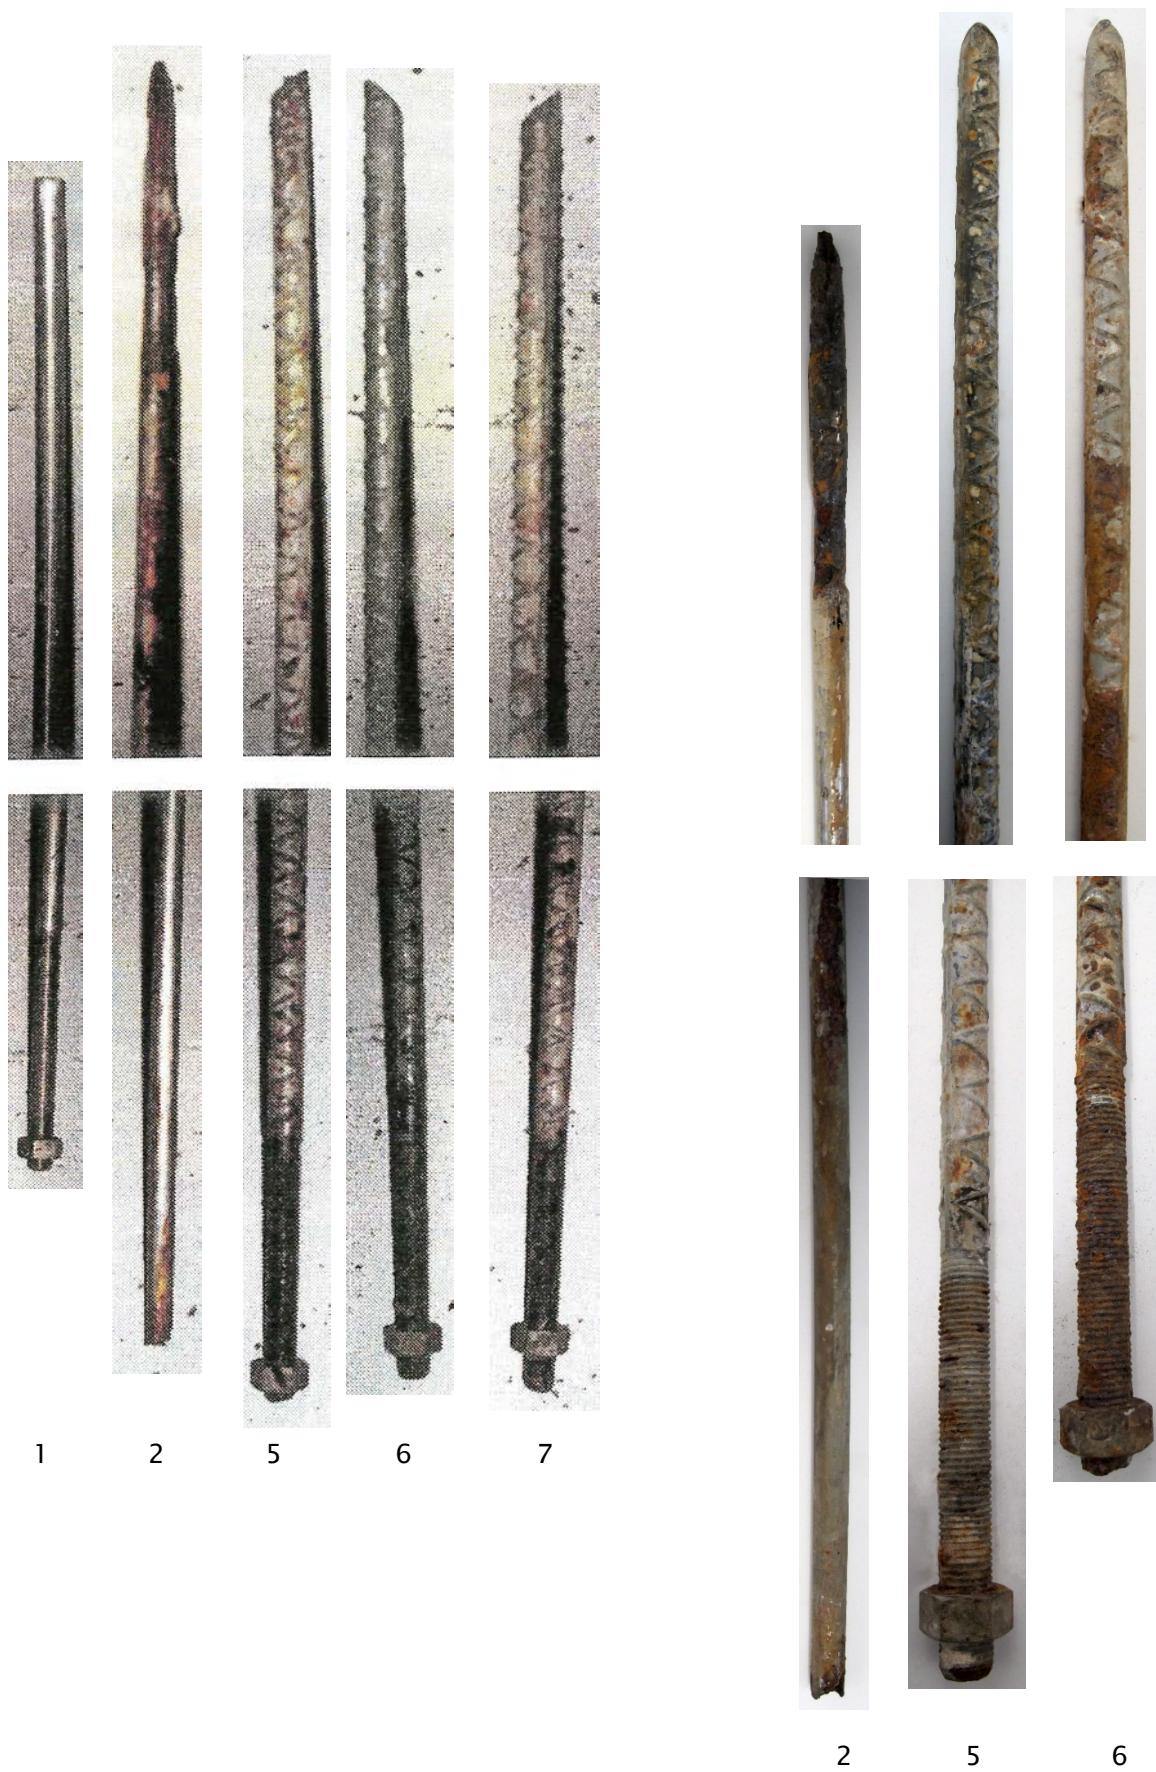
Bolt nr.		Inspeksjoner		
		1988	1992	2011
1	Rustfritt rundstål	Ingen korrosjon.	Ingen korrosjon.	-
2			Sterkt korrodert. Kraftig korrosjon på en halvdel – økende grad mot enden av boltehull. Kraftig korrosjon/ groptæring i begge bolteender.	Sterkt korrodert. Tilsynelatende lite forandring fra 1992.
3		Noe korrosjon på boltestamme og i gjenge- partiet.	-	-
4		Noe korrosjon i gjengepartiet.	-	-

Figur 1 Bolt nr. 1, 2 (rustfrie kvaliteter) og 5-7 (kamstålbolter) i 1992 t.v. [1], bolt nr. 2, 5 og 6 i 2011 t.h.

Av de rustfrie boltene er det kun én igjen, bolt nr. 2. Det er ingen visuell beskrivelse av bolten før etter 11 år, men da er den beskrevet som sterkt korrodert og det ser man også fra foto (Figur 1). Denne bolten var den første i testfeltet som viste en reduksjon i vekt. Ut fra rapportert vekt ser man en voldsom endring i korrosjonshastigheten fra de første syv årene til de neste 23 årene. Fra 0,4 gram per år til nesten 6 gram per år. Det er mulig at bolten ikke ble tilstrekkelig rengjort før veiing i 1988 og at den reelle vektreduksjonen var større de første 7 årene. Visuelt ser boltene veldig like ut i 1992 som i 2011, noe som kan tyde på at det har vært lite korrosjon de siste 19 årene.

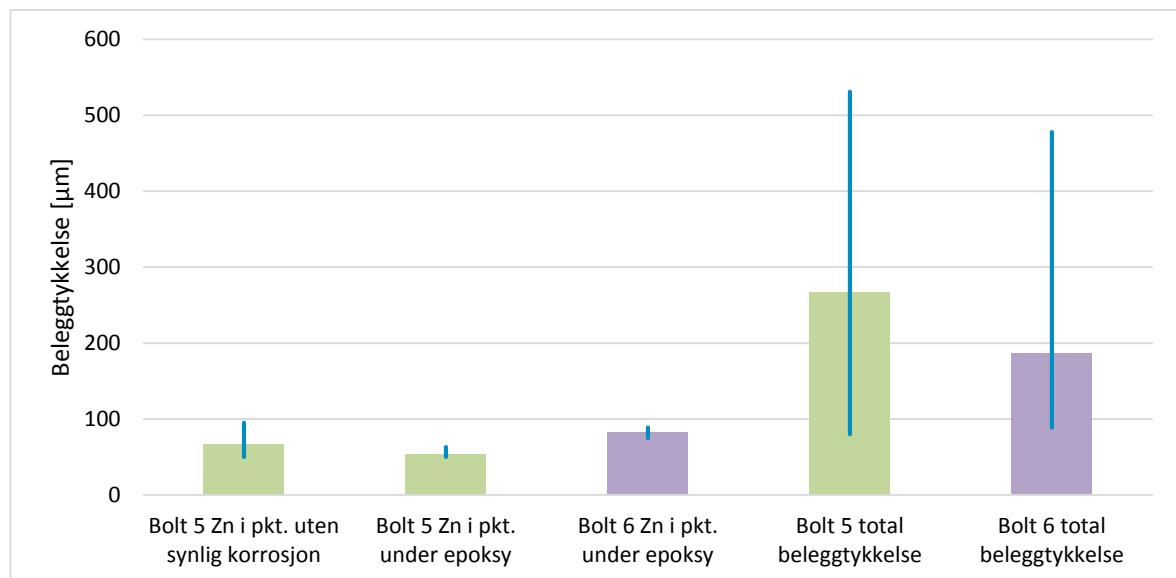
Målte beleggtykkelser for boltestammene til bolt nr. 5 og 6 er angitt i Figur 2. Sinktykkelsen er målt i punkter der løs epoksy ble fjernet og for bolt 5 ble sinktykkelsen også målt i områder uten synlig korrosjon. Dette ble ikke gjort for bolt 6 da den ikke hadde områder uten synlig korrosjon. Total beleggtykkelse er målt systematisk langs hele boltestammen. Det er ingen målinger av beleggtykkelse fra boltenes gjengepartier.

Søylene i figuren angir gjennomsnittlig tykkelse, mens linjene gir spredningen.

Bolt nr. 5				Bolt nr. 6			
	Antall pkt.	Min (µm)	Maks (µm)	Gj.snitt (µm)	Antall pkt.	Min (µm)	Maks (µm)	Gj.snitt (µm)
Sinktykkelse* (i punkter uten synlig korrosjon)	10	50	95	67				
Sinktykkelse* (epoksy fjernet)	3	50	63	54	2	75	89	82
Total tykkelse* (sink + epoksy)	33	80	531	267	24	89	478	187

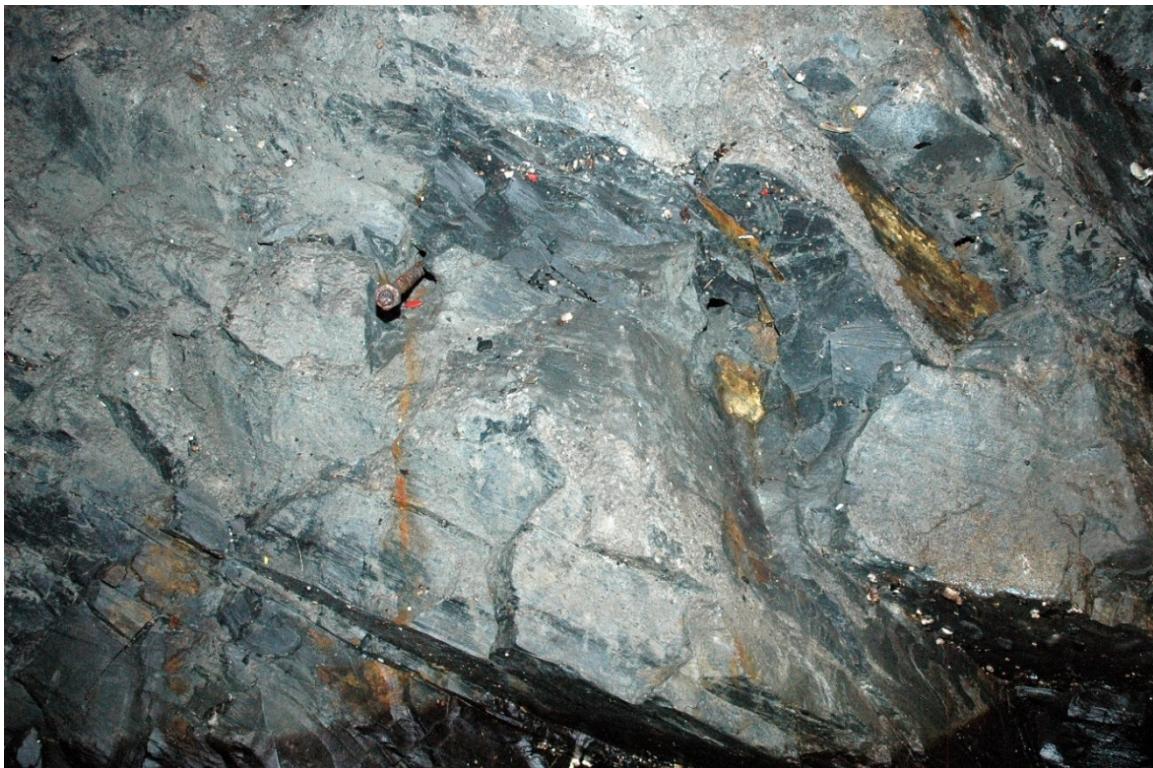
Figur 1 Boltehull nr. 1 (lengst fra inngang pumpebrønn) med bolt nr. 6 (kamstål) og boltehull nr. 2 og 3 som er tomme

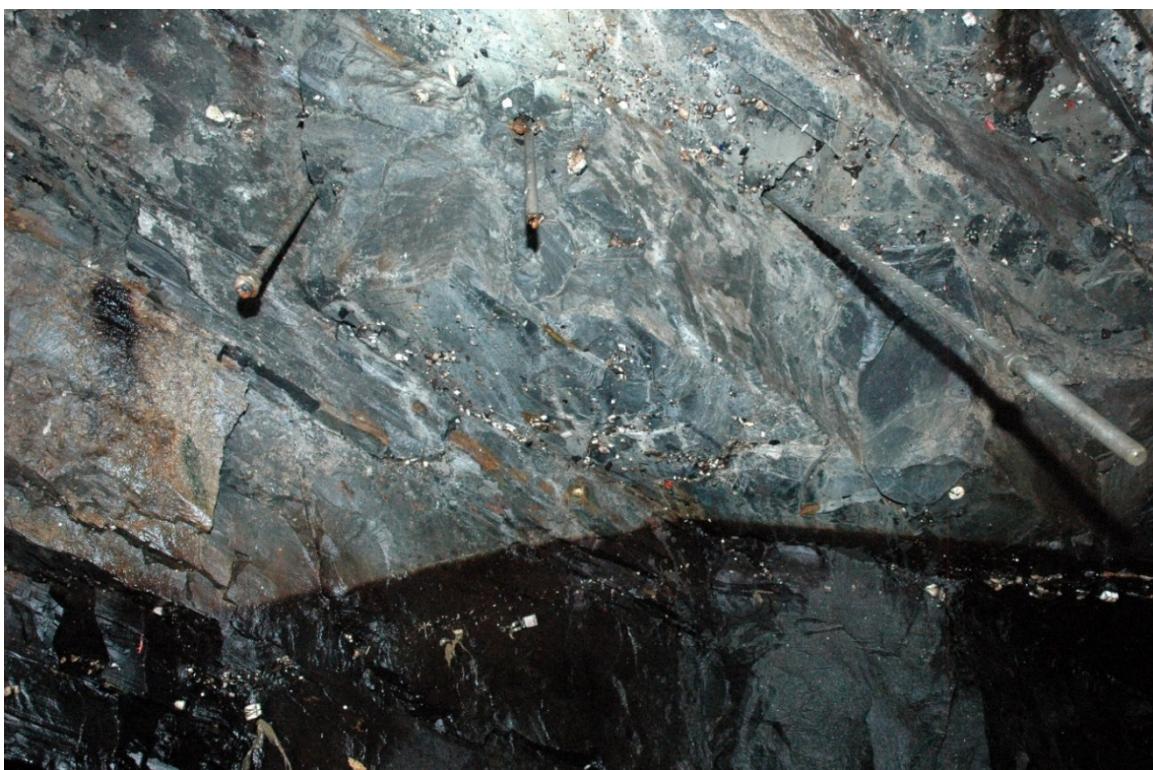
Figur 2 Boltehull nr. 4 med bolt nr. 5 (kamstål), boltehull nr. 5 med bolt nr. 2 (rustfri) og boltehull nr. 6 med «ny» ukjent bolt som ikke tilhører testfeltet.

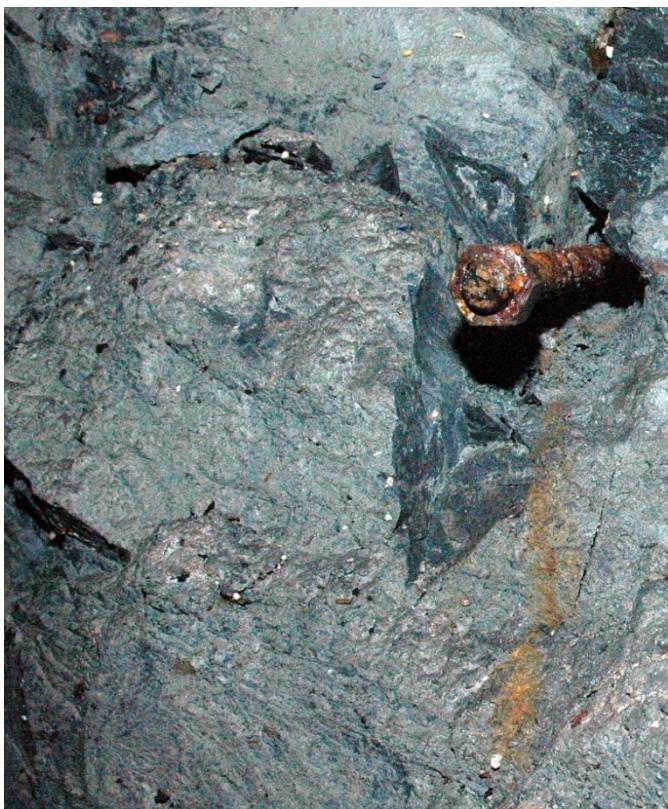
Figur 3 Kamstålbolt, nr. 6 (i boltehull nr. 1)

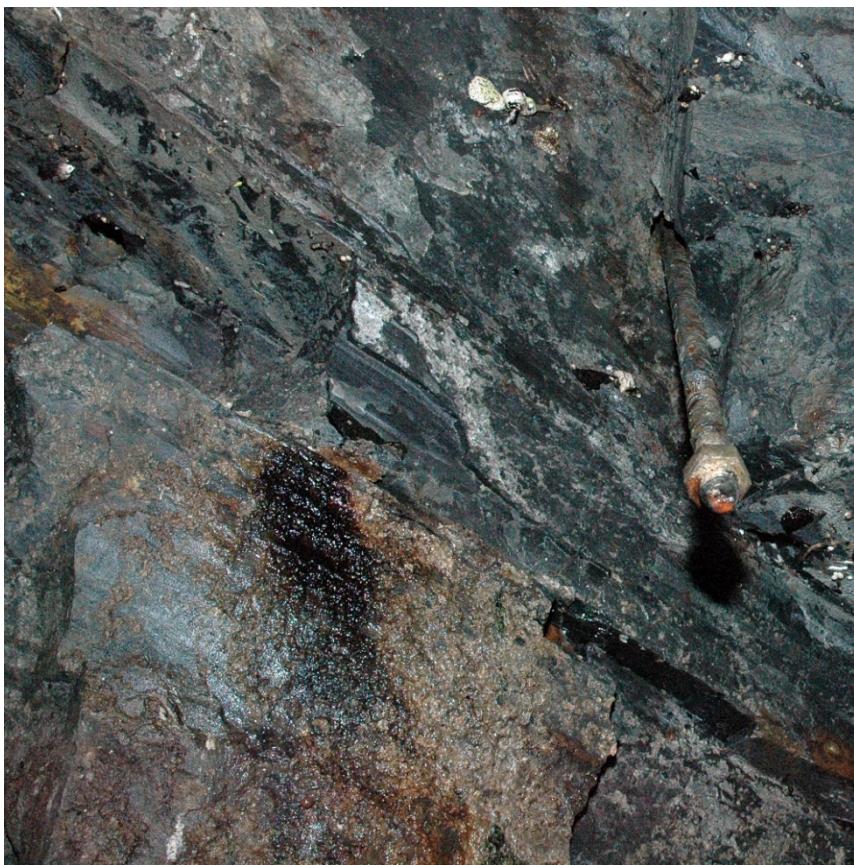
Figur 4 Kamstålbolt, nr. 5 (i boltehull nr. 4)

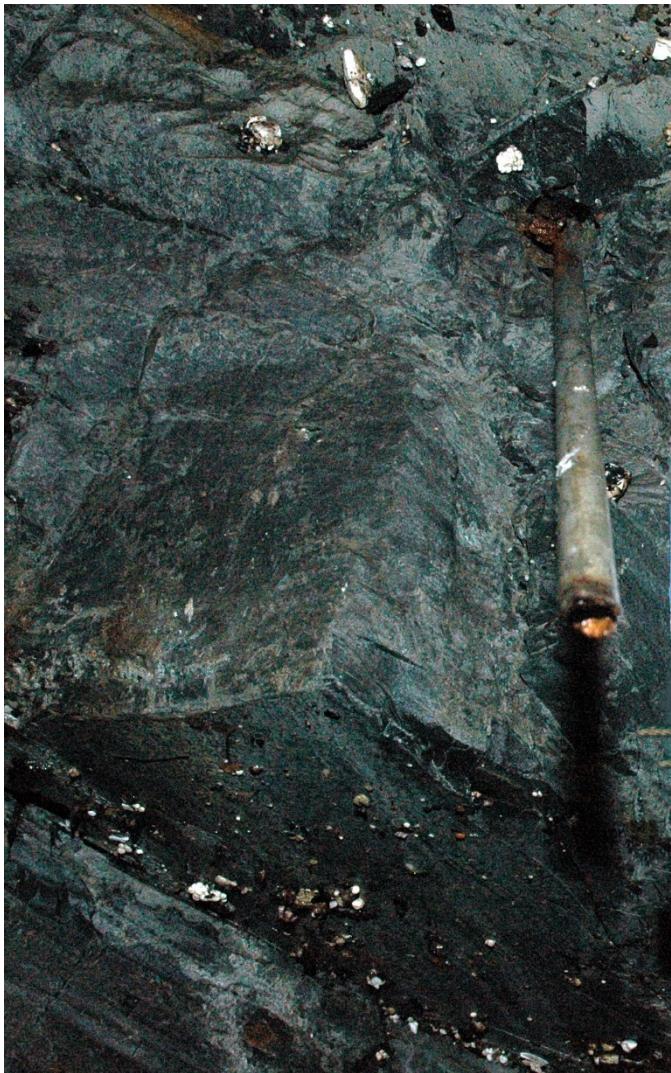
Figur 5 Rustfri bolt, nr. 2 (i boltehull nr. 5)

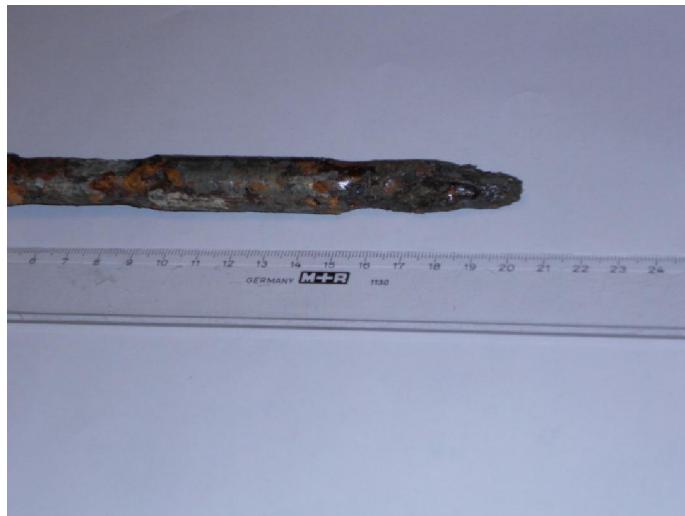
The bolt is about 149.5 cm long. Both ends of the bolt are corroded. The pointed end shown in Figure 1 is about a 15.5 cm long and with severe corrosion. Corroded areas are also found along the entire length of the bolt to the other end. At that end the bolt is hollow, presumably due to corrosion, see Figure 2. It should be noted that there is no sign of a threaded area on this bolt. According to Report 1608, inspection in 1992, the pointed end was inside the rock hole but the corroded area at that end has practically the same length as the threaded area on the other bolts. Judging from the figures in Report 1608 the corrosion damage observed now on this bolt is similar to the corrosion seen in 1992. The corrosion process has, therefore, not been very intense from 1992.

Figure 1. Stainless steel bolt. The pointed corroded end.

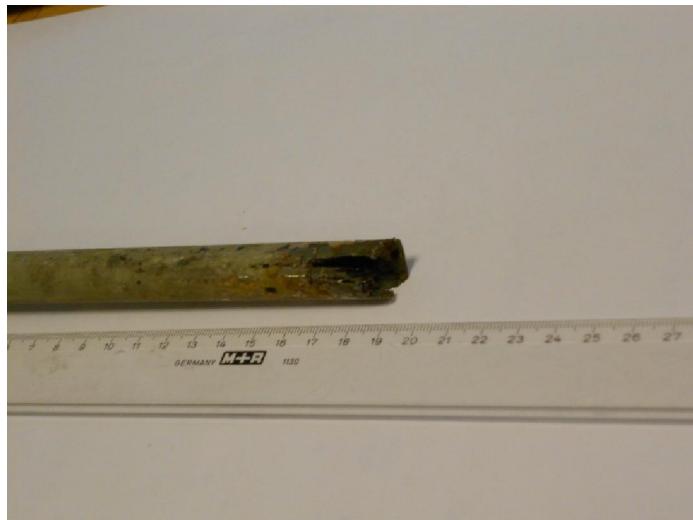
Figure 2. Stainless steel bolt. The hollow corroded end.

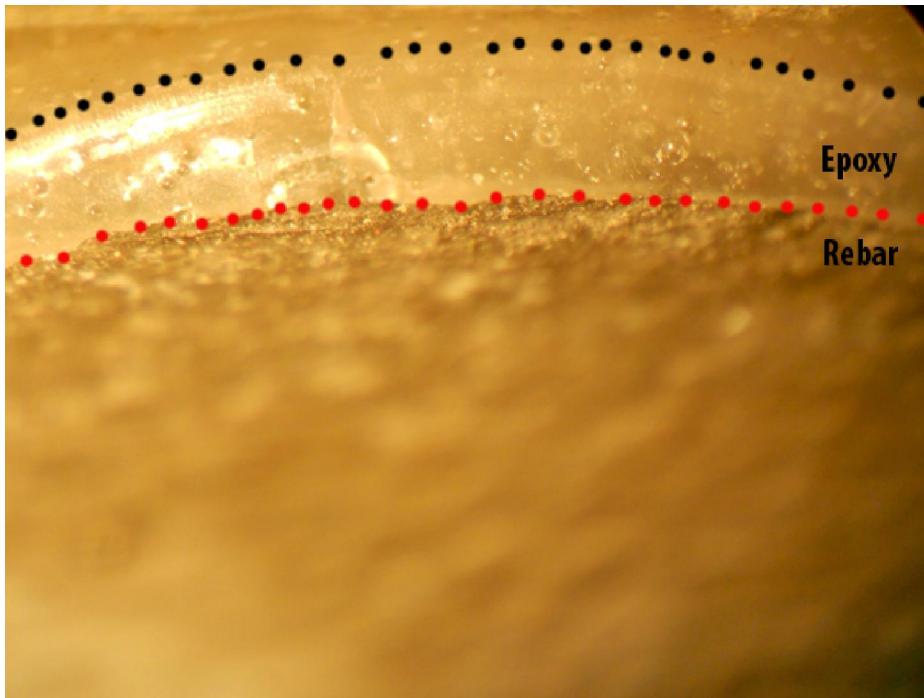
Looking at a cross section of the epoxy layer it seems clear that this coating was applied to the bolt in one layer. Figure 3 shows a cross section of the coating taken in a stereoscope. The distribution of air bubbles in the coating is even throughout the entire layer, which indicates that the coating was applied in one layer. In addition, no clear boundaries are seen within the layer. Therefore, it is assumed that this is bolt nr. 5 in Report 1608, which has one coat of clear epoxy. The thickness of the epoxy layer is, however, more in line with a normally applied 2-3 layer coating thickness. The ribs on the bolt facilitate the application of the paint in such a thick single layer.

Figure 3. Bolt nr. 5. Photomicrograph of the epoxy coating. The black dots mark the outer surface of the clear epoxy coating and the red dots mark the epoxy coating/steel bar interface.

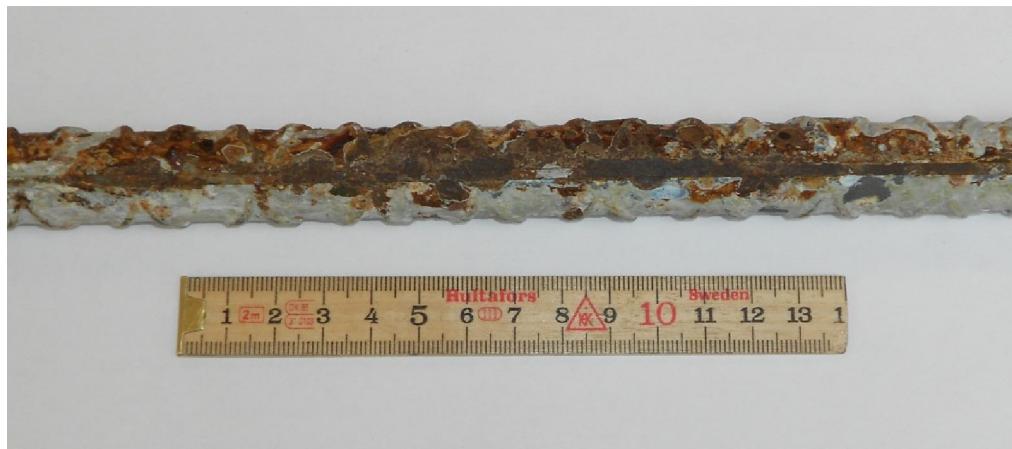
The entire area of the bolt, has some surface corrosion. The surface corrosion is intense from V-shaped area no. 22 to no. 42. The area between no. 34 and 38 has pitting in one of the longitudinal ribs of the bolt, see Figure 5. Another corroded area lies between V-shaped areas 80 and 89. The depth of the pits was measured. The maximum depth was only about 500 microns.

Figure 5. Bolt nr. 6. Surface corrosion and pitting.

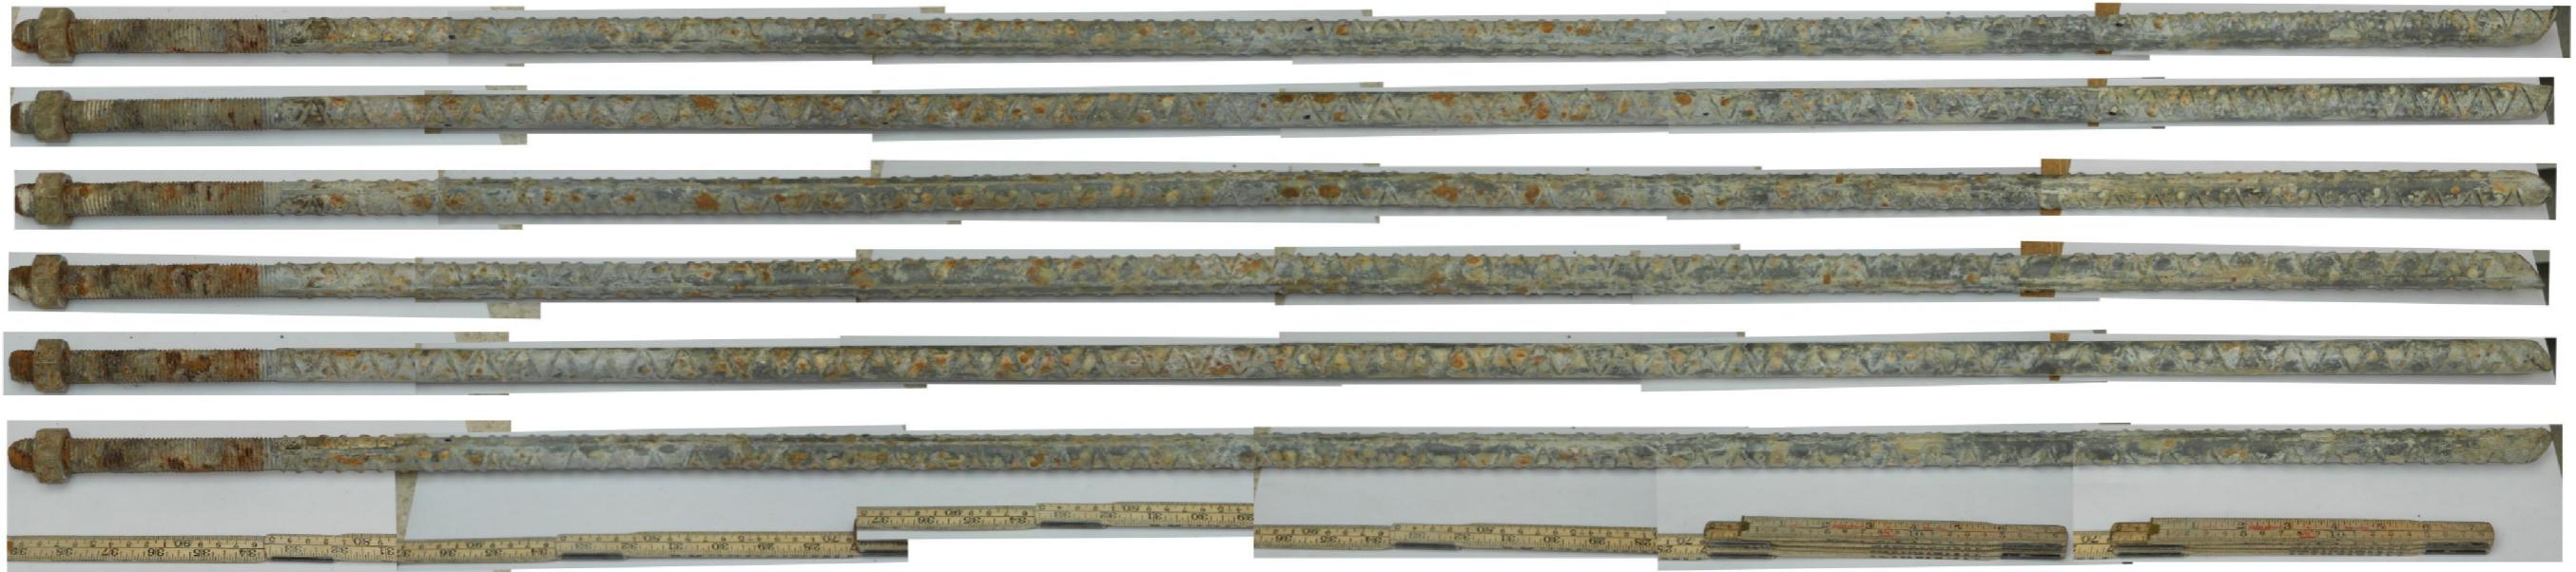
The bolt is about 149.5 cm long, with about 15 cm long threads and a nut at one end and sloped face on the other end. The stainless steel nut is not corroded. The threads are corroded and along the entire length of the bolt, rust coloured areas can be found. Figure 7 shows the bolt as received by Mannvit, before it was cleaned.

Figure 7. Bolt nr. 5 Galvanized with one layer of clear epoxy before cleaning.

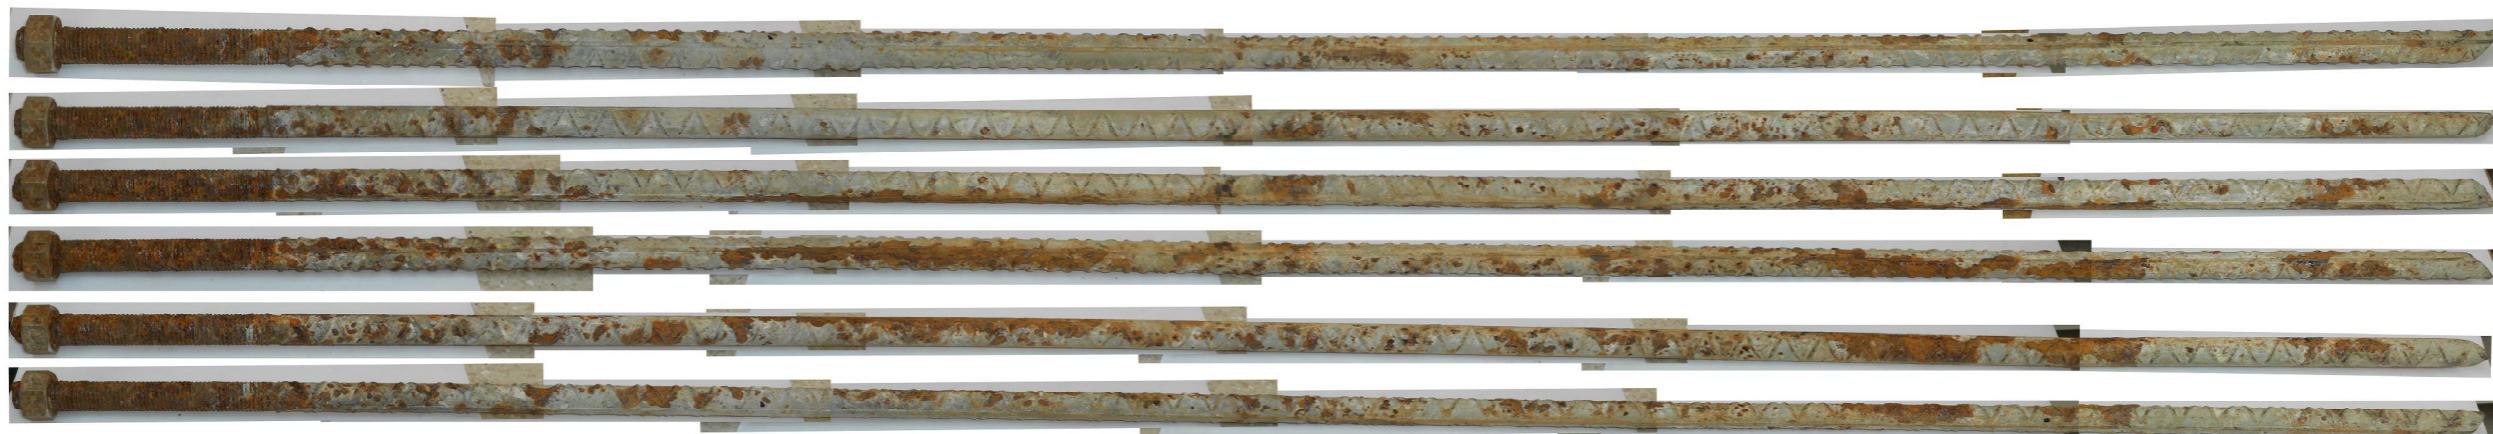
The bolt is about 150 cm long, with about 15 cm long threads and a nut at one end and sloped face on the other end. The stainless steel nut is not corroded. The threaded stem has surface corrosion. The rest of the bolt is probably not seriously corroded, but more surface corrosion is clearly visible on this bolt than on bolt nr. 5. Figure 8 shows the bolt as received by Mannvit, before it was cleaned.

Figure 8. Bolt nr. 6 Galvanized with one layer of gray epoxy before cleaning.

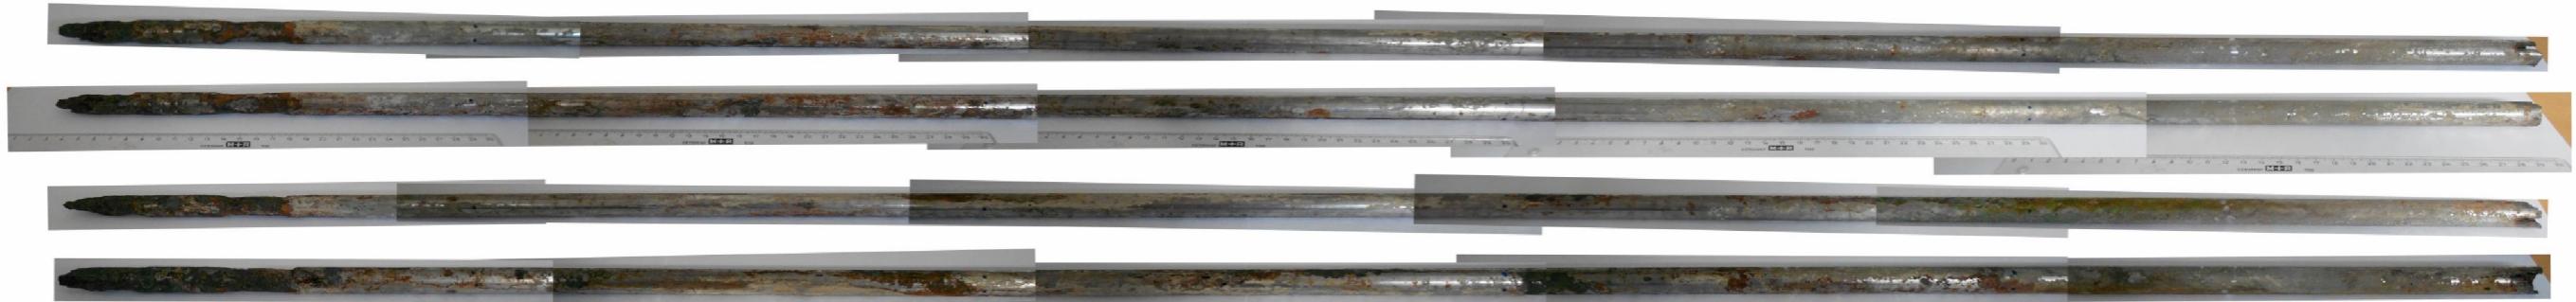
Figure 9. Bolt nr. 2 Stainless steel bolt after cleaning.

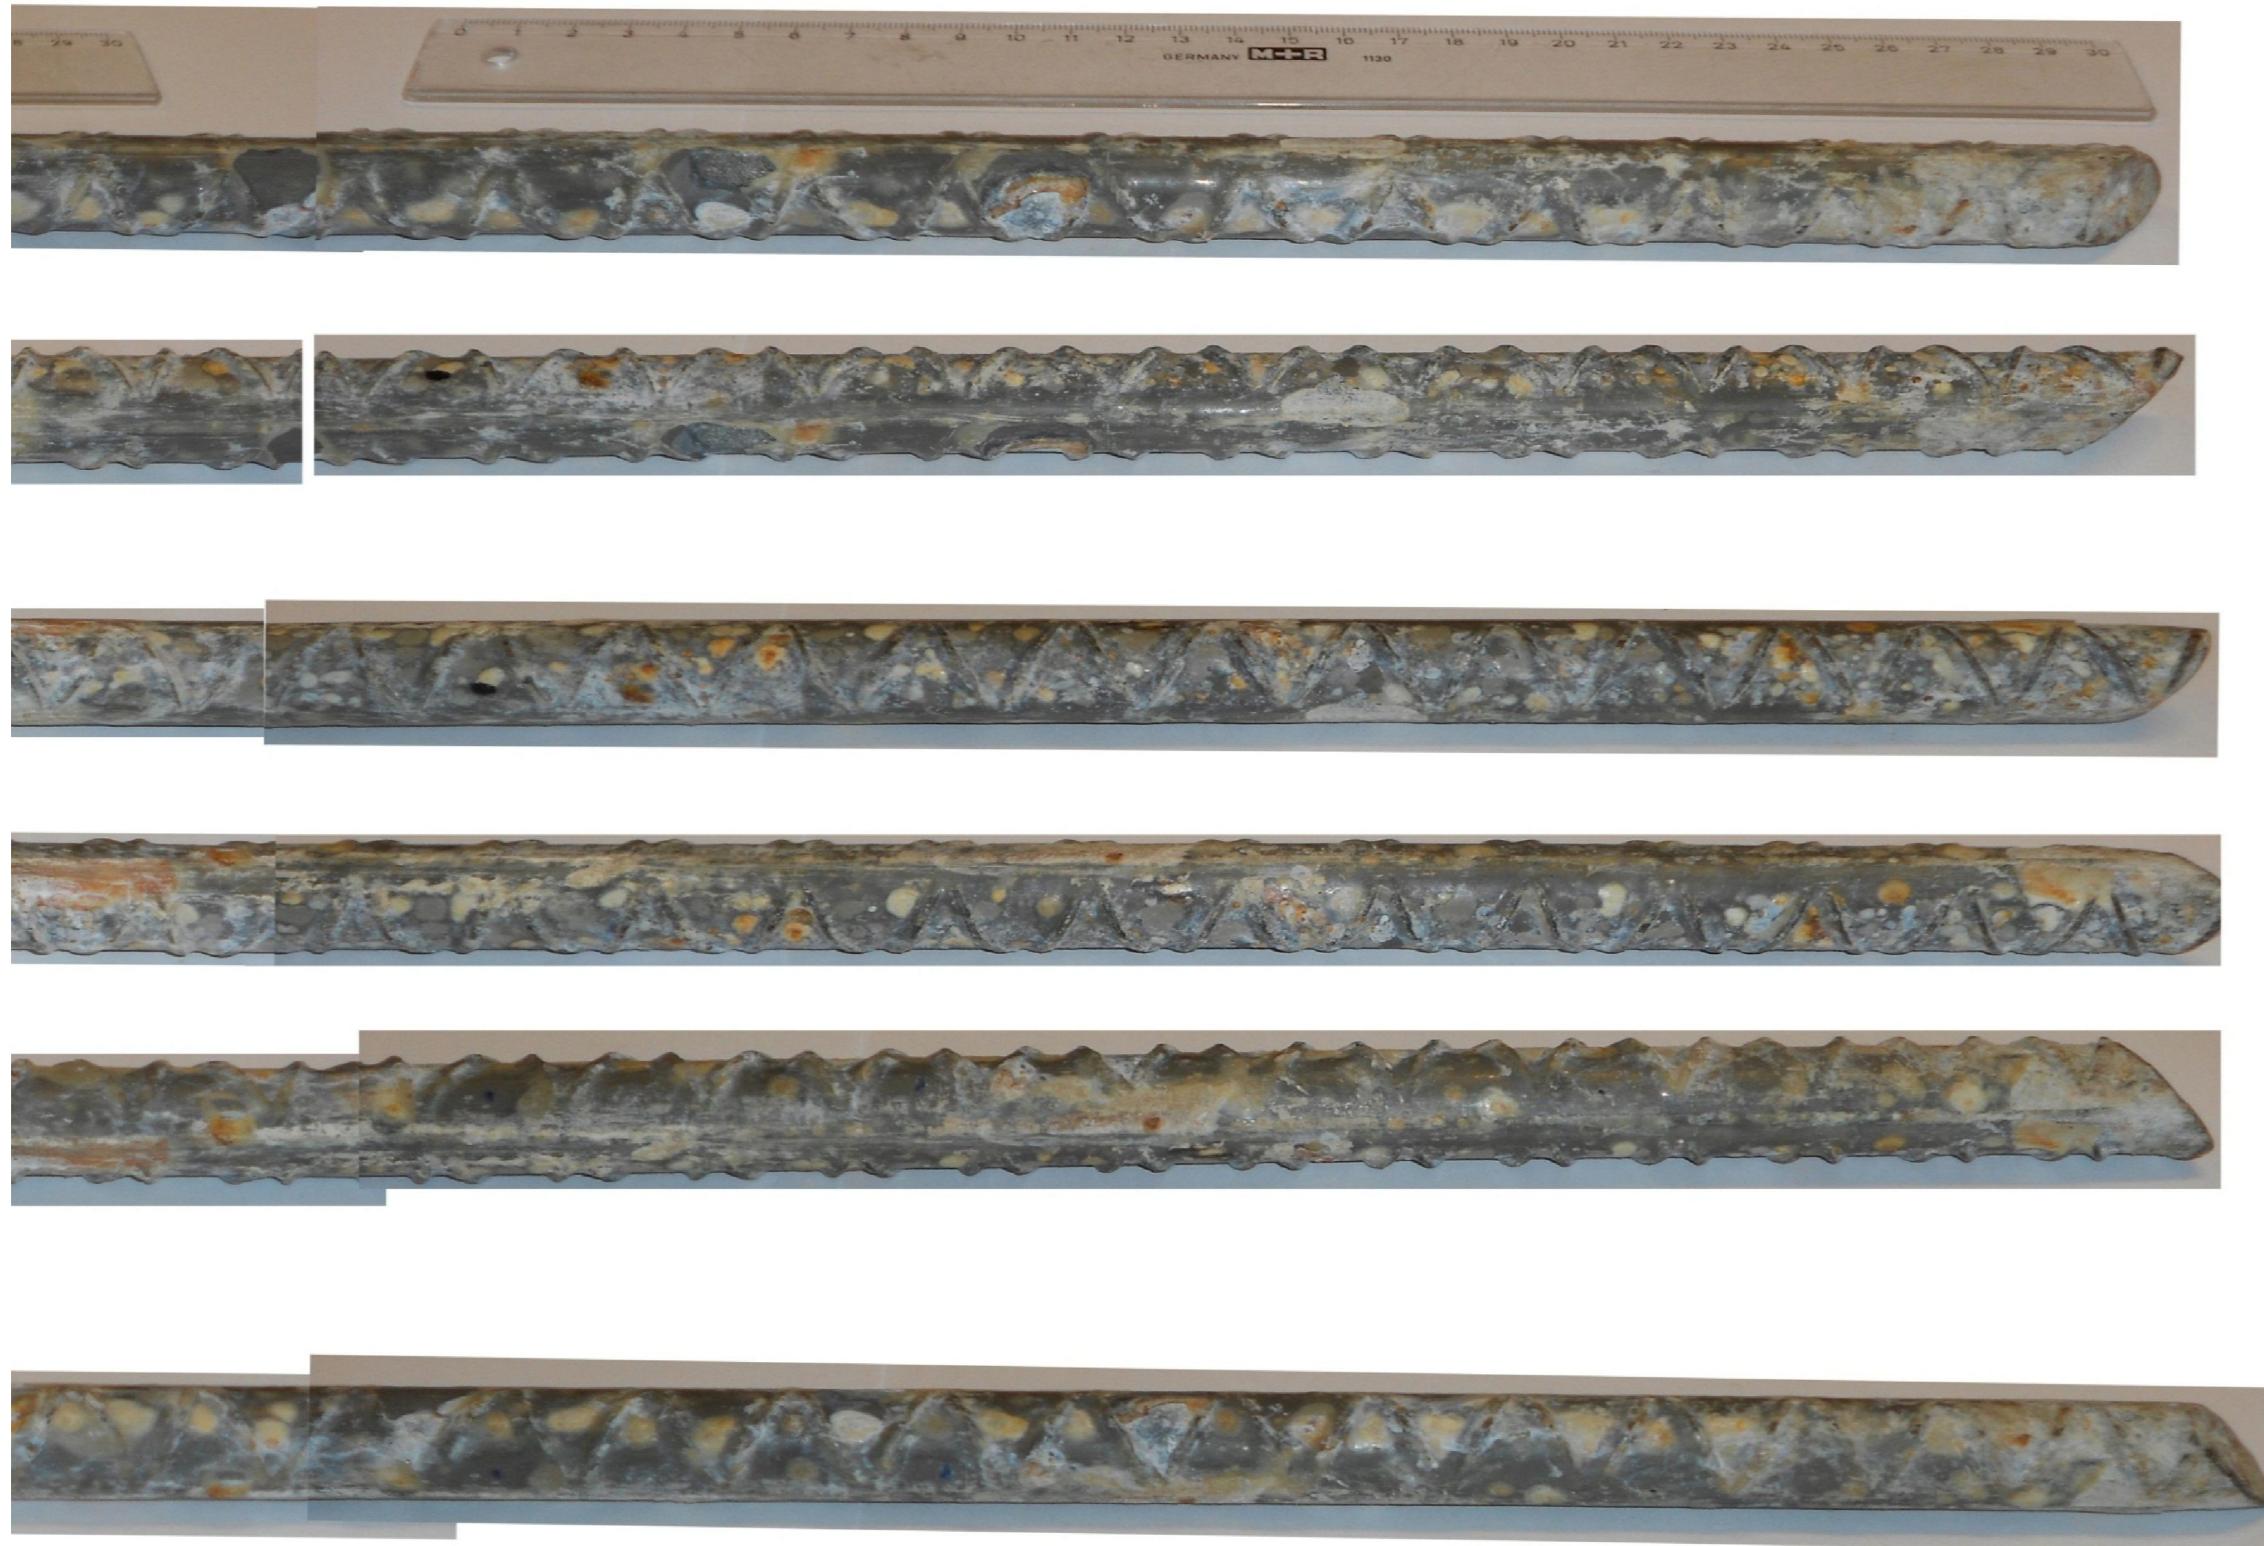
Figure 10. Bolt nr. 5 Galvanized with one layer of clear epoxy after cleaning.
