Korrosjonsforsøk på bolter i Vardøtunnelen

Etatsprogrammet Varige konstruksjoner 2012-2015

Nr. 464

Corrosion test on rock bolts in the Vardø tunnel

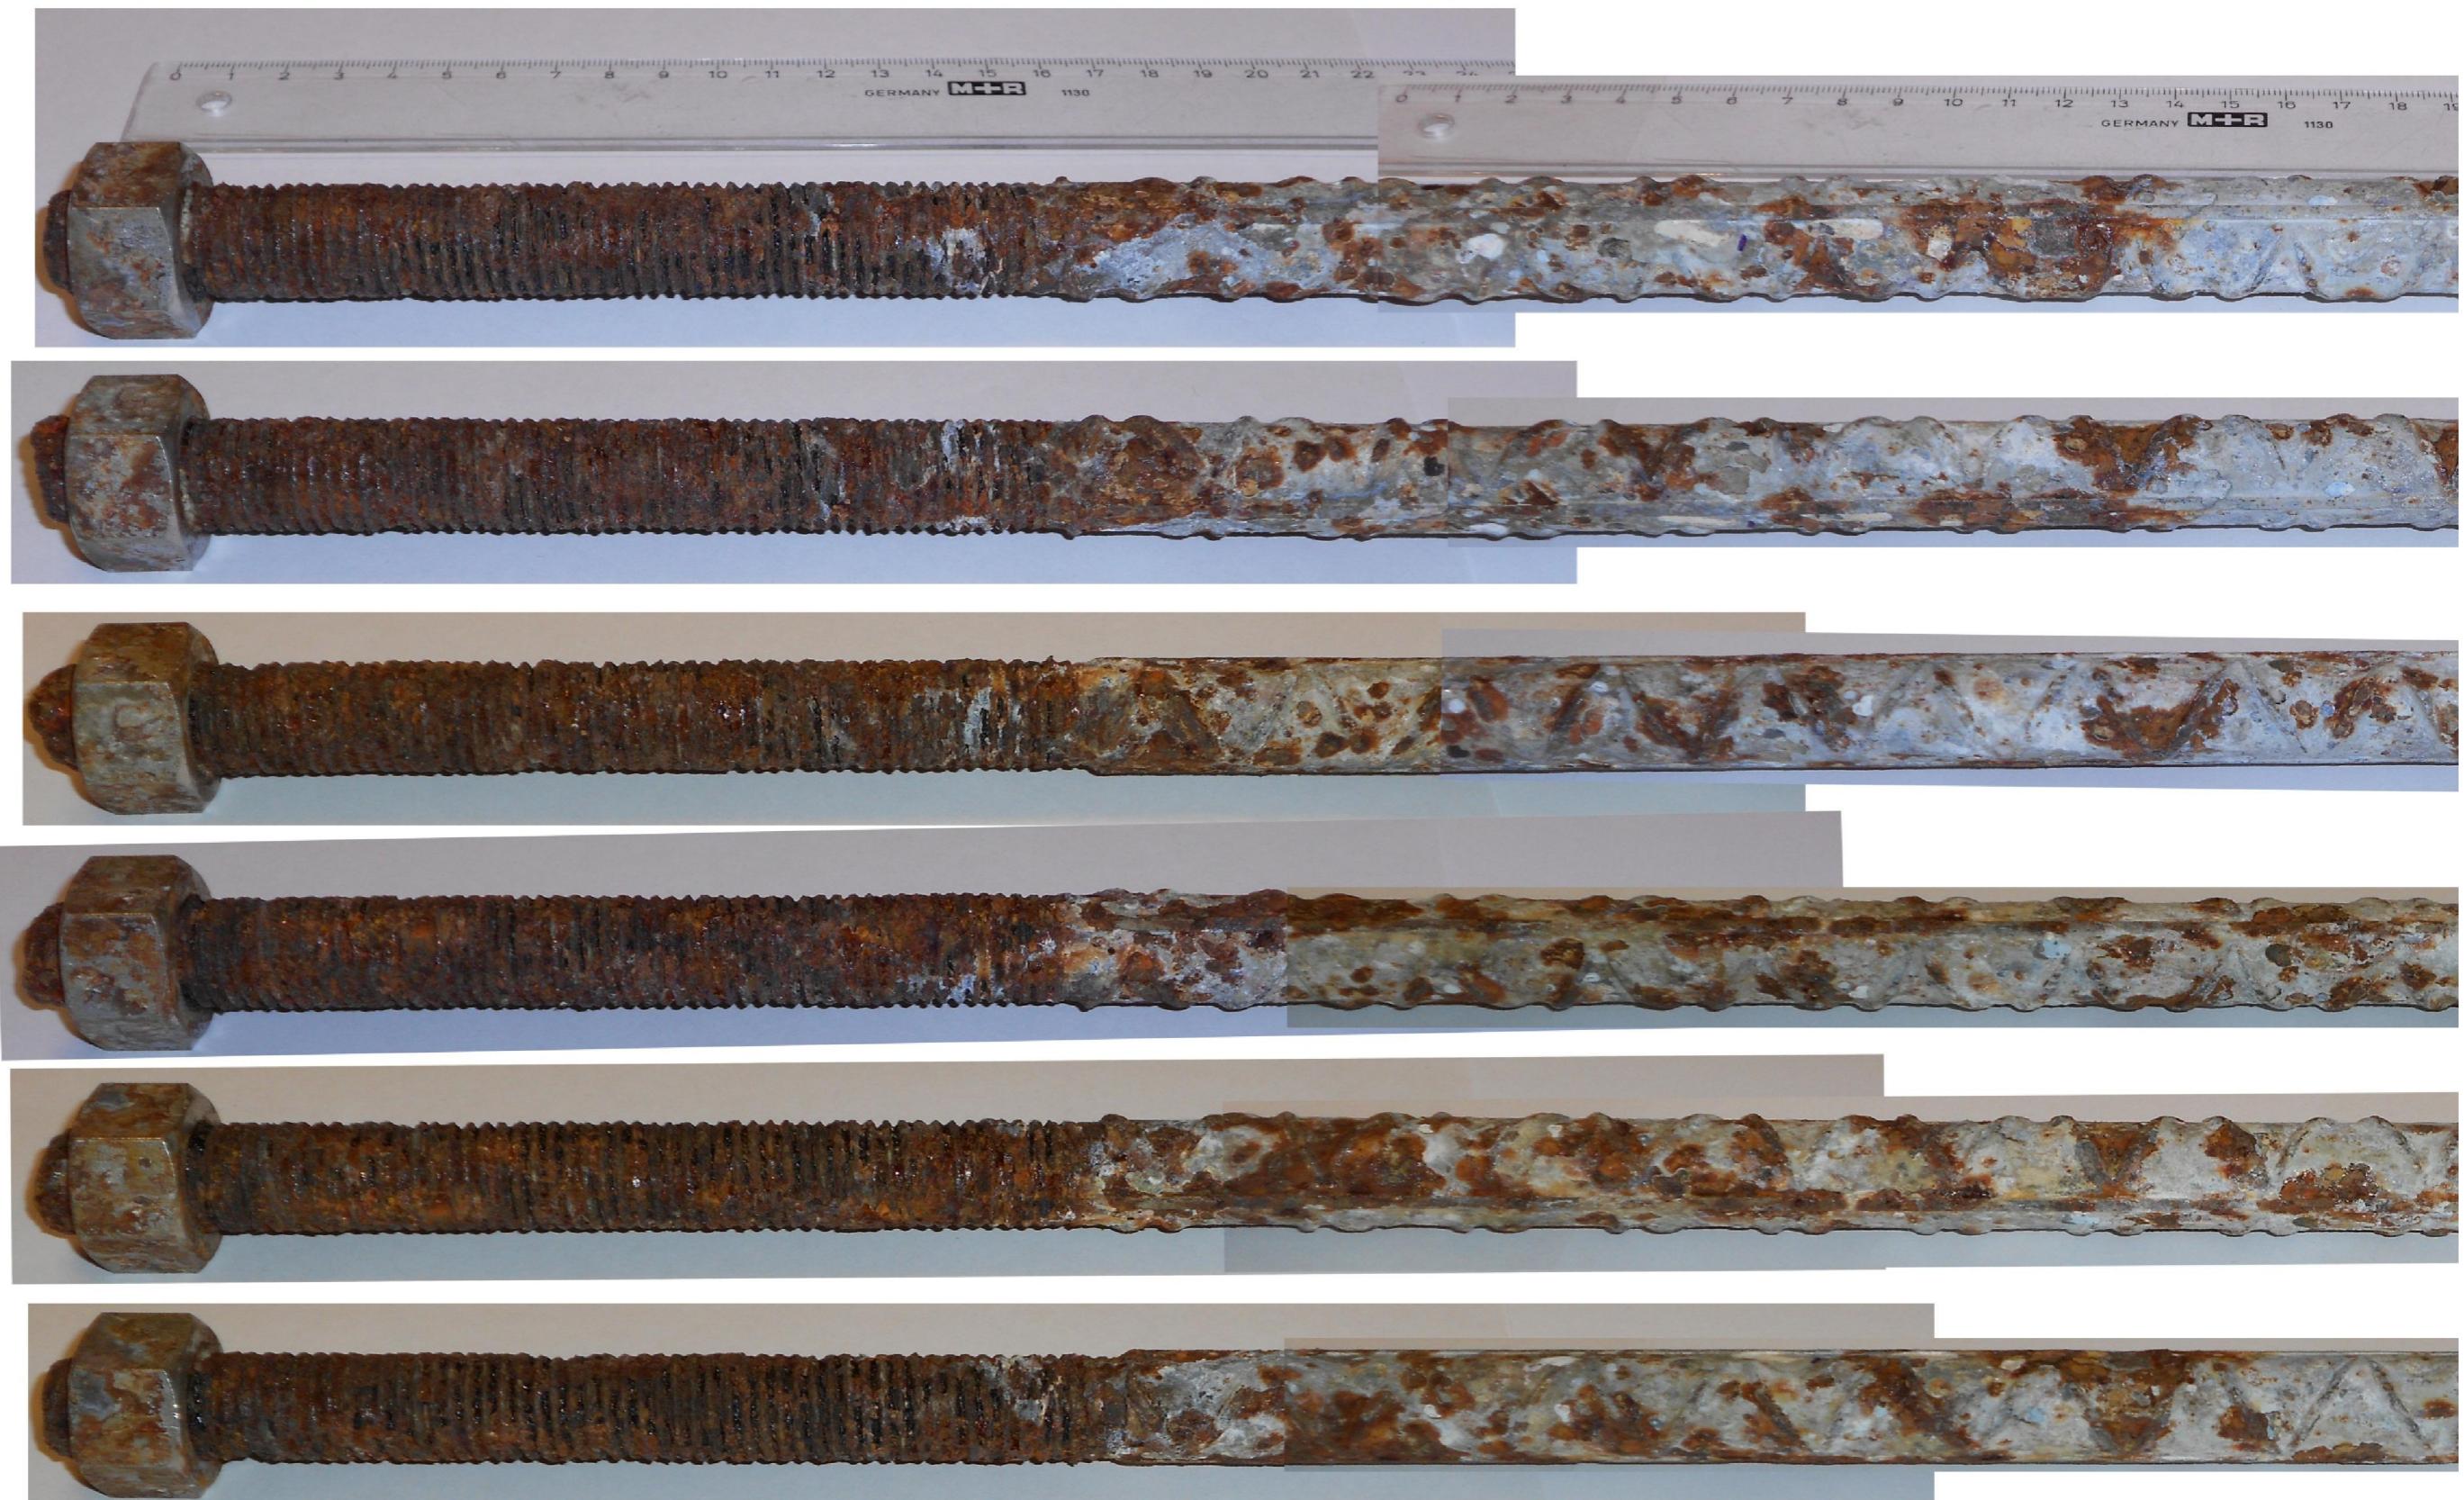
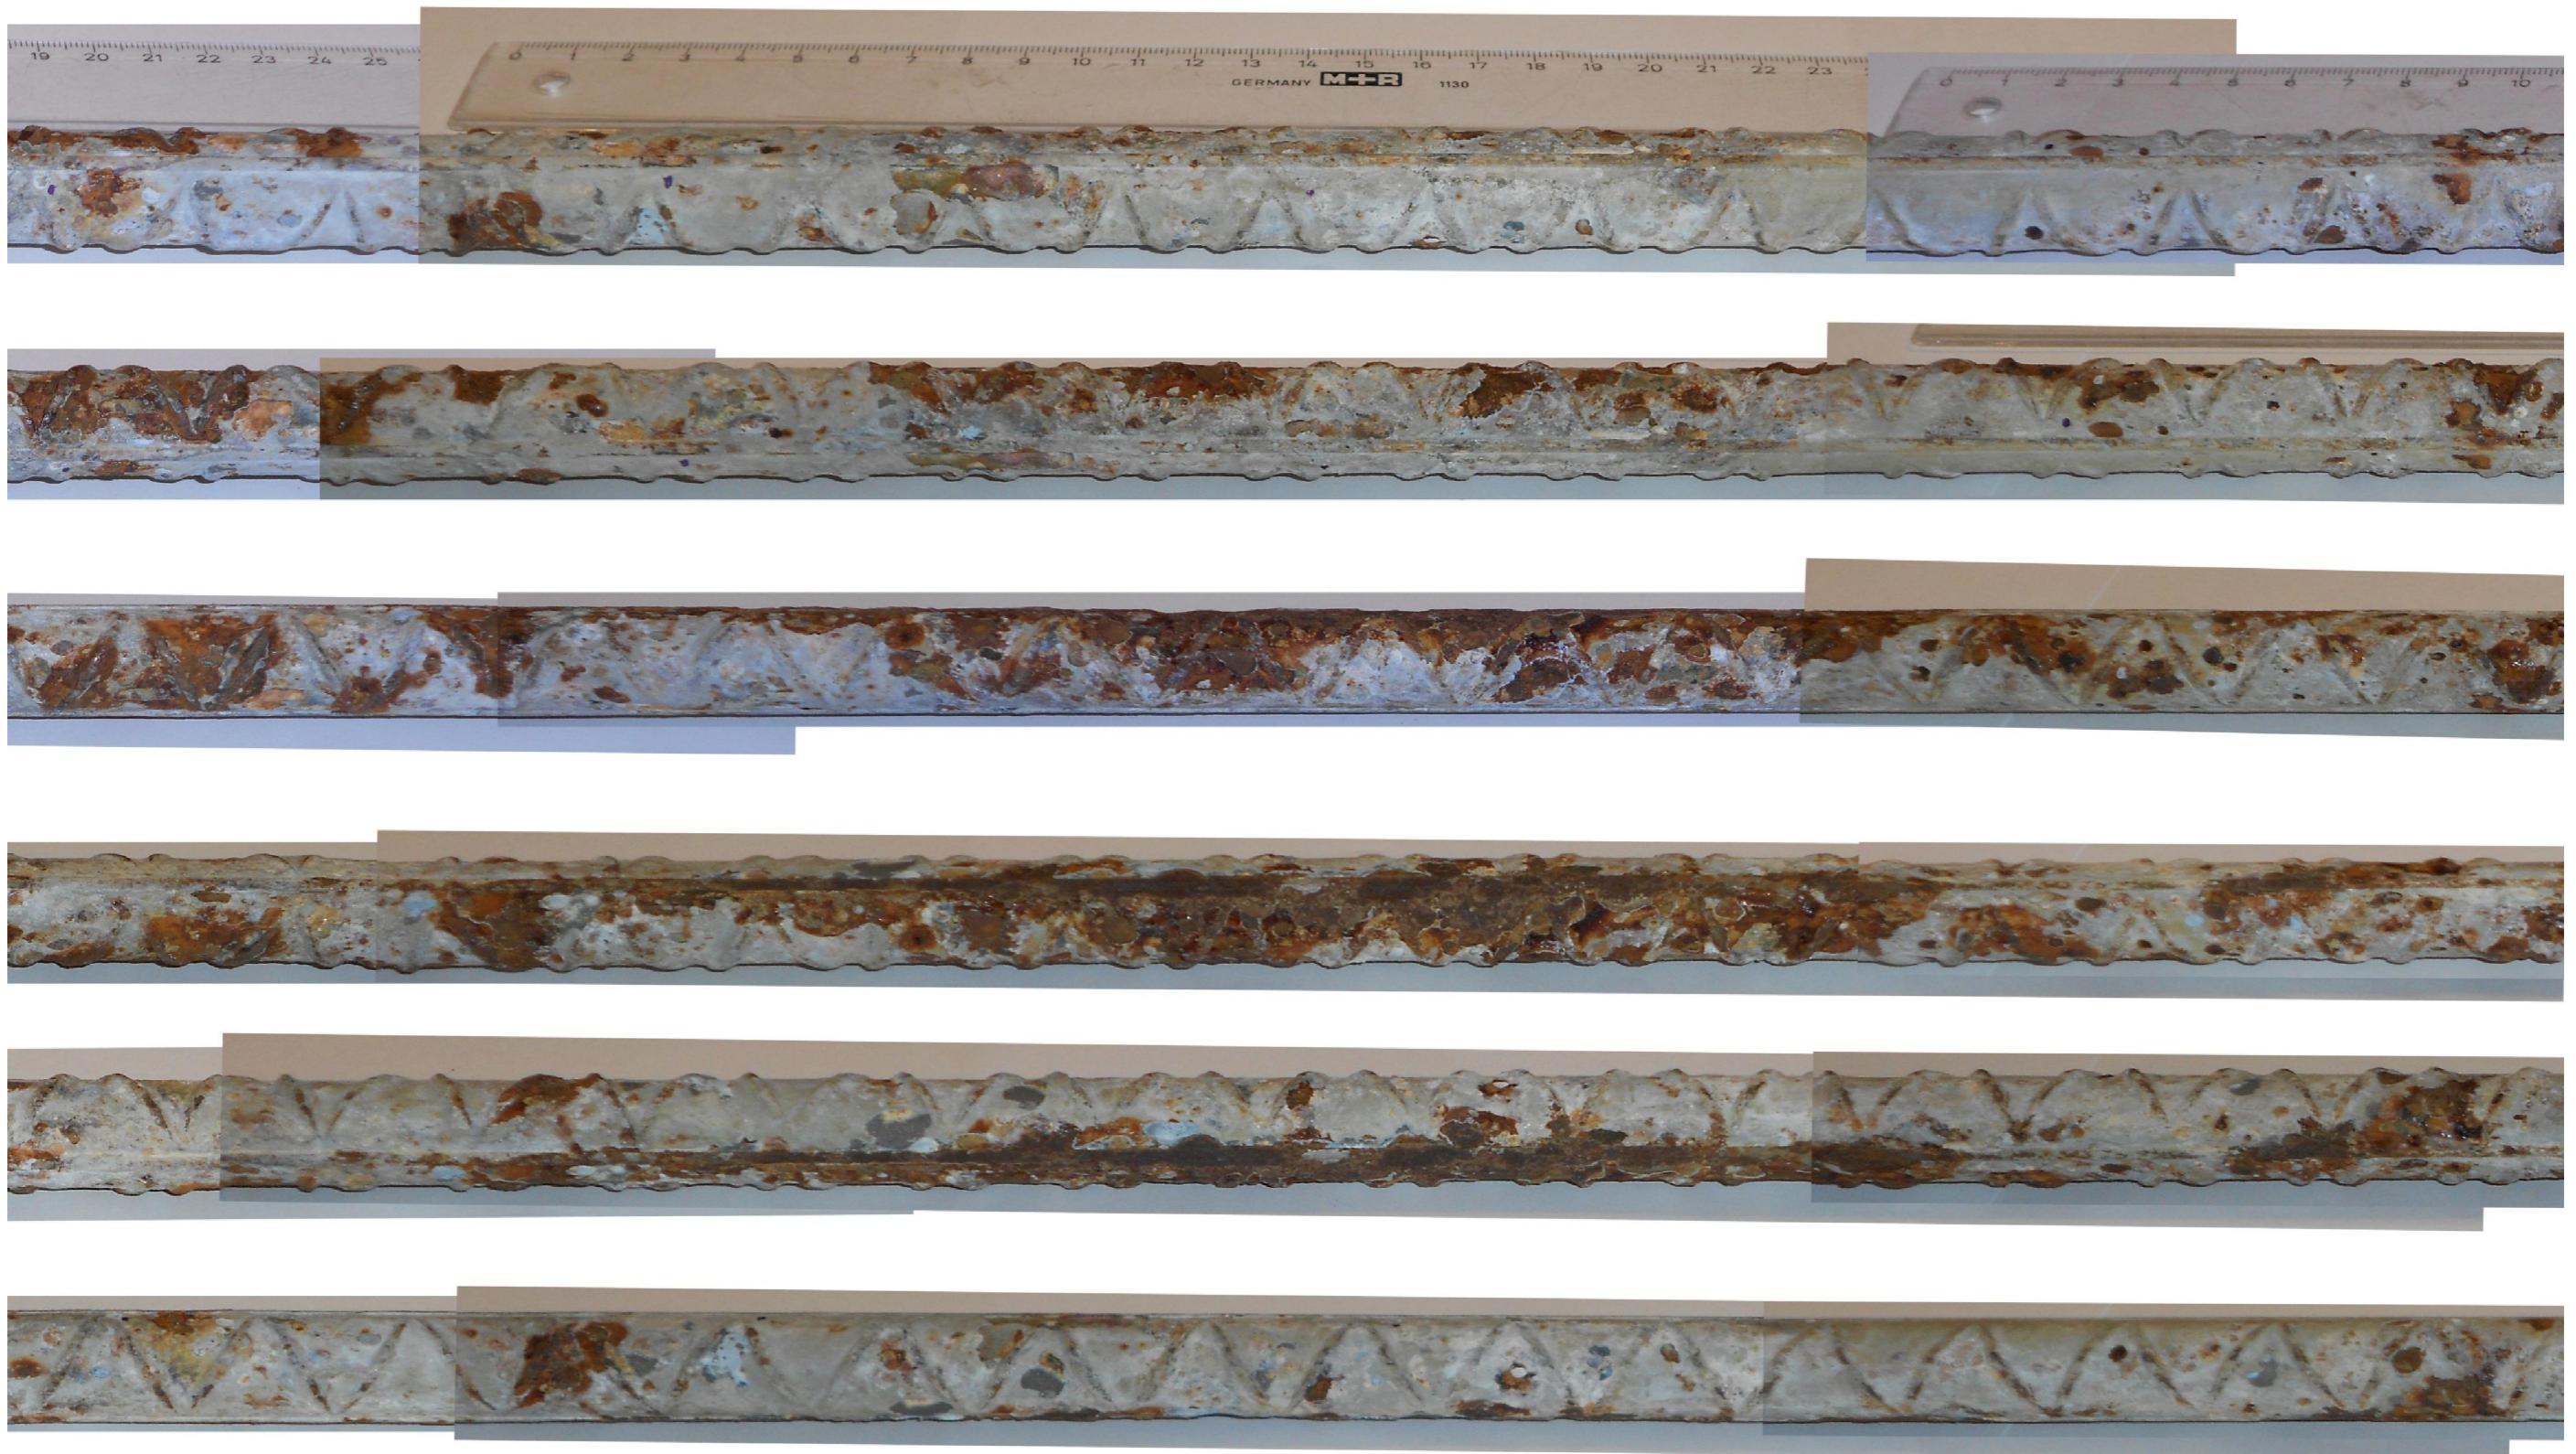
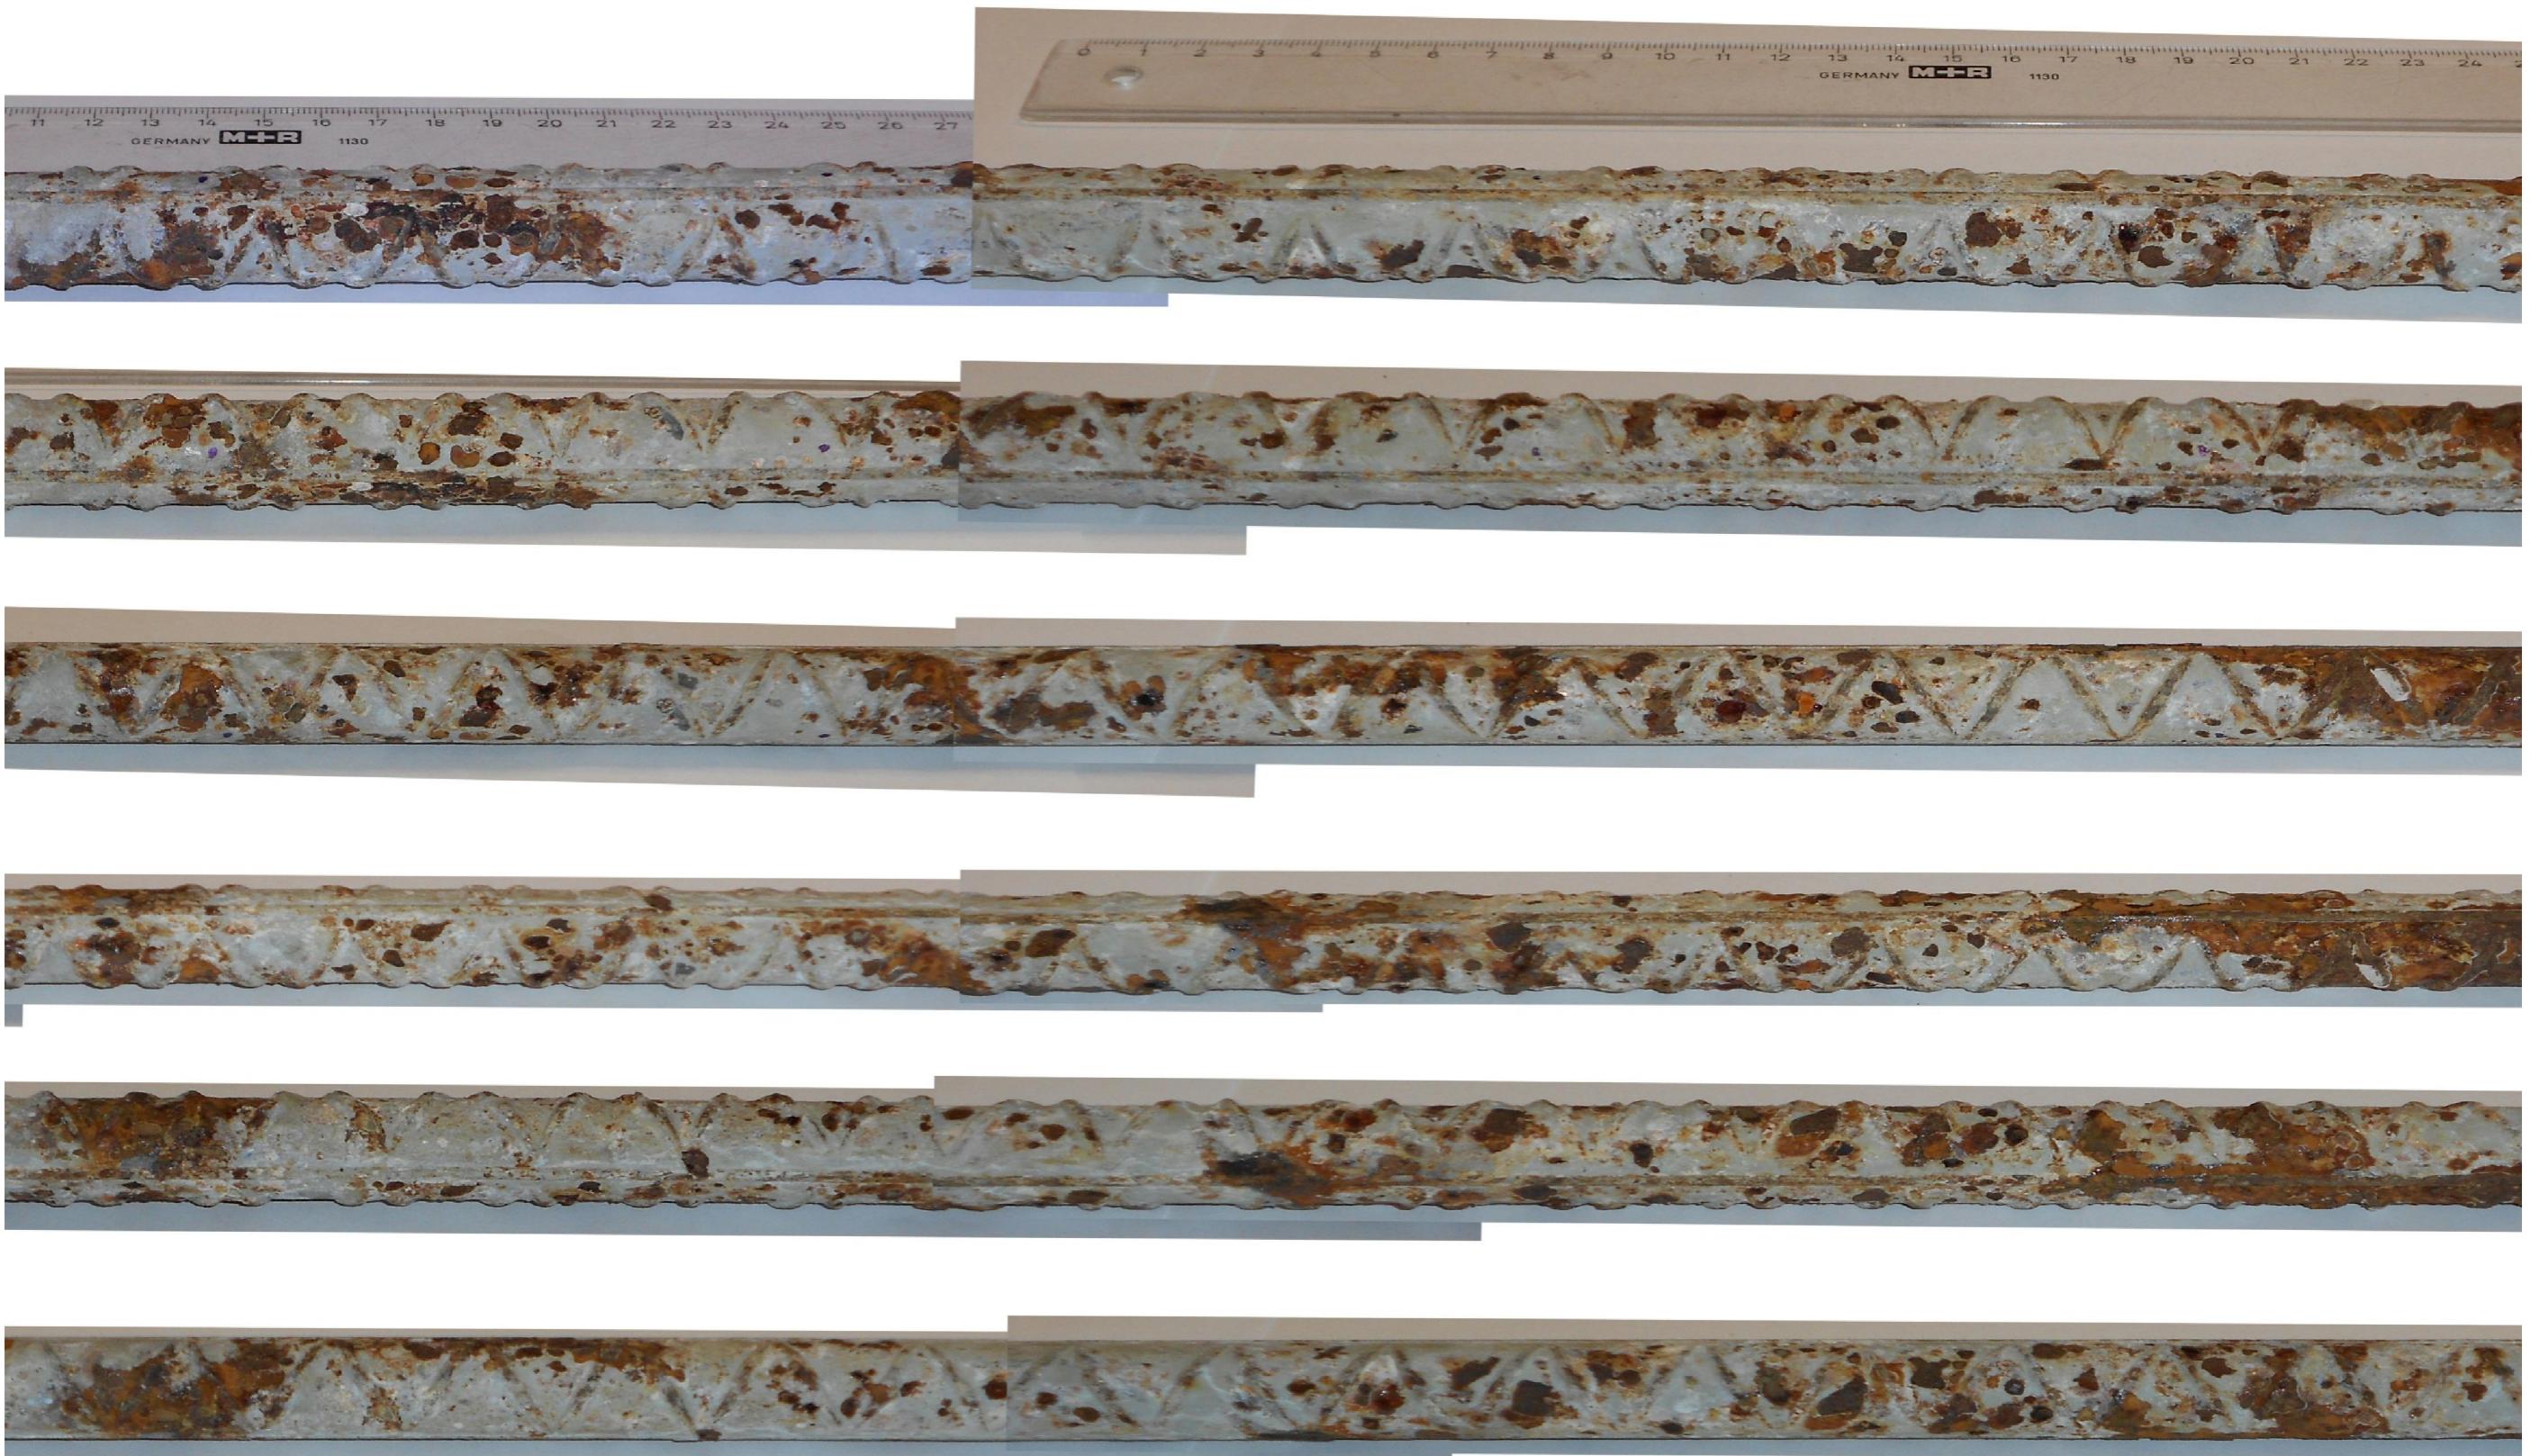
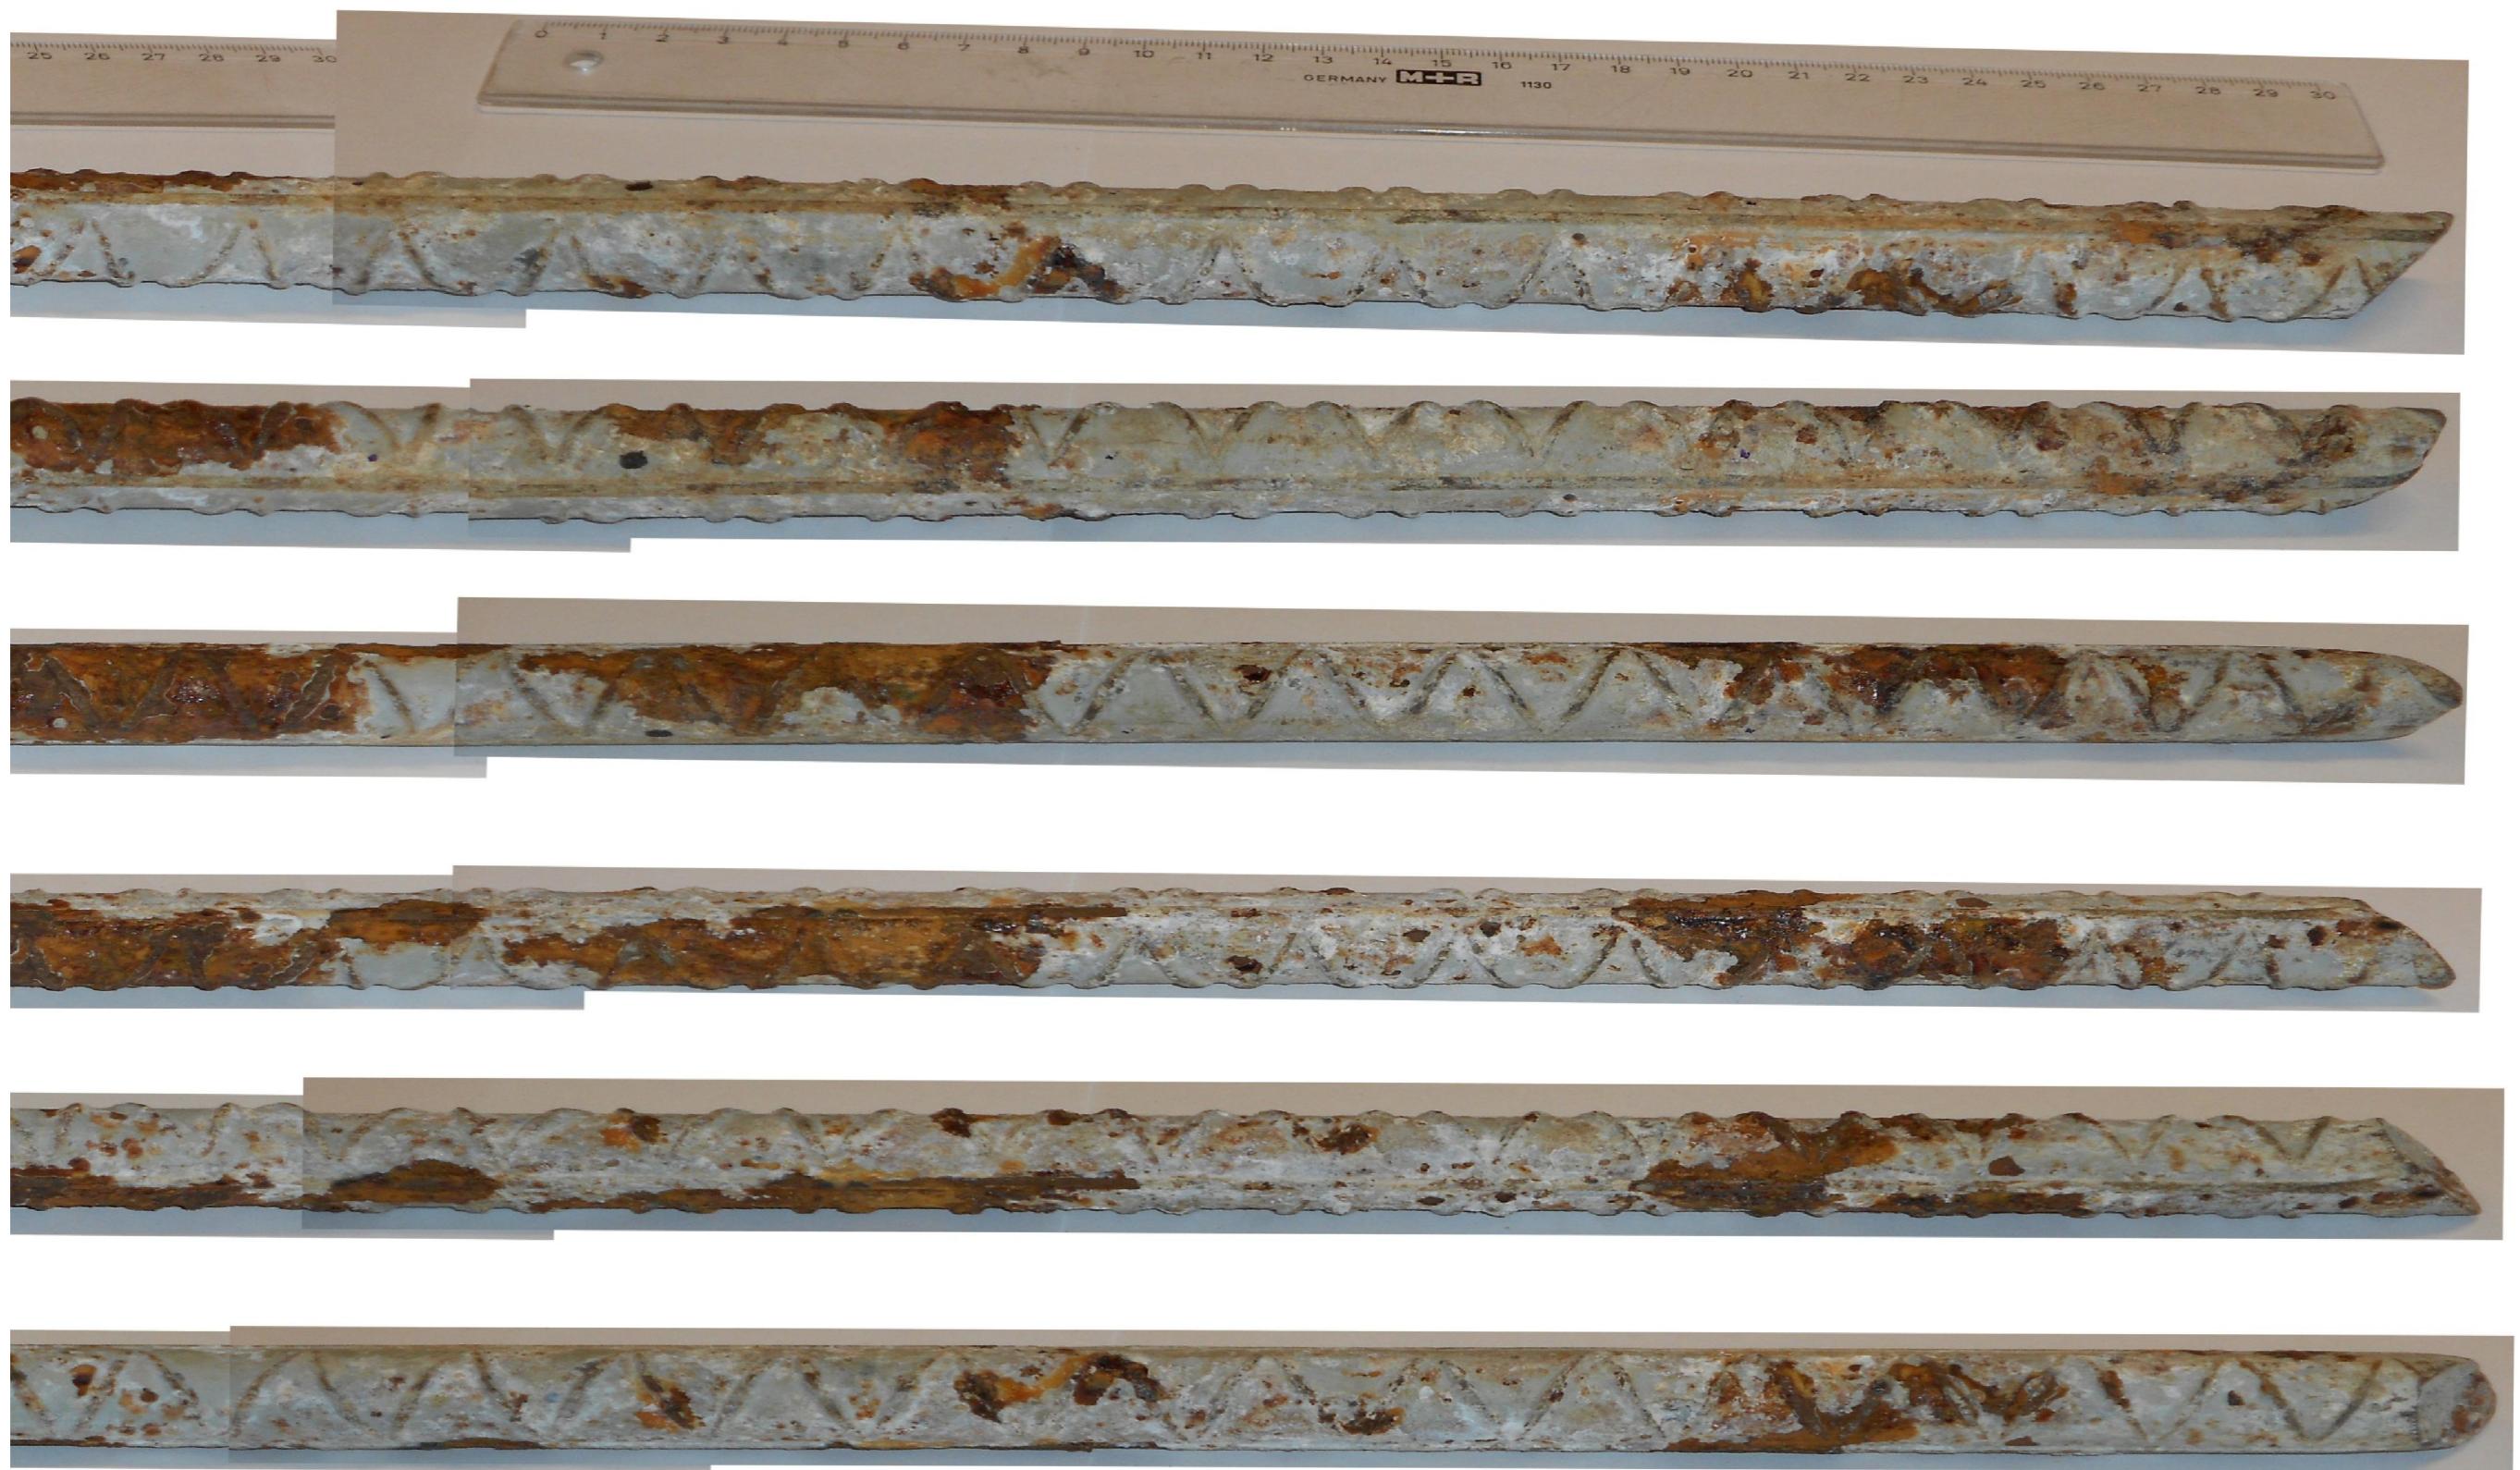
Figure 11. Bolt nr. 6 Galvanized with one layer of gray epoxy after cleaning.
