**Norwegian public Roads  
Administration**

Publication no. 100

# Lightweight filling materials for road construction

Oslo, December 2002

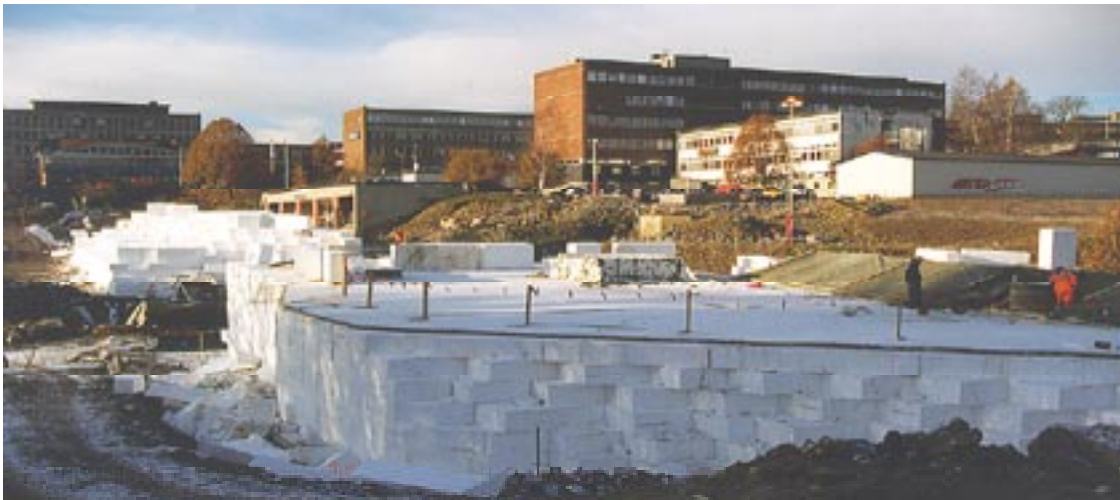
Figure 1: An EPS embankment with vertical walls for a city tramline in Oslo as an alternative to a bridge.

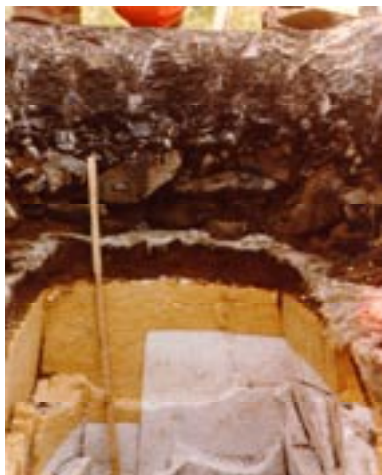
Figure 2: Excavation of the first EPS embankment at Flom bridge.

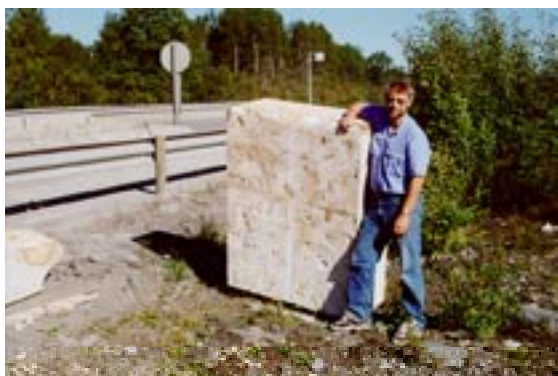
Figure 3: Excavation of a 24 years old EPS block from the first EPS embankment at Flom bridge.

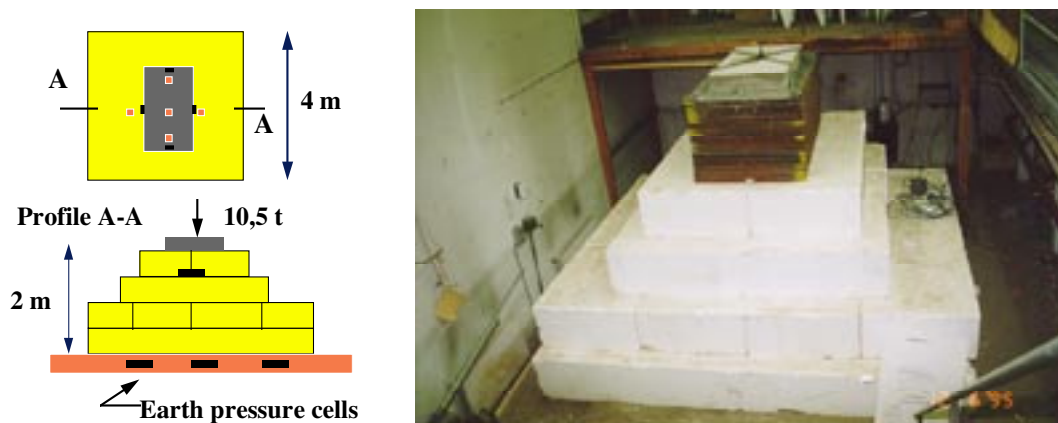
Figure 8: EPS test fill at the Norwegian Road Research Laboratory (now the Road Technology Department)

In a laboratory test at the Norwegian Road Research Laboratory (now the Road Technology Department) a test fill of height 2 m with normal size blocks and a compressive strength  $\sigma = 100$  kPa has been loaded to a value of  $q_{dw} = 52.5$  kPa and the resulting deformations observed over a period of 3 years (Figure 8). The results are shown in Figure 9 together with calculated deformations to be expected according to the theories introduced by Magnan & Serratrice.

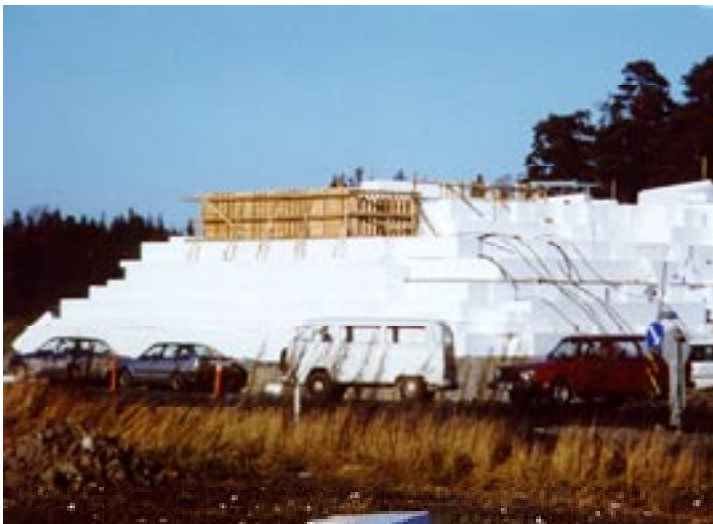
Figure 10: Construction of one abutment on the EPS embankments at Løkkeberg bridge.

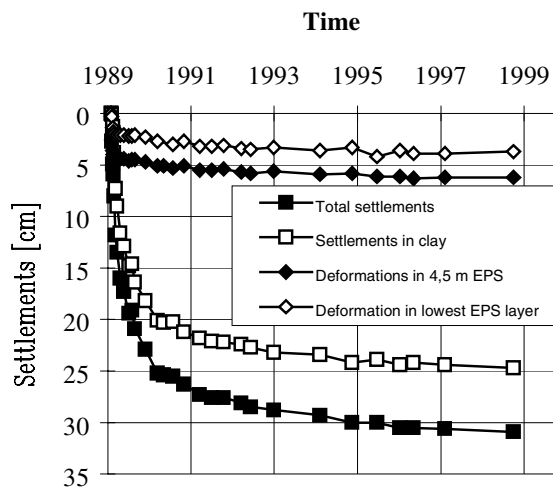
Figure 13: Creep deformation at Løkkeberg.

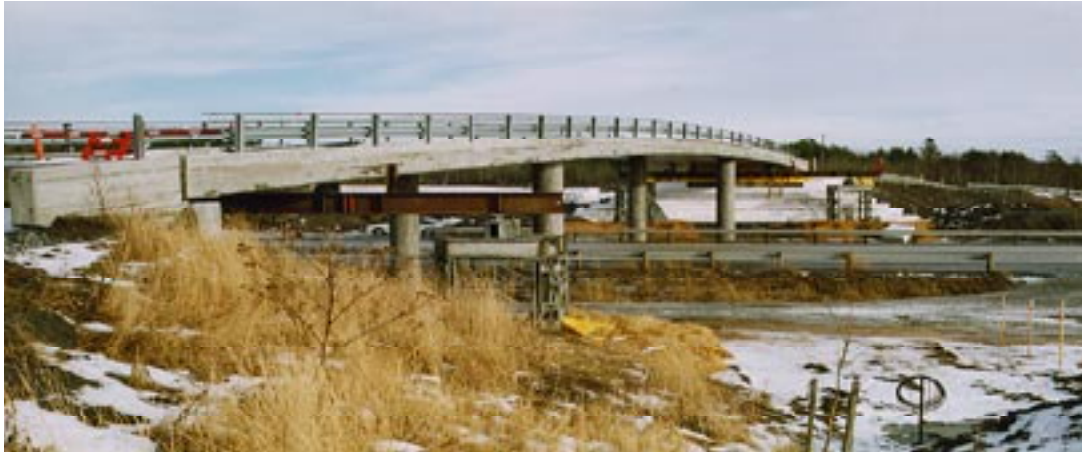
Figure 20: Temporary support of abutments at Hjelmungen.

Repair works were initiated in December 1995 and completed in the spring of 1996. One abutment was treated at a time while the bridge deck was provided with a temporary support as shown in Figure 20. Thickness and densities of the original filling materials were recorded as they were removed in order to have accurate data for control of load and settlement calculations. After removing the old abutments, the concrete piles were inspected regarding possible damage before being cut at ground level. No pile damage was observed. Construction of the EPS fills could then start. In this case three different qualities of EPS were utilized. In the zone directly beneath the bridge abutment, as indicated by the trapezoidal shaped lines in Figure 19, a material quality of  $\sigma = 235$  kPa was specified for the first three block layers beneath the bottom slab of the abutment. Further down a material quality of  $\sigma = 180$  kPa was specified within the indicated zone. For the rest of the EPS fill a material quality of  $\sigma = 100$  kPa was used. These quality requirements have been decided based on evaluation of stress distribution in the material in order to keep the stress level for dead loads within 30 % of the material strength. Stricter geometric requirements than normal were also enforced related to block dimensions in order to obtain an even fill and reduce initial deformations when the load from the bridge deck was transferred to the new abutment.

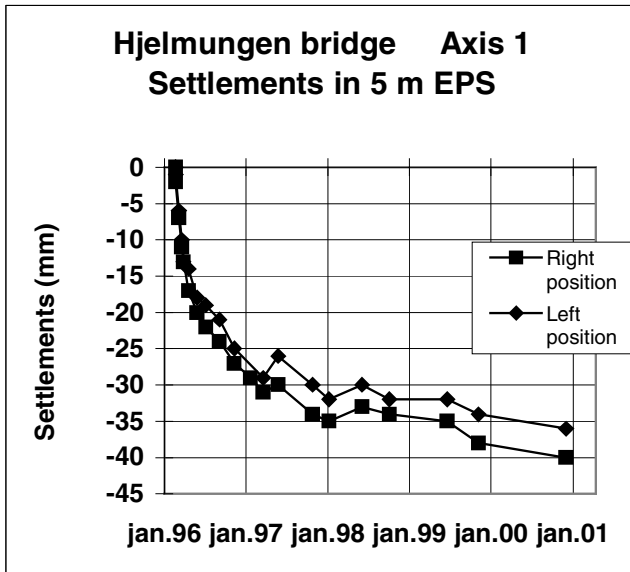
Figure 22: Measured settlements at Hjelmungen.

In order to monitor the behaviour of the reconstructed bridge both settlement and stress gauges have been installed. The different types of gauges and their locations in relation to the bridge abutment are indicated on the cross section in Figure 21. Prior to reconstruction the settlement rates of the adjoining fills were observed to be 100 mm/year and constant. After reconstruction the settlements have nearly been halted as shown on Figure 22.

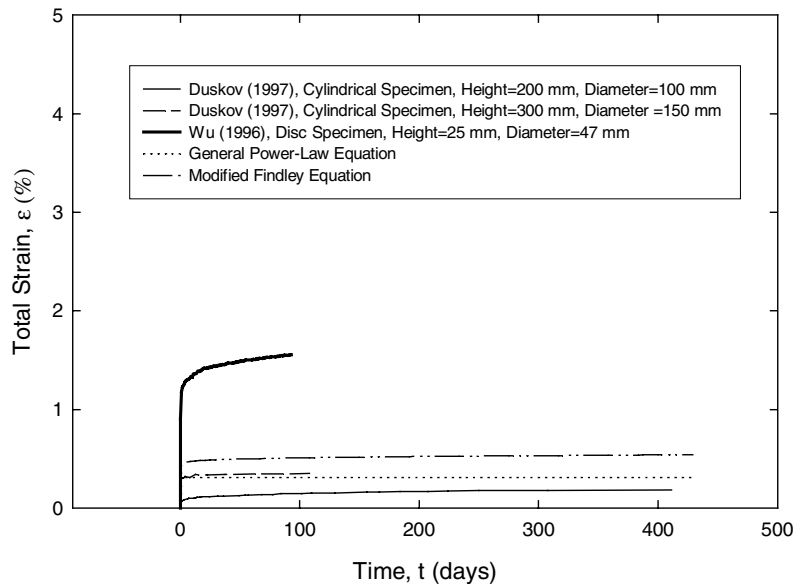
Figure 1: Comparison of Laboratory Compression Creep Test Data for an EPS Density of 20 kg/m<sup>3</sup> and Applied Stress of 20 kPa and Calculated Values.

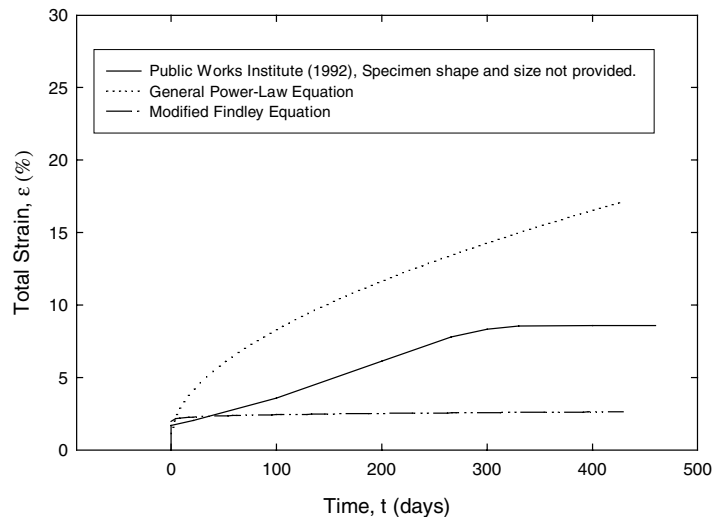
Figure 2: Comparison of laboratory compression creep test data for an EPS density of  $20 \text{ kg/m}^3$  and applied stress of  $70 \text{ kPa}$  and calculated values.

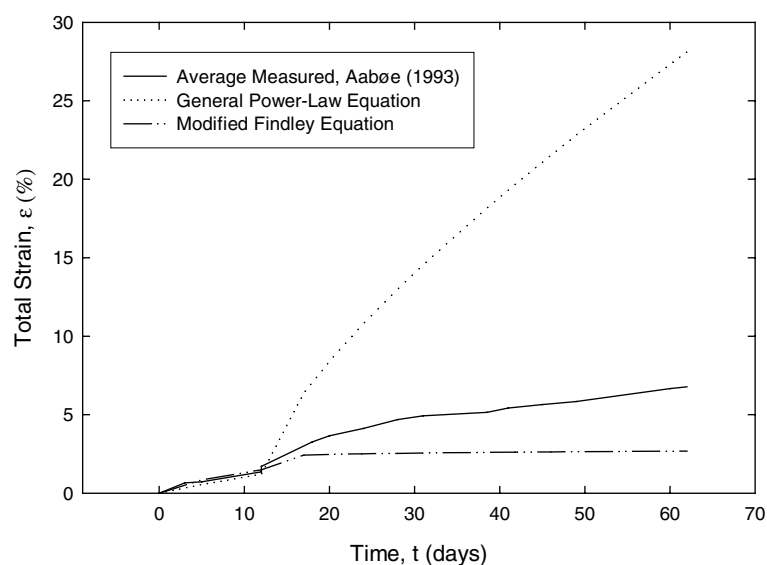
Figure 3: Comparison of full-size EPS block creep test data and the creep equations for an EPS density of  $20 \text{ kg/m}^3$  and an applied stress of 34 kPa for days 1-5, 55 kPa for days 5-12, and 79 kPa for days 12-62.

Figure 3 shows a comparison between the calculated and measured total strains for compressive stresses of 34, 55 and 79 kPa. At the initial stress levels of 34 and 55 kPa, both the general power-law and modified Findley equations predict total strains that are in agreement with the measured strains. At the largest stress of 79 kPa, the power-law equation significantly overestimates the measured strains and the modified Findley equation underestimates the measured strains. However, the modified Findley equation provides the best agreement with the measured values especially as the time,  $t$ , increases.

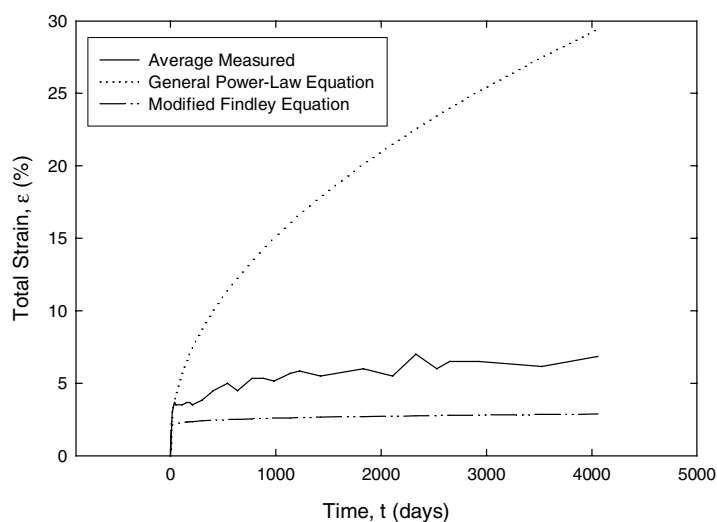
Figure 5: Comparison of total vertical strain measured in the lowest EPS block layer of the field test fill and the general power-law and modified Findley equations.

Figure 5 shows the total vertical strain measured in the lowest block layer. The density of the bottom row of EPS blocks is  $20 \text{ kg/m}^3$  and the original thickness of the EPS blocks is 0.6 m. Three pressure cells were installed below the first row of blocks. An average pressure of 67 kPa was recorded in the three pressure cells during the period that the vertical strain was being obtained from the settlement rods. As shown in Figure 5, the power-law and modified Findley equations significantly overestimate and underestimate the measured total strains, respectively. However, the total strains predicted by the modified Findley equation are again in better agreement with the measured values than the power-law equation.

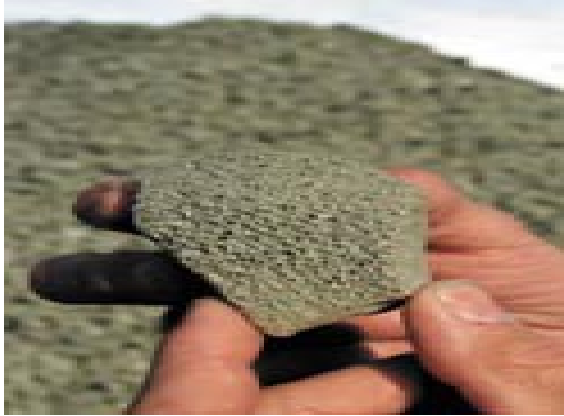
Figure1: Typical foamglass particle.

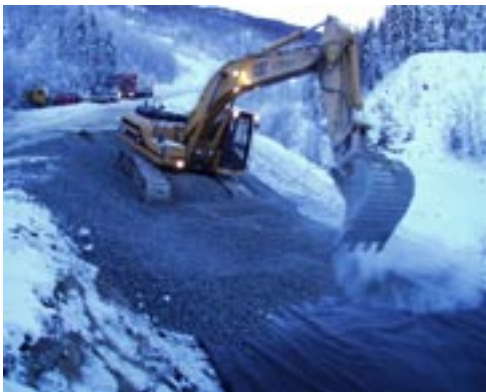
Figure 3: Placing of foamglass with excavator.

Due to erosion along the riverbed a 10 m high road slope failed over a distance of some 30 m. At the river level and in the slope the subsoil consisted of quick clay of medium strength. In order to re-open the road and prevent further erosion along the riverbank and more slides, it was necessary to quickly implement repair measures. Erosion protection was established using blasted rock before filling the slide area with foamglass of the Hasopor type. The material was delivered on site by large trucks and side tipped into slide area. Volumes of up to 100 m<sup>3</sup> could be transported in one haul. The foamglass was then distributed and placed in layers of 0.5 m thickness by a 30 tonnes crawler mounted excavator and compacted by 3-4 passes by the crawler belts giving a compaction ratio of 1.4. In this way a total volume of 300 m<sup>3</sup> was placed within the time span of 4 hours, see Figure 3.

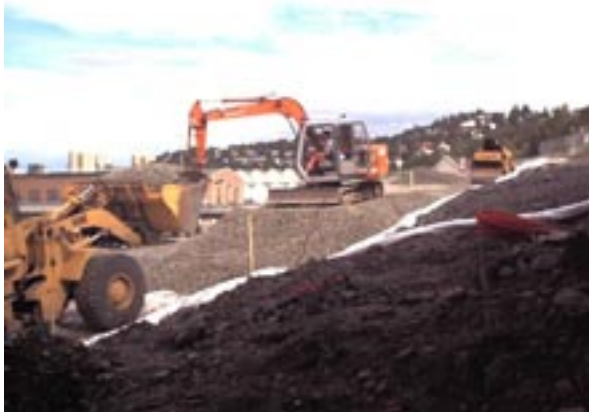
Figure 5: Distributing foamglass material using a crawler mounted excavator (Hitachi EX60, 8 tonnes). For internal transport on site a shovel dozer (CAT 923E) was used.

The foamglass was placed in layer thickness up to 2 m. The top surface was levelled off by the excavator. Compaction was performed by the crawler belts of the excavator, see Figure 5. On the slopes light compaction was performed with the excavator bucket. The natural slope angle for uncompacted foamglass seems to be 45°.

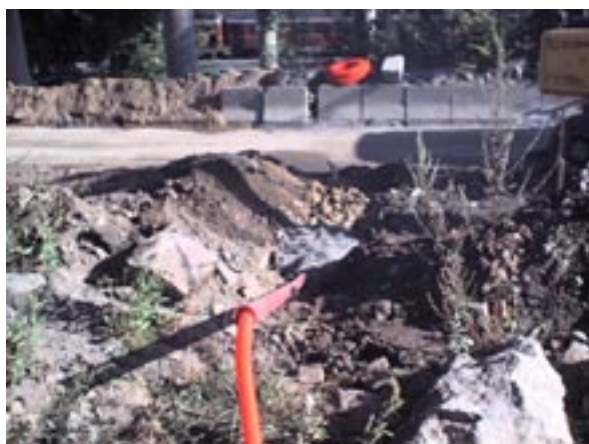
Figure 7: Monitoring long term deformations with tube settlement gauges.

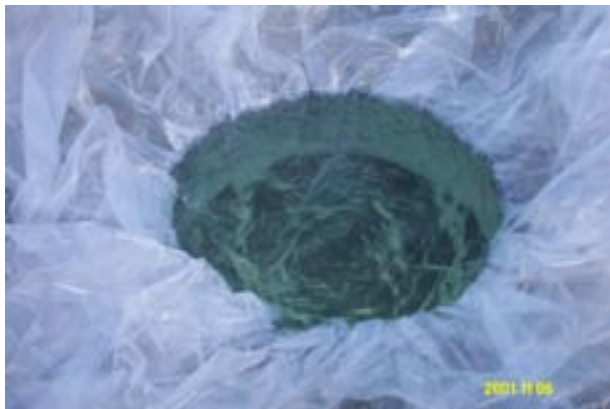
Figure 10: Water used to measure excavated volume.

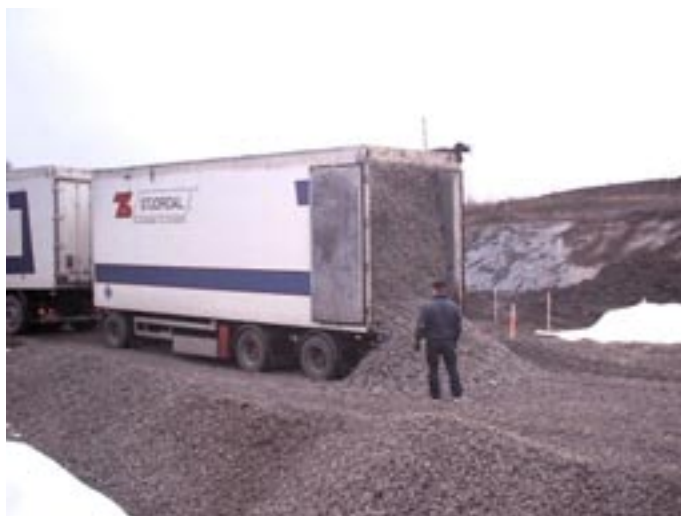
Figure 11: Transport to site in large trucks.

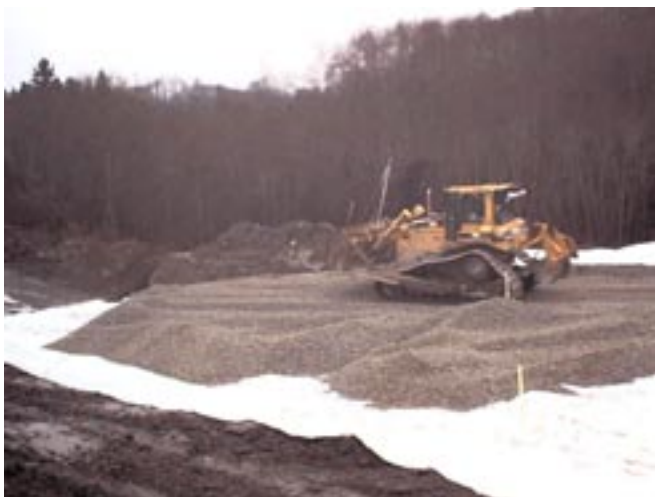
Figure 12: Distribution and compaction with dozer.
