ROLLER-COMPACTED CONCRETE PAVEMENTS IN NORWAY

REPORT

TECHNOLOGY REPORT 2429

ROLLER-COMPACTED CONCRETE PAVEMENTS IN NORWAY 20 YEARS EXPERIENCE

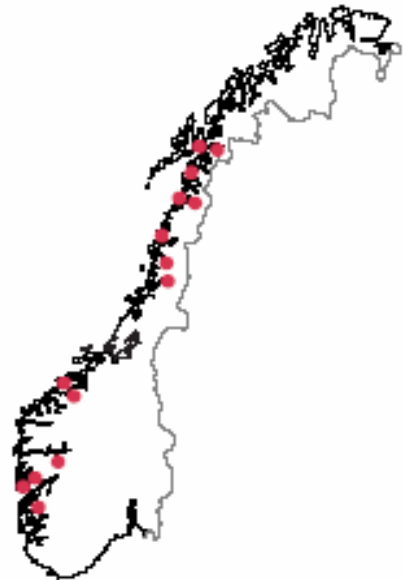
Figure 1: Constructed roller-compacted concrete pavement by year and geographic location.

Of the 68 km of roller-compacted concrete pavements, nearly 60 km are in tunnels.

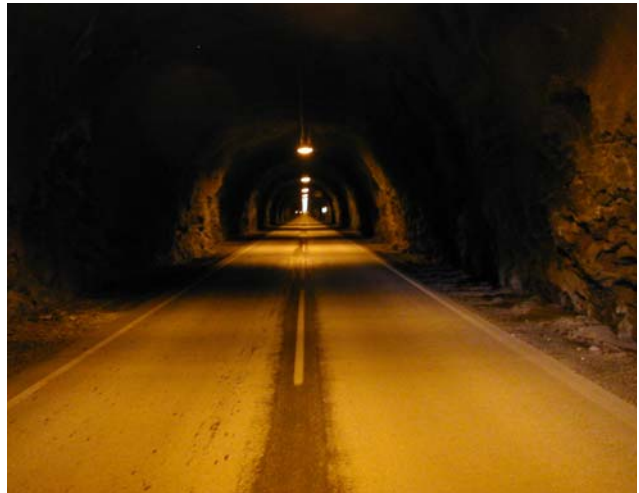
Figure 2: The picture shows a roller-compacted concrete pavement in Steigen Tunnel.

The tunnel is straight and built for small traffic volumes. Production of the pavement went well. However, each lane was paved separately resulting in a longitudinal joint of low quality that had to be repaired shortly after completion. Due to small temperature variations and low traffic loading, the pavement is in excellent condition after 15 years of service and a lifetime of 100 years is possible.

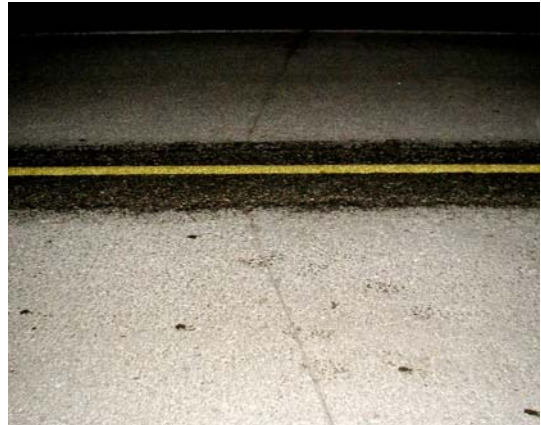
Figure 4: Inclined joints after approximately 15 years service. Longitudinal centre joint was repaired after uncontrolled cracking.

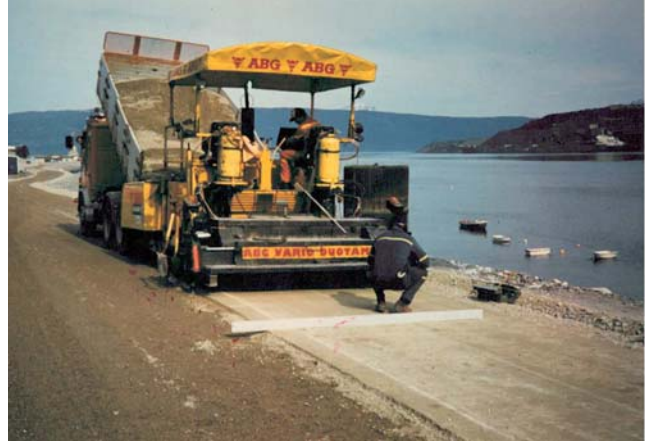
Figure 6: Casting roller-compacted concrete on one of the first projects.

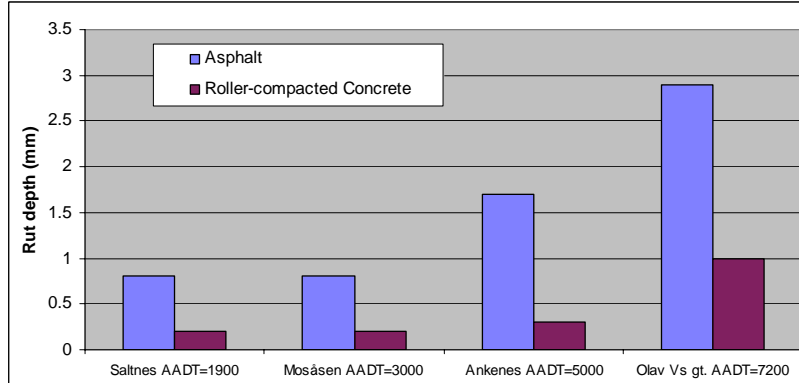
Figure 7: Observed rutting per year (mm) for stretches of road with asphalt and roller-compacted concrete pavements.

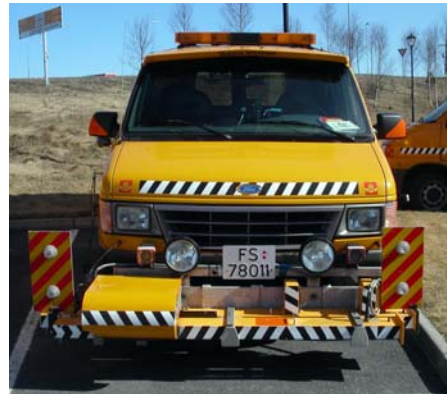
Figure 8: Vehicle "ALFRED" used for measurement of road surface unevenness and texture.

The condition of concrete pavements in tunnels is recorded every year by the ALFRED measurement vehicle in accordance with standard procedures. Rut depth and IRI (International Roughness Index) are calculated for 20 m sections and are used in the PMS (Pavement Management System) for detailed planning of maintenance activities for rolling six-year periods. Over 95% of the national road network is measured in this way every year. The results are stored in NPRAs Road Data Bank.

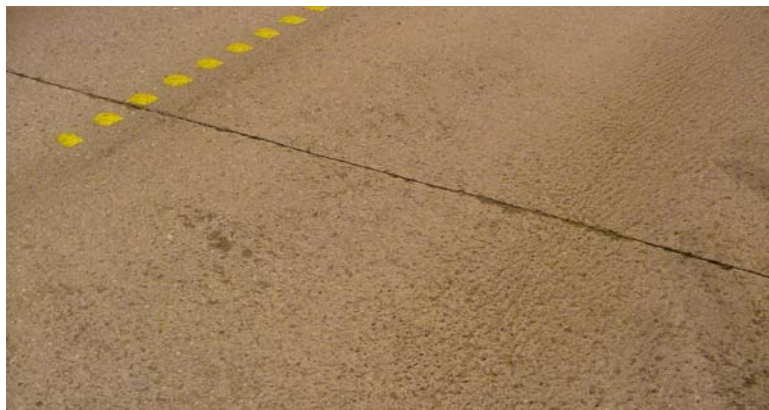
Figure 11: Example of a joint.

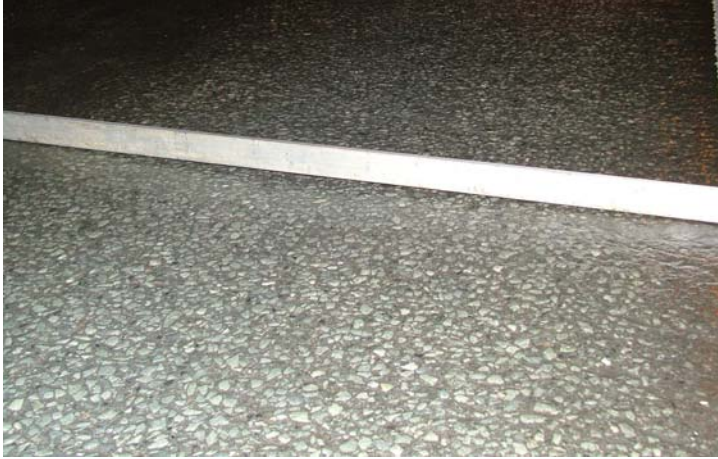
Rubber coated rollers were used during paving to increase the proportion of aggregate in the surface layer, as this gives a better surface resistance against studded tyres.

Figure 12: Example of good distribution of aggregates on the surface.

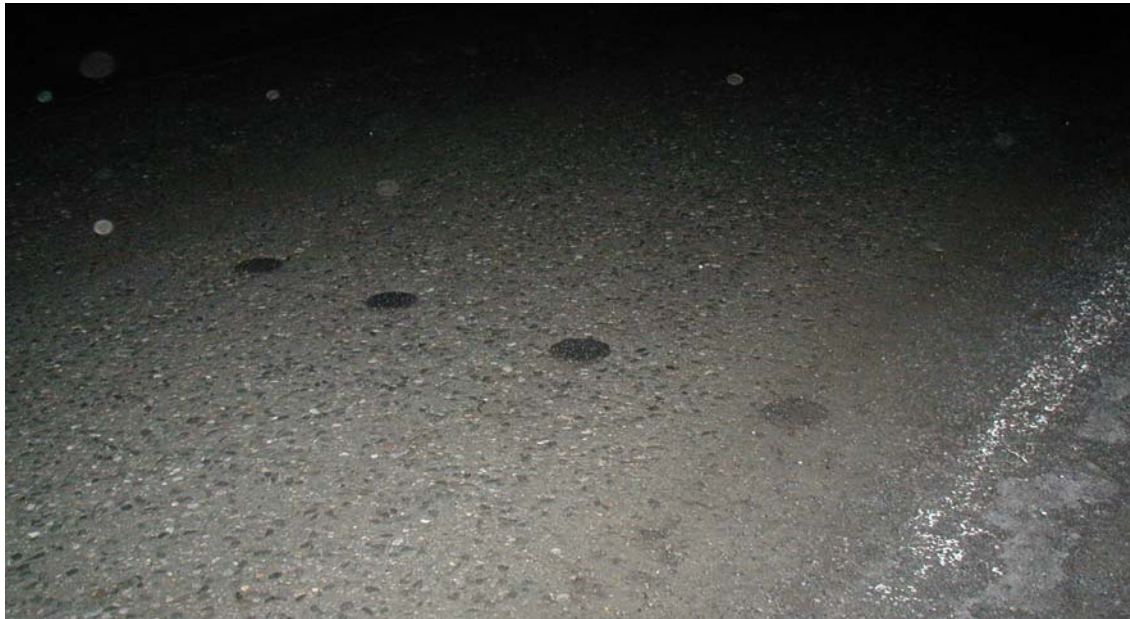
Figure 13: Concrete surface with test cores.

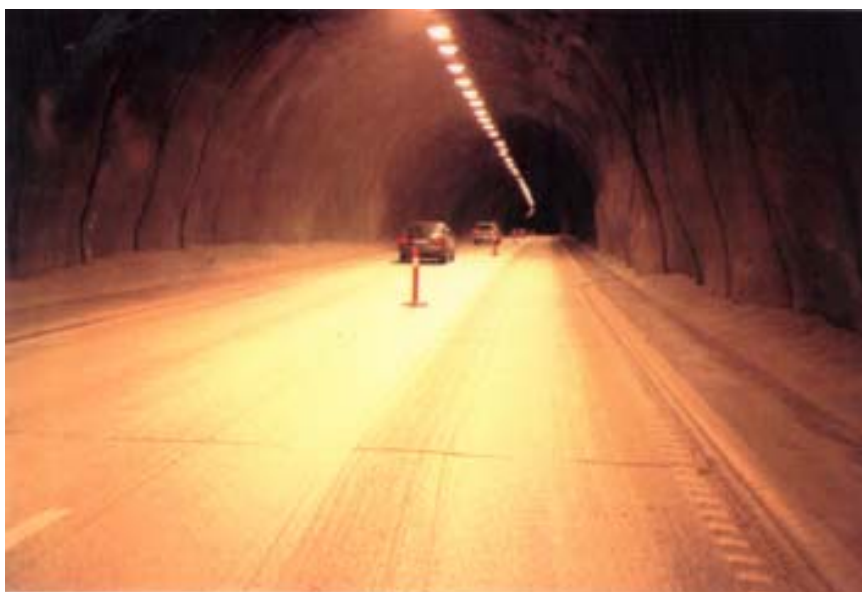
Figure 14: Picture from a tunnel with face/stud – milling work. There are very little experiences with this method in Norway.

The most inexpensive repair method is milling with a face/stud milling machine, which costs approximately 1/3 the cost of a new asphalt layer. This is of course assuming that the joints are not heavily damaged and that there is no uncontrolled cracking or potholes in the pavement.

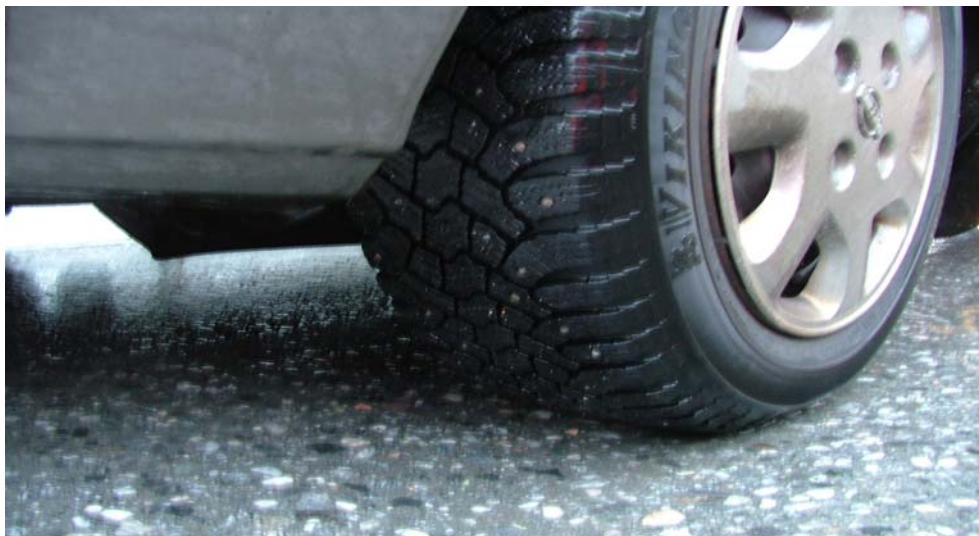
Figure 15: Studded tires, one of the main problems for pavement maintenance.
