Deterioration Mechanisms and Durability of Sprayed Concrete for Rock Support in Tunnels

Proefschrift

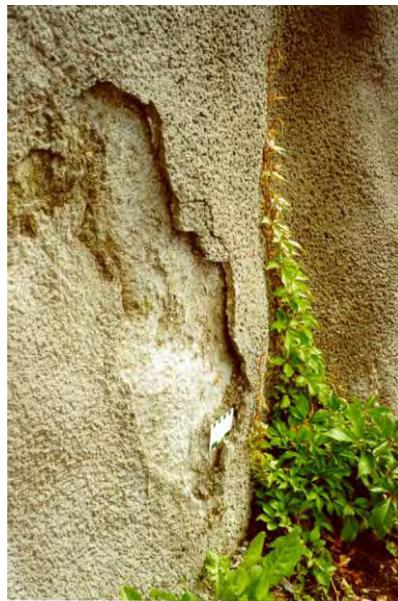
Figure 1. Spalling in steel fibre reinforced sprayed concrete due to thaumasite sulfate attack and associated carbonation (Hagelia and Grønhaug 2000).

concrete made with Sulfate Resisting Portland Cement (SRPC) and silica fume. The concrete was sprayed on Alum Shale in a road cut (Figure 1). It was found that spalling here was caused by Thaumassite Sulfate Attack (TSA) with associated carbonation and destructive steel fibre corrosion (Grønhaug and Hagelia 2000, Hagelia and Grønhaug 2000). This finding triggered a further interest in sulfate attack, and notably the intriguing possibility that the old and more extensive attack perhaps represented a severe case of TSA.

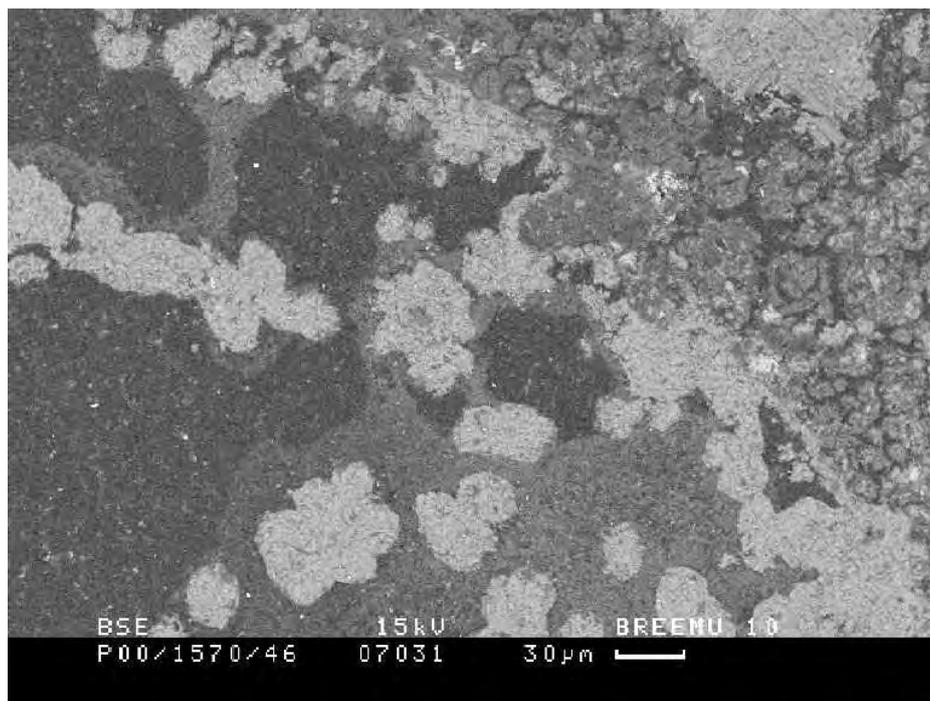
Figure 1: Co-precipitation of Popcorn calcite (bright) and surrounding Type 1-2 thaumasite (grey) in a partly filled entrapment void within 2 years old sprayed concrete in the Svartdal tunnel (BS-image). This TF-PCD process requires elevated concentrations of calcium and carbonate ions relative to sulfate ions. Notice the presence of very porous cement hydrates (granular/grey) next to aggregate (upper right), which may represent loss of calcium and silicon. See text for details. Scale bar = 30 μm .

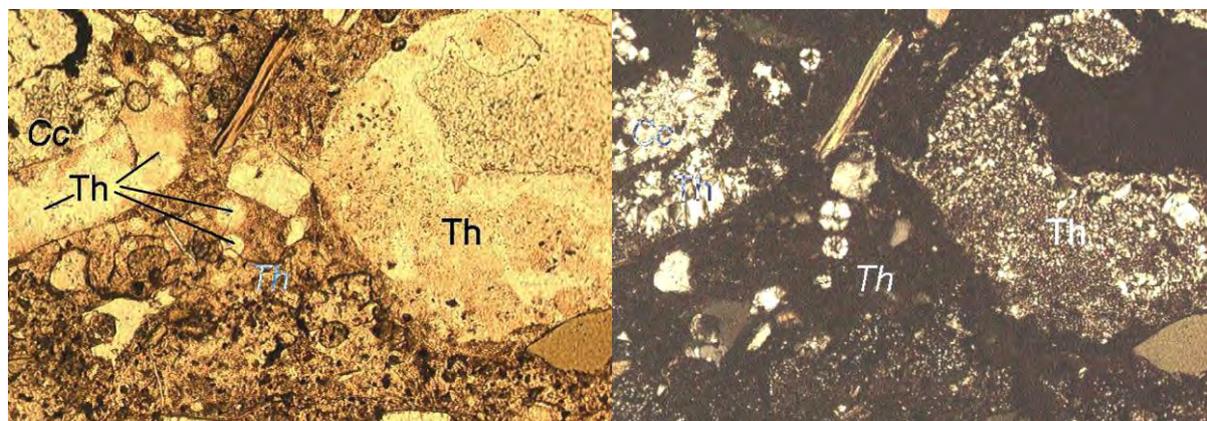
Figure 2: TF and TSA (Zone 3) in a small remnant of sprayed concrete from within a TSA-mush in the Freifjord sub sea tunnel. Thaumasisite of Type 2 (Th) occurs: a) in two large entrapment voids with subsequent calcite deposition (Cc in left void): b) in smaller air voids and c) as thaumasite of Type 1 and 2 scattered about in depleted cement paste (area around and below Th). Plane polarised light and crossed polars, respectively. Horizontal fields of view 1 mm.

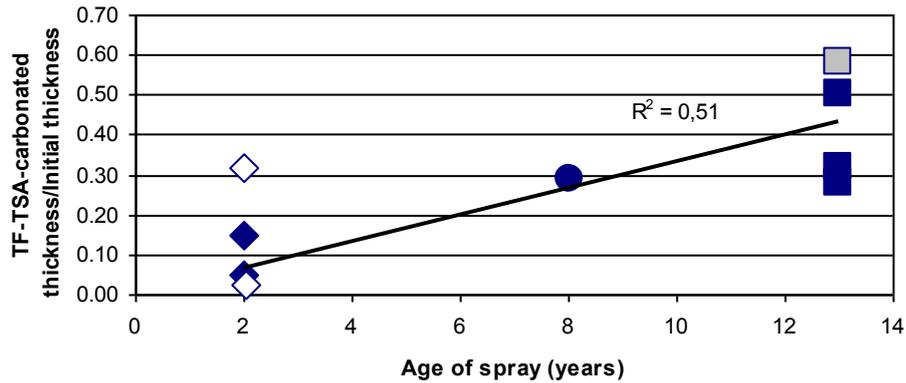
Figure 3 – Development of the TF – TSA – carbonation with time in modern steel fibre reinforced sprayed concretes made with SRPC and silica fume in contact with Oslo Alum Shale. w/c about 0.4-0.5. Squares = Åkebergveien cut (grey filled symbol contains some 1970 spray); Filled circle = Ekeberg tunnel; Diamonds = Svartdal tunnel: Open diamonds made with Al-sulfate accelerator: Filled symbols, with water glass accelerator. The TF-TSA-carbonated thickness in each core represents the sum of bleached- surface parallel zones within which this reaction was developed.

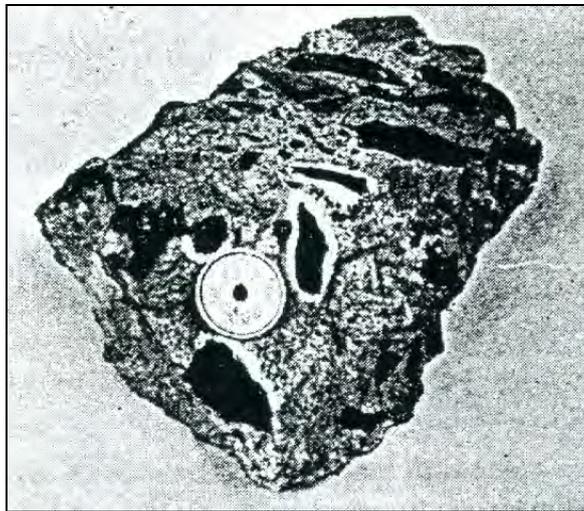
Figure 2: Old construction concrete with white “halos” of reaction products around Alum Shale aggregate particles [1].

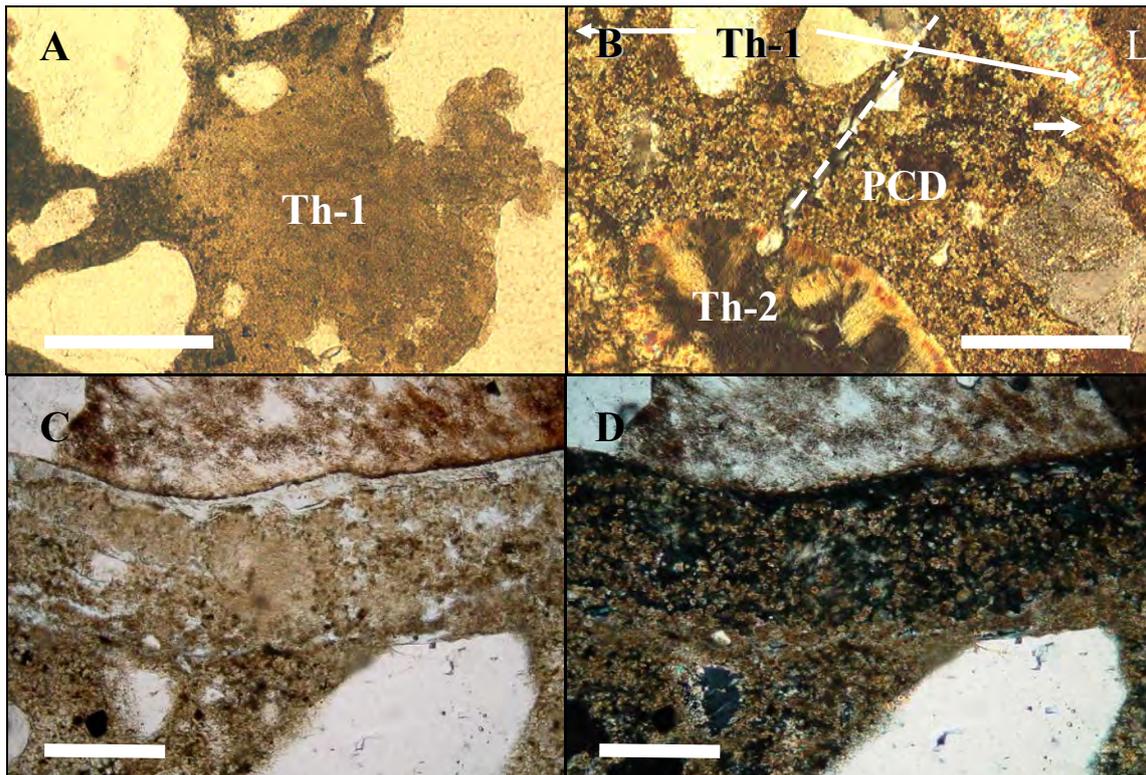
Figure 3: A) and B) Scale bars = 300 μm : A) Plane light: Sample 1647/7 (Series 12 Nor PC 85 with trass), showing evidence of Stage 1 incipient TSA (Th-1) at the expense of sound cement paste: i.e. with pristine C-S-H (left) at the edge of an air void (right). B) Crossed polars: Sample 1647/6 (Series 1 Nor PC without additives): Stage 1 TSA (Th-1) had formed locally within the cement paste matrix and along the margin with a biomicritic limestone aggregate (L). Stage 2 decalcification of C-S-H and associated Popcorn calcite deposition (PCD) at partial expense of Th-1 (small arrow). Subsequent Stage 3, full scale TSA (Th-2) formed at the expense of the assemblage PCD – decalcified C-S-H. Notice the micro crack (stippled line) restricted to the assemblage with PCD having formed at a high angle to the reaction front. C) Plane light and D) crossed polars: Scale bars = 0.2 mm: Sample 1647/6 with Stage 1 TSA associated with an adherence crack adjacent to a large granitic aggregate particle. This was followed by Stage 2 decalcification of C-S-H and PCD involving partial decomposition of thaumasite.

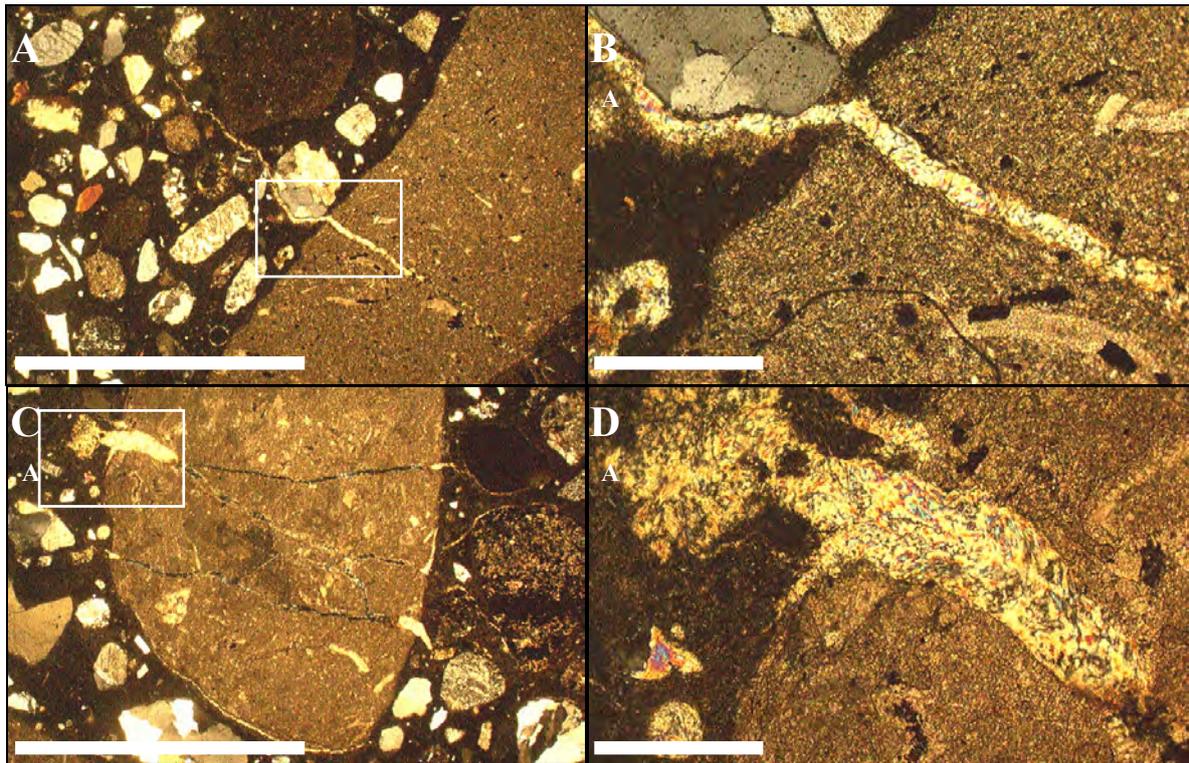
Figure 4: Crack development associated with thaumasite growth about 1-2 cm beneath the outer leached zone in Sample 1647/12 (Series 8 Nor PC with limestone fines). A) Most focused growth of thaumasite within the region where the micro crack straddles the cement paste matrix – biomicritic limestone aggregate interface. Notice that the crack dissipates in both directions. The joint in lower right was essentially open with sparse deposit of thaumasite. B) Close up detail from A showing high birefringence Type III thaumasite which grades into lower birefringence characteristic of Type II thaumasite in paste away from the interface. C) Overview of several thaumasite wedges, representing forceful growth along several micro cracks across the interface of biomicritic limestone and well-preserved cement paste matrix. Some micro cracks inside limestone were empty; others were partly filled with thaumasite or fringed with a very scattered needle shaped mineral (possibly ettringite or Type I thaumasite). D) Detail of thaumasite wedge sitting at the interface showing Type III thaumasite with 2nd order blue-green birefringence where in contact with limestone aggregate, and first order yellow birefringence (Type II) where in contact with cement paste matrix as well as at the termination at the empty crack (lower right). Notice pyrite (black) within limestone. Scale bars: A and C = 2.5 mm; B and D: = 300 μ m. Crossed polars.

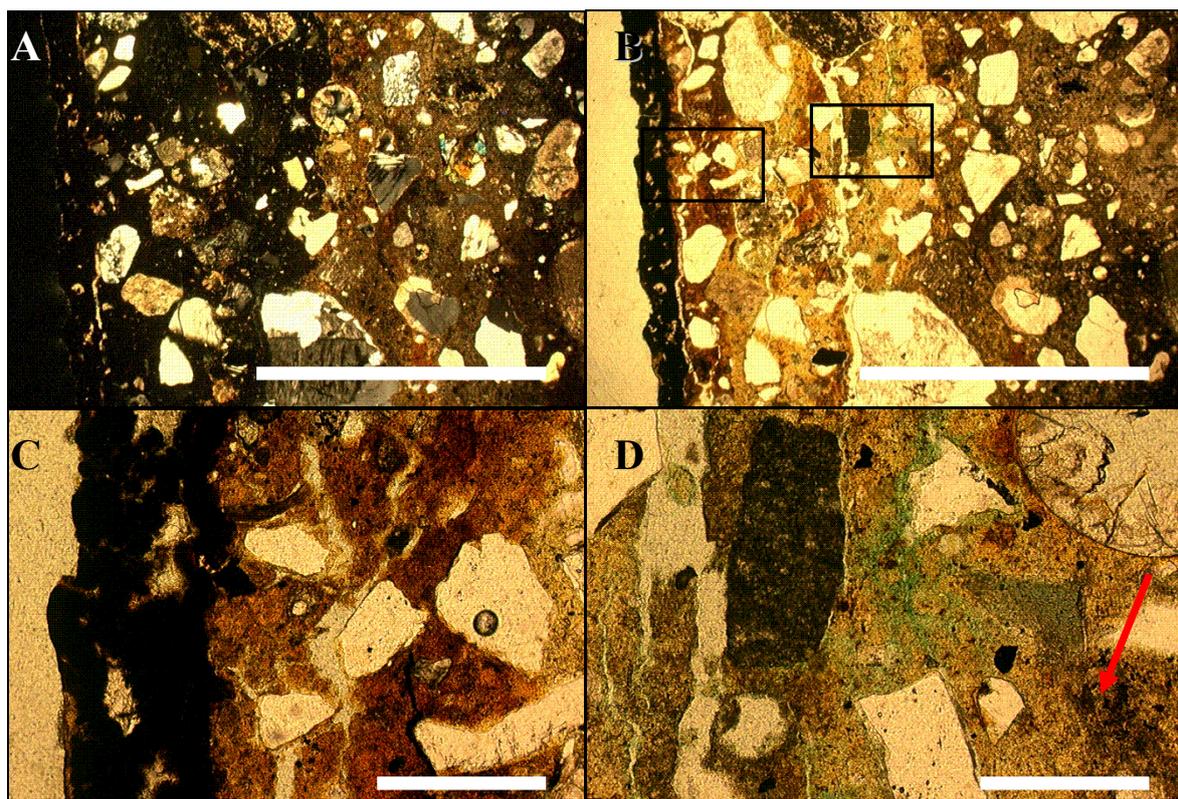
Figure 5: Effects of acid attack and carbonation in outer parts of sample 1647/7 (Series 12 Nor PC with trass). A) Crossed polars and B) plane polarised light of same domain, scale bar = 2.5 mm: Stage 6 outer ca 300 μm wide dark dense surface layer of Fe-hydroxide followed by a ca 2-2.5 mm very porous iron stained zone of extremely depleted carbonate free cement paste outside a distinct ca 2 mm thick fine grained carbonated zone (Stage 5) with somewhat Ca depleted cement paste inside (= Stage 2 far right). C) and D) in plane polarised light, scale bar = 300 μm : Outer dense Fe –deposit with calcite inclusions, sitting on extensively iron stained and microcracked very friable cement paste. D) Transition from inner leached cement paste into fine-grained carbonated zone: Lower right showing only local development of PCD (arrow) in Ca-depleted cement paste matrix. Middle right, ordinary carbonation: Upper right; air void filled with blocky calcite. Otherwise brown weak iron staining and pores (bluish green stain from preparation was not filling well; all sub-parallel microcracks appearing white are empty).

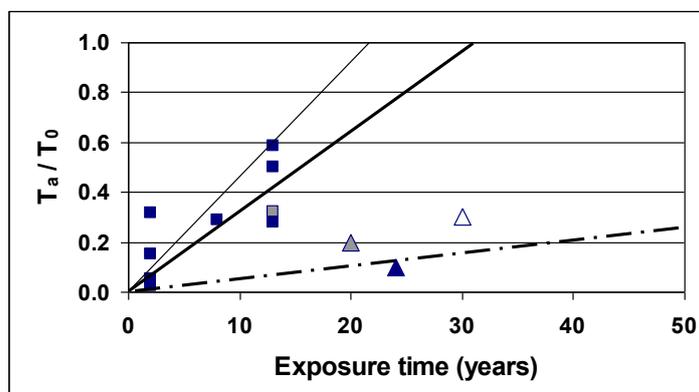
Figure 6: Comparison of deteriorated thickness (T_a) versus initial thickness (T_o) for SRPC based sprayed concrete with SF on Oslo Alum Shale (squares) [4]), with exposed Blindtarmen test prisms (triangles; filled = Series 12 Nor PC with natural pozzolana; dark grey = Series 8 Nor PC with limestone filler; open = Series 1 Nor PC reference). w/c –ratios 0.45-0.5. The thick full line approximately corresponds to initial sprayed concrete thickness = 10 cm whilst the thick stippled line represents Blindtarmen Nor PC with SF [5].

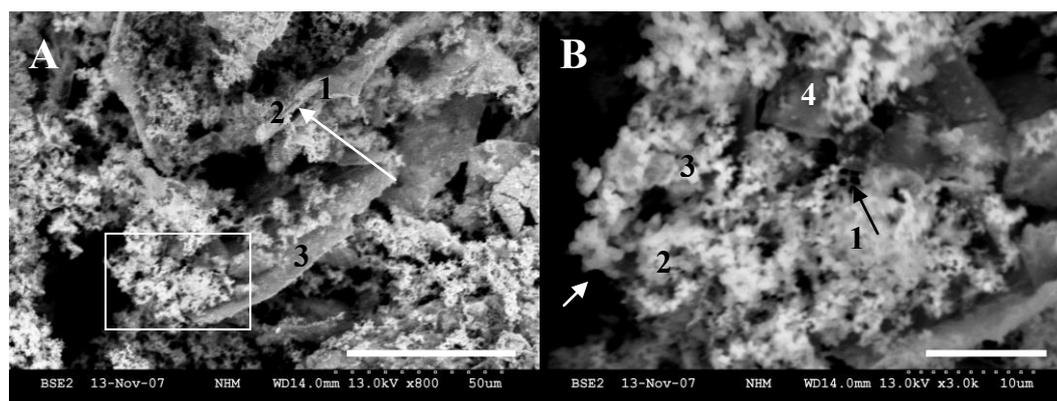
Figure 2: Bacterial deposits found in Tunnel water 320-06 (Back Scatter Images). A: Presence of apparent *Leptothrix ochracea* (arrow) and associated biominerals. B: Smaller abundant coccoidal to rod like shapes (white arrow) sometimes forming a “network” (black arrow) which likely represents *Acidithiobacillus ferrooxidans*, *Acidithiobacillus thiooxidans* or both. Numbers refer to point analyses given in Table 3. Scale bars: 50 μm and 10 μm, respectively.

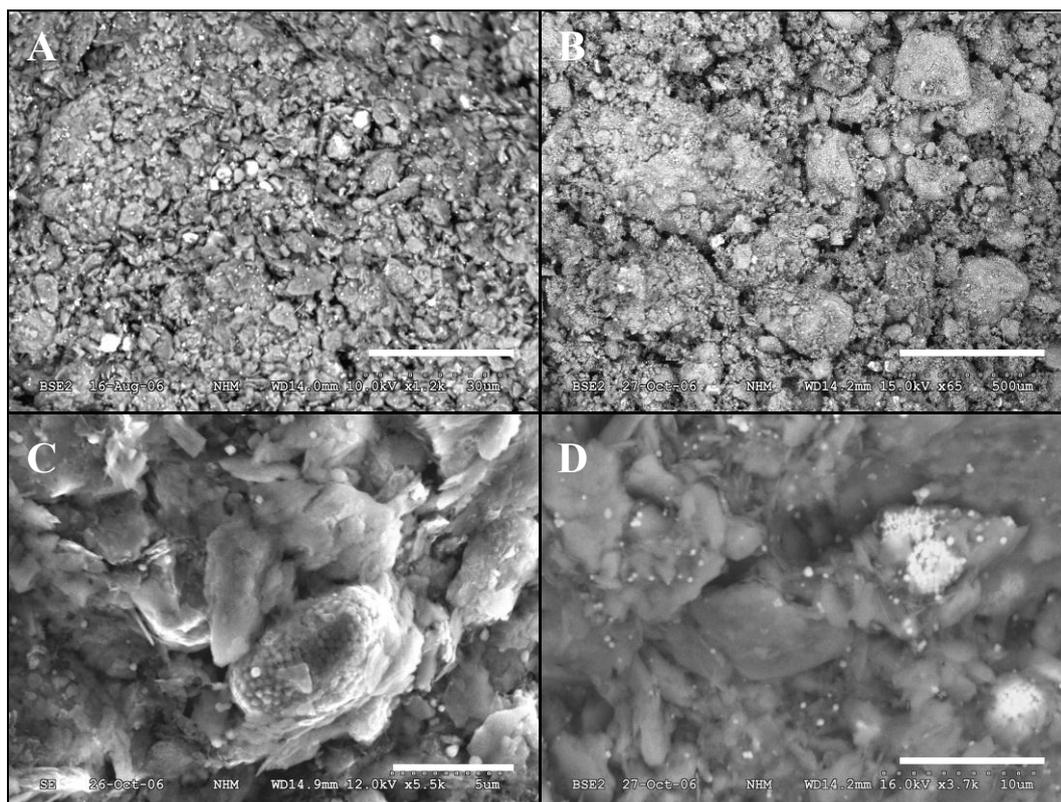
Figure 3A: Representative Back scatter electron (BSE) image of initial Alum Shale powder before the leakage experiment. Scale bar = 30 µm. B: BSE image of powder after leaching in Water 2 showing separation and agglomeration. Scale bar = 500 µm. C: Secondary electron (SE) image of apparently slightly reacted framboidal pyrite after leaching in Water 1: Scale bar = 5 µm. D: BSE image of possibly slightly reacted framboidal pyrite (bright) after leaching in Water 2: Notice also very small sulfide grains < 1 µm. Scale bar = 10 µm. There was no obvious sign of sulfide oxidising bacteria.

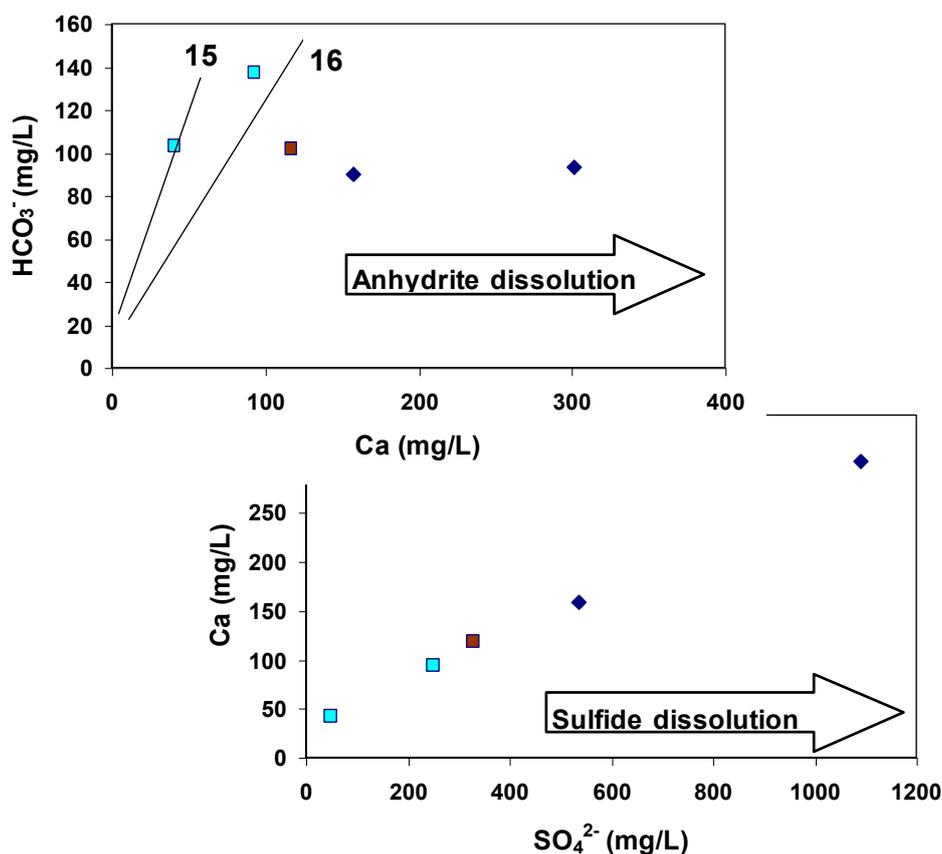
Figure 11: Results of leaching experiment on anhydrite and iron sulfide bearing Alum Shale from Gran (diamonds), black shale (dark square) and limestone (light squares). Trends for calcite dissolution according to Reactions 15 and 16 for are indicated.

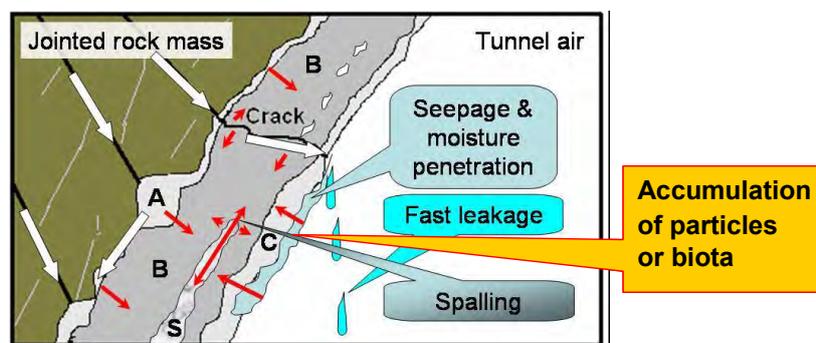
Figure 1: Cross section showing the anatomy of chemical attack within sprayed concrete. Ground water enters by advection (white arrows) or diffusion (small arrows). Layers A and C represent deteriorations, S represents spalling and Layer B remaining sound concrete.

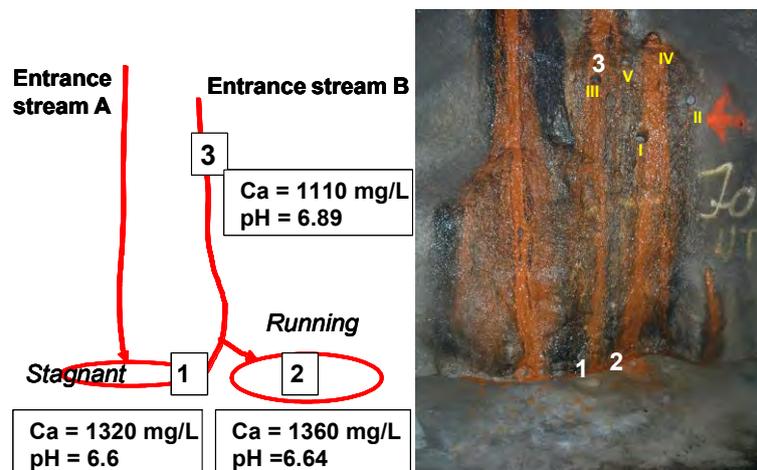
Figure 2: Locality Oslo 1a showing locations of Cores Kj I to V and water samples 1, 2 & 3: Ca was leached from concrete under influence of mildly acidic water. The small leakage on the lower right had formed an up to 4-5 cm deep groove into the concrete.

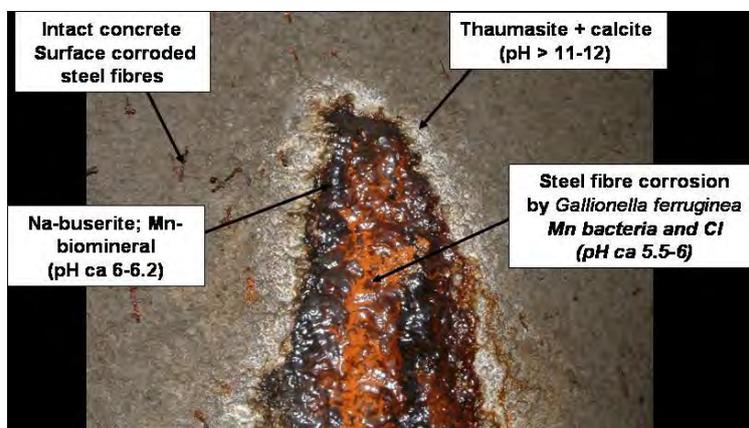
Figure 3: Locality Oslo 1a. Entrance point of saline leakage with dark Mn bacterial slime and iron bacteria leading to cement paste degradation. Image about 55 cm wide.

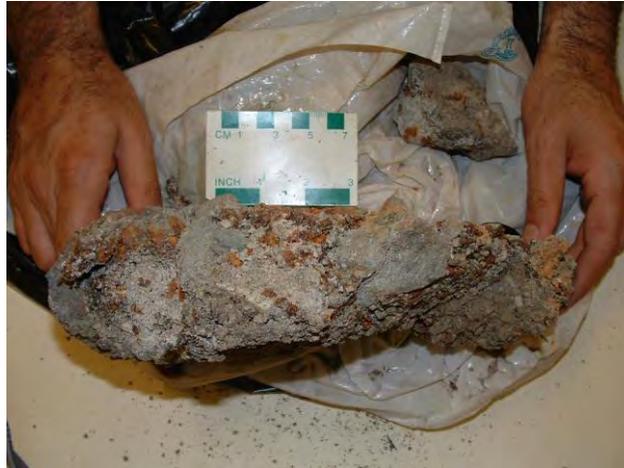
Figure 4: Spall V5, with extremely friable cement paste matrix from underneath layered Mn and Fe biofilm. Five year's old sprayed concrete from Locality 2c, Oslofjord subsea tunnel.

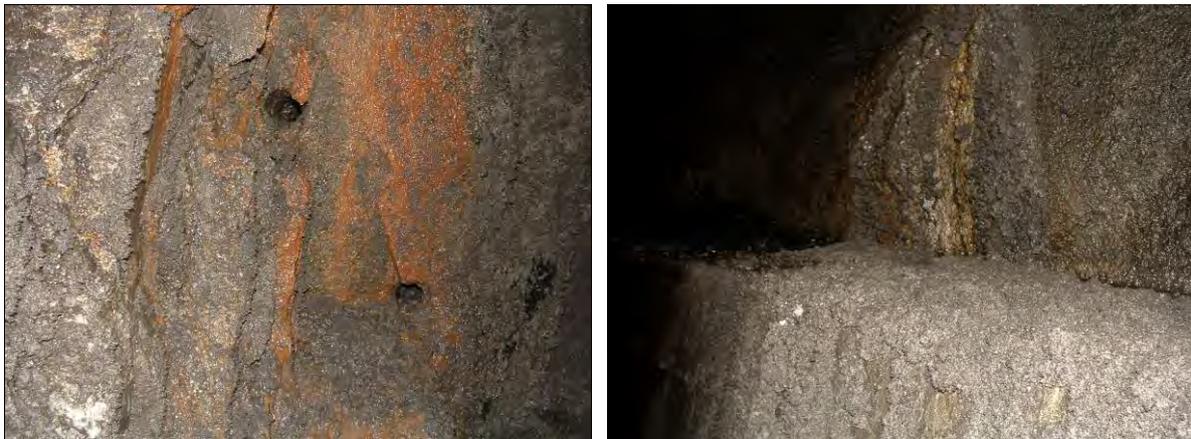
Figure 5: Freiffjord subsea tunnel at concrete age 16 years. Left: Extensive breakdown of sprayed concrete attacked by saline ground water and Mn-Fe biofilms, overlain by grey carbon bearing gypsum mush. Notice the partly erased old core holes: Image width = 140 cm. Right: Thick carbon bearing gypsum deposit on cast concrete banquette derived from a leaky crack through decalcified and friable sprayed concrete. Image width = 200 cm.

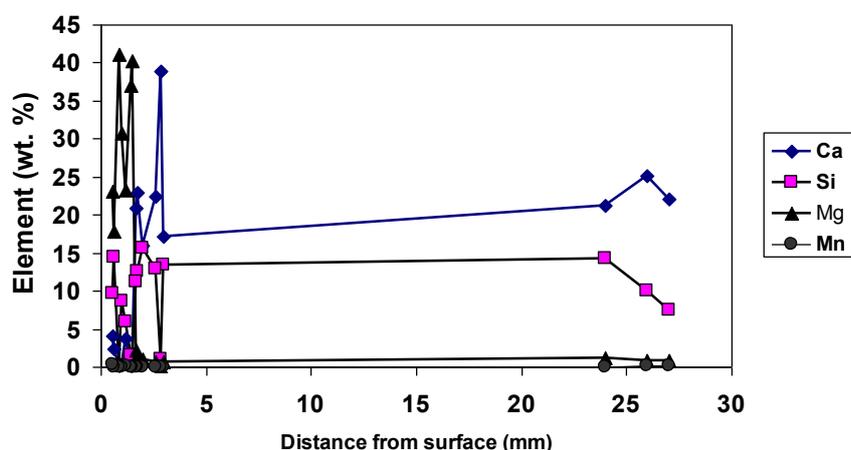
Figure 7: Element variation (EMPA) within degraded cement paste matrix in Core 5800, Freifjord subsea tunnel. The very high Ca at about 3 mm depth represents calcite. High Mg with low Si and Ca was mainly M-C-S-H with disseminated brucite. The colour of M-C-S-H in plane polarised light was pale yellowish-brown whilst intact paste at levels deeper than 3 mm was dark.

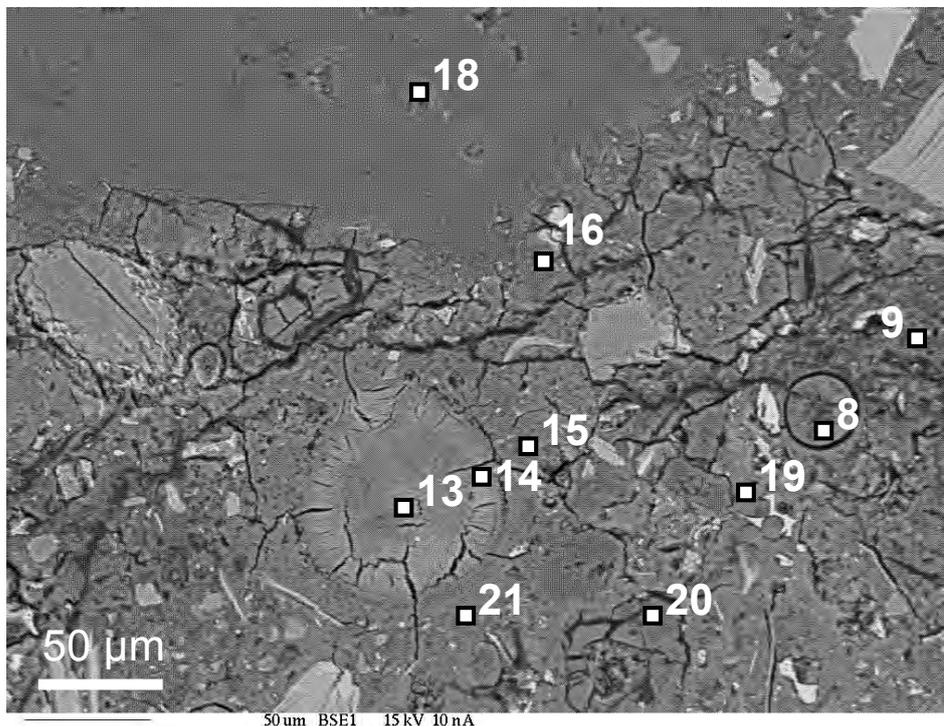
Figure 8: BSE image of sample Pr-3 about 30 mm below outer surface of sprayed concrete. M-C-S-H was well developed within cement pastes and globules and was accompanied by thaumasite. Freifjord subsea tunnel. Scale bar = 50µm.

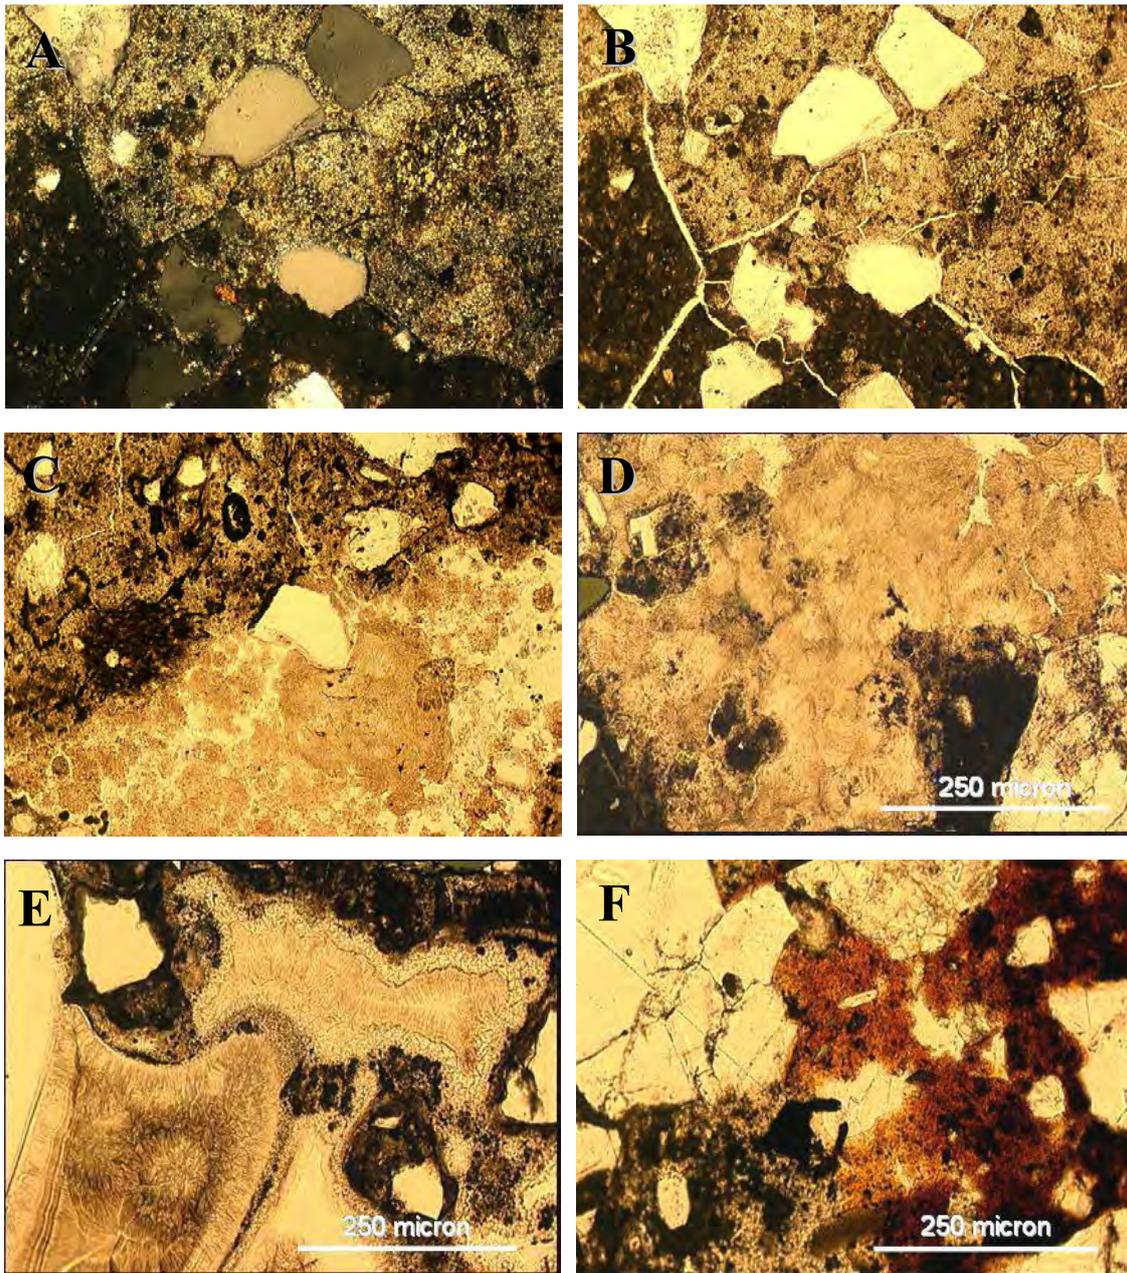
Figure 9: Typical abiotic reaction products in subsea concrete. A and B (same frame): Light coloured M-C-S-H with abundant very fine grained calcite and possible portlandite, and dark pristine paste in sample H-2004. Notice the shrinkage cracks. C: Full scale TSA mush (lower) and M-C-S-H (upper) in Core Kj V (Layer A). D: Full scale TSA mush in Core 6150 at transition between Layers A and B. E: Brucite deposits (mid Layer A) and E: rust stained porous M-C-S-H in Core 6150. Images in plane polarised light, except from A (crossed polars). Same scale. See Table 4 for further details.

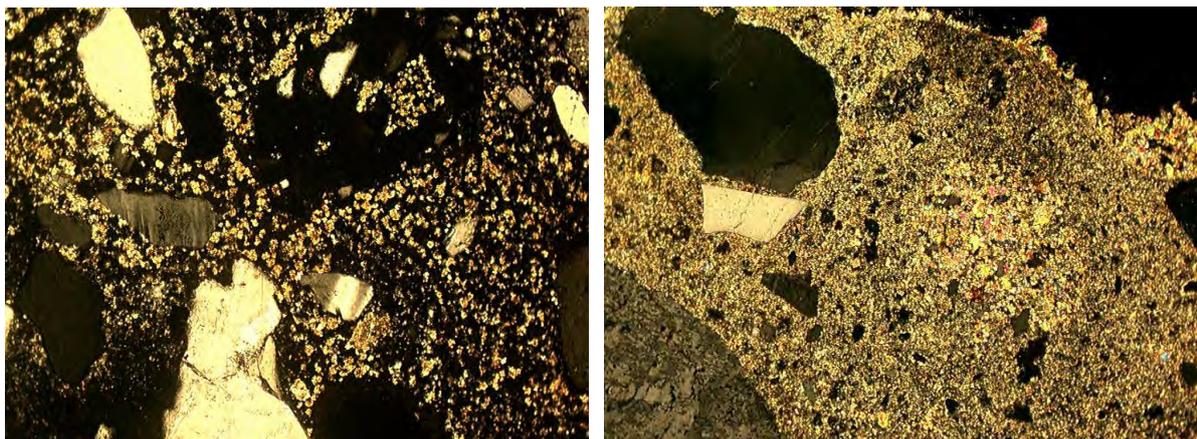
Figure 10: Left: Classic PCD within Ca depleted paste (Core 1374). Right: Popcorn like calcite precipitation within Mg infected cement paste (sample H-2004). Crossed polars: image widths = 650 μm .

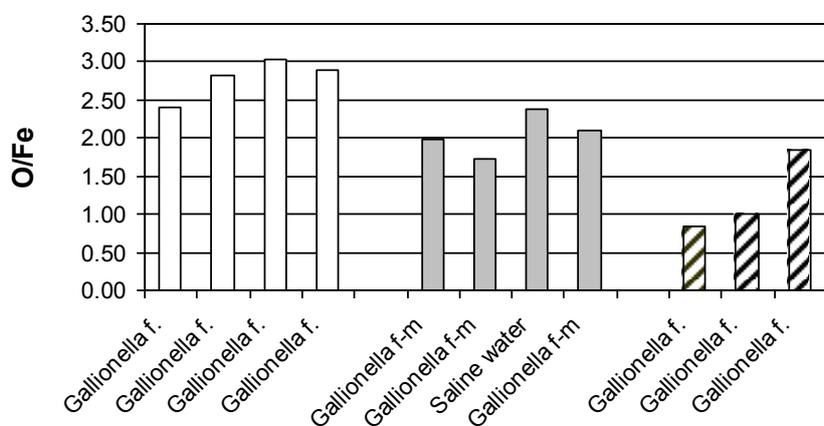
Figure 13: O/Fe (atomic ratios) of *Gallionella sp.* from SEM analyses (Tables 5 and 6). White = pristine *Gallionella ferruginea*. Grey = The Mn enriched scattered *Gallionella* on Mn-platelets (e.g. O/Fe+Mn). Hatched = Aged heavily Fe encrusted *Gallionella ferruginea*.

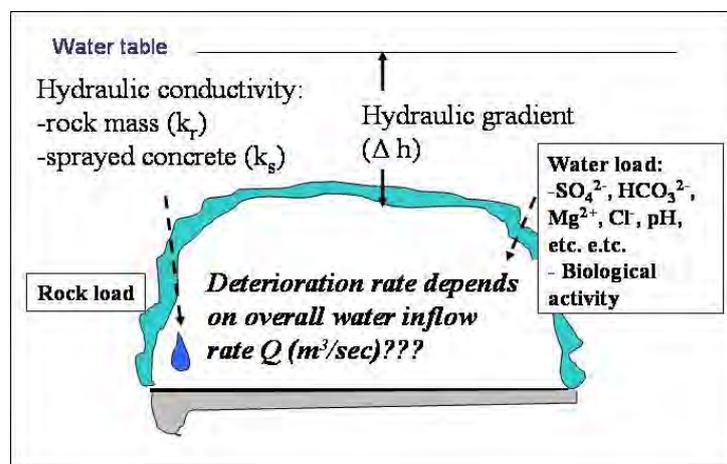
Figure 1: Principal aspects of environmental loads acting on sprayed concrete in tunnels.

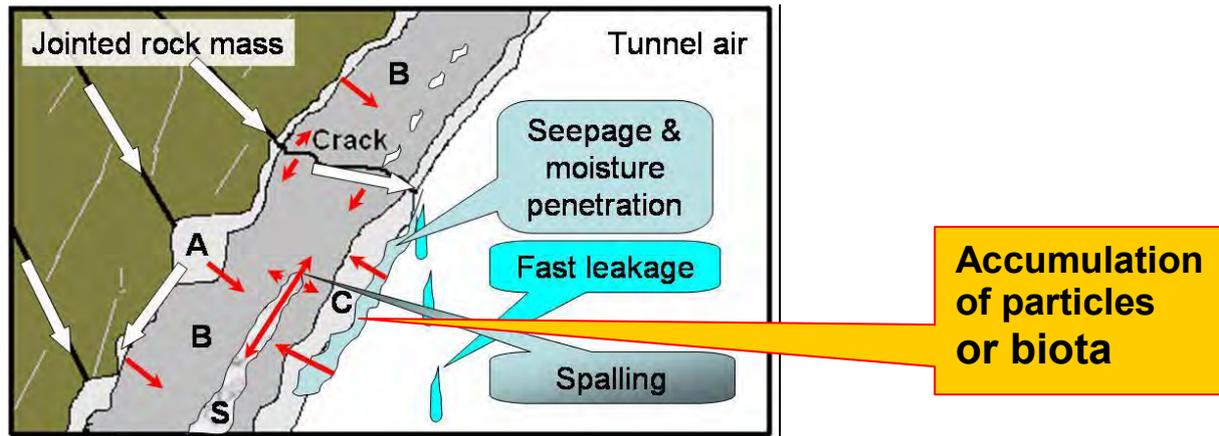
Figure 2: Anatomy of chemical attack within sprayed concrete. Ground water enters by advection (white arrows) or diffusion (small arrows). Layers A, B, C & S are explained in text.

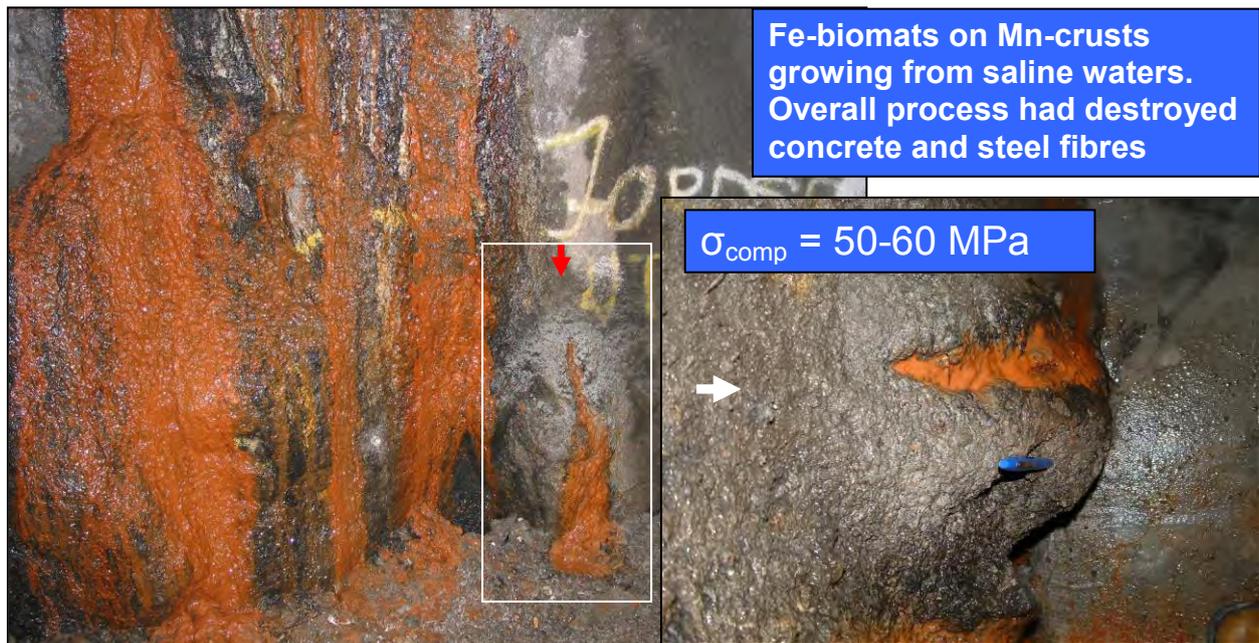
Figure 3: Complex seawater attack in the Oslofjord subsea tunnel facilitated by mild acid attack due to chemical reactions within two layer biofilm consisting of *Gallionella ferruginea* and *Leptothrix sp.* The process also attacks initially strong concrete from the outer surface (inset).

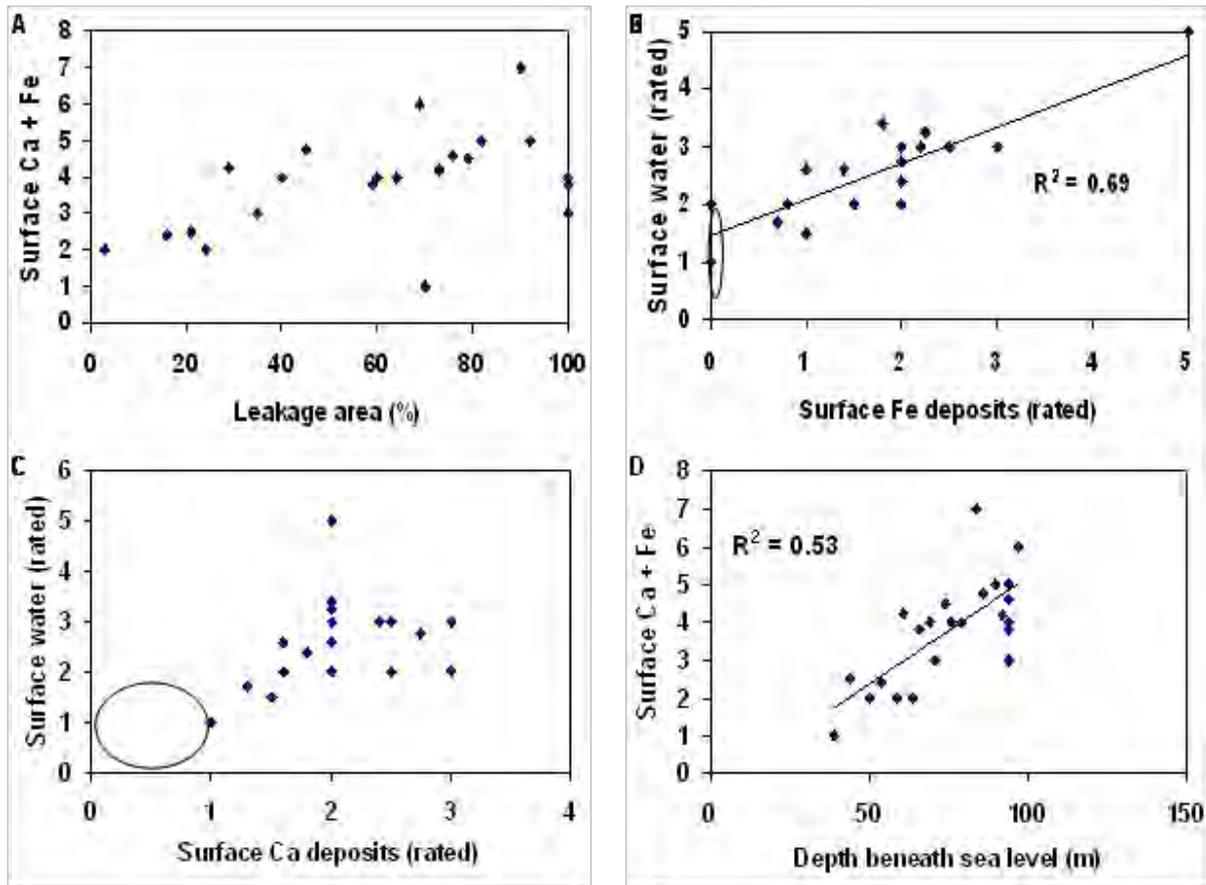
Figure 4: Surface deposits of iron ± manganese (Fe) and Calcite (Ca) show positive correlation with leaching area (A); local surface waters (B, C) and hydraulic gradient (D). Data from the Flekkerøy subsea tunnel. Ellipses represent variation in the fresh water sections under land.

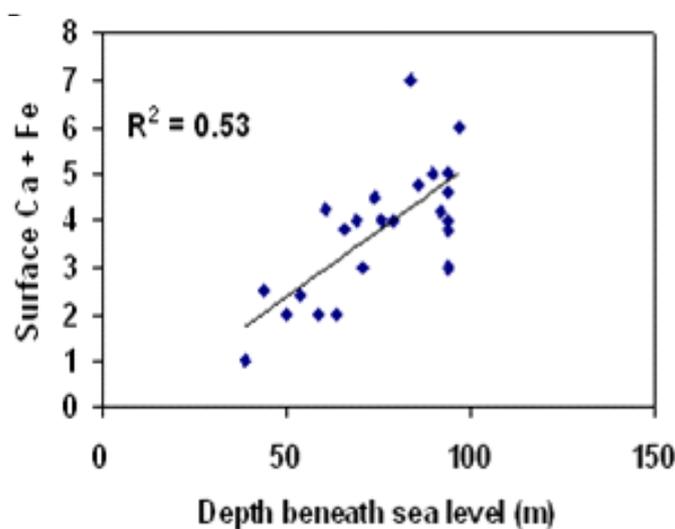
Figure 2: Surface deposits (rated) of calcite (leached Ca from cement paste) and iron ± manganese oxides (Fe) in the Flekkerøy subsea tunnel, showing a positive correlation with hydraulic gradient (depth beneath sea level) (cf.[5,6]).

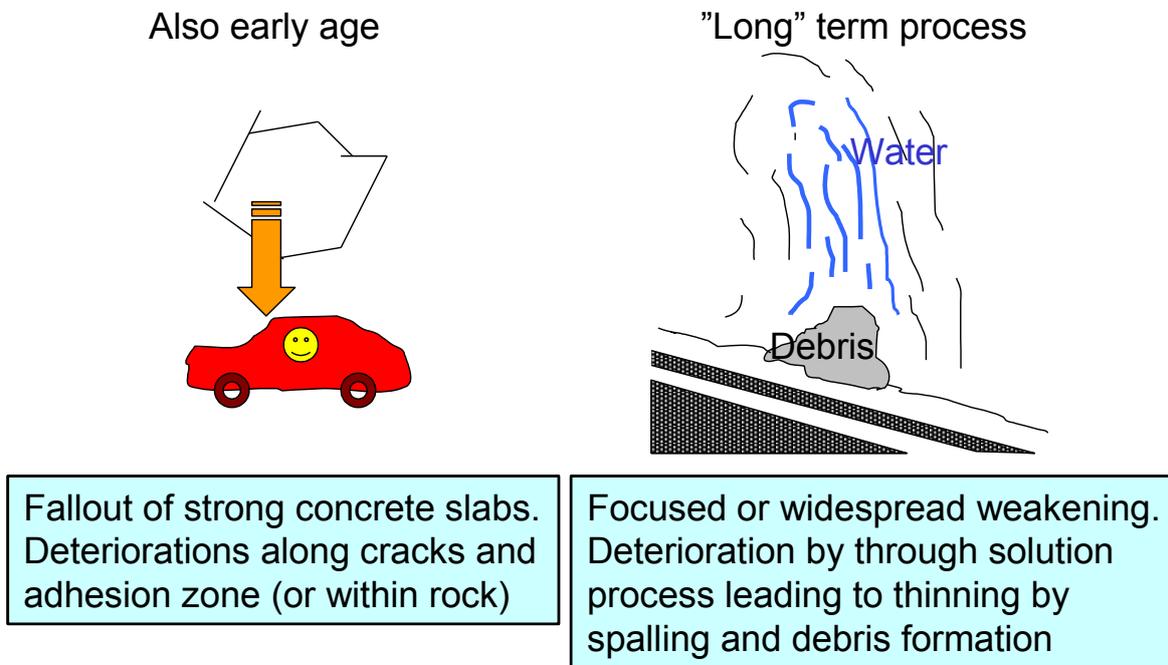
Figure 3: Two principal types of structural deterioration in sprayed concrete linings.

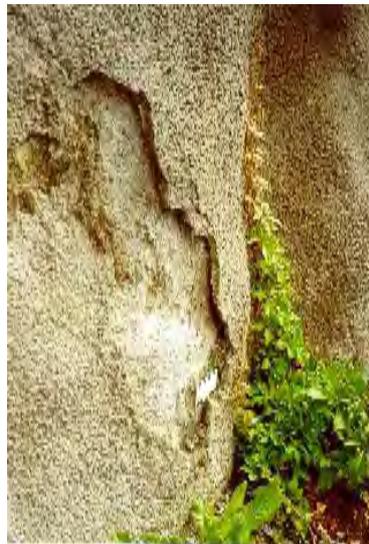
Figure 4: Spalling after less than 13 years in a 1987 steel fibre reinforced concrete (SRPC and SF), due to TSA and carbonation due to PCD. A previous spray had been severely affected and was replaced after 17 years in service. Alum Shale environment, Åkebergveien Oslo.

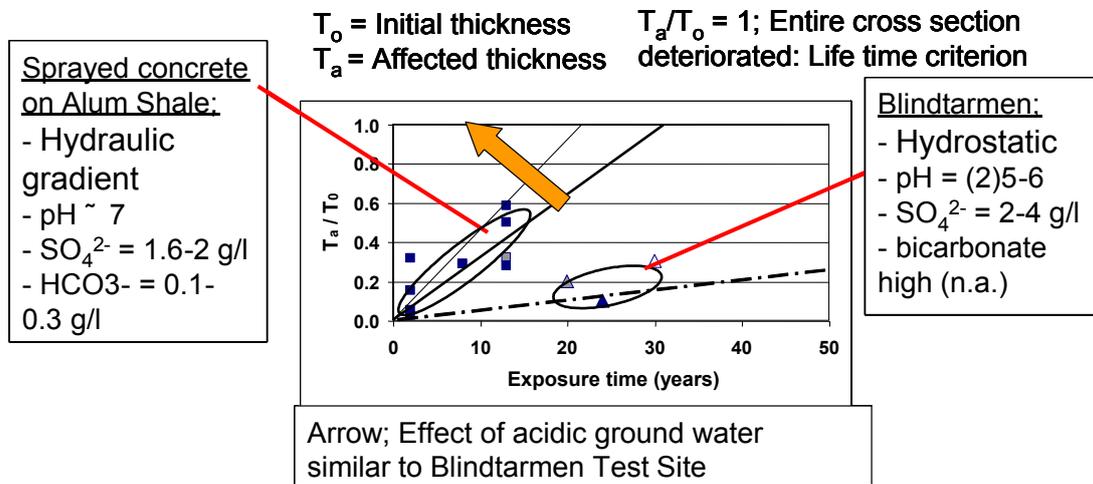
Figure 5: Lifetime of sprayed concrete under a hydraulic gradient is potentially shorter than concrete immersed under hydrostatic conditions, such as the Blindtarmen test samples. Thick continuous line represents 10 cm thick sprayed concrete (SRPC and 5 % SF) the thick stippled line 10 cm thick Blindtarmen test prisms (PC and 15 % SF)[14].

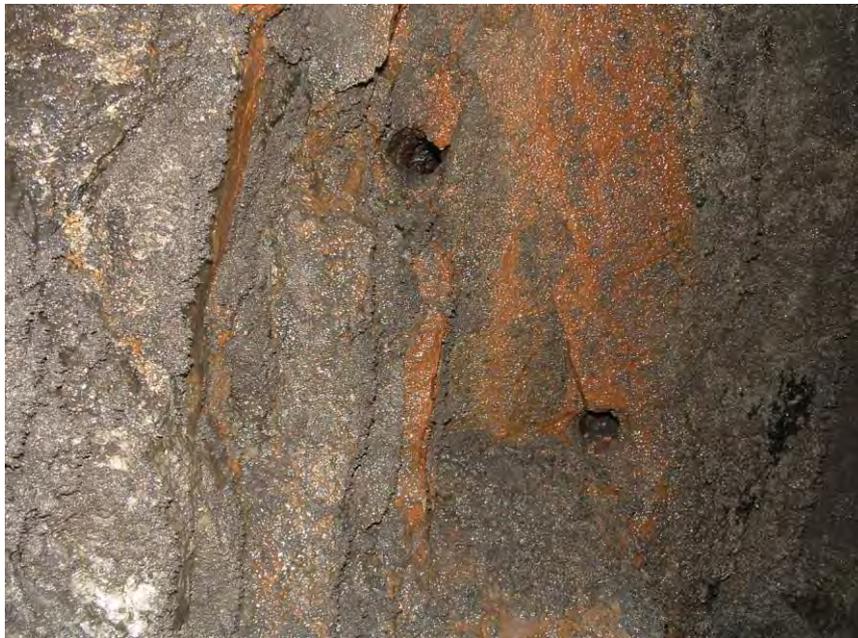
Figure 6: Old core locations in the Freifjord subsea tunnel showing extensive breakdown of the sprayed concrete 16 years later. Rusty and black areas (right) consist of iron oxihydroxide from *Gallionella ferruginea* and manganese oxides derived from *Leptothrix* sp. Grey deposits consist of gypsum formed from Ca in concrete and sulfate from seawater.

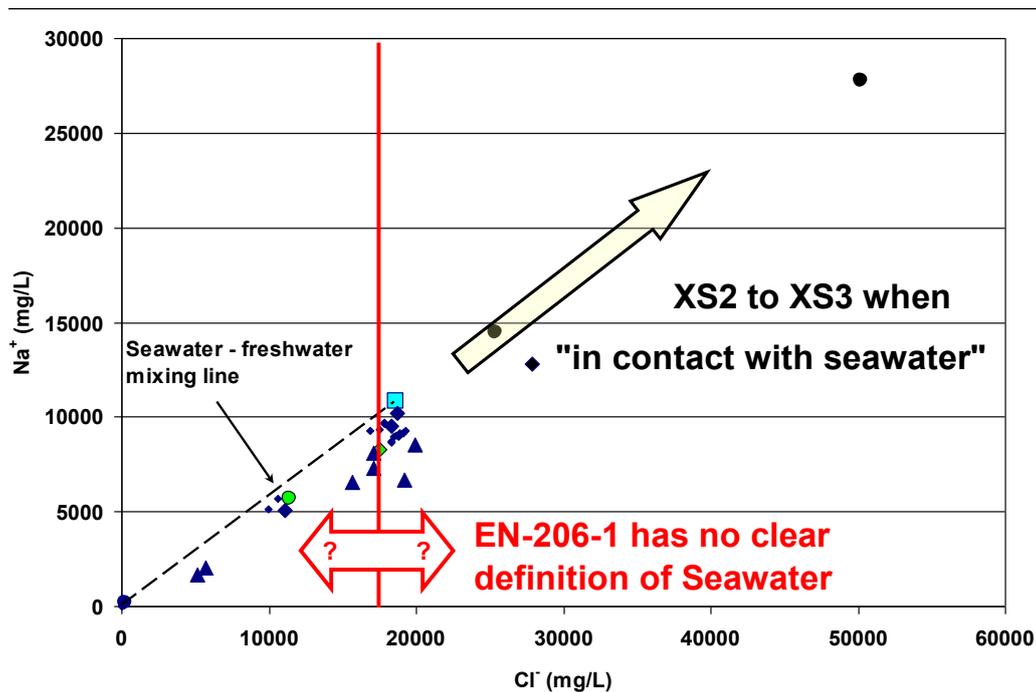
Figure 7: Chloride and sodium variation in waters collected in subsea tunnels and land tunnels. Circles = Byfjord; triangles = Freifjord; diamonds = Flekkerøy; small diamonds = Oslofjord, and square = seawater. Big arrow, trend of evaporation.

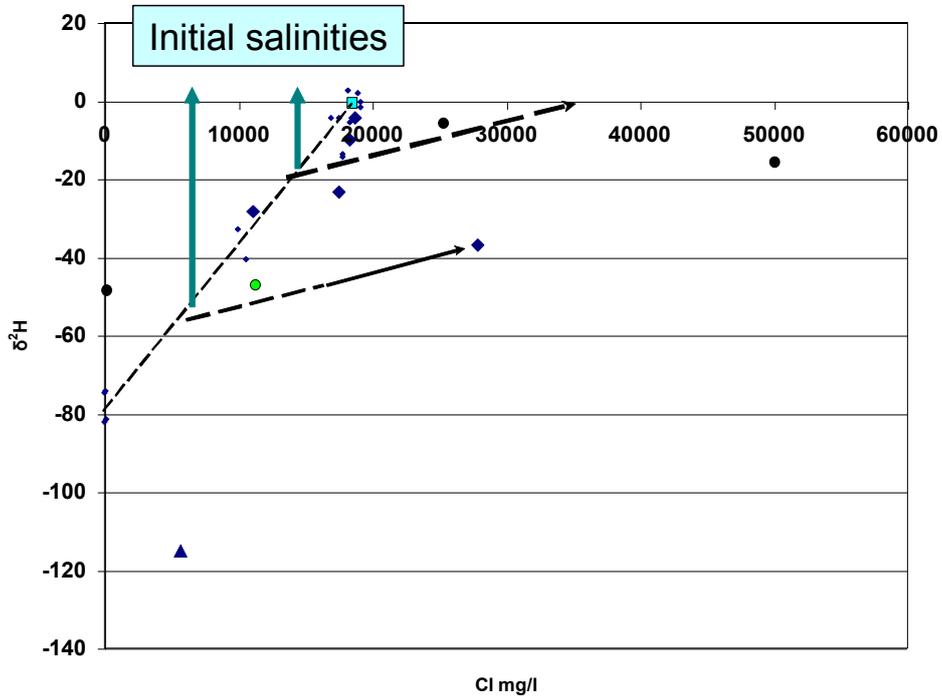
Figure 9: Chlorine concentrations versus H isotopes of waters collected in subsea tunnels. Stippled arrows represent effects of evaporation. Thin stippled line is the mixing line of seawater and freshwater and thick arrows indicate initial salinities prior to evaporation.
