Deterioration Mechanisms and Durability of Sprayed Concrete for Rock Support in Tunnels

Proefschrift

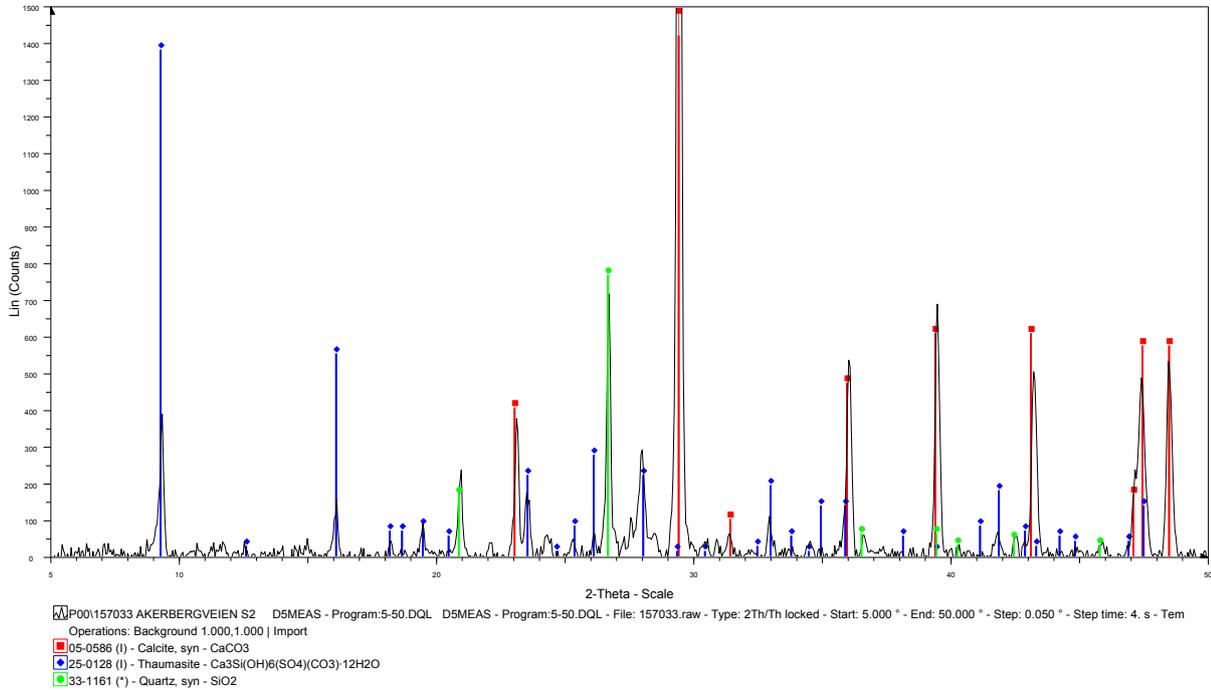
Figure A1-2-1: X-ray diffractogram of a 1-2 cm wide concrete mush behind Spall 2 Sample 2: BRE – P00/1570/33 (see field photos: Figure A1-4-2).

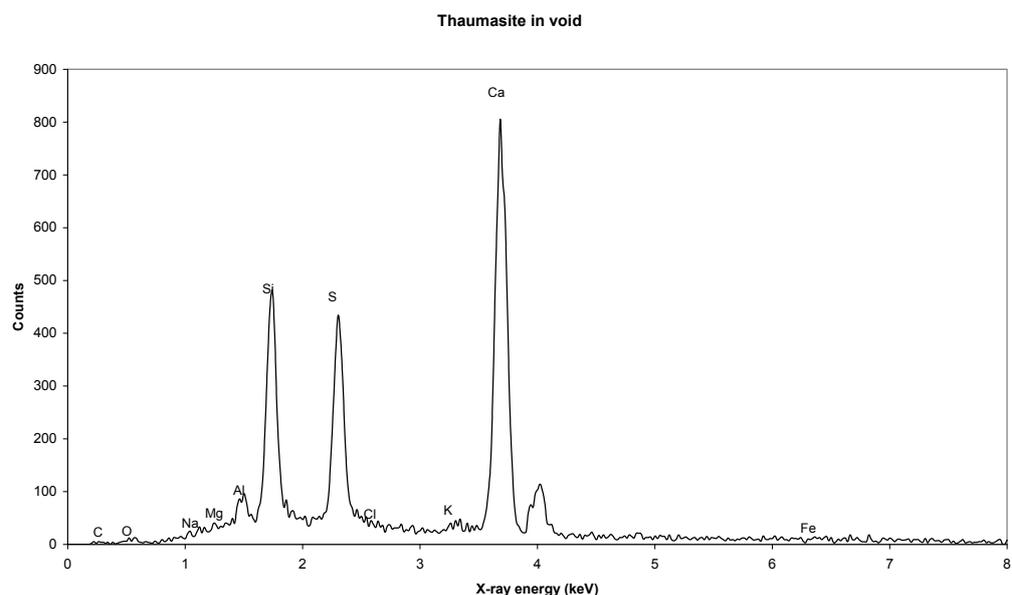
Figure A1-3-1: EDS spectrum of thaumasite filling an entrapment void in < 2 years old sprayed concrete from the Svartdal tunnel, Oslo. Core 370a.

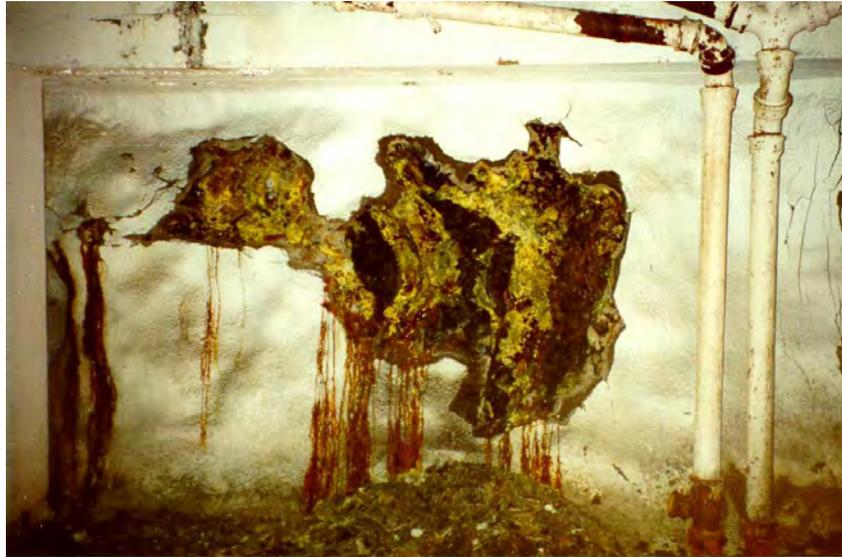
Figure A1-4-1: Effects of swelling Alum Shale and sulfate attack in abandoned civil defence shelter in 2000. This now ca. 40 years old (in 2010) sprayed concrete was made with SRPC (dry method, no steel fibre reinforcement). The thickness was about 5-6 cm and severely infected by TF-TSA-carbonation associated with ettringite and gypsum. The cement paste matrix was severely leached and porous. The exposed Alum Shale surface was heavily coated with secondary jarosite and also carried gypsum and iron-oxyhydroxides. Notice the heavy accumulation of completely disintegrated concrete fragments at the base. Image width = 3 m.

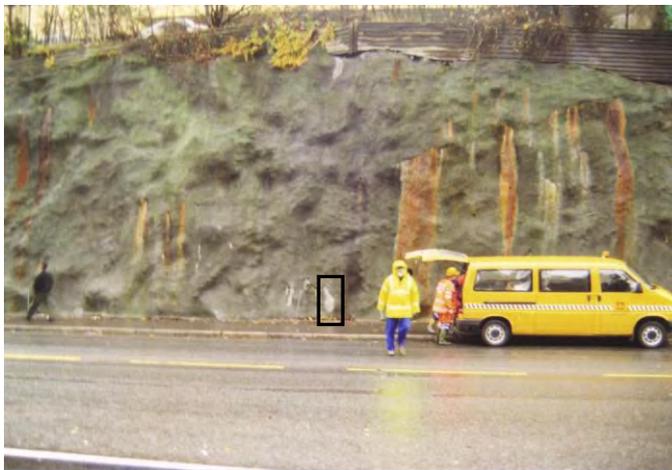
Figure A1-4-2 *Left*: Overview of sprayed concrete Åkebergveien road cut, city of Oslo in 2000, sitting on Lower Ordovician Alum Shale interbedded with Upper Carboniferous syenite sills (“mænaite”). Cores 1-4 were extracted here. This is the first published case of TSA in Norway (Hagelia and Grønhaug 2000; Hagelia et al. 2001). This steel fibre reinforced wet sprayed concrete was 13 years old and made with SRPC and silica fume. A previous SRPC based 1970 spray was demolished and replaced in 1987. Notice spalling and ferric iron stains, reflecting effects of iron sulfide oxidation. Deformations were also observed. *Right*: Detail of the spalling (sample “Spall 2) along a 2 cm white mush zone consisting of thaumasite and calcite due to TSA and PCD. Steel fibres were totally destroyed by corrosion in the process. The 1987 spray has not yet been replaced (2010) and is now about 23 years old.

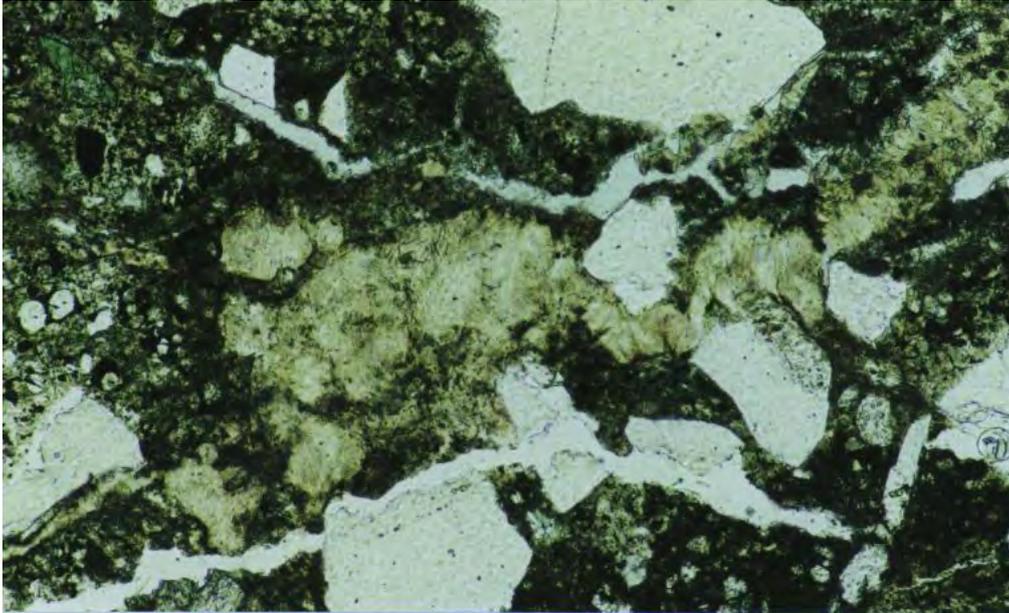
Figure A1-4-3a. Thaumascite Sulfate Attack (TSA). Thaumascite replacing the cement paste matrix in the 13 years old Åkebergveien sprayed concrete. Plane polarised light; lower: crossed polars. Core 2, thin section 1570/28. Width of field = 1.8 mm.

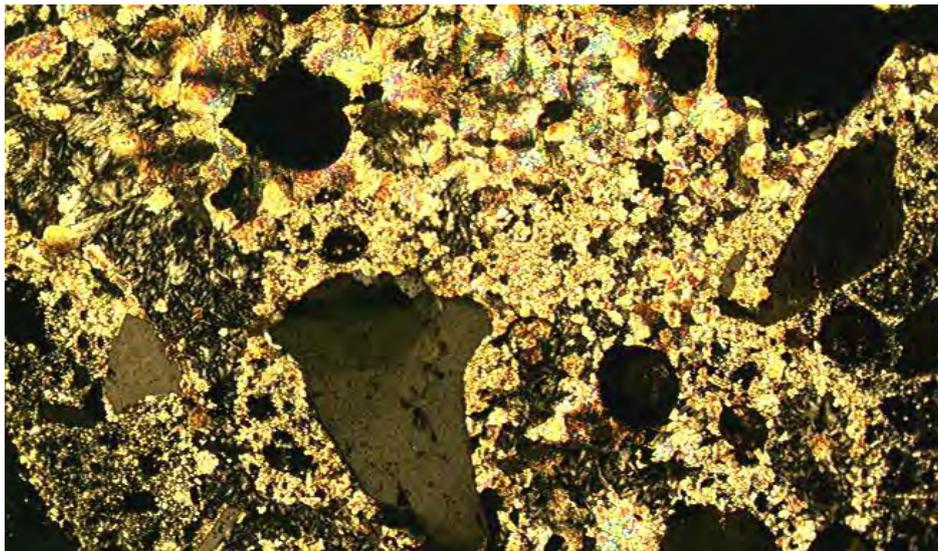
Figure A1-4-6: Sprayed concrete in the Åkeberg road cut. Spall 2, thin section Pr.1. 13 years old. Thaumasite (left central) and Ca-depleted cement paste (lower left and right) extensively replaced by secondary calcite representing the *end product of the TF-TSA-carbonation* process, which leads to internal release of sulfate ions. The resulting cement paste is friable, permeable and sensitive to acid attack: Crossed polars, Width of field: 1.5 mm.

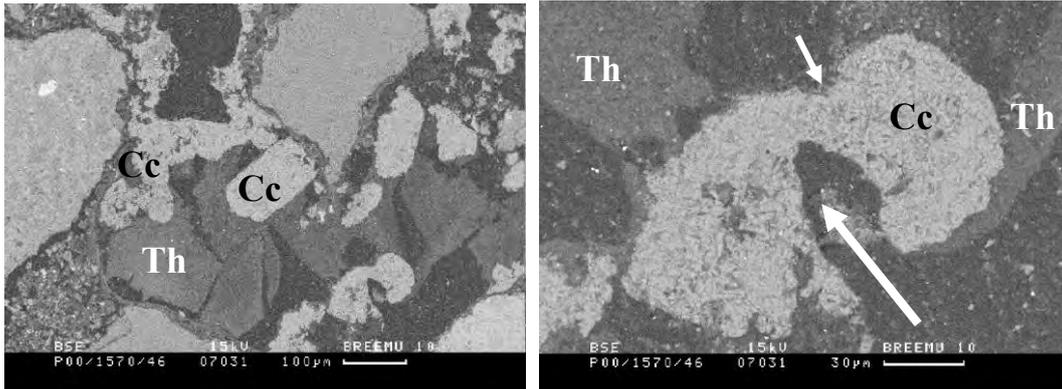
Figure A1-4-7: Sprayed concrete from the Svartdal tunnel (Core 370a, thin section 1570/46) showing co-precipitation of thaumasite (TF) and calcite in an entrapment void. Notice the original crystal faces only in direct contact with thaumasite. Right: detail showing dissolution (arrows) of calcite and thaumasite due to later acid attack. Back Scatter images. Scale bars: 100 µm and 30 µm, respectively.

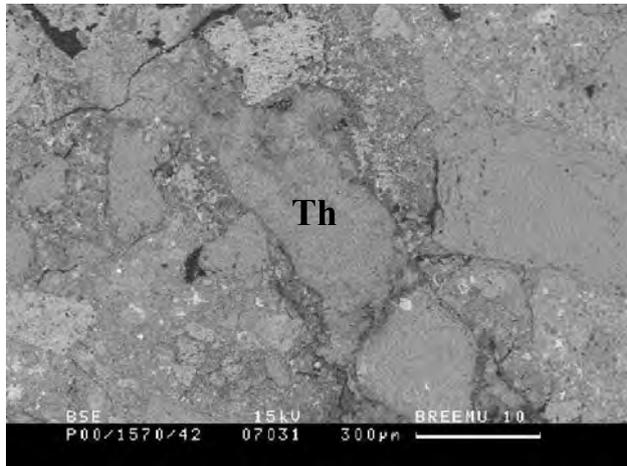
Figure A1-4-8: Thaumasite (Th) mass replacing cement paste (TSA) at Åkeberg road cut. Spall 2, thin section 1570/42: Back Scatter. Scale bar: 300 µm.

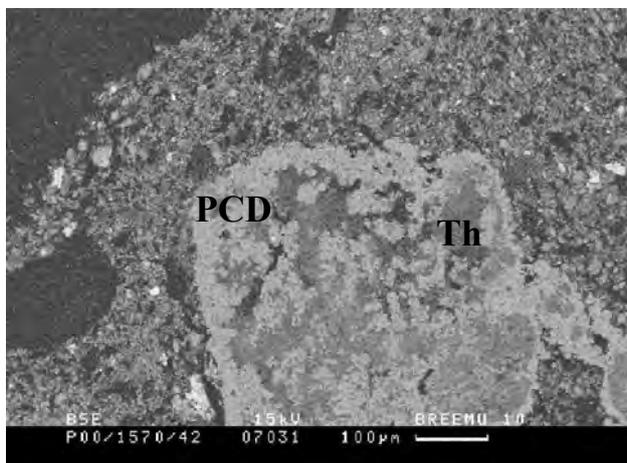
Figure A1-4-9: Extensive formation of Popcorn calcite (PCD) at the expense of thaumasite (Th). Thaumasite had initially formed at the expense of cement paste (TSA). Outermost part of 13 years old sprayed concrete in the Åkeberg road cut. Spall 2, thin section 1570/42. Back Scatter. Scale bar: 100 µm

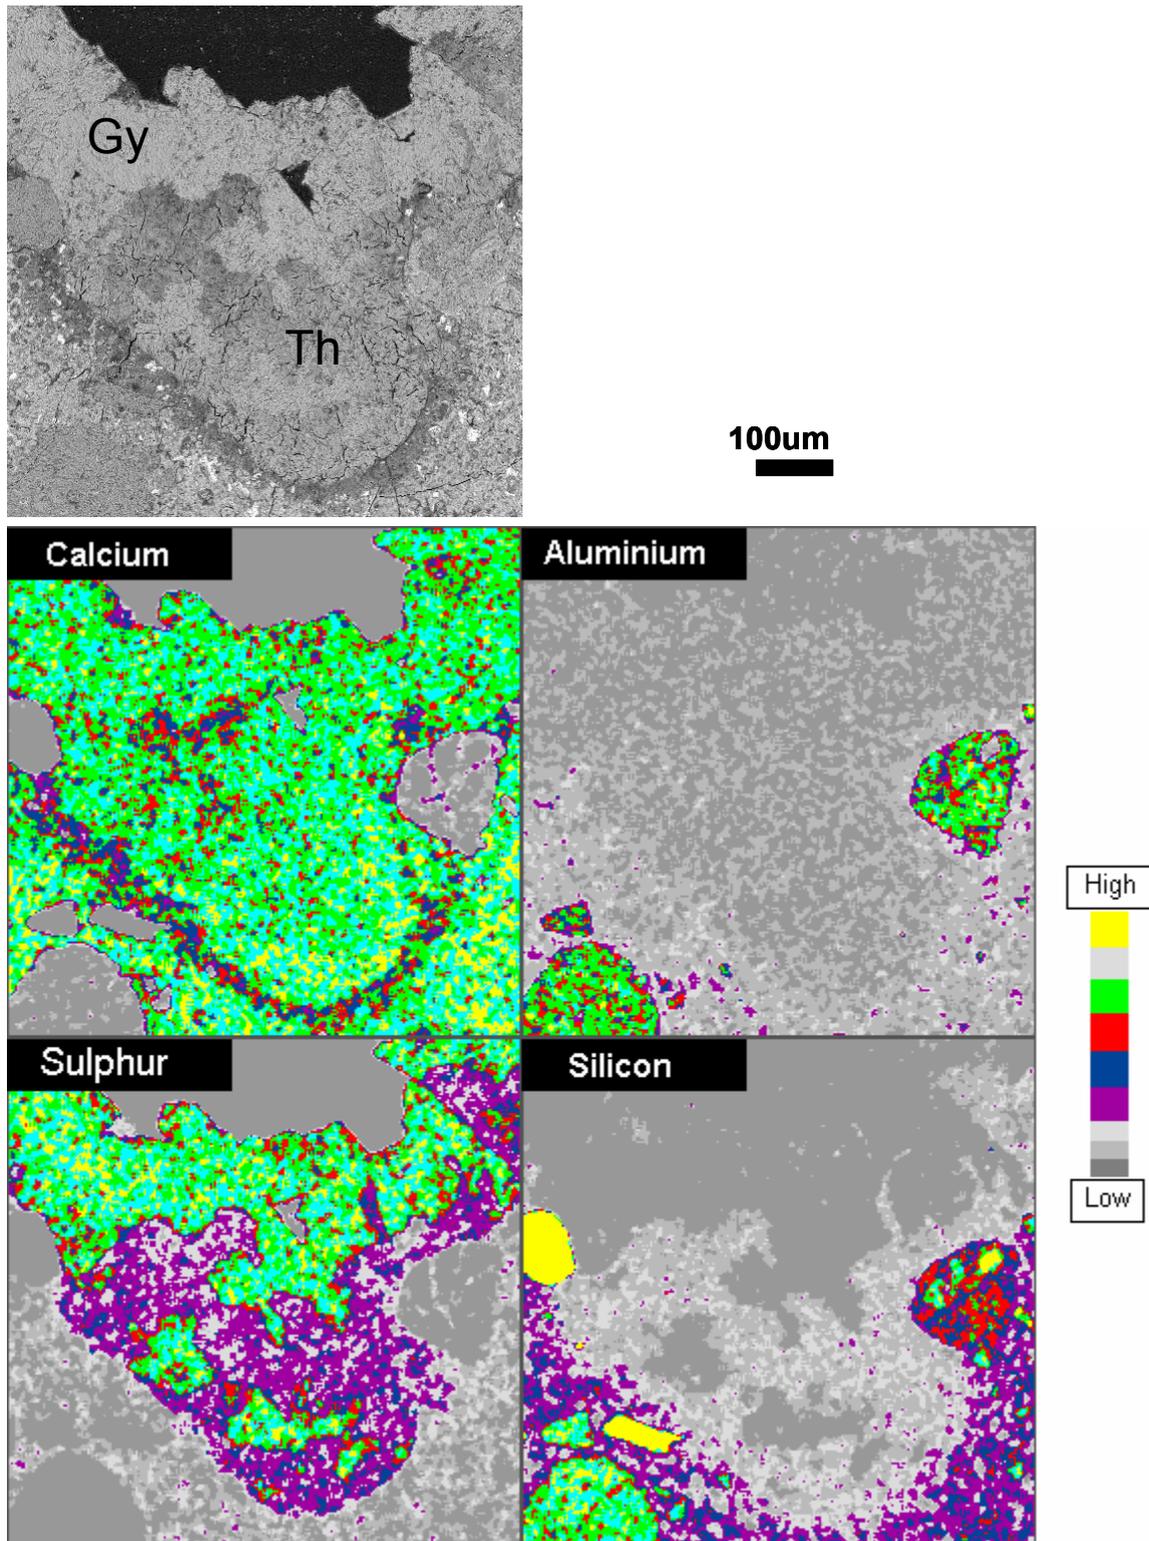
Figure A1-4-10: Back Scatter image and corresponding X-ray maps of thaumasite (Th) and coexisting gypsum (Gy) deposited within an entrapment void in Åkebergveien sprayed concrete. Notice the ca 25 µm wide rim of Ca-depletion (lower) within surrounding cement paste matrix at the contact adjacent to thaumasite. Core 4, thin section 1570/30.

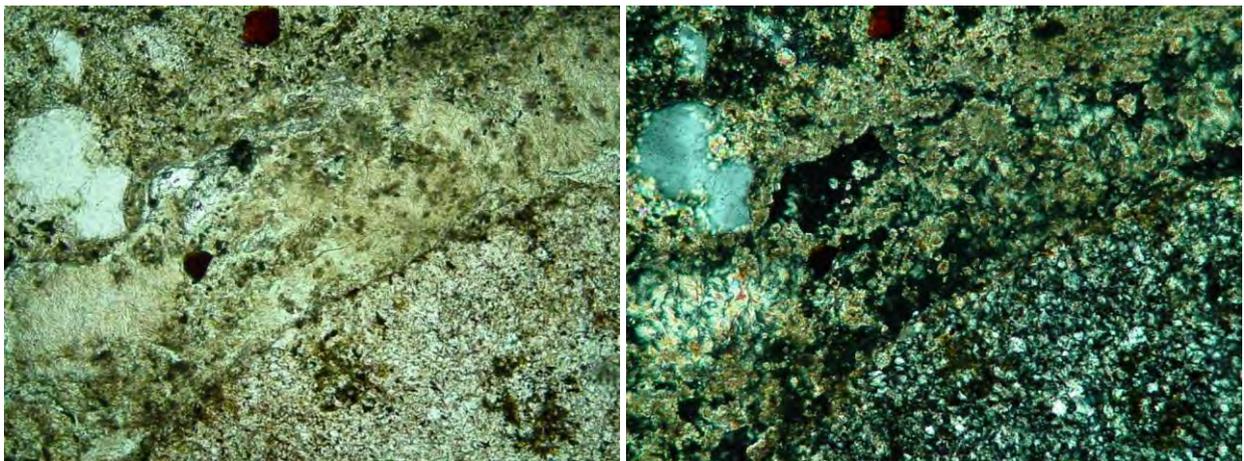
Figure A2-3-2: Blindtarmen, from the interior of Sample 1647/3 (Series 1-18 Nor PC). Plane polarised light (left image) and crossed polars (right image). Thaumasite (lower left with 2nd order birefringence), was extensively replaced by Popcorn calcite whilst thaumasite sulfate was liberated to the pore solution for further attack. Width of field = 0.9 mm.

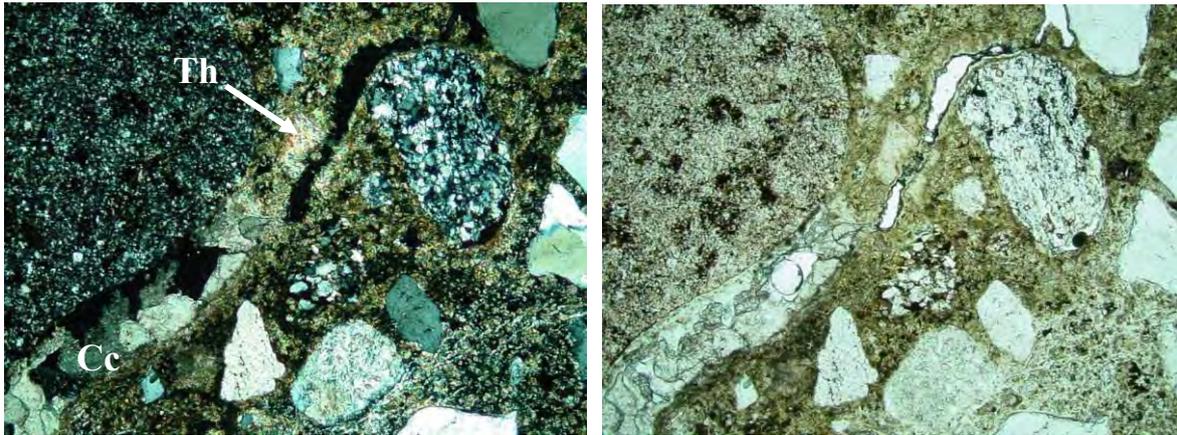
Figure A2-3-3: Sample 1647/3 Norwegian PC showing a vein of thaumasite (Th) and calcite (Cc). Notice also finer calcite formed at expense of thaumasite. Image width 1.8 mm.

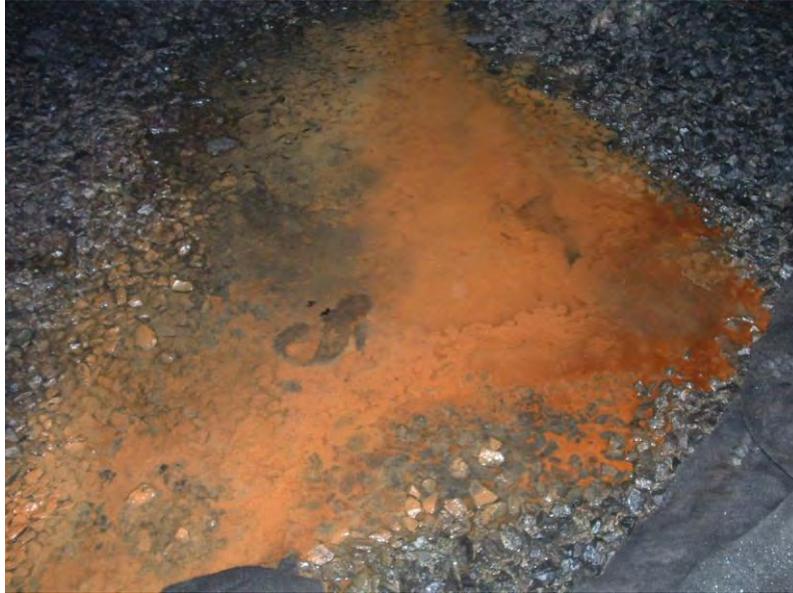
Figure A4-5-1: Svartdal tunnel water sample 320-06 and rusty and dark bacterial slime was collected from this pond just beneath the Alum Shale core sample station (before drilling).

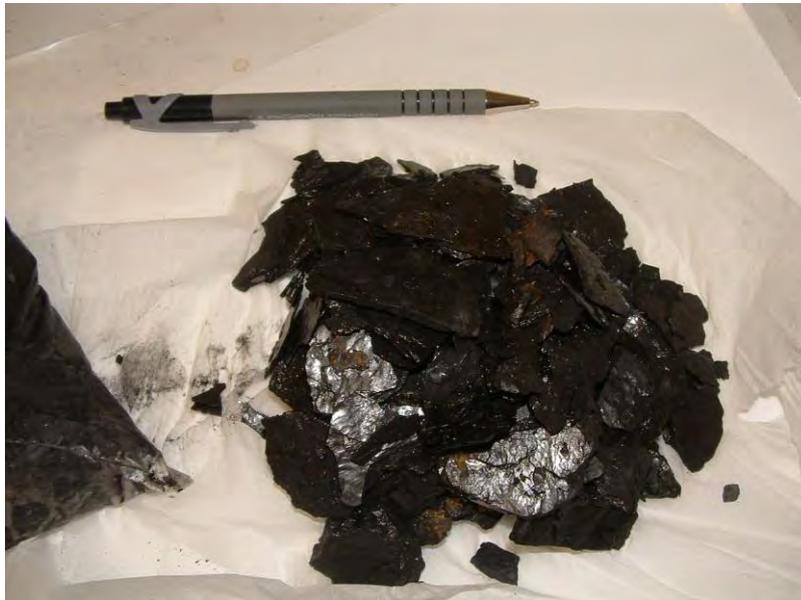
Figure A4-5-2: Svartdal tunnel Alum Shale core sample 320-06U after first manual crushing, representing a pure Black Shale without secondary calcite vein material.

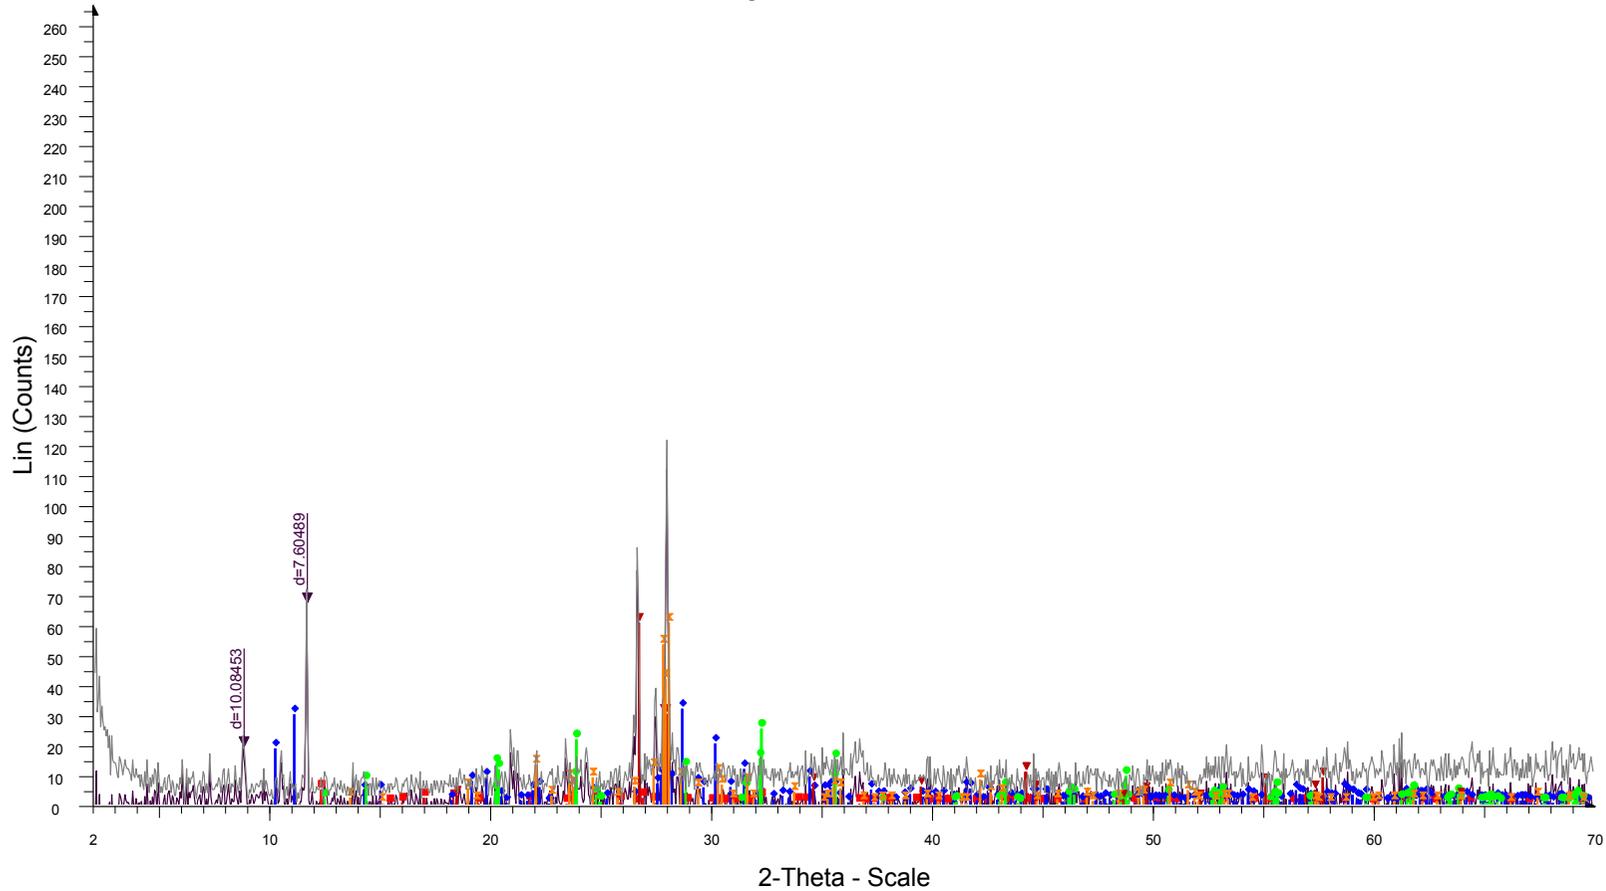
- ☒ Sementprøve 6150e - File: 100804-Hagelia-6150e.RAW - Type: 2Th/Th locked - Start: 2.000 ° - End: 70. Operations: Import ☒ 00-041-1486 (*) - Anorthite, ordered - CaAl₂Si₂O₈ - Y: 50.00 % - d x by: 1. - WL: 1.5406 - Triclinic - a 8.
- ☒ Sementprøve 6150e - File: 100804-Hagelia-6150e.RAW - Type: 2Th/Th locked - Start: 2.000 ° - End: 70. Operations: Background 1.000,1.000 | Import
- ☒ 00-045-0500 (Q) - Iron Hydrogen Phosphate Hydrate - FeH₃P₂O₈·4H₂O/FeH₃(PO₄)₂·4H₂O - Y: 4.17 %
- ☒ 00-045-0121 (C) - Iron Hydrogen Phosphate - Fe₅P₄O₂₀H₁₀ - Y: 26.39 % - d x by: 1. - WL: 1.5406 - Mo
- ☒ 00-045-0319 (*) - Sodium Iron Phosphate - Na₃Fe₂(PO₄)₃ - Y: 20.83 % - d x by: 1. - WL: 1.5406 - Mono
- ☒ 00-045-1436 (I) - Giniite, Fe-rich, syn - Fe₅(PO₄)₄(OH)₃·2H₂O - Y: 50.00 % - d x by: 1. - WL: 1.5406 - O

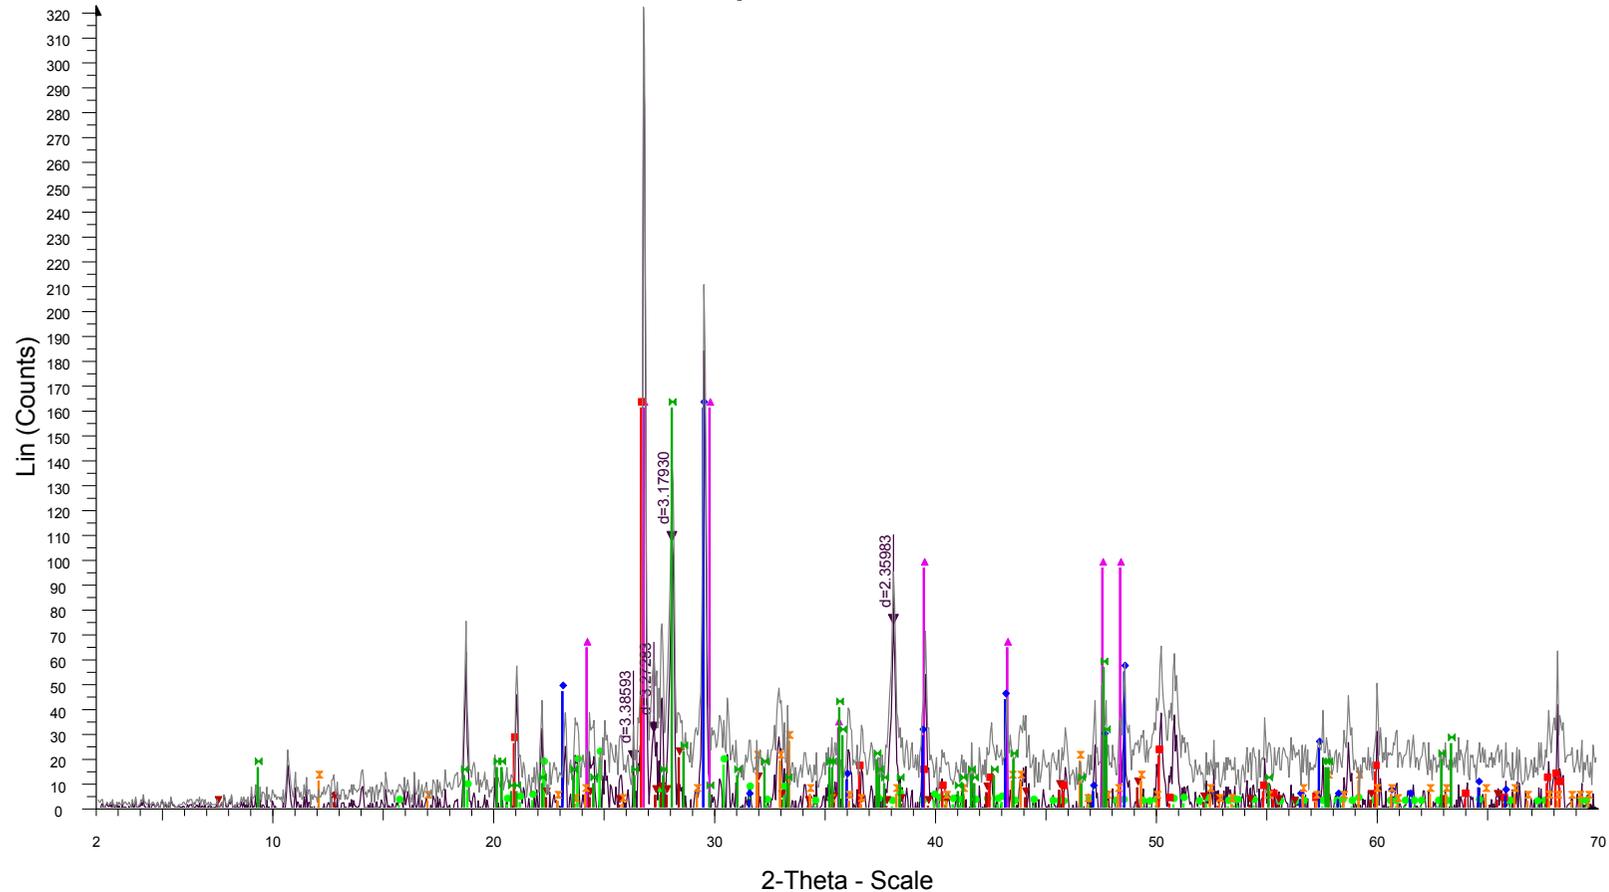
- sementprøve 1373 C - File: 010405sement 1373C.RAW - Type: 2Th/Th locked - Start: 2.000 ° - End: 70. Operations: Import
- sementprøve 1373 C - File: 010405sement 1373C.RAW - Type: 2Th/Th locked - Start: 2.000 ° - End: 70. Operations: Background 3.802,1.000 | Import

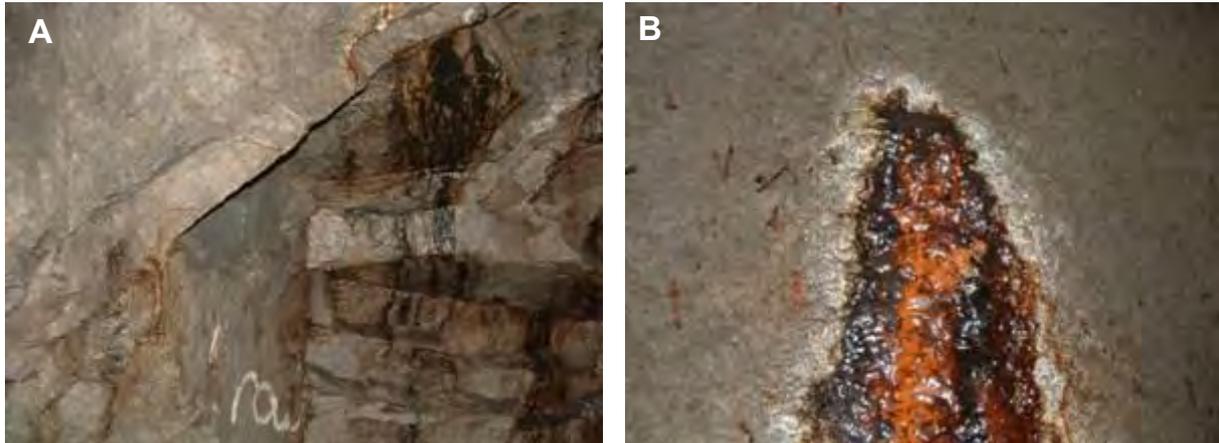
Figure A5-4-1: Locality Oslo 1a: A. Local barren rock with black Mn-oxides and Mn biofilm suggesting Mn^{2+} was mainly derived from ground water: B) Entrance point of a leakage showing black slime consisting of Mn-oxidising bacteria (resembling *Leptothrix discophora*) and the biomineral Na-buserite. Red rust (central) was derived from oxidation of steel fibres which was catalysed by Fe-oxidising bacterium *Gallionella ferruginea*. The white outer halo consisted of thaumasite and calcite.

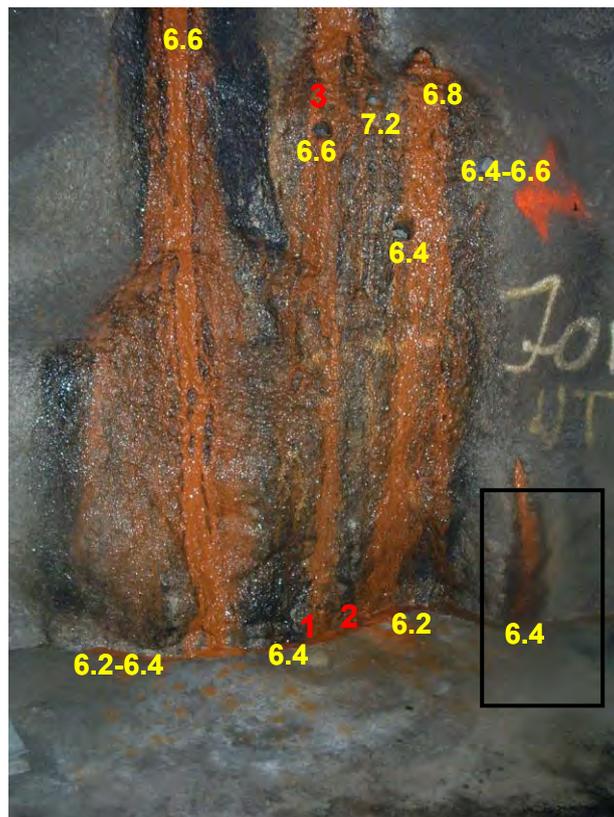
Figure A5-4-2: Locality Oslo 1a in September 2005 (concrete age \approx 6 years) showing pH variation in water and locations of the three sample stations for water chemistry (1, 2 & 3; cf. Table 2 in Chapter 7). Notice that the overall pH dropped by up to one pH unit downstream within the Mn-Fe biofilm, but pH as low as 5.5 was measured at other times (Table 3 in Chapter 7).

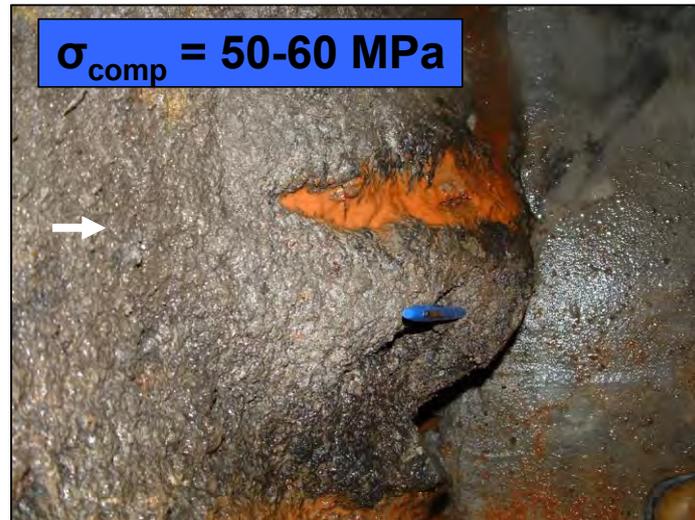
Figure A5-4-3: Small leakage (frame of previous figure) showing a groove with up to 4-5 cm of material loss related to acid producing reactions within Mn-Fe biofilms. Notice the smoothed surface (arrow) with minor loss also in the moist surrounding area. Nearby dry concrete some 1-2 m away had ordinary strength, which likely represents the initial quality of the domains now degraded by the composite bacterial - saline water attack.

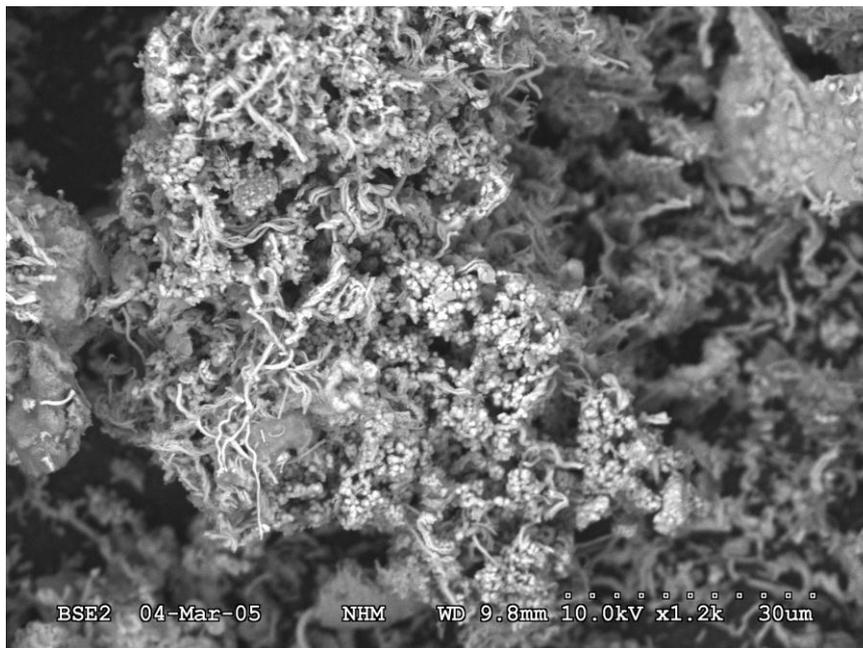
Figure A5-4-4: Locality Oslo 1a. Sample 0-2005 of *Gallionella ferruginea* slime (here aged) was the most commonly observed iron bacterium in the subsea tunnel sections. Width of field = 105 μm . SEM micro chemical data are given in Table 6 in Chapter 7.

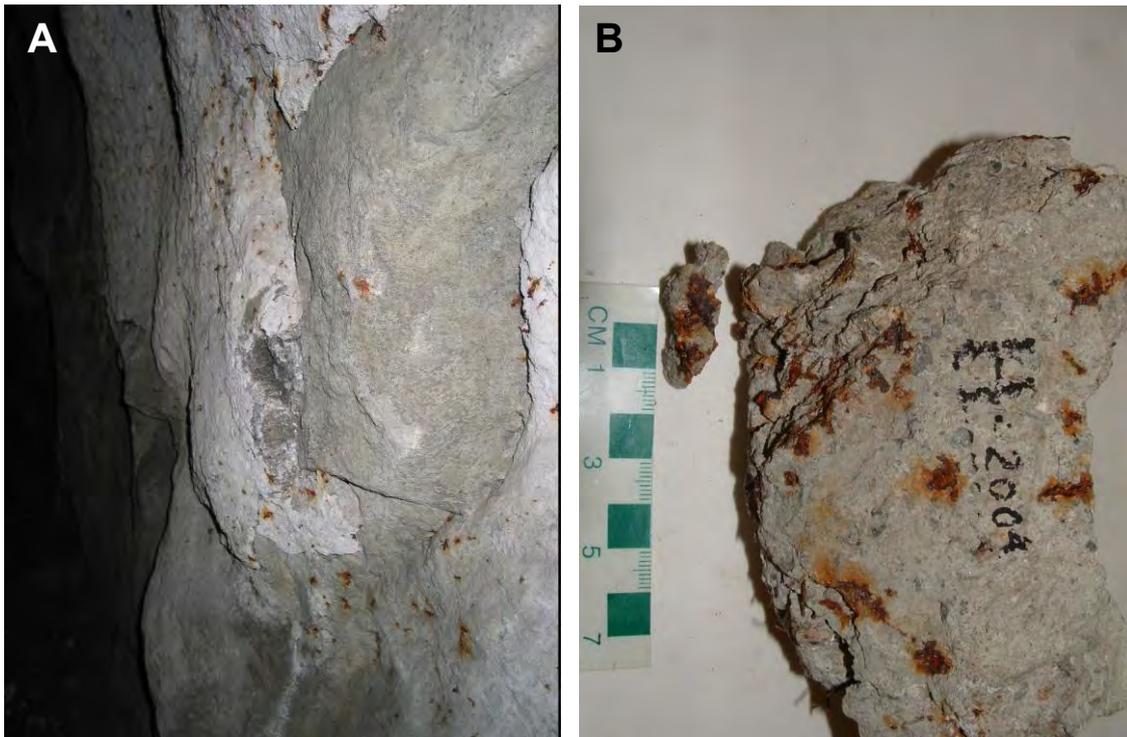
Figure A5-4-5: Locality Oslo 1b. February 2004. A: White weathered friable sprayed concrete influenced by saline water attack. Destructive steel fibre corrosion. Concrete replaced after about 4-5 years in service. B: Sample H-2004 from outer parts (Layer C). The cement paste matrix of white paste was transformed into MCSH and PCD and scattered TF with local TSA.

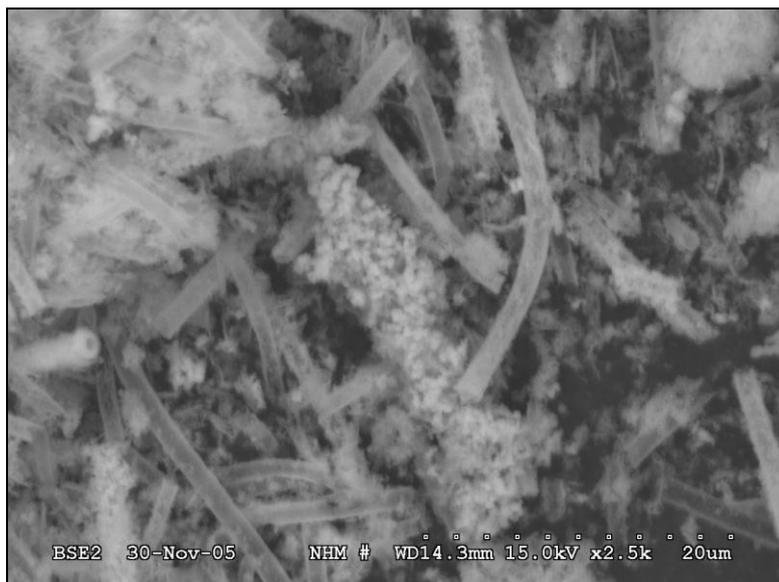
Figure A5-4-7: Iron bacterium *Leptothrix ochracea* with suspect heavily Fe-encrusted *Gallionella ferruginea* (image centre) from ditch water at Location Oslo 2c. (BSE image: width of field 50 μm).

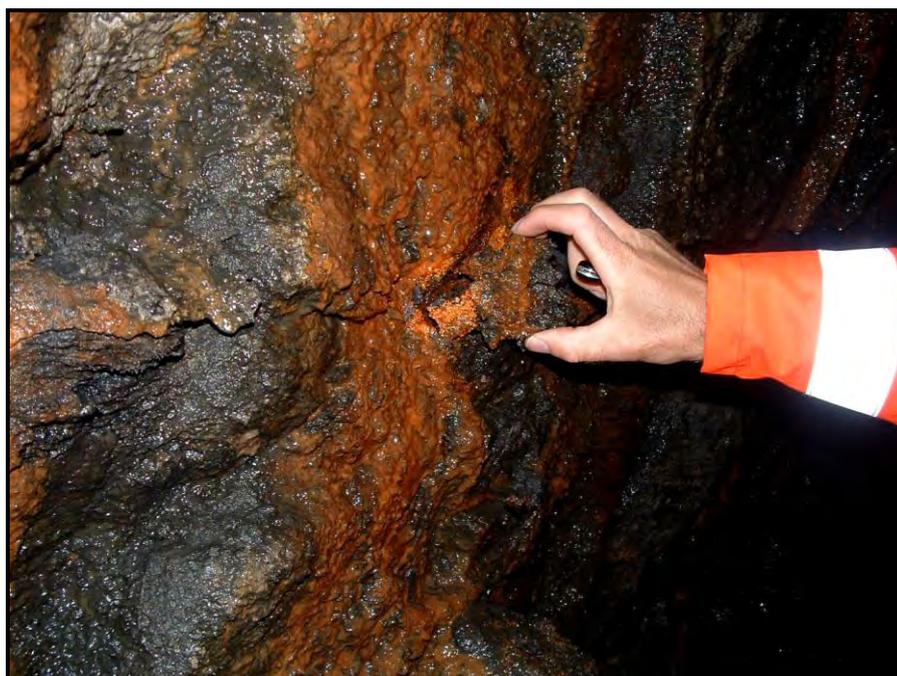
Figure A5-4-8: Freifjord subsea tunnel. Extensively deteriorated sprayed concrete due to interaction with Mn-Fe biofilms and saline ground water. pH = 5.8 in small leakages. Black and rusty crust material consisted of Na-buserite (hydrous Mn-oxide biomineral), amorphous Fe (likely ferrihydrite), the clay minerals vermiculite and dickite (with a HCONH_2 group), quartz and plagioclase. Situation from June 2006: concrete age 16 years.

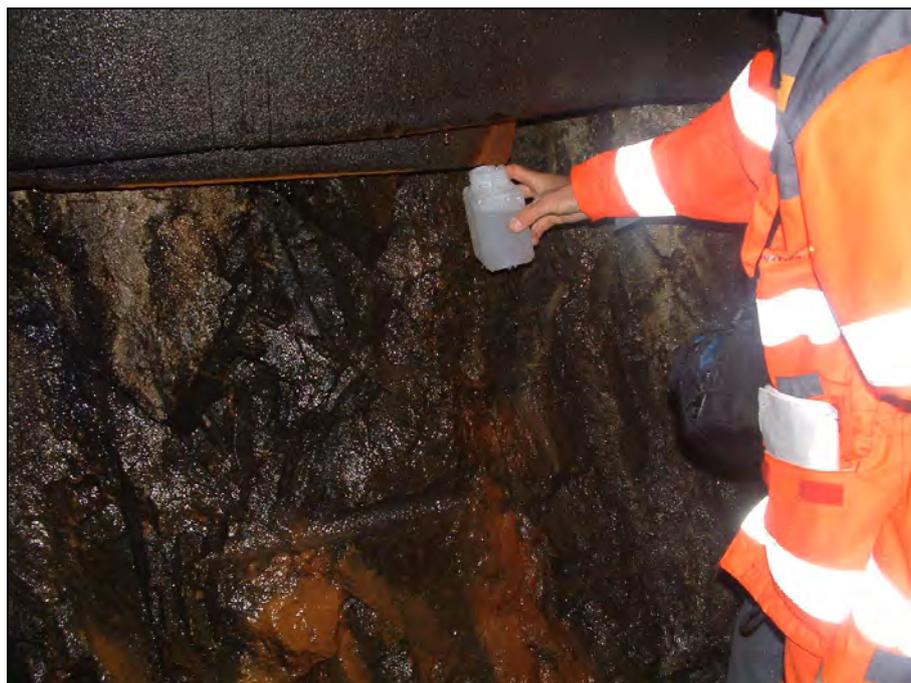
Figure A5-4-9: Freifjord subsea tunnel. Sampling of water 4930-1 from leakages draining across a water panel within 15-20 meters of the location in Figure A5-4-8. The water leakages behind this panel were associated with Mn-Fe biofilms, showing extensive interaction with degraded concrete in the tunnel crown. The water was brackish (Table 2, Chapter 7) and sulfur isotopes showed very significant influence of sulfate reduction (Table 9).

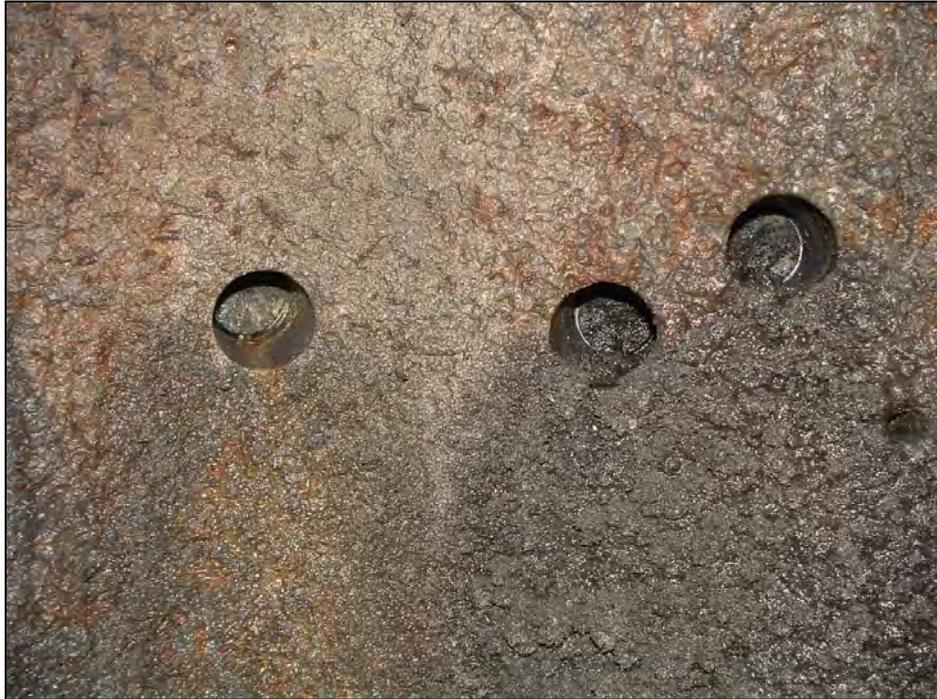
Figure A5-4-11: Freifjord subsea tunnel in 2006. Concrete age: \approx 16 years. Surface deposits of gypsum with some crystalline carbon precipitating from saline water draining at the concrete/rock interface. Core 6150-2 from 2003 = left hole with pH = 6.2 in 2006. The other cores were older and had accumulated much more gypsum. Note the smoothed rust stained and bleached concrete surface. Gypsum formation consumes acid suggesting pH in water behind the sprayed concrete layer was $<$ 6. The carbon was derived from dead bacteria occurring at the concrete/rock interface. Core holes (Φ = 50 mm).

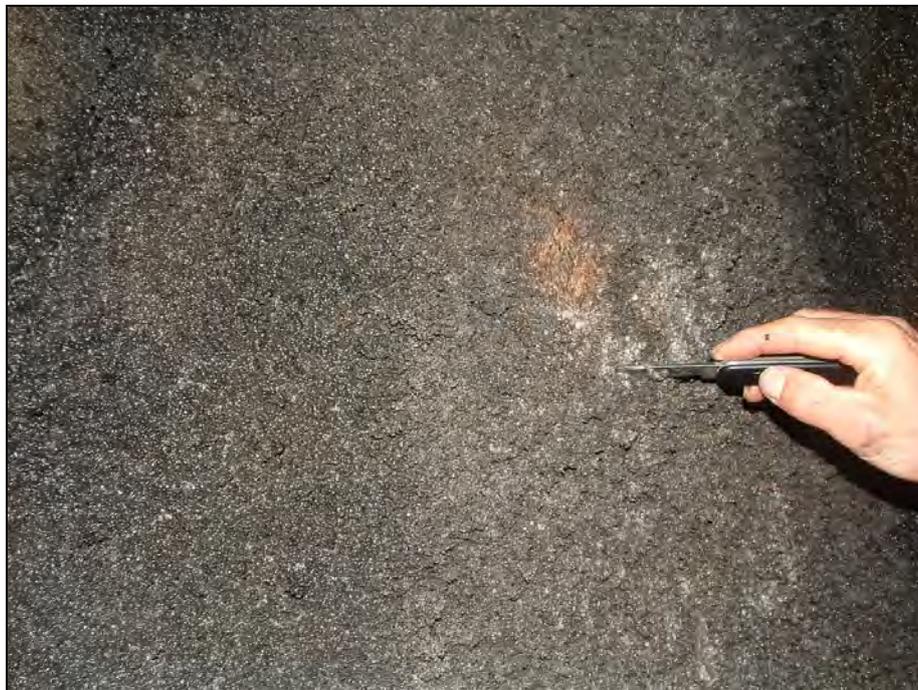
Figure A5-4-12: Freifjord subsea tunnel. Concrete age: \approx 16 years. Gypsum deposit with crystalline carbon (5-10 mm thick).

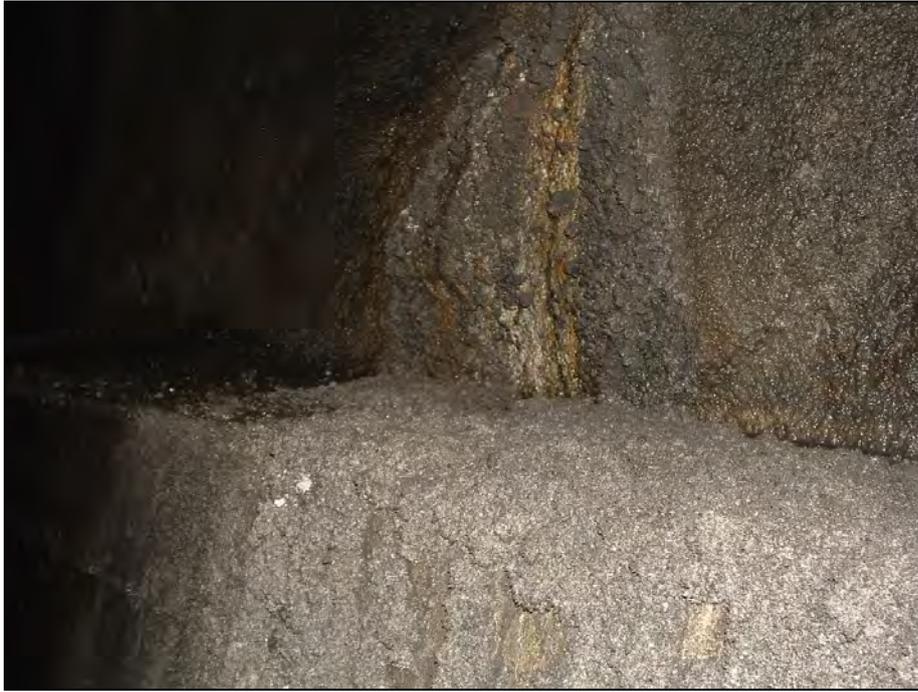
Figure A5-4-13: Freifjord subsea tunnel. Concrete age: \approx 16 years. Very extensive deposition of gypsum mush associated with a leaky crack through weathered decalcified, friable and rust stained sprayed concrete, running over a cast concrete banquette (“Rivers of gypsum”). On either side the sprayed concrete was covered by a similar thin gypsum deposit.

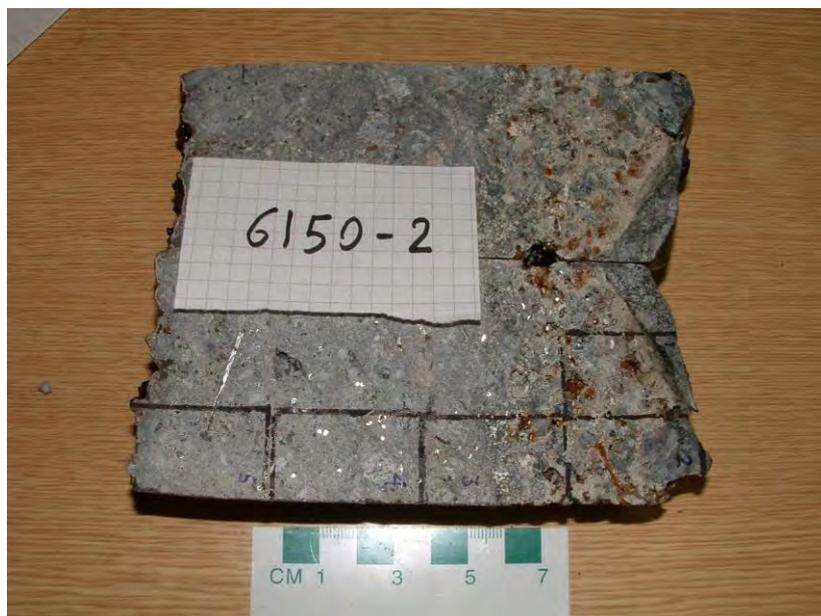
Figure A5-4-14: Freifjord subsea tunnel. Concrete age: \approx 13 years. Core 6150-2 with 45-50 mm degraded friable sprayed concrete and destructive steel fibre corrosion within Layer A against the rock mass (right). The degradation was characterised by Mg ingress (forming MCSH and brucite) and local Thaumassite Sulfate attack (TSA) at the transition to more sound concrete. Calcite, laumontite, aragonite and nordstrandite also occurred. Impact from microbial activity acting from behind the spray was indicated by the presence of several phosphate minerals, a possible phenyl phosphate hydrate (Table A-5-2) and a carboxylate (an organic mineral) formed: a) within concrete 3 mm from the concrete/rock (Figure A5-4-15) and b) as a microscopic thin deposit on the outer surface (left).

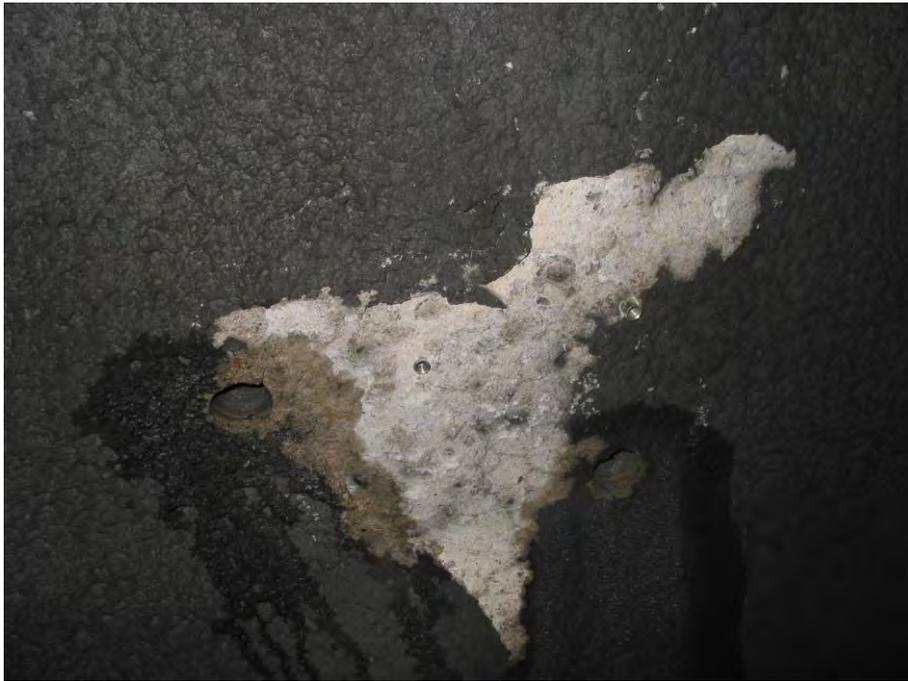
Figure A6-3-1 Spalling in dry extensively carbonated sprayed concrete at chainage 43720 m in the Lier tunnel. Two 50 mm cores were extracted for thin sectioning. The concrete was frequently sounder deeper inside, yet showing evidence of a sulfate attack in previous years. The dark outer surface represents dusts mainly consisting of carbon and iron.
