Internt sulfatangrep i sprøytebetong med perlitt

STATENS VEGVESENS RAPPORTAR

Nr. 582

E16 Nes tunnelen

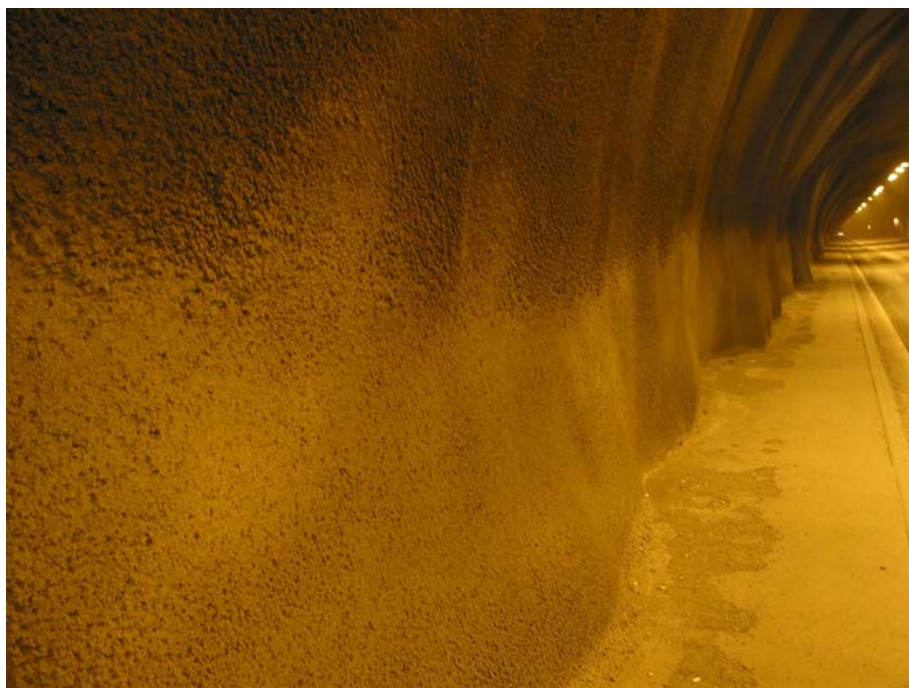
Figur 2 Nestunnelen rett etter reparasjon i 2002. Ny sprøytebetong med perlitt blei påført, saman med eit ytre lag av mikro-PP fiber betong utan perlitt. Fiberfri sprøytebetong blei til slutt sprøyta opp på den nedste meteren over vegbanen. Foto: Statens vegvesen.

Reparasjonane i 2002 blei kontrollerte både under og etter slutført arbeid, og det blei rapportert at dei var vellykka og utført med høg kvalitet. Resultatet er vist i Figur 2.

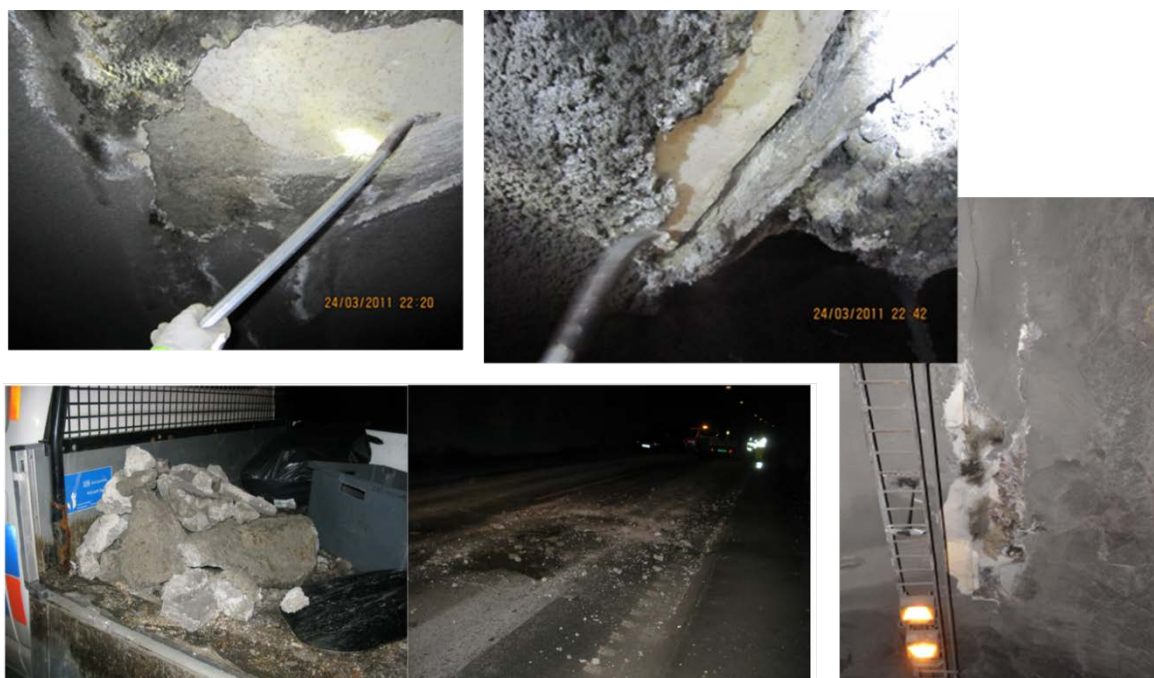
Figur 3 Nestunnelen i 2011, ni år etter reparasjon. Det var kraftig avskaling i heile tunnelen med nedfall og skade på bil. PE-skummet var blottlagd fleire stader. Foto: Statens vegvesen.

Etter omkring ni år var det observert avskaling, og tidleg på morgonen den 3. mars 2011 falt det ned omkring 200 kg sprøytebetong (Figur 3 og Figur 4). Ein bil blei skadd, og tunnelen blei stengt med det same. Det viste seg at avskalinga av sprøytebetongen var utvikla over mestedelen av tunnelen, og i mykje større omfang enn det som var synleg ved overflateinspeksjon. Avskalinga hadde tydeleg samanheng med svært omfattande karbonatisering og frostbelastning. Sannsynlegvis var avskalinga også påverka av dynamiske laster frå vegtrafikken (Holm 2011). Dette støttast også av målte trykk og sugkrefter på nokså tilsvarande konstruksjonar (Davik 1994).

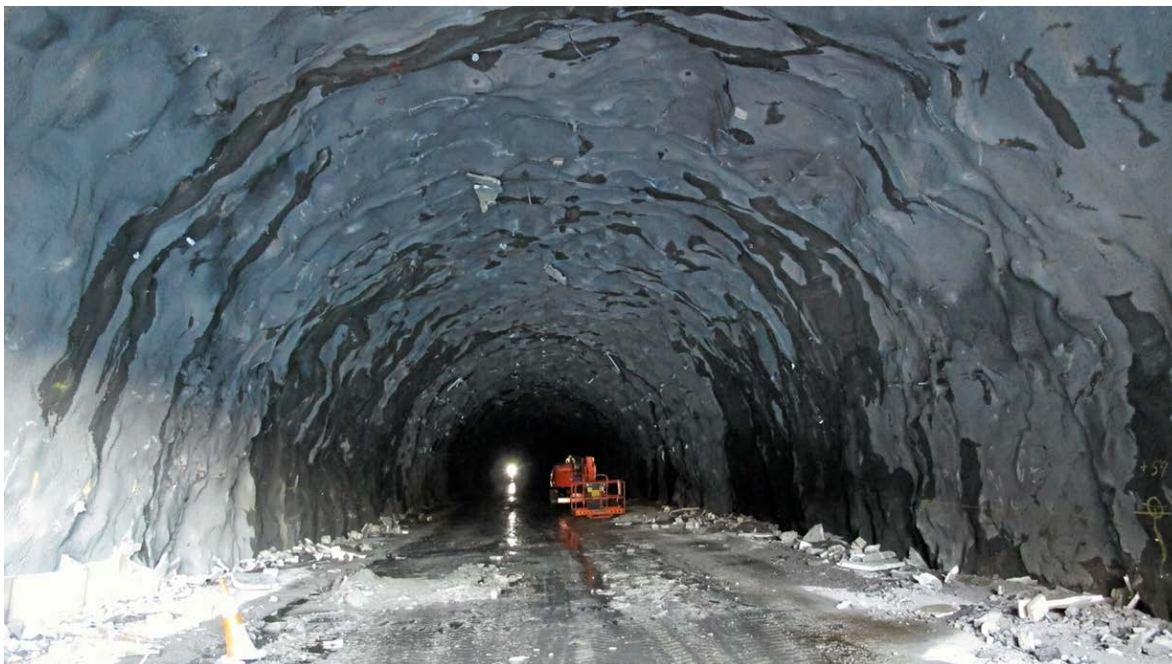
Figur 4 Situasjon etter at vass- og frostsikringskvelvet var rive ned. Det var relativt tørt i tunnelen, men med lokale fuktgjennomslag. Kvit og pulverisert perlittbetong ligg på vegbanen saman med restar av PE-skum. Foto: Statens vegvesen.

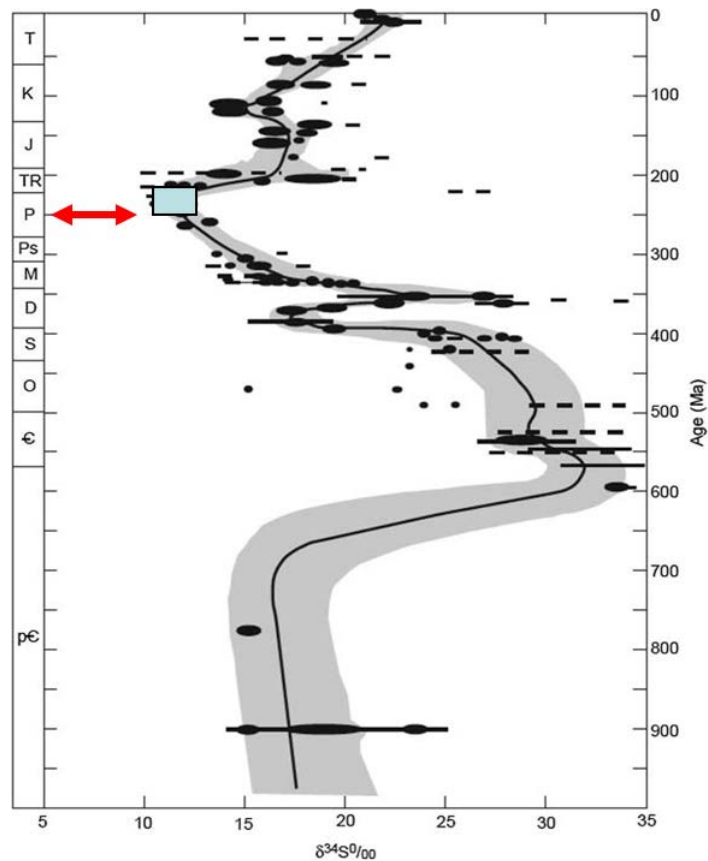
Gips som tilsettast sementklinker kjem frå gammalt inndampa havvatn. Fordi svovelisotop-samansetninga ($\delta^{34}\text{S}$) i havet har endra seg over geologisk tid (Figur 8: Claypool et al. 1980) er det muleg å bruke svovelisotopar for å avgrense opphavet til råmaterialet. Svovel frå forbrenning av olje og kol har andre verdiar, og er ofte anrika i ^{32}S .

Figur 8 Gips tilsett sementklinker kjem frå gammalt inndampa havvatn. Svovelisotop- samansetninga ($\delta^{34}\text{S}$) i havet har endra seg over geologisk tid (Claypool et al. 1980). Den røde pila viser $\delta^{34}\text{S}$ verdiane i perlittbetongen, og kan ikkje forklarast ut frå kjent variasjon i råmaterialet for tilsett gips, men er ei blanding av sement-gips og svært sannsynleg SO_2 tilført frå gass i perlitt.
