Magnetkis i betongtilslag

Effekt på betongs bestandighet

STATENS VEGVESENS RAPPORTER

Nr. 463

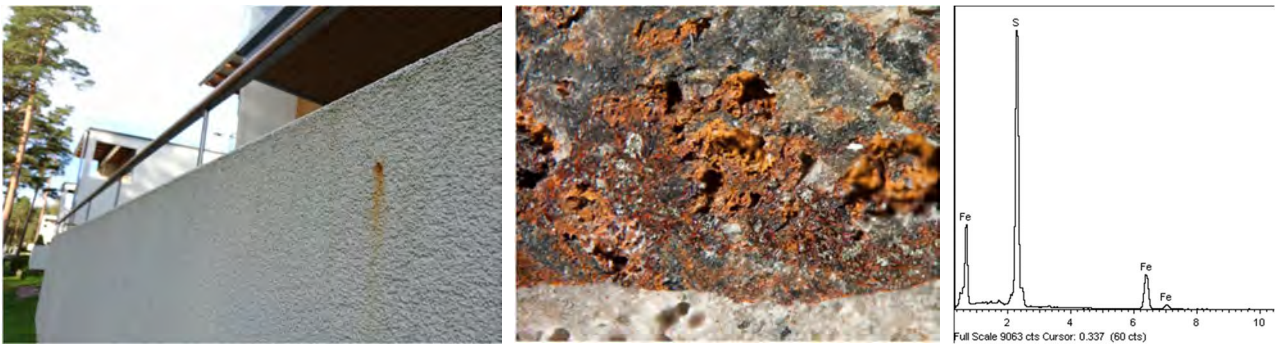
In every case the visible signs were rusty surfaces and pop outs. The first thought was that it is question about rusty steel bars in the elements. But in every case the bars were of stainless steel and the bars were in excellent condition. By studying the cored samples with thin section and SEM we found that it is question about damages caused by sulphide minerals (Fig. 1.). The damages were not structural but mainly esthetic.

Fig. 1. Damages caused by sulphide minerals on the surface of a concrete panel.

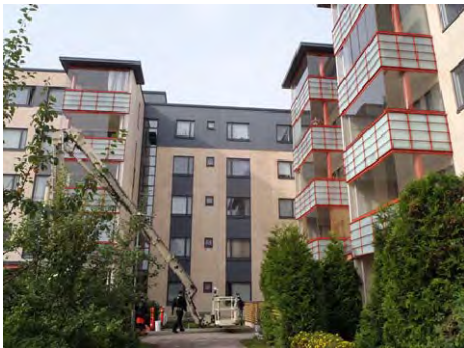
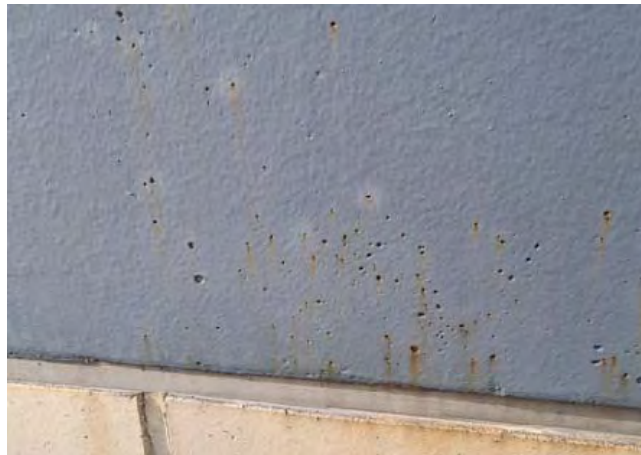
- Case N:o 1 apartment house in Vantaa

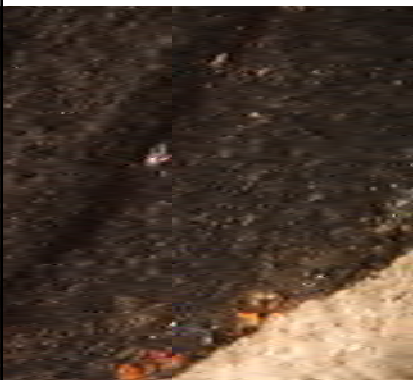
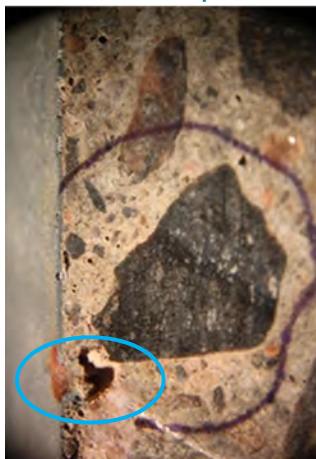
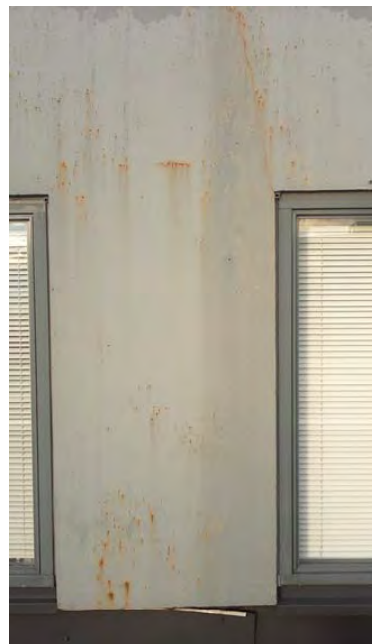
- Case N:o 2 apartment house in Espoo

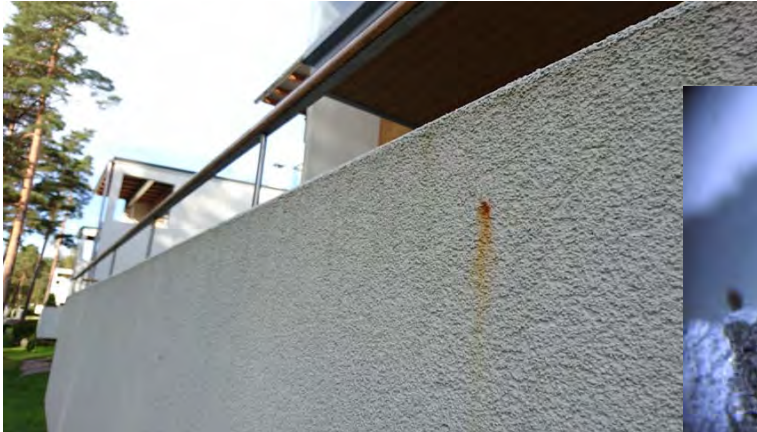
- Case N:o 3 apartment house in Espoo

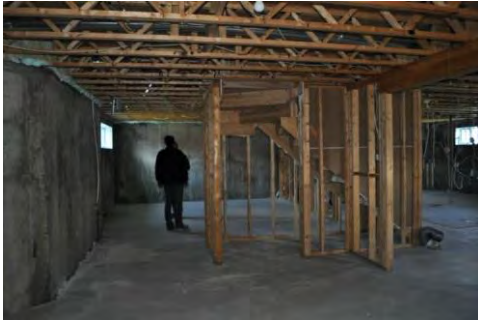
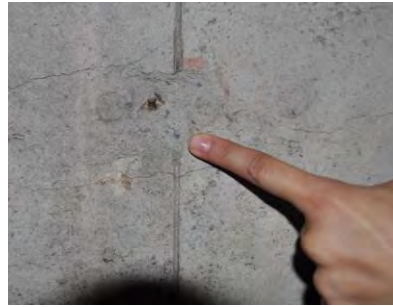
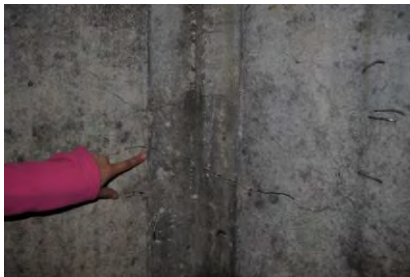
Visual inspection of deteriorated houses

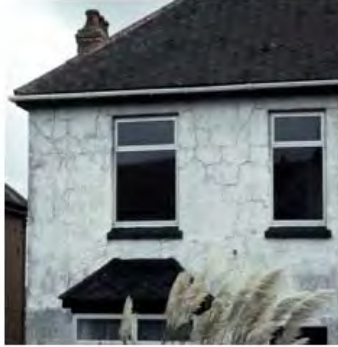
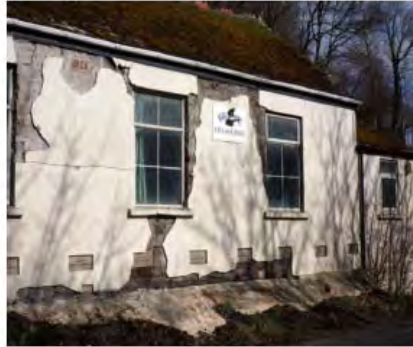
Figure 3: Photographs of two different properties exhibiting characteristic mundic damage

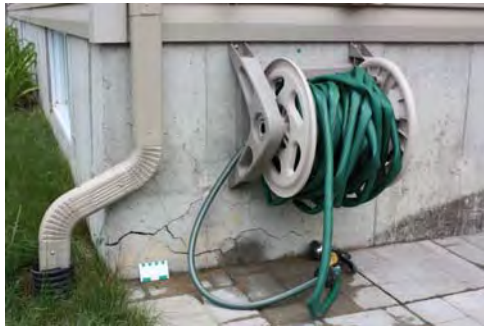
Rapid (< 3-4 years) deterioration of concrete elements in the Trois-Rivières area (Quebec, Canada)

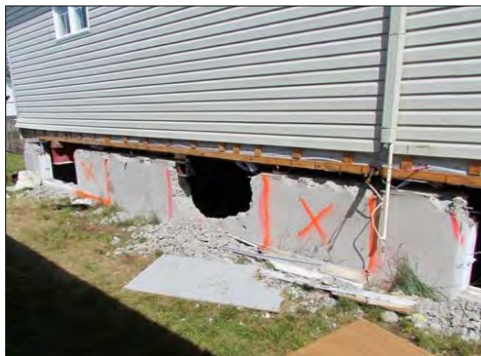
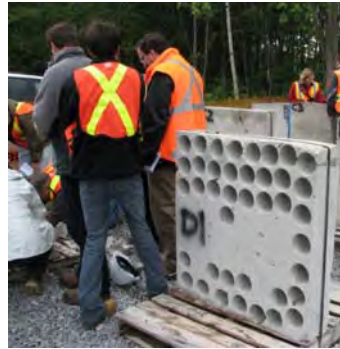
Outdoor exposure testing

5 blocks per house foundation

- Non destructive testing (Sh. U.)
- Expansion (Nov. 2011-Aug. 2014)
- Monitoring of cracking
- Sampling of blocks
