Inspeksjon av etterspent armering i betongbruer

Nr. 699

Utredning av metoder for inspeksjon av etterspent armering i betongbruer

FoU-programmet Bedre Bruvedlikehold 2017-2021

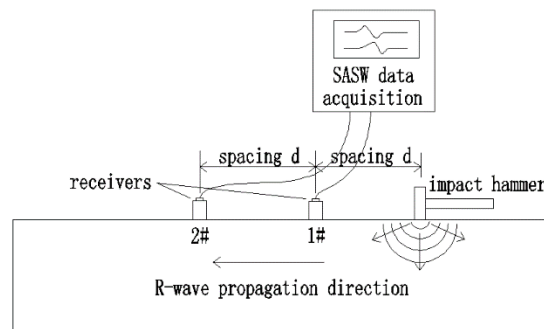
Figure 3.3 Simplified diagram of the SASW-method (from www.mdpi.com)

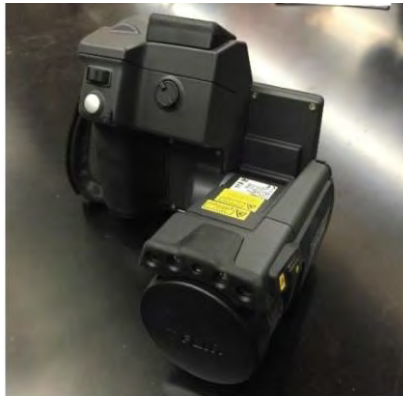
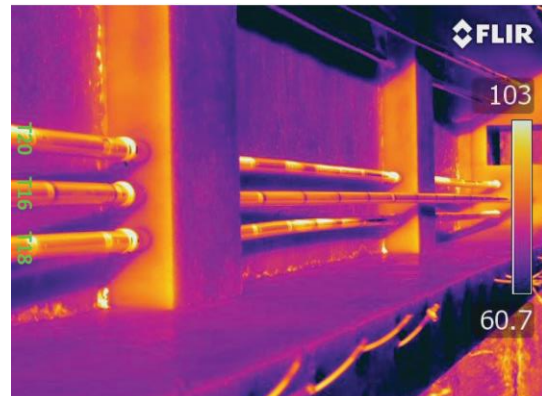
The primary basis for IRT inspection lies in the emissivity of individual materials within the object being examined. Depending on the emissivity of the different materials, each material within the object may release or absorb heat at different rates, and the differential temperatures during this transition period can provide valuable information about the object. The uneven cooling or heating of the metal or nonmetal ducts, the surrounding concrete, the good grout and the various defects should be identifiable in a temperature profile. Therefore, it is important to perform IRT during times of the day when atmospheric temperature gradients are high, thus forcing the object being inspected to heat or cool in order to reach equilibrium with the surrounding environment. The capabilities and limitations of the IRT inspection technique are discussed in table 3.8.

Figure 3.8 IRT Technique using FLIR T640 Infrared Camera and sample of infrared image of external tendons, from (<http://nap.edu/24779>)

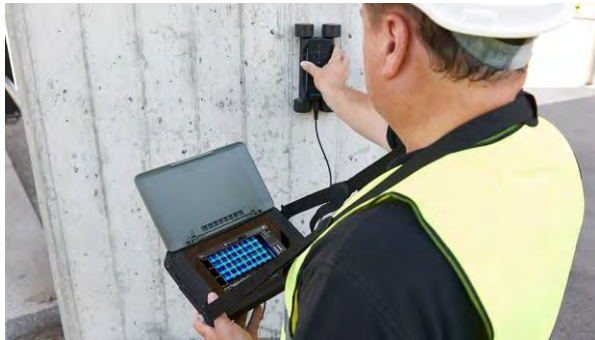
A low frequency magnetic field is applied on the surface of the structure; the presence of embedded reinforcement alters this field, and a measurement of this change provides information on the reinforcement. Cover meter surveys form part of most concrete condition surveys of buildings or structures. Cover meter surveys can also locate main and secondary reinforcement, determine bar sizes and spacing and determine minimum cover thickness and cover variability across an element. The position of reinforcing steel and pre-stressing strands is sometimes also required, in order to circumvent them during core sampling or other tests which may be affected by their presence (concrete resistivity).

Figure 3.9 Use of cover meter, from (<http://www.proceq.com>)

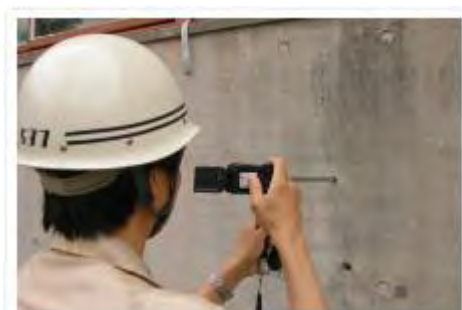
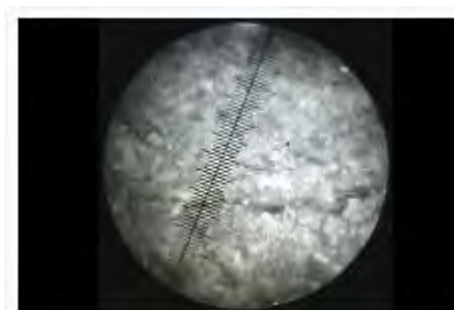
This technique, borrowed from medical applications, is a slightly destructive method. Holes (approximately 25 mm in diameter) are drilled. After meticulous cleaning of the hole from dust and loose material, the endoscope is introduced into the hole. The core of the endoscope, consisting of optical fibres, allows for direct observation of the walls of the hole. In addition, pictures can be taken at any depth of the hole.

Figure 3.11 Use of endoscope identifying a crack in concrete, from ([http:// www.nishimatsu.co.jp](http://www.nishimatsu.co.jp))

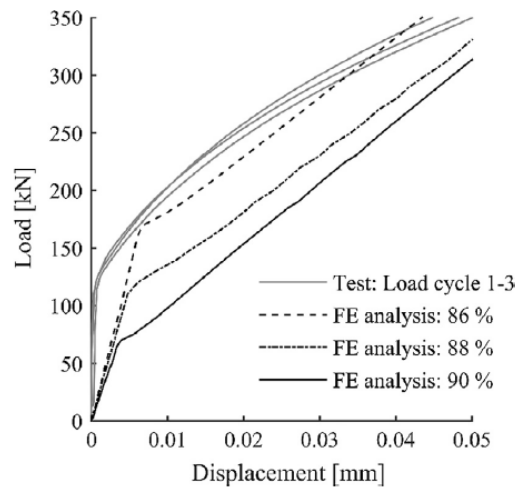
When using the decompression-load method, the depth of the compression zone of the cracked concrete is one parameter that has a significant impact on the outcome. At the same time, the compression depth of the actual section can be uncertain due to nonlinear strain distributions and the lack of reliable measurements, for example see (Nilimaa et. al., 2015). Results from the test on the Kiruna Bridge show that the remaining force varies between some 60 to 90 %, Bagge (2017). Comparisons between field results and FE calculations are given in Figure 3.15.

Figure 3.15. Load-displacement behaviour at crack opening according to test at the Kiruna bridge and FE analyses at indicated level of prestress losses, Bagge et al. (2017).

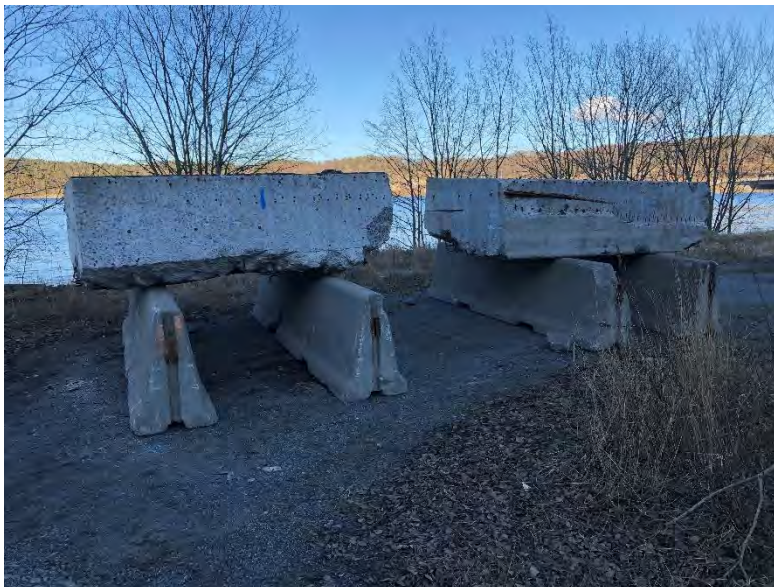
The results of the inspection showed some limitations of certain equipment, especially in segment 2, where the tendon ducts were at a depth of about 450 mm.

Figure 7.1 The two bridge segments in Larvik, Norway

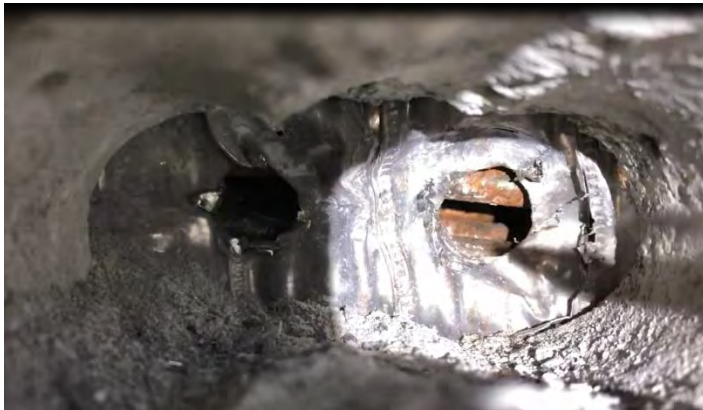
Figure 7.7 Visual inspection of tendons with missing grout

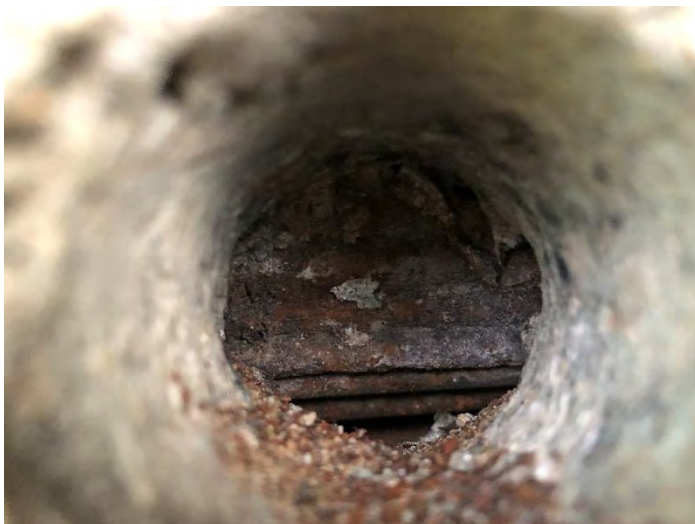
Figure 7.8 Missing grout and corrosion confirmed with visual inspection

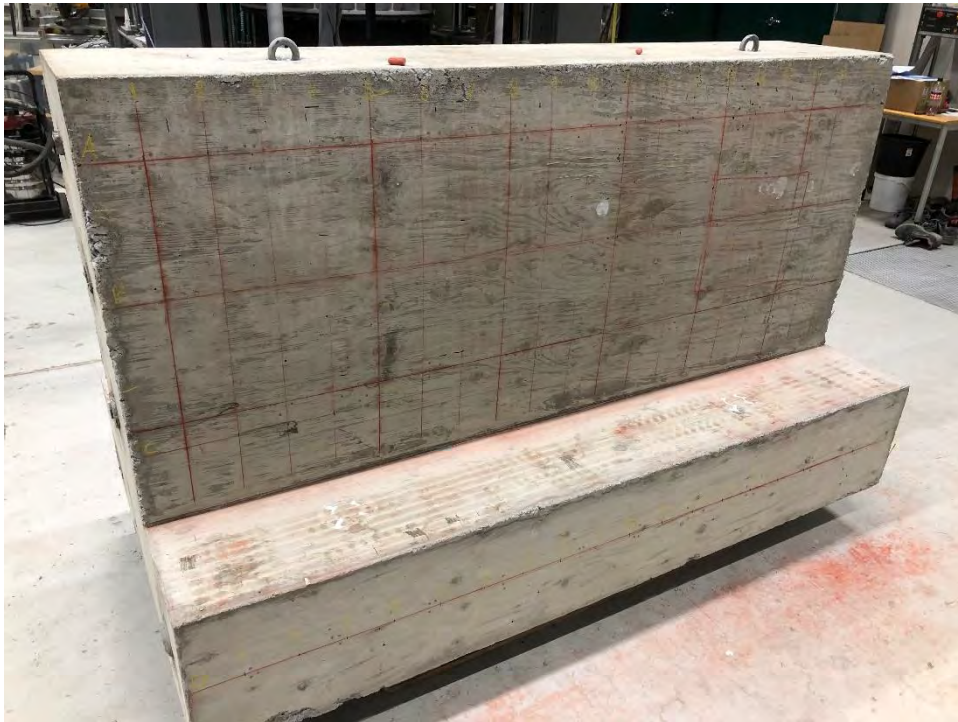
Photo 2.1 Mock-up specimen in Luleå

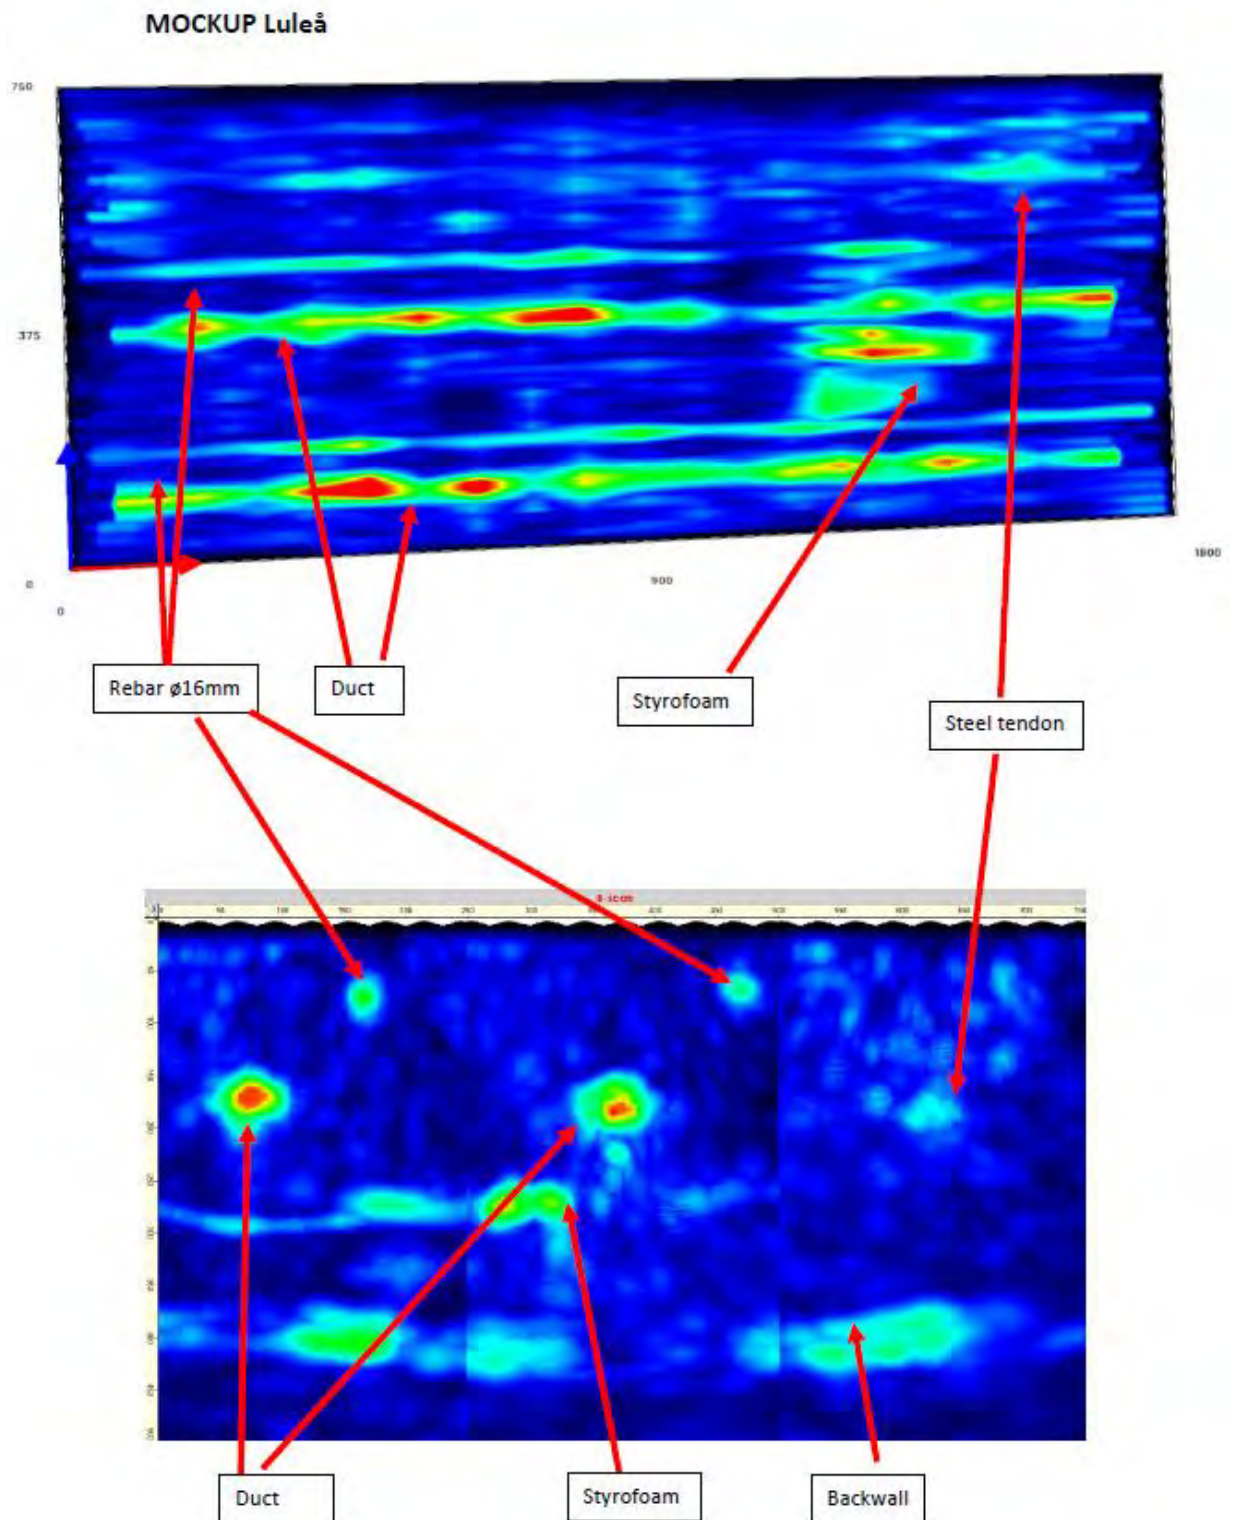
Fig 3.1 Different findings in the mockup

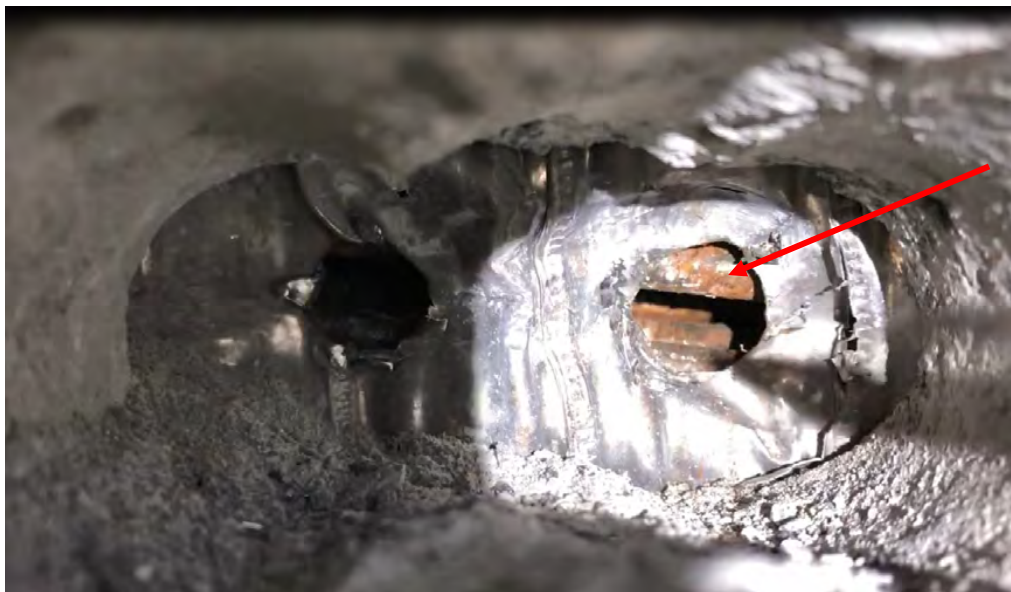
Photo no 6.1: Tendon duct 3SC with confirmed wire breakage

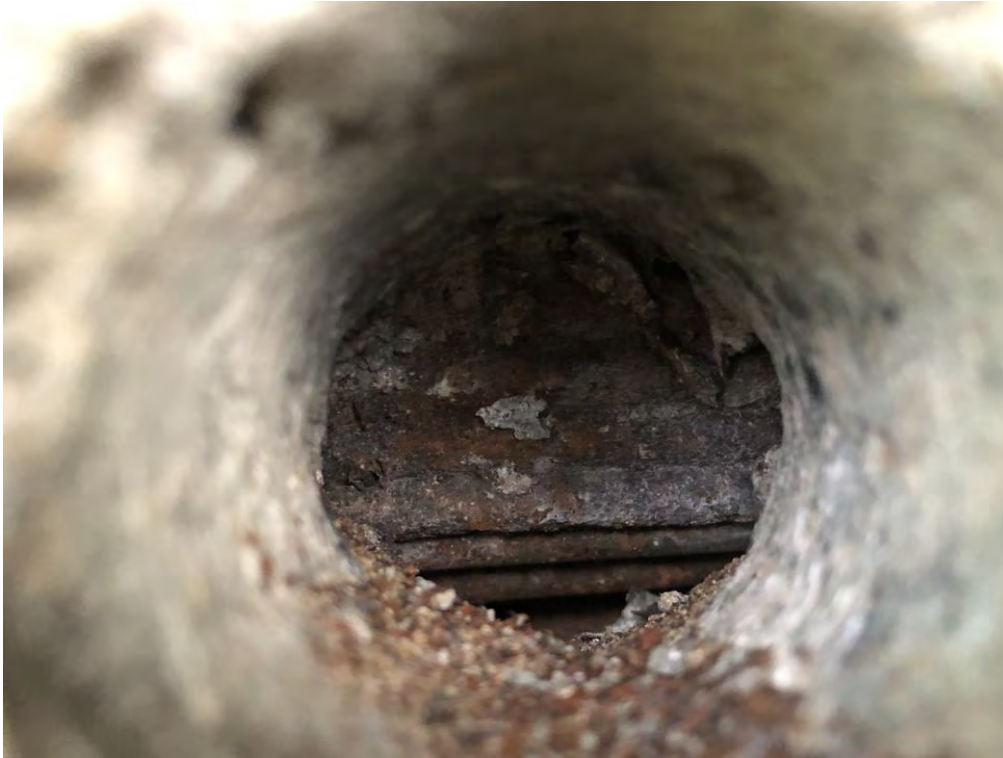
Photo no 6.3: Missing grout and corrosion in tendon duct 1NC.

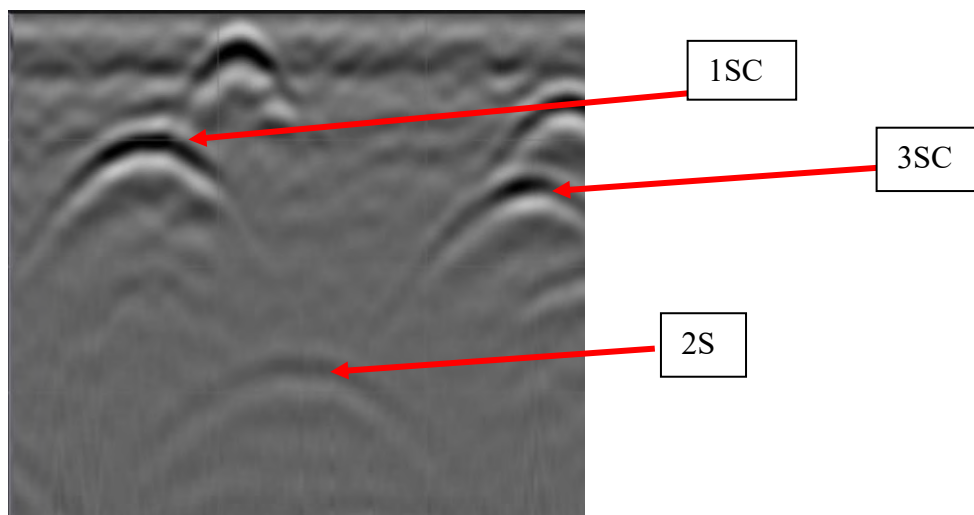
Figure 6.4.2: Results from GPR

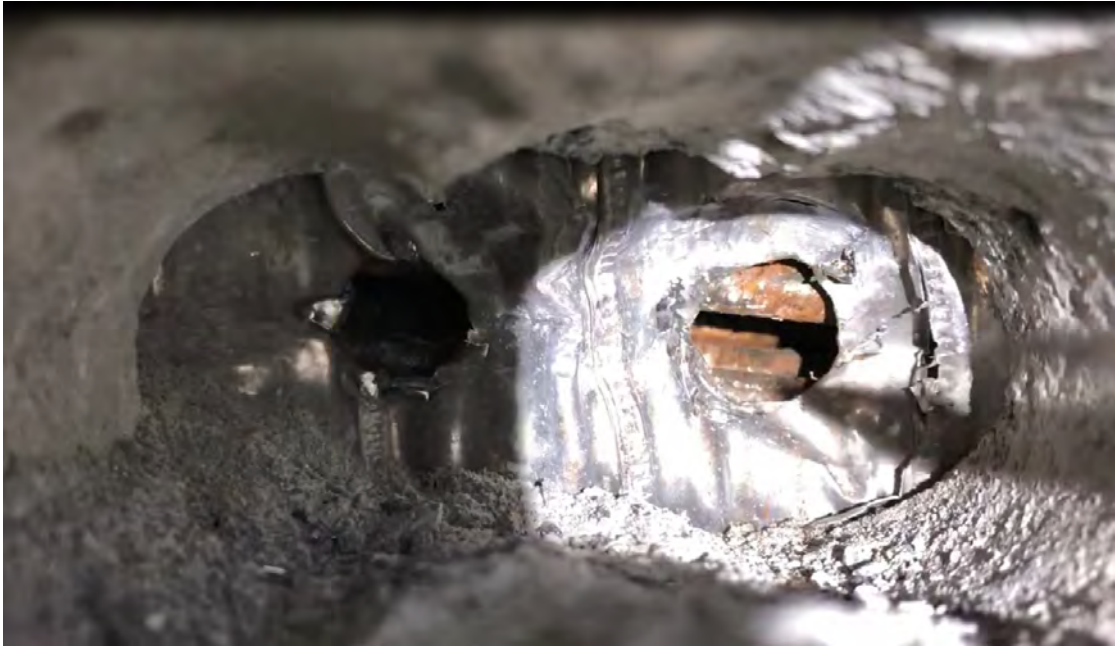
Photo no 6.4.3: Tendon duct 3SC with confirmed void and wire breakage
