Laser measurement of pavement condition

E8 Borealis, Skibotn – Border Finland

Nr. 712

Laser measurement of pavement condition on E8 Borealis

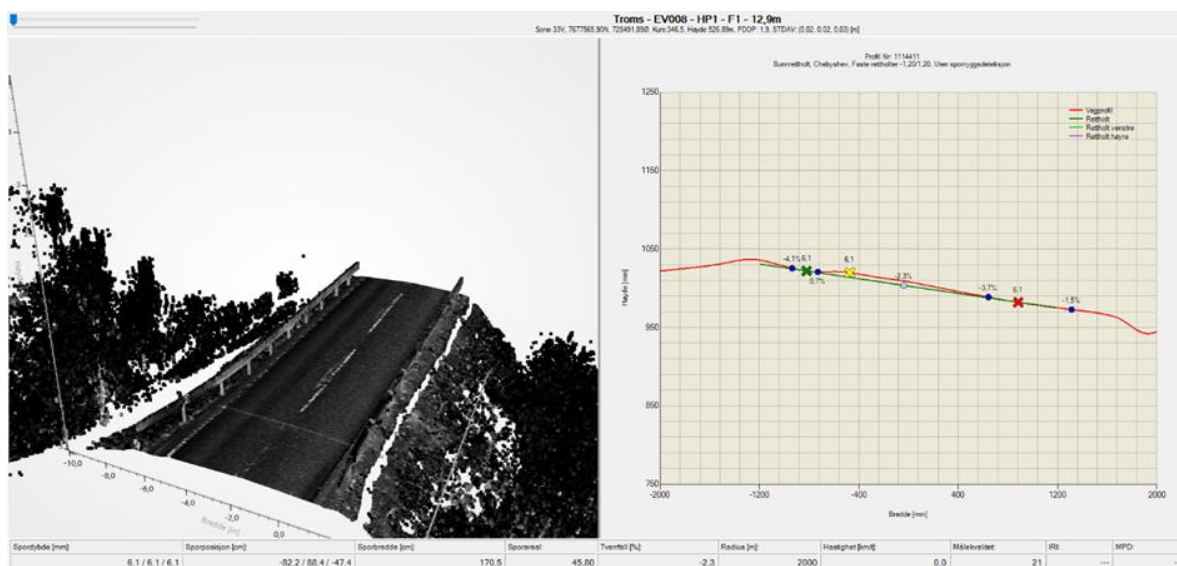
Figure 3: Point cloud and transversal profile from ViaPPS desktop

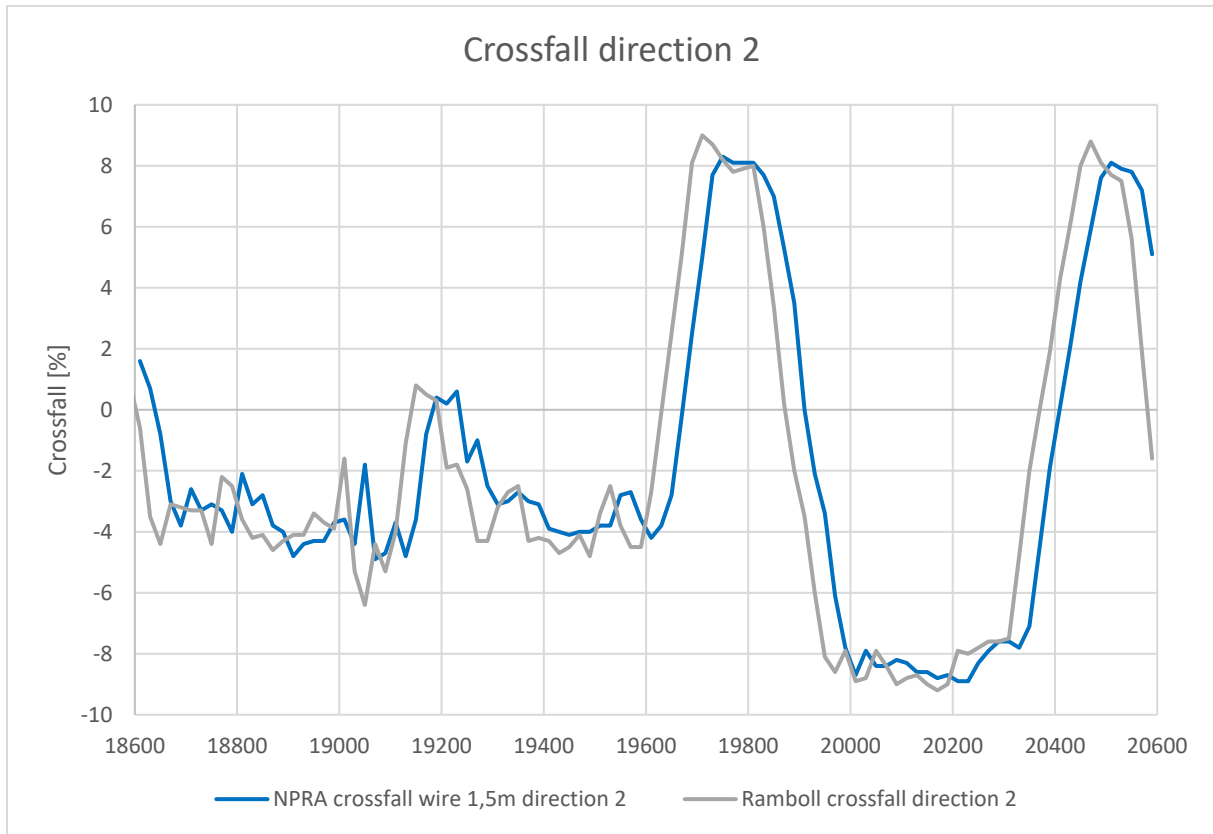
Figure 27: Crossfall, 20-meter segments, direction 2, Ramboll

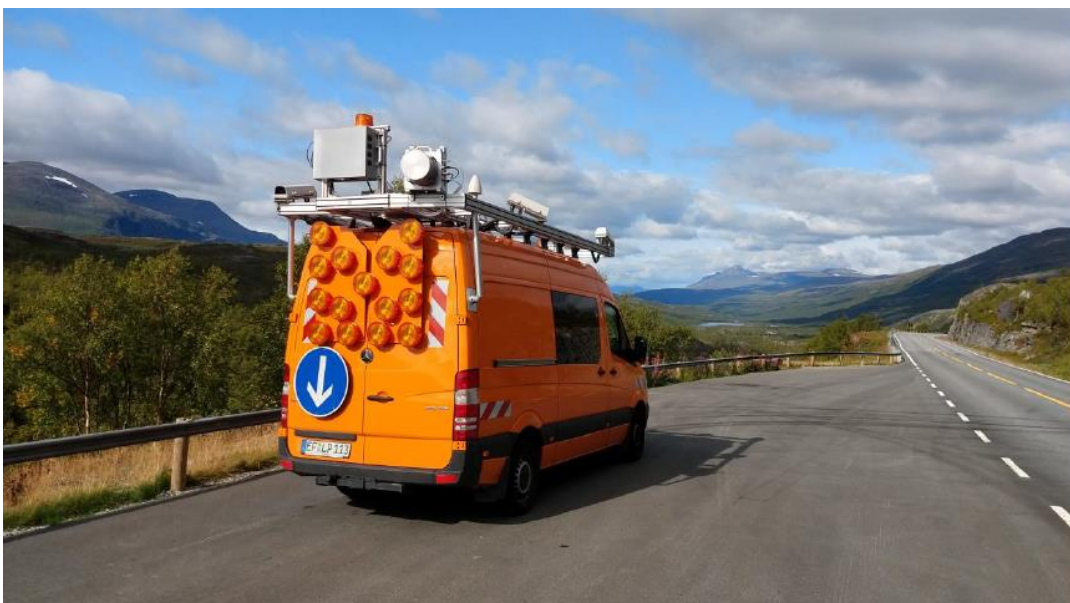
Figure 39: Lehmann + Partner measurement van [9]

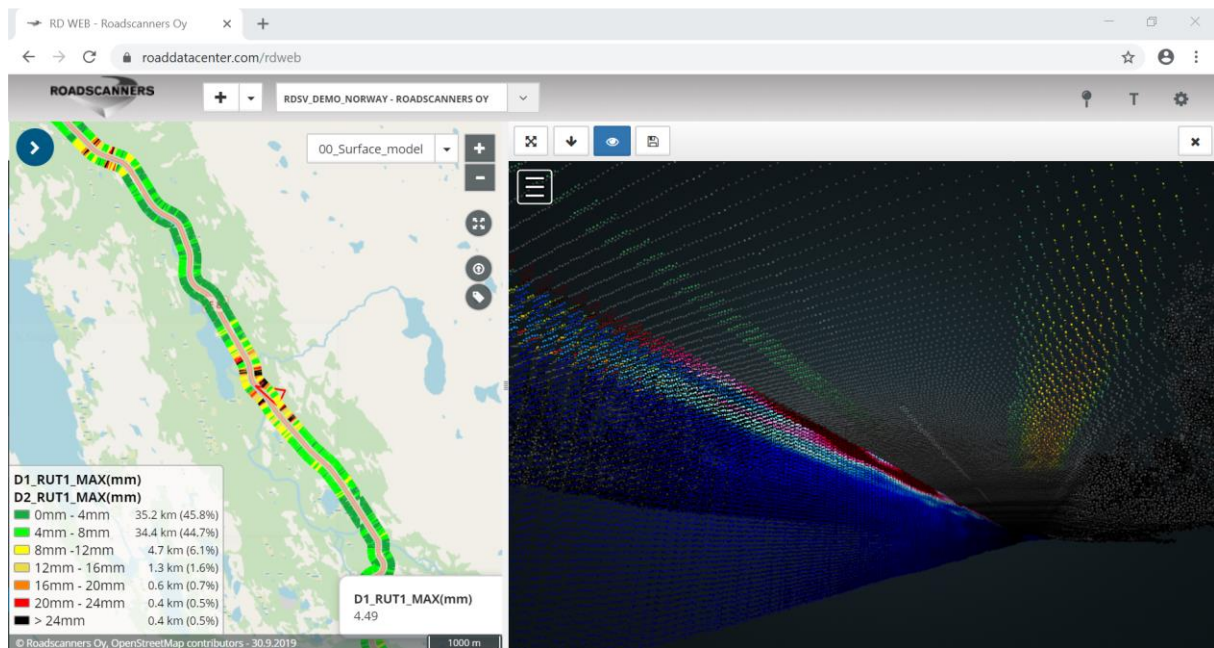
Figure 5. Screenshot from Road Data Center like presented in Figure 10. Right side presents moisture analysis as colored point cloud calculated from ground penetrating radar measurement. Dark red indicates higher moisture compared to blue areas.

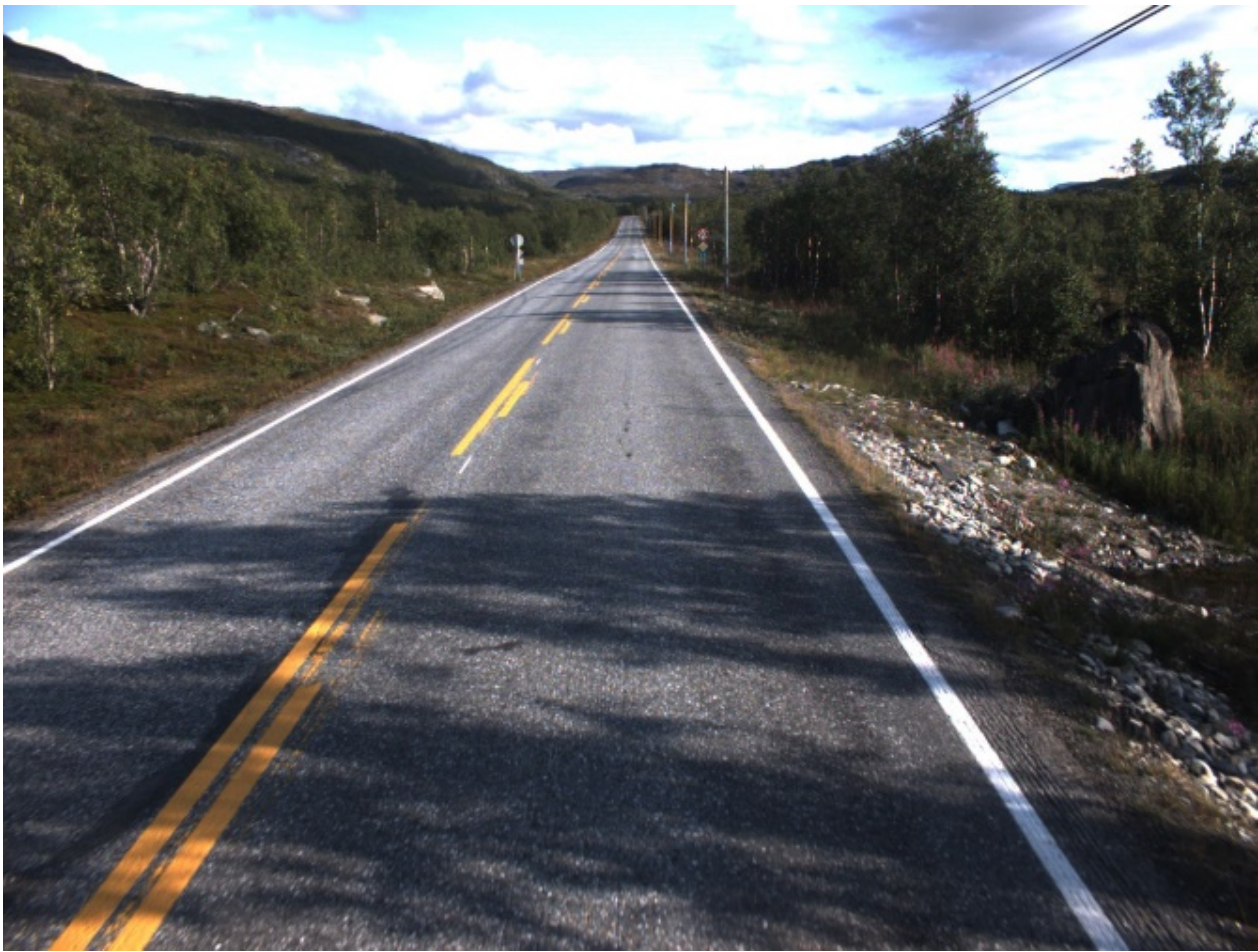
Figures 1 and 2 present crack images from the LCMS system. The details of from crack detection is much better than visual detection from front view images can provide.

Figure 1. Front view image and LCMS overlay from direction 2, location 27280

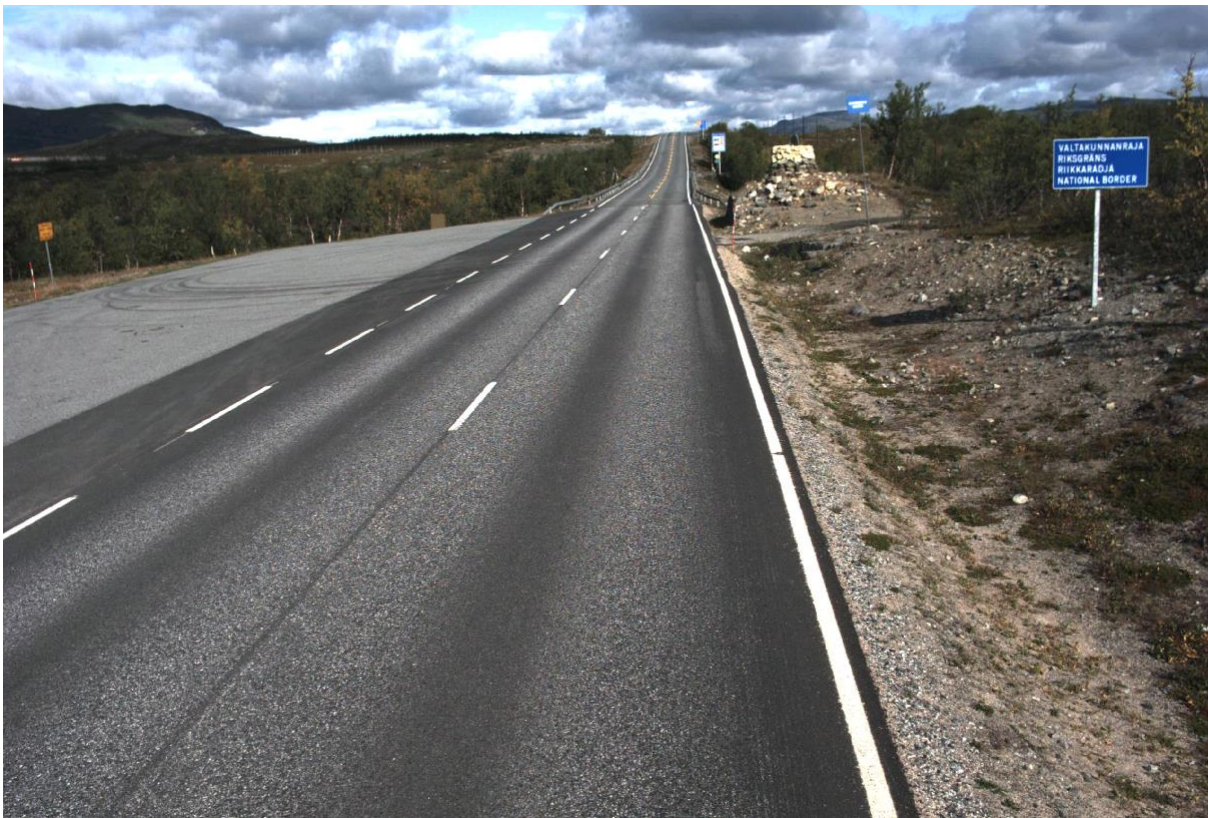
It must be mentioned that there was rain during the night from 2019-08-21 to 2019-08-22. The surface condition was mostly dry in this timeslot. Nevertheless, some cracks were still soaked with moisture.

Figure 2: Example image from the measurement on E8 on 2019-08-22, noon.

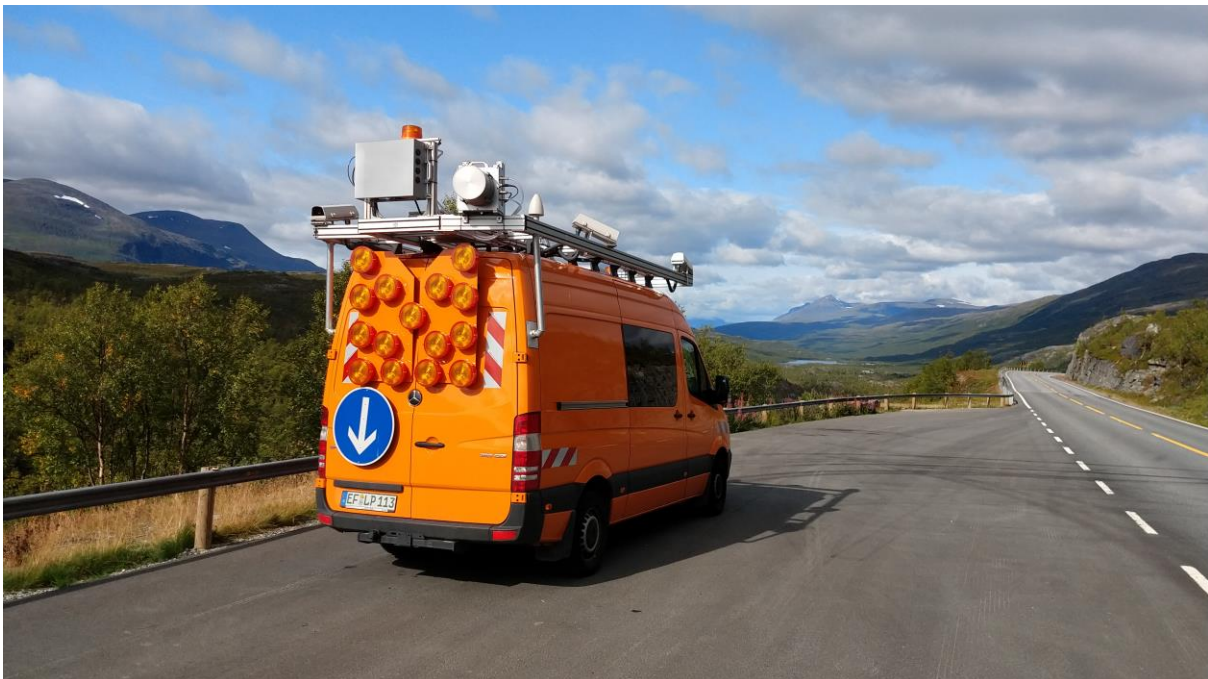
The mobile mapping system I.R.I.S 13 is a kinematic measuring system for pavement condition survey and for collecting roads environment at traffic speed. The main components are:

Figure 3: Mobile Mapping System I.R.I.S 13 with an inertial positioning system, several cameras and LiDAR sensors mounted on the roof rack. This image has been taken during the measurement on 22nd August 2019 on E8.

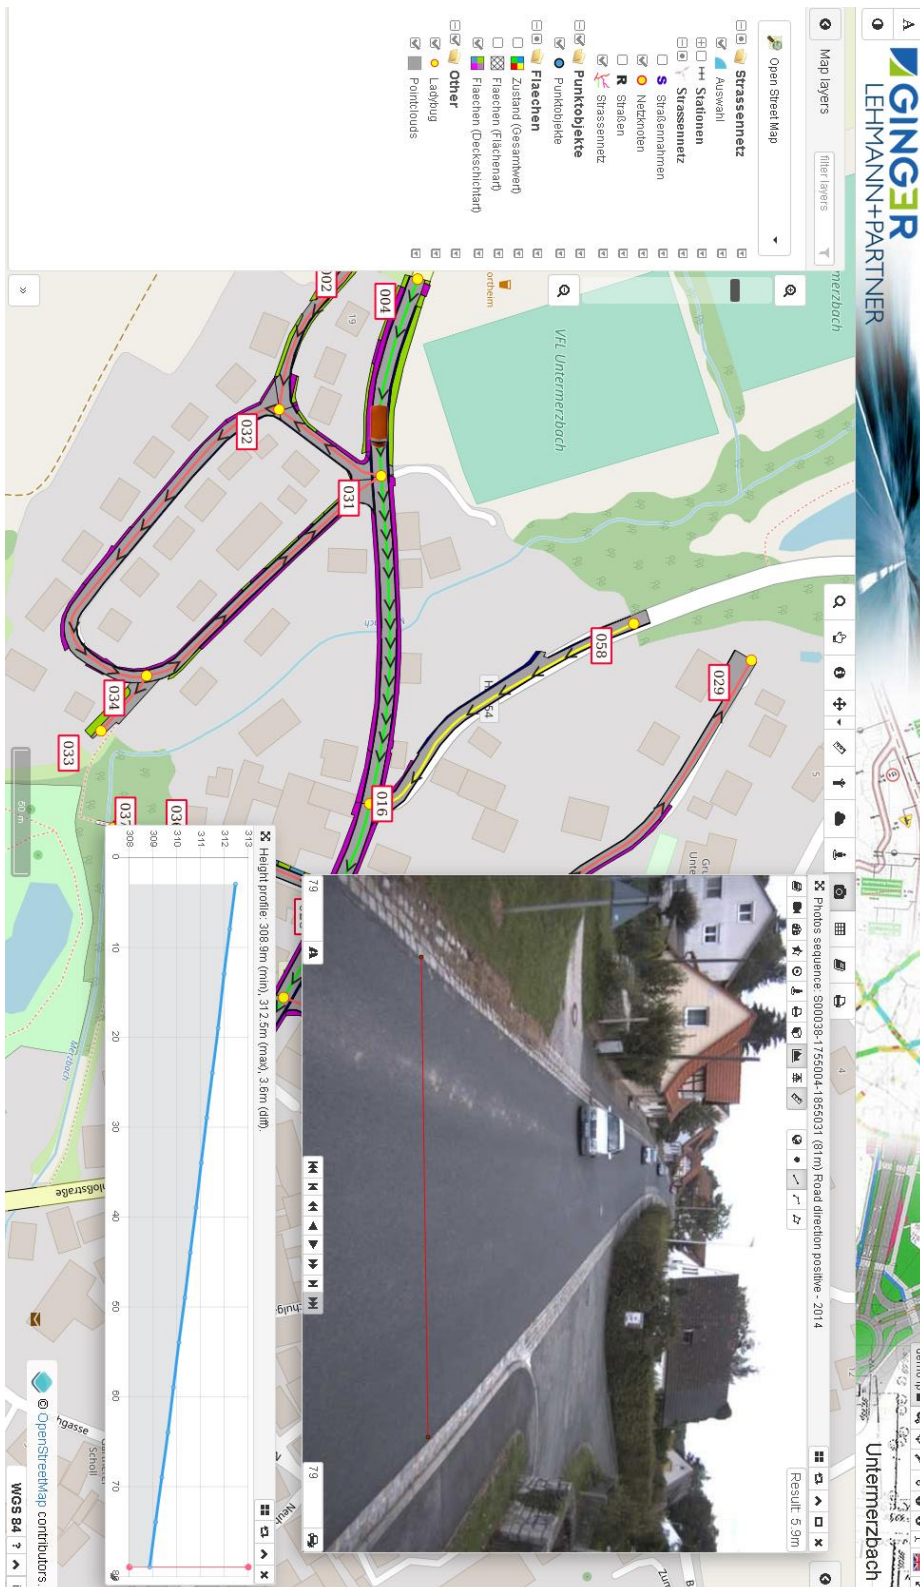
Figure 8: Example of the so-called LP-portal. This is a web-GIS solution for visualization of and interaction with all data recorded and analysed by LEHMANN+PARTNER. As an offline alternative we provide a free image viewer software that interacts with the free and open-source QGIS.

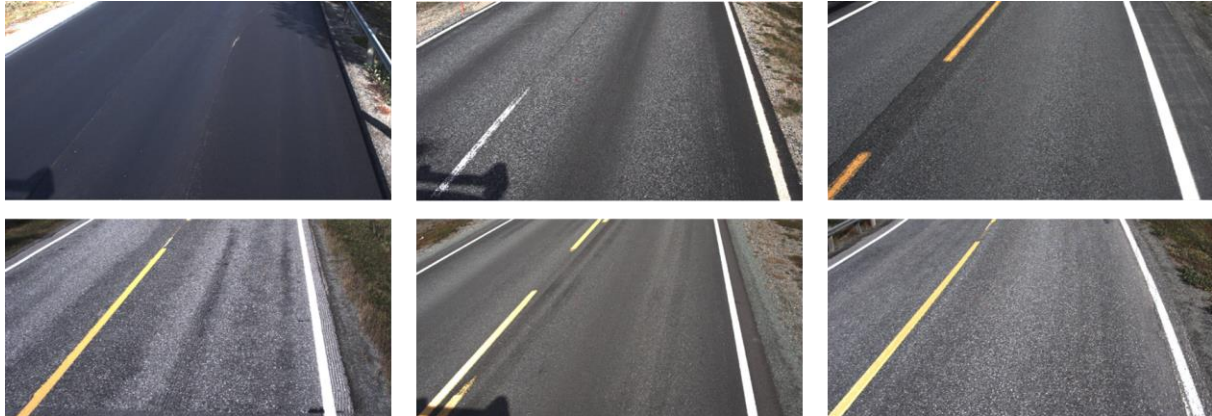
Figure 11: Examples of the different asphalt surface types along the measured track.

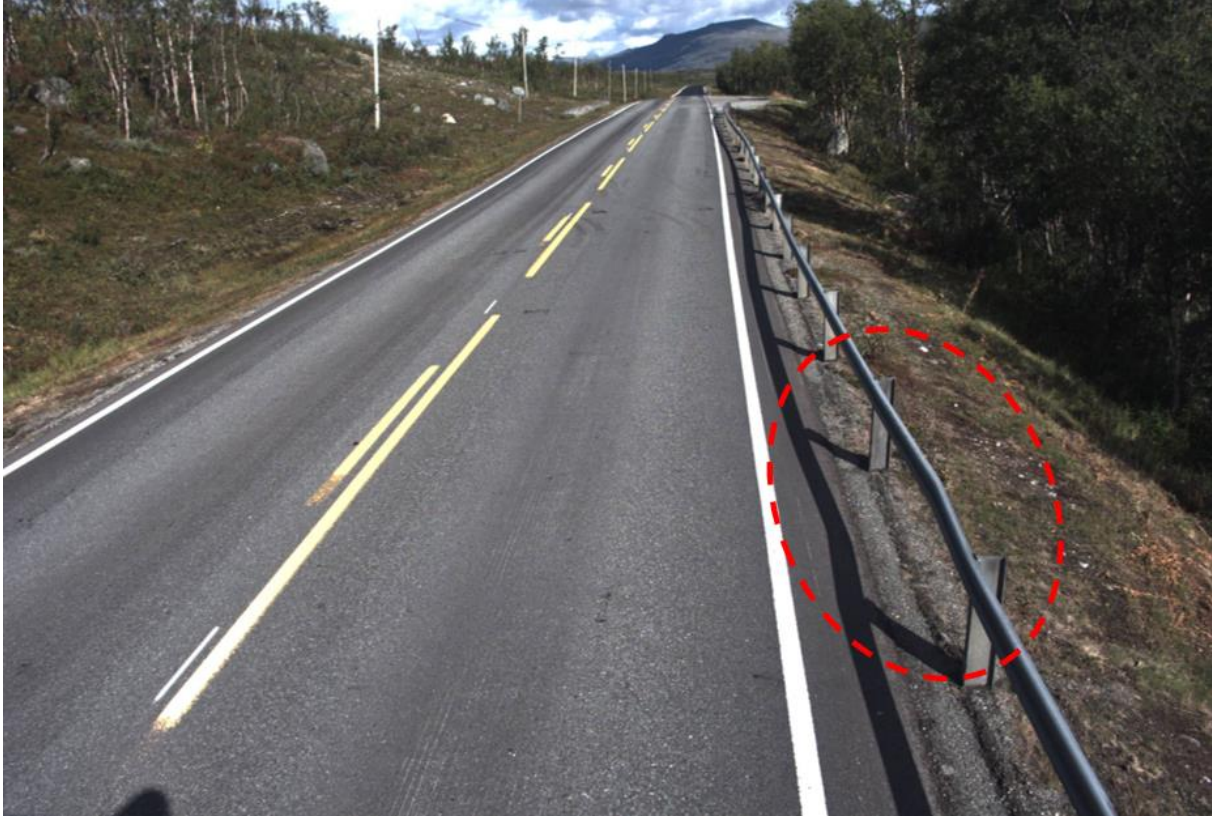
Figure 13: Example for a deformed guard rail.

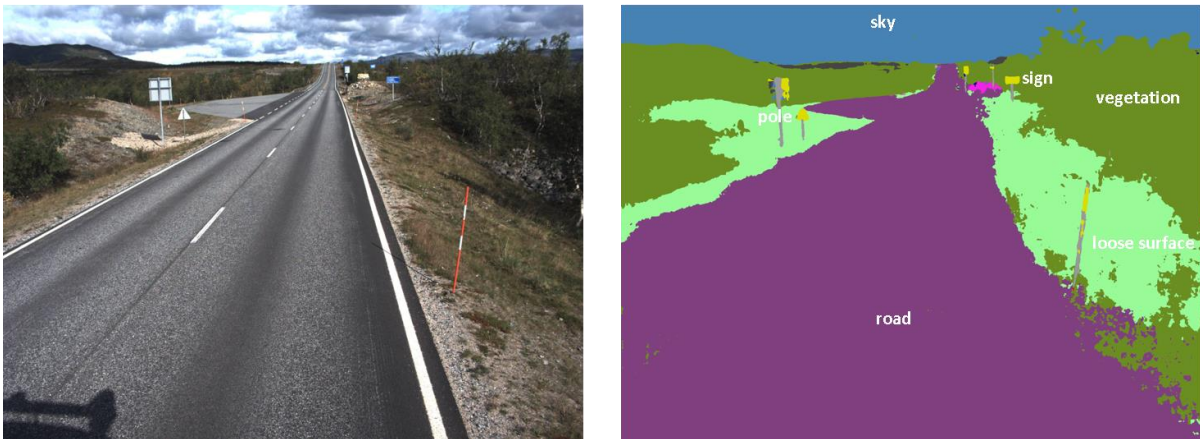
Figure 14:Automated object detection and classification on image data.

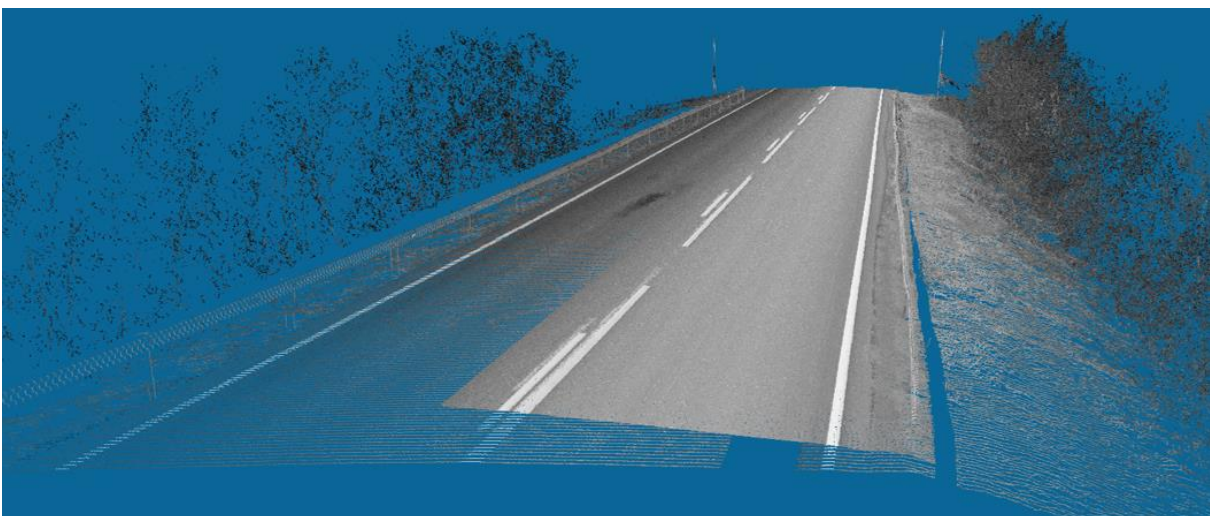
Figure 15:Perspective view along 3D point clouds from CPS (sparse points) and PPS+ (dense points).

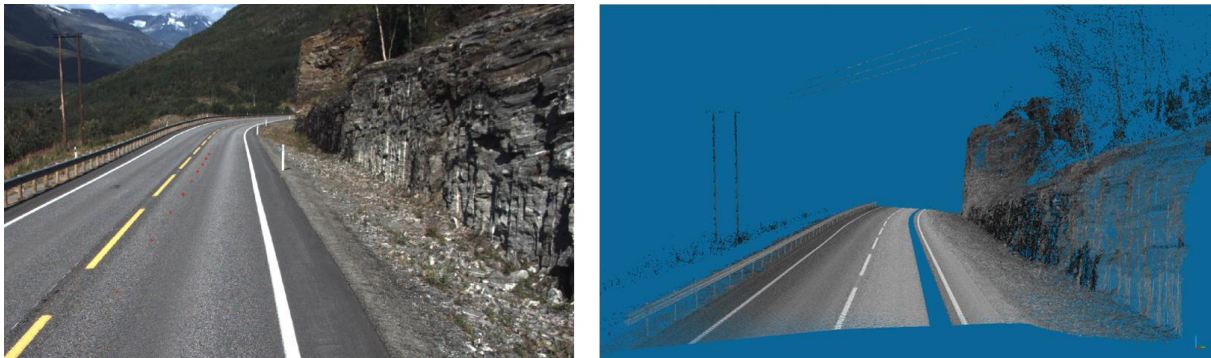
Figure 16: Possible application for CPS data.
