# Effects of chloride, sulfate and pH on the corrosion of tensile wires in grouted tendon ducts in Herøysundet bridge

Master's thesis in Materials Science and Engineering

June 2022

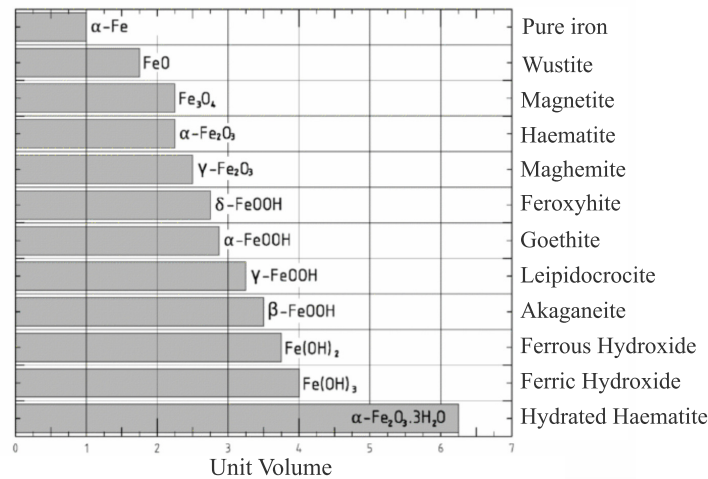
**Figure 2.2:** Relative volume of iron and some of its oxides [27].

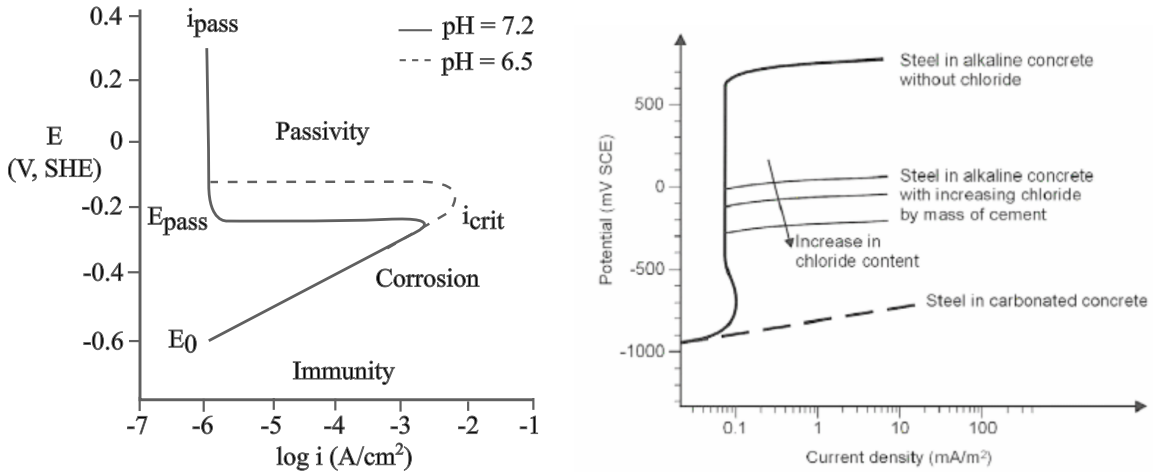
(a) The anodic polarization curves for  $Fe - H_2O$  measured against a SHE [38].

In solutions simulating the conditions of concrete the polarization curve will look somewhat different, see Figure 2.5b, where the anodic polarization curve is measured against a saturated calomel electrode (SCE). As can be seen in Figure 2.5b, the addition of carbon and chlorides will minimize the passive area, making the steel reach an active state at lower potentials.

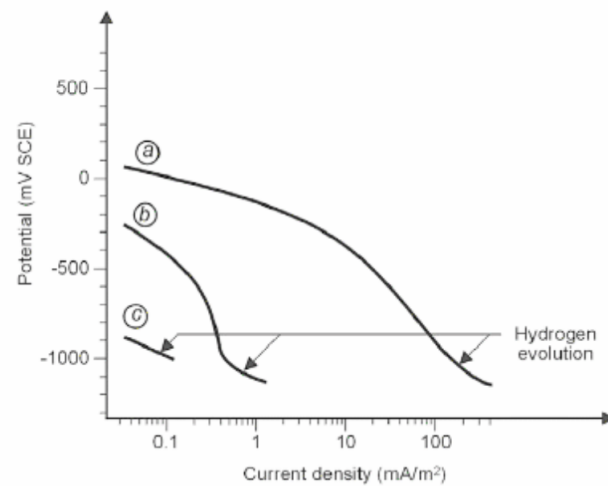
**Figure 2.6:** An illustration of the cathodic polarization curve of steel in concrete measured against SCE. Divided by different moisture content: (a) semidry; (b) wet; (c) completely saturated [16].

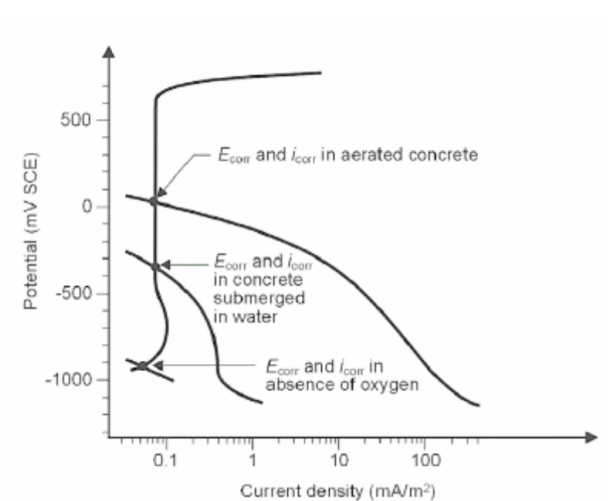
**Figure 2.7:** An illustration of  $i_{corr}$  and  $E_{corr}$  from anodic and cathodic polarization curves of steel in concrete [16].

When combining the plots of the anodic and cathodic curves it is possible to find the corrosion current density,  $i_{corr}$ , and the corrosion potential,  $E_{corr}$ , from the intersection between the two, see Figure 2.7.  $E_{corr}$  and  $i_{corr}$  can be found from the intersection given that the ohmic drop is negligible [16].

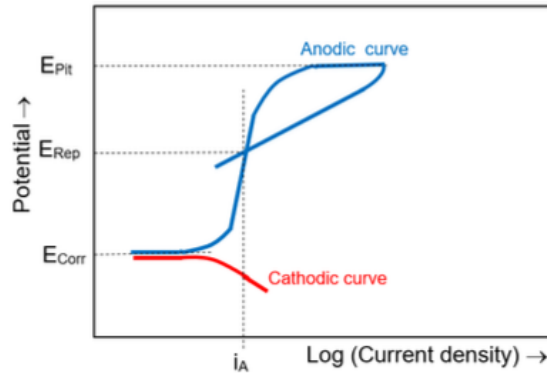
**Figure 2.9:** A schematic presentation of a cyclic polarization curve depicting  $E_{Corr}$ ,  $E_{Pit}$  and  $E_{Rep}$  [50].

The potential required for the chlorides to locally break down the passive layer is known as the pitting potential,  $E_{pit}$ , [38]. By analyzing the anodic polarization curves the pitting potential can be found as shown in Figure 2.9. In an active pit, the lower limit for corrosion is given by the repassivation potential,  $E_{rep}$ . Therefore, the critical potential must be more positive than the repassivation potential in order to initiate corrosion.

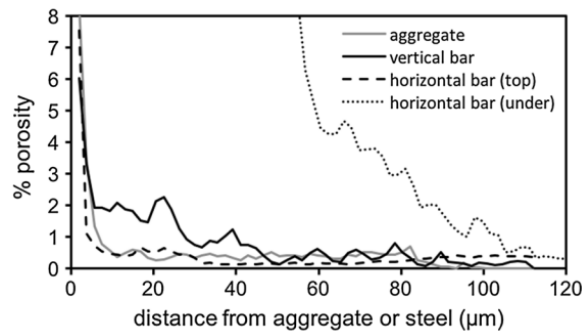
**Figure 2.11:** Porosity next to the ITZ and SCI [5].

Next to the SCI a higher porosity is often naturally present. This is similar to the interfacial transition zone (ITZ), and is caused by a reduced packing density, see Figure 2.11.

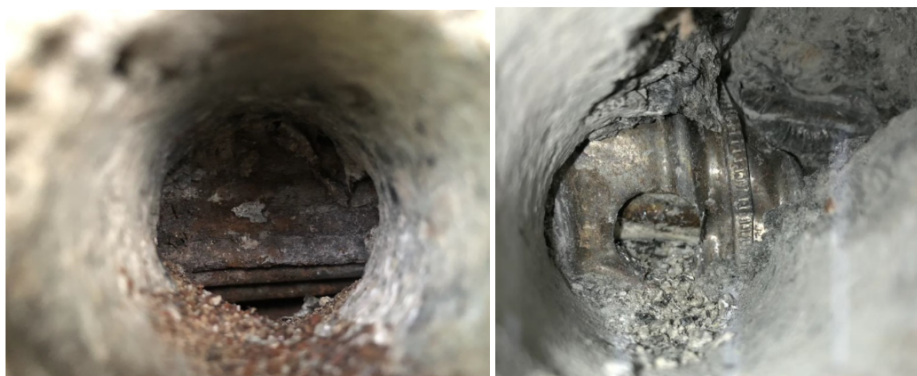
**Figure 3.7:** Tendon duct and tensile wires - Left: missing grout and corrosion on both duct and wires. Right: filled with grout and no sign of corrosion on either component [79].

SVV, in cooperation with NTNU, performed an inspection in 2019 to determine the state of the tendon ducts, grout and tensile wires. The inspection revealed areas where the wires showed signs of general corrosion, some areas with severe pitting damages and other areas completely covered with grout and without sign of corrosion, see Figure 3.7. In one of the tendon ducts, fractured tensile wires were discovered. The state of the tendon ducts varied from unaffected by corrosion on both the inside and outside to highly corroded on both sides. In most cases, the state of the tendon ducts showed corrosion on the internal side, while the outside was without corrosion. With regards to the grout, areas were found with large voids that were completely lacking grout, while in other areas the grout filled the tendon duct completely. There were also areas where the consistency of the grout varied from normal dry to moist and from intact to completely frost deteriorated. Different states of the grout gathered from the bridge is displayed in Figure 3.8. More images from the inspection are given in Appendix E.

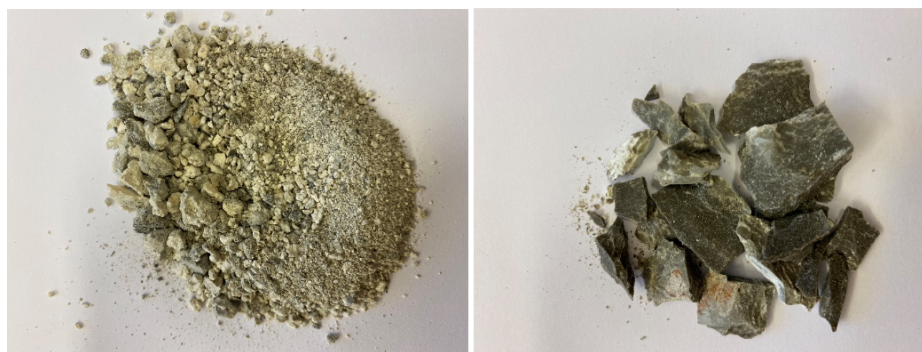
**Figure 3.8:** Grout gathered from different locations in the bridge [79].

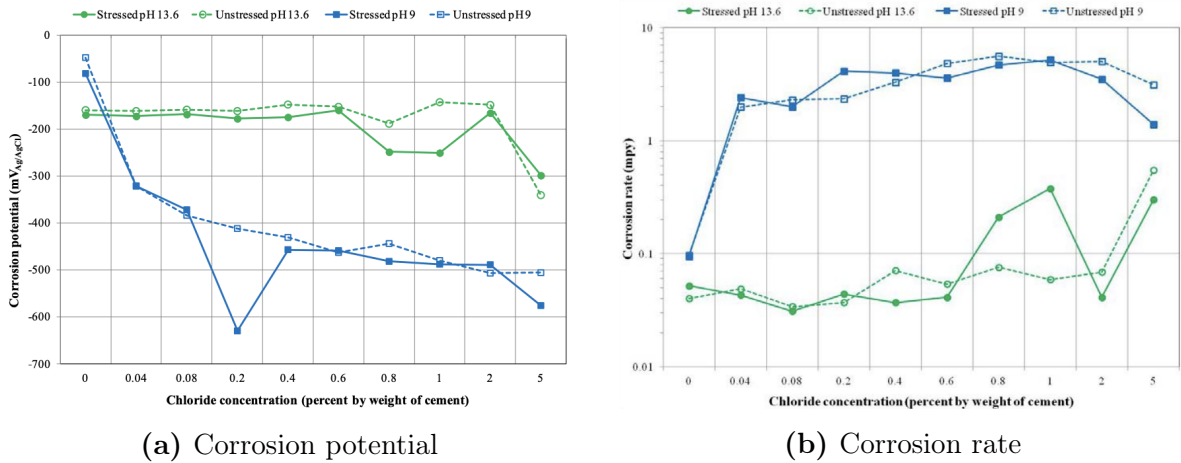
**Figure 4.6:** Results from tests for single wire specimen under different test environments measured by Lee and Zielske [4].

The experimental test setup used a Ag/AgCl electrode as a reference electrode [4]. Tests were run both with wires subjected to no external stresses and on wires prestressed to 60% of the guaranteed ultimate tensile strength. The results of the corrosion potential data is given in Figure 4.6.

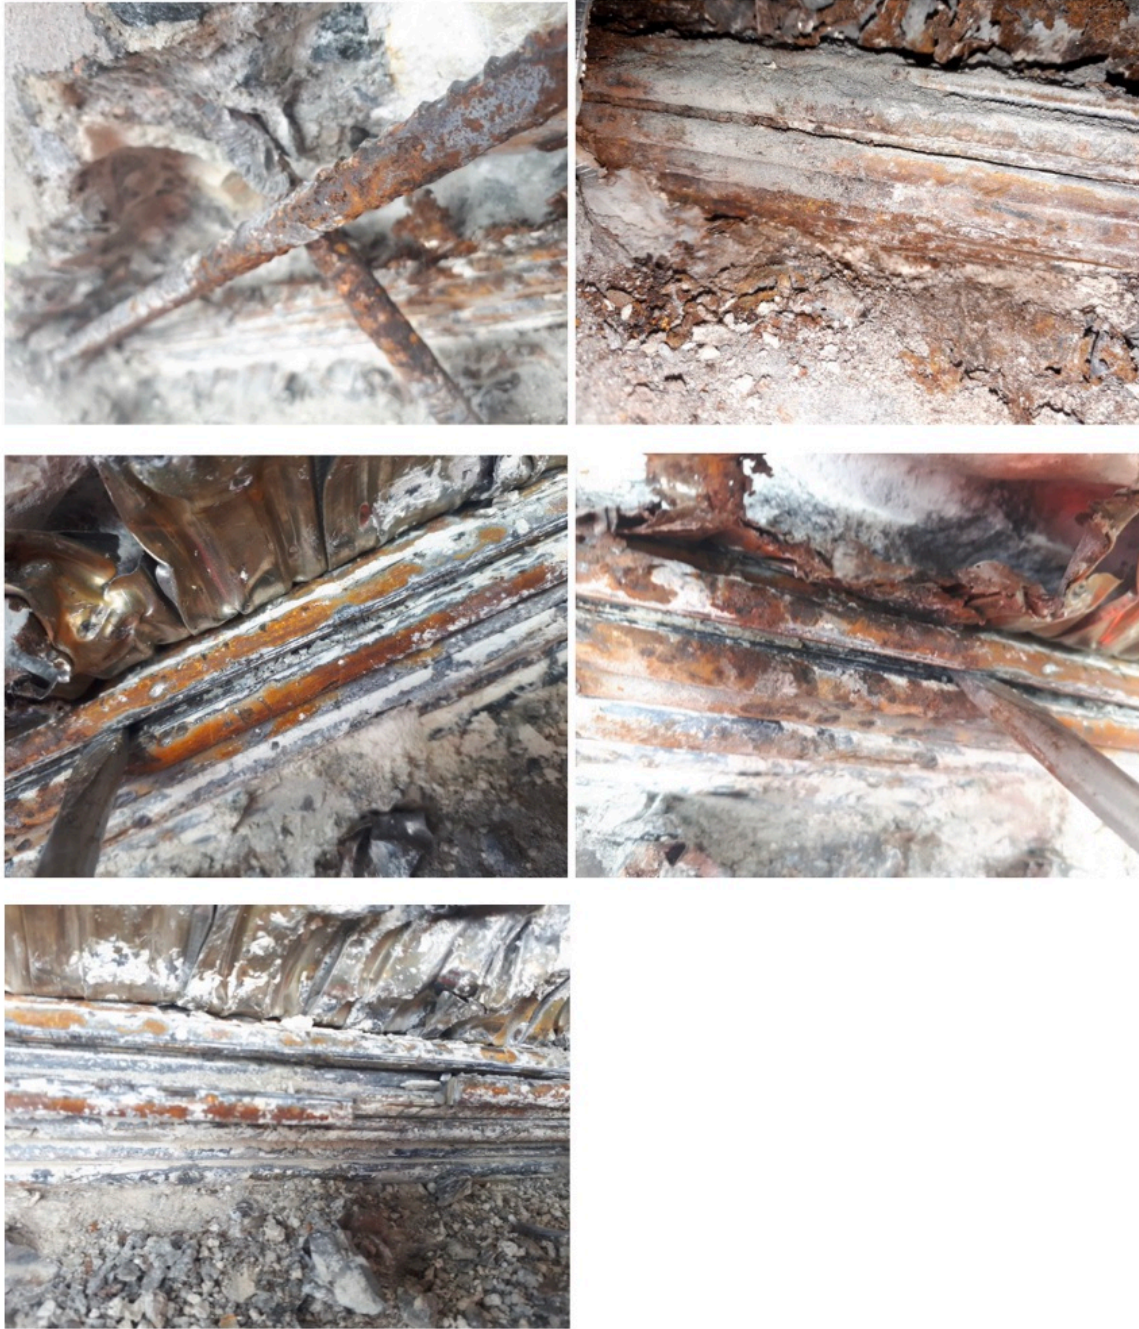
**Figure E.2:** Images taken from inspection site 2. Corresponds to image E1-5 to E1-9 in Appendix F, respectively

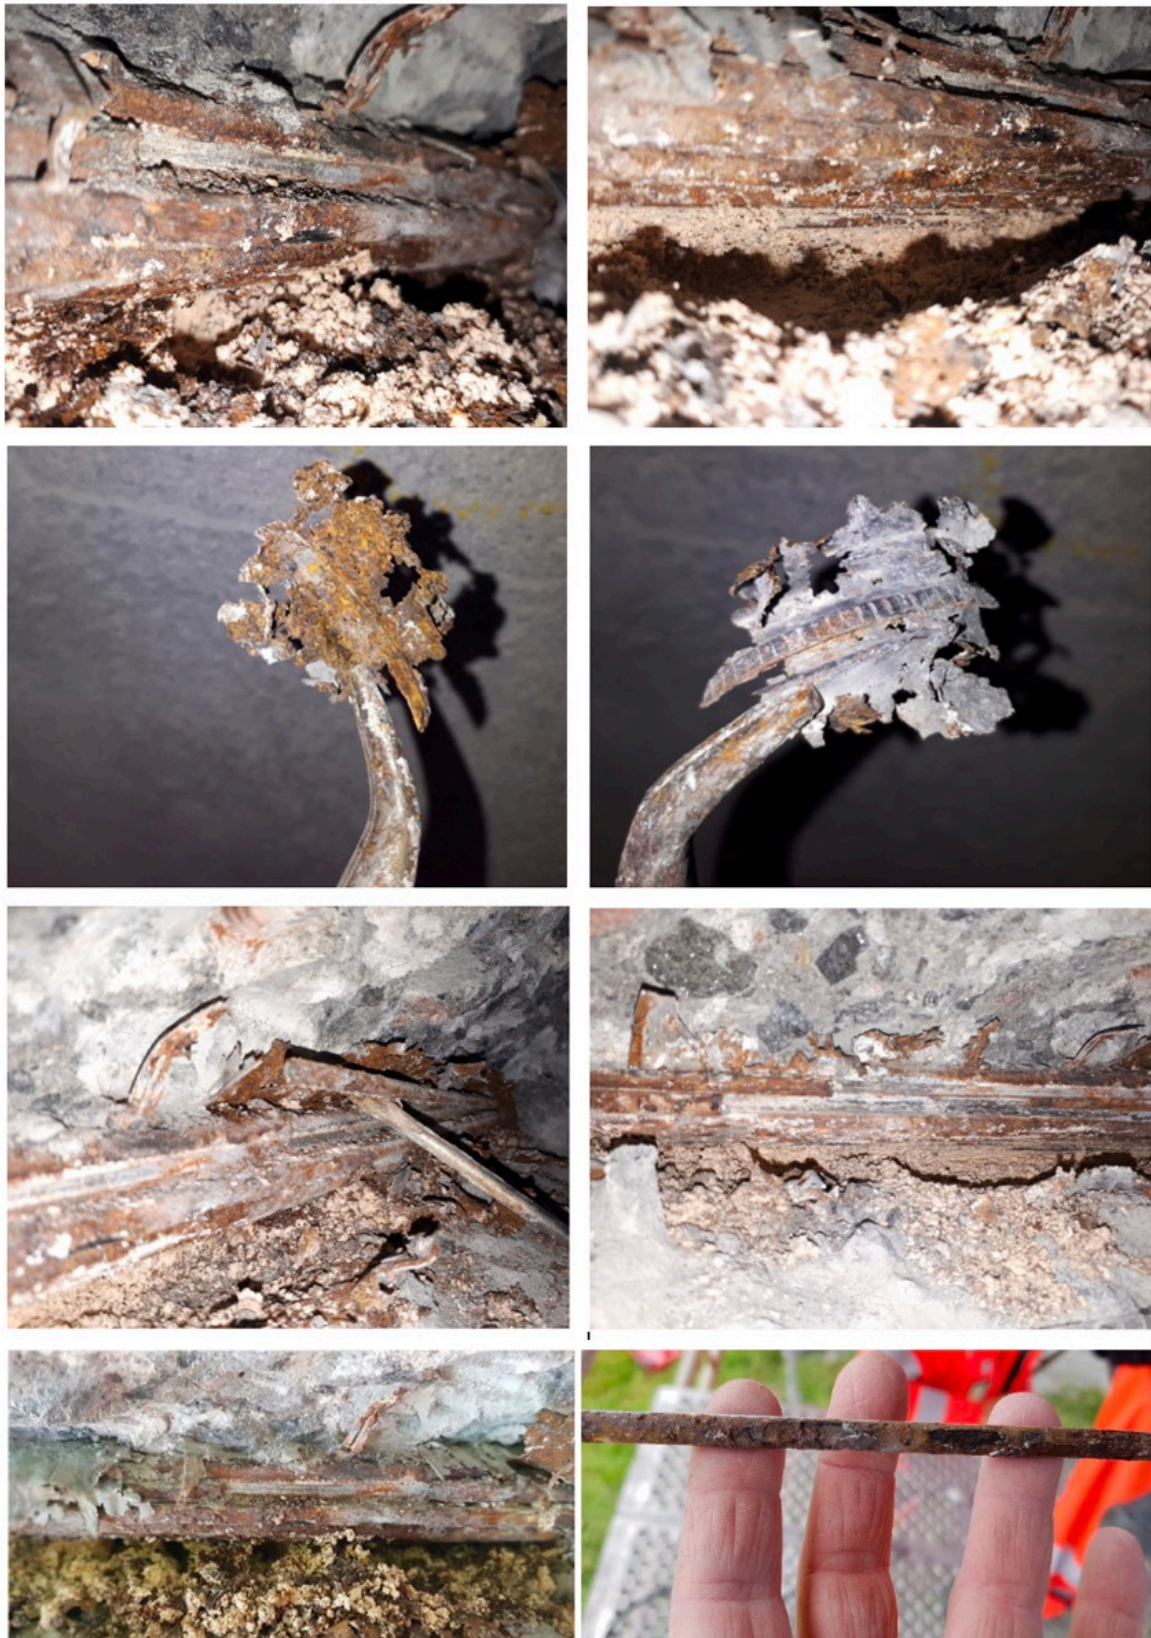
**Figure E.3:** Images taken from inspection site 3. Corresponds to image E1-10 to E1-17 in Appendix F, respectively

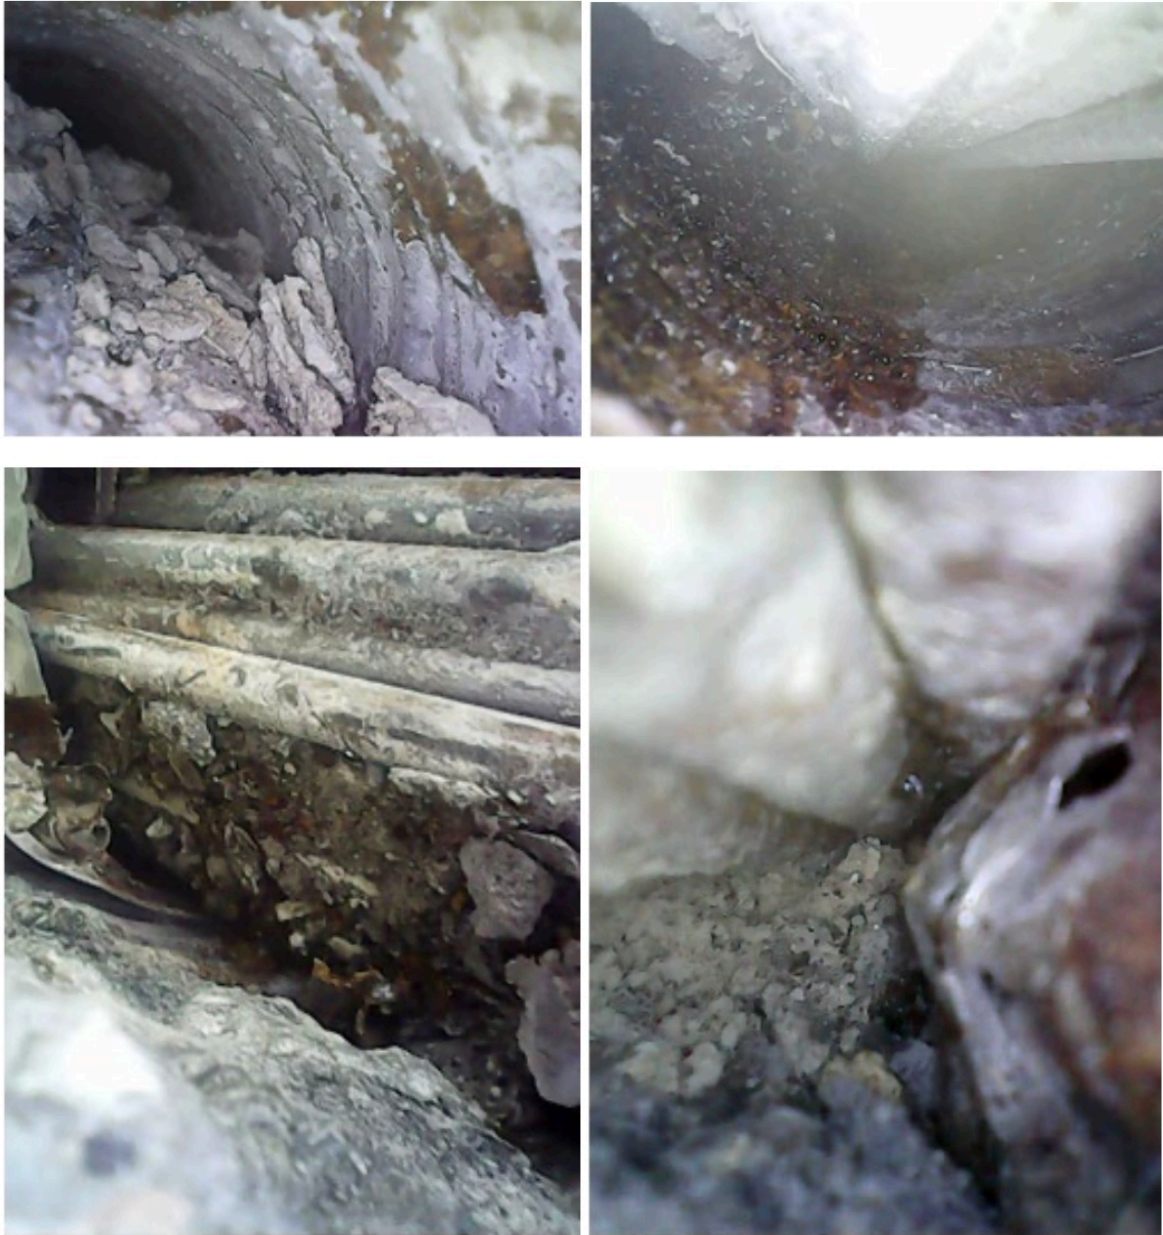
**Figure E.4:** Images taken from inspection site 1. Corresponds to image E2-1 to E2-4 in Appendix F, respectively

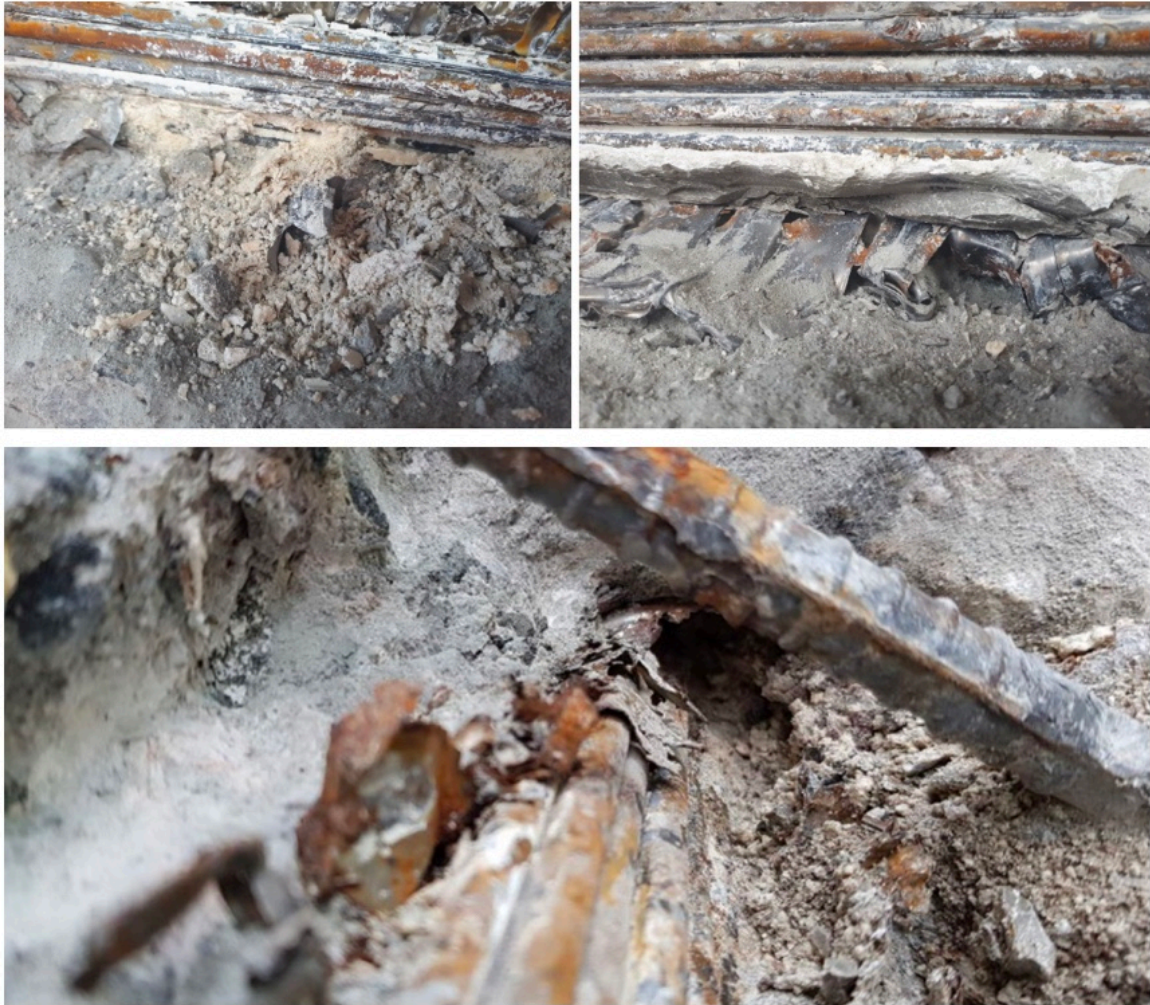
**Figure E.5:** Images taken from inspection site 2. Corresponds to image E2-5 to E2-7 in Appendix F, respectively
