Long-term performance of cathodic protection (CP) of marine bridge, inspection of Sortlandsbrua 27 years after CP installation

An investigation of performance and damages on the installation.

Master's thesis in Experience-based Part-time Master
programme Road and Railway Engineering
Supervisor: Mette Rica Geiker
May 2019

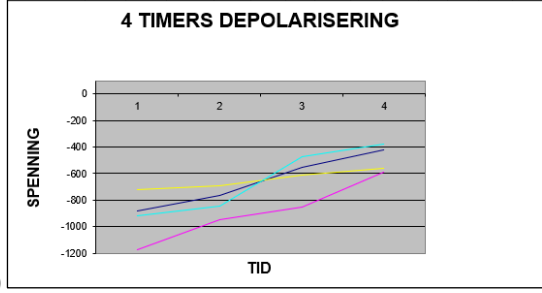
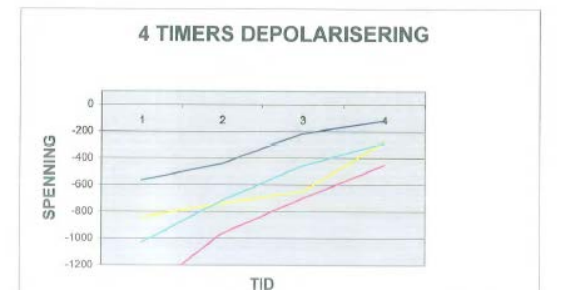
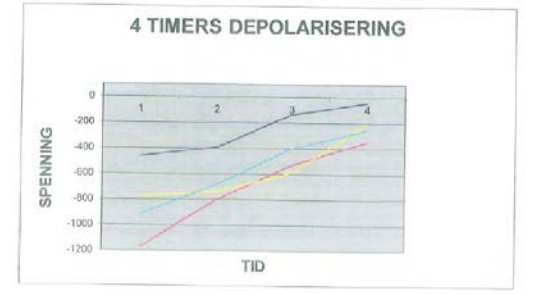
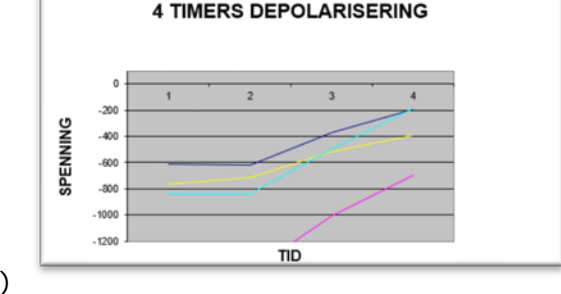
Figure 4-5 Depolarization of pillar 11 a) from 1993, b) from May 2011 c) from August 2011 and d) from 2018

The measurements show that the installation is still working. However, the numbers for pillar 11 might be concerning regarding the possibility of development of hydrogen embrittlement, as one of the reference electrodes record much lower potentials than allowed for cathodic protection. This can also be a defect reference electrode that shows wrong numbers but should be investigated further.

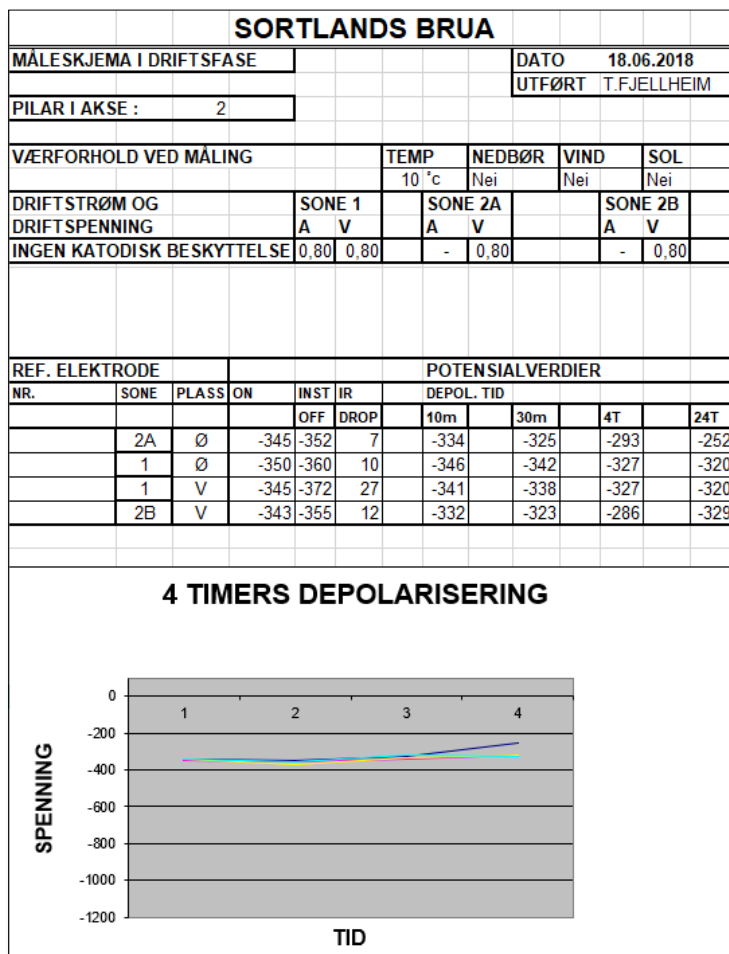
Figure 4-6 Depolarization from pillar 2 June 2018

The reference electrodes installed at most of the pillars seem to still be working. However, at several of the pillars the measurements from June 2018 are flat lining.

The pillars where the lines are flat are pillar 2, 3, 6, 7, 8 and 18. That is 6 out of 18 pillars where the results from the depolarization measurements can't prove that the construction is protected. This is more likely to be a result of defected reference electrodes than a defect CP-installation. Measurements from 1993 showed 3 reference electrodes with flat results, one from each on pillar 8, 12 and 18. The reason for why the reference cell in pillar 12 is working again is unknown, though it might still be defect even though it gives readings.

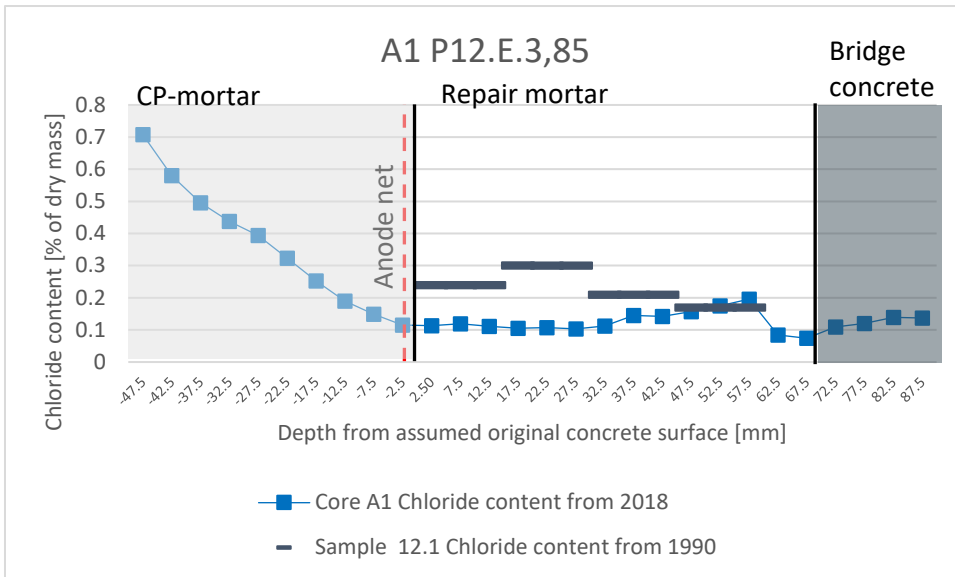
Figure 5-5 Chloride content core A1

The graph in Figure 5-5 shows high chloride ingress through the surface protection. This is not unexpected as surface protections usually doesn't last more than 10 years or so (Bertolini 2013). The ingress into the repair mortar is a bit unexpected. The original concrete where sample 12.1 was taken was removed when installing the CP and replaced with repair mortar. When the CP was installed the chloride content of the repair mortar should have been 0. There is a possibility that migrating ions have contributed to the higher point at 57.5mm compared to 62.5 and 67.5, but it is not expected as the rebars usually would be found at 30-40mm depth. However, it could be a rebar there, as there have been observed some rebars with an original cover depth of 88mm (Table 5). There was no rebar discovered in this sample.

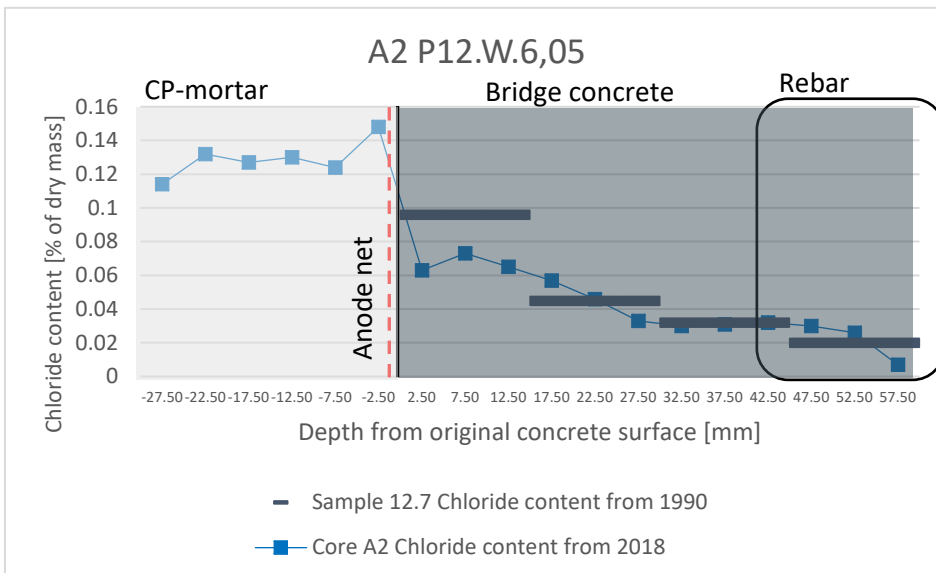
Figure 5-6 Chloride content core A2

In the graph in Figure 5-6 there is a clear drop in chloride content when moving from the CP-mortar into the bridge concrete. It seems that some chloride has moved into the CP-mortar. Even though the chloride content is low in this sample there has still been movement of the chlorides since the amount has lowered compared to sample 12.7.

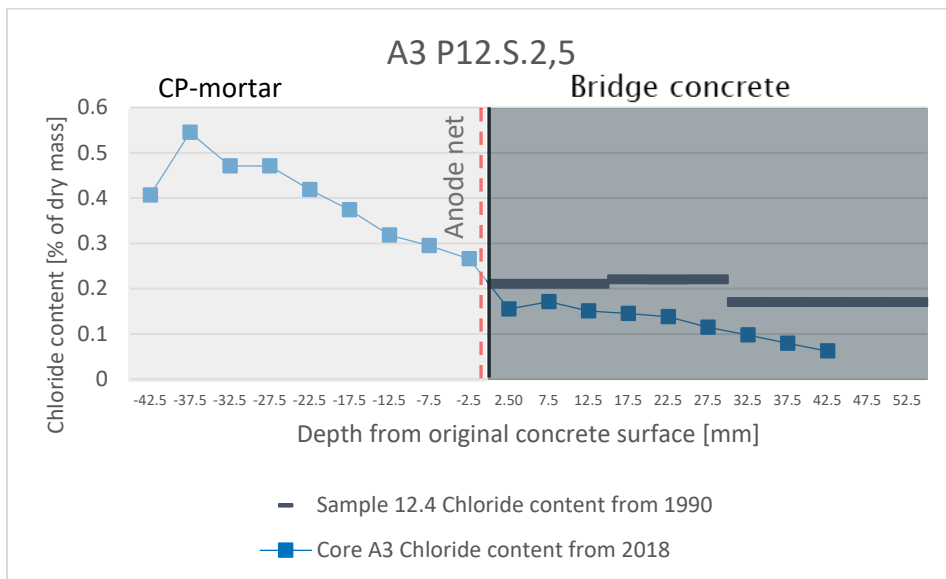
Figure 5-7 Chloride content core A3

Shown in Figure 5-7 there is a small drop in chloride content from the CP-mortar and into the bridge concrete. However, when considering the chloride content to cement ratio the difference is probably not that big. There seem to have been some movement of chlorides compared to sample 12.4, especially regarding the chloride content form 1990 further into the construction.

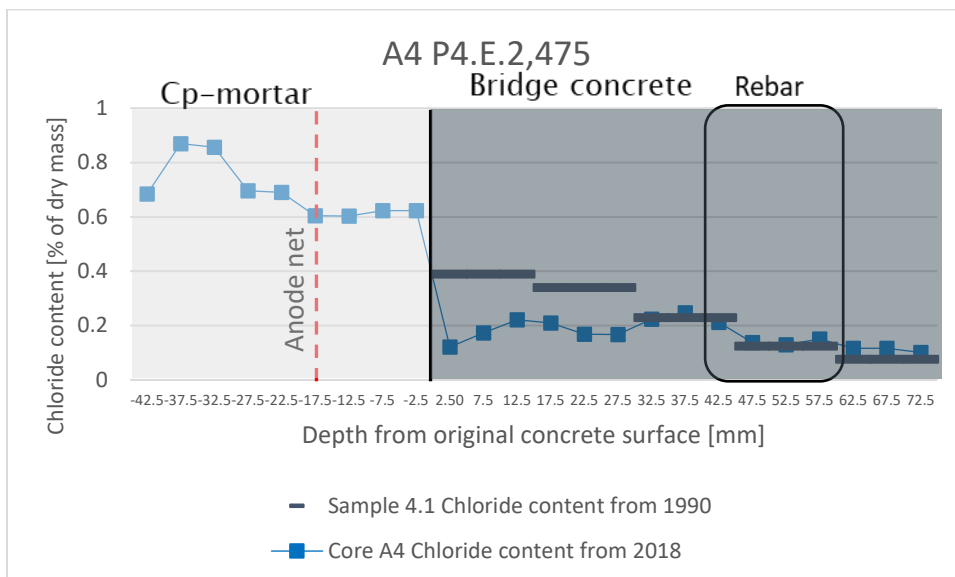
Figure 5-8 Chloride content core A4

The graph in Figure 5-8 shows a massive drop in chloride content when going from the CP mortar into the bridge concrete. There has been a great reduction in the outer 30mm of the bridge concrete. It seems that the chlorides in front of the rebars have been affected, but not the ones behind. Inaccuracies in measurements regarding the placement of the graph and rebar could result in that the small top slightly in front of the rebar, as it presumably should be on the front of the rebar.

It is interesting to note that the chloride content in the CP mortar is almost level from - 27.5 mm to -2.5 mm. There seem to be at max close to the surface and then a declining chloride graph to the anode net, then an almost flat line until the drop into the bridge concrete. Inside the CP-mortar it seems that the chlorides don't migrate towards the anode net but rather build up evenly throughout the mortar.

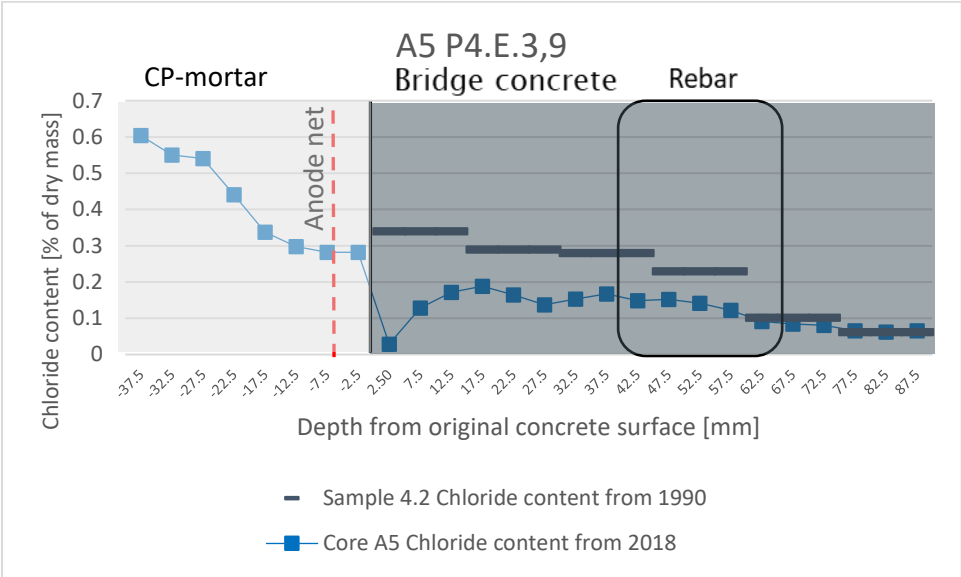
Figure 5-9 Chloride content core A5

The observations in Figure 5-9 of core A5 are similar to the ones from A4 and Figure 5-8. The area where the chlorides from the concrete has been removed is larger, even though the rebars are closer to the surface. The observed rebar in this sample is a main bar and there should be cross reinforcement and stirrups on the outside of the observed rebar if the core had cut through the stirrups.

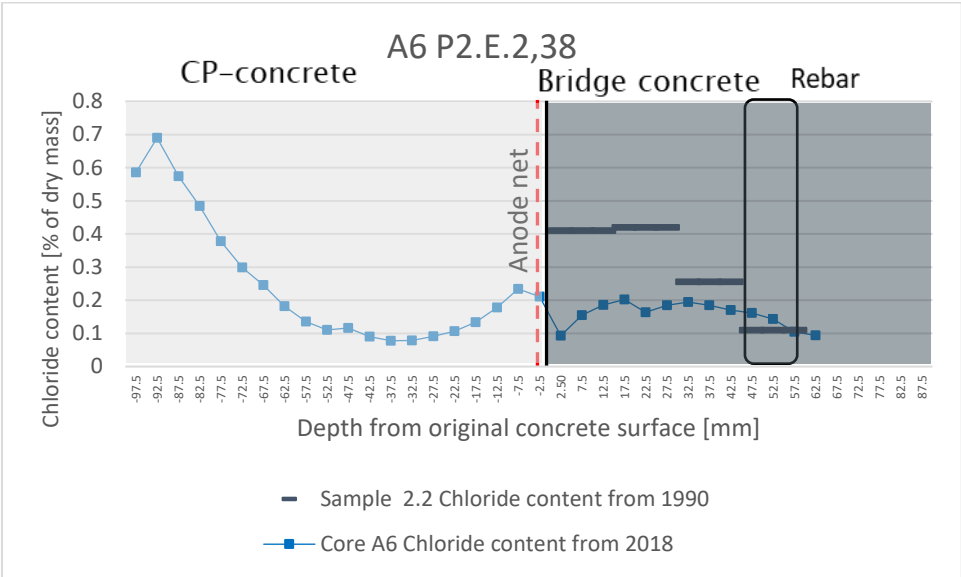
Figure 5-10 Chloride content core A6

The graph of A6 in Figure 5-10 shows a drop of chloride content in the outer most layer of the bridge concrete. The ingress from the outside and the ingress from the underlying concrete can be seen clearly. It is apparent that a lot of the chlorides have moved out of the bridge concrete and into the CP-concrete as the content is much lower in sample A6

than in sample 2.2. Most likely the chloride content at the rebars were similar in 1990 to the levels now. With such coarse levels it is difficult to determine where the line would go if the grindings were finer.

Much of the chlorides in the CP-mortar must have entered from the outside. This is apparent from the cores with such a long distance that the fronts, from the inside and outside, haven't met yet (Figure 5-10 and Figure 5-11)

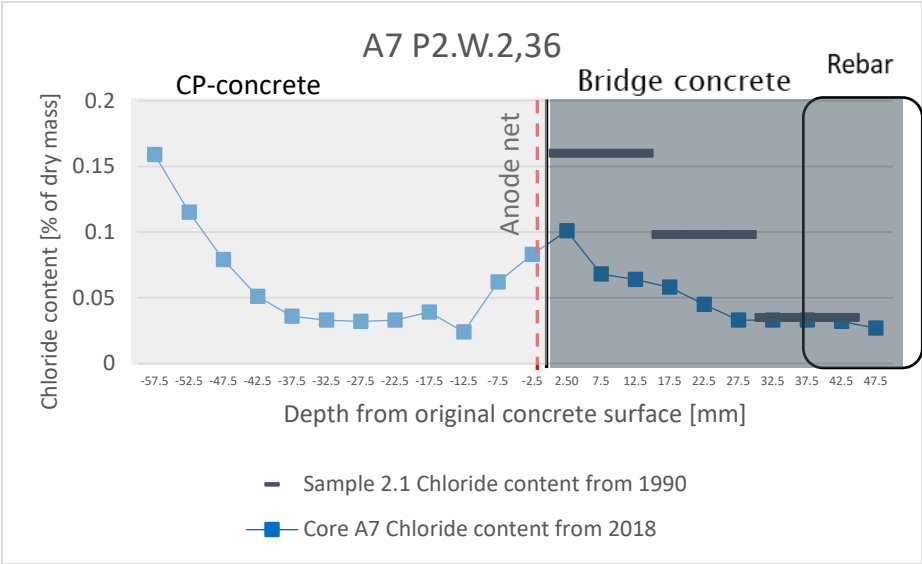
Figure 5-11 Chloride content core A7

Figure 5-11 shows the graph of A7 which is similar to A6, but the scale is much lower, because A7 is taken from the western side of pillar 2 and A6 from the eastern side. The chlorides that have moved from the bridge concrete have moved from the area more than 10mm in front of the rebars. The chloride peak is in the bridge concrete. This can be an error in where the graph is placed compared to how it is.

case for the collected samples. Except A7 (from 2.36m at the eastern side of pillar 2 with casted concrete) (Figure 5-11) which seem to be more like the profiles from the quay in Oslo (Rodum and Lindland 2012) after 5 years (Figure 3-3).

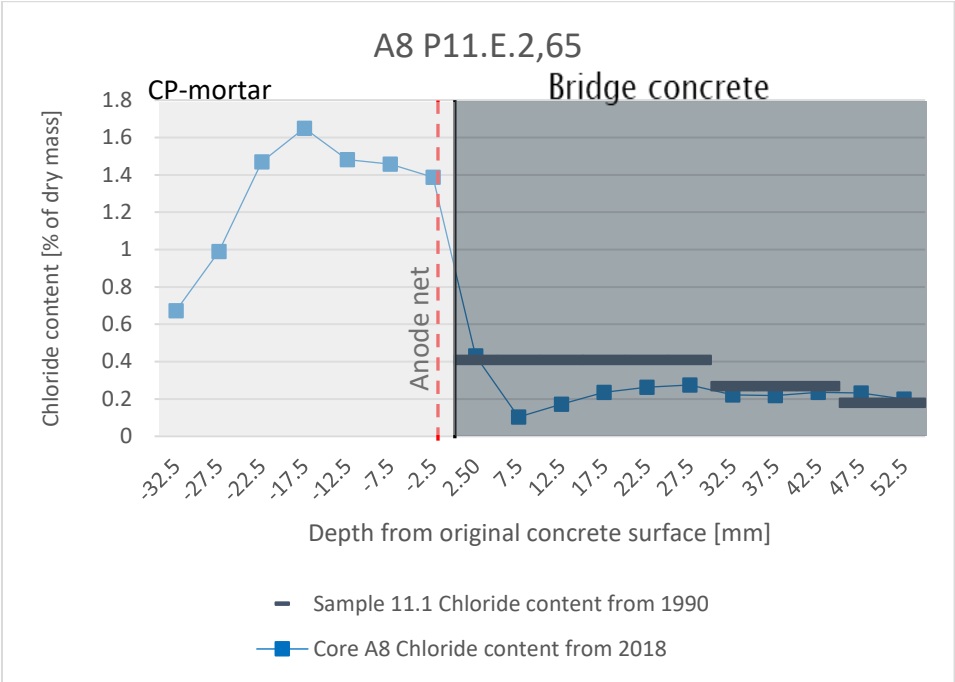
Figure 5-12 Chloride content core A8

Figure 5-12 shows a drop of chloride content from the CP-mortar to the bridge concrete in core A8 that is large. In comparison to the other graphs the drop here is not as steep,

as the point 2.5mm is higher than 7.5mm. This may be a result of the core breaking at the interface between the bridge concrete and CP-mortar that may have caused inaccuracy in measured layers compared to grinded levels.

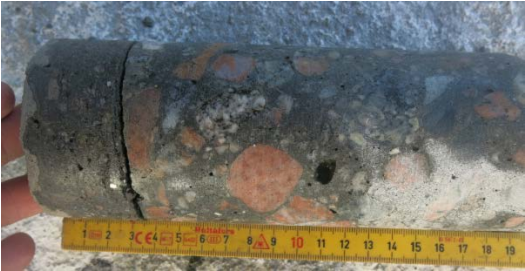
Figure 5-13 core A8 broken at the CP-mortar and bridge concrete interface

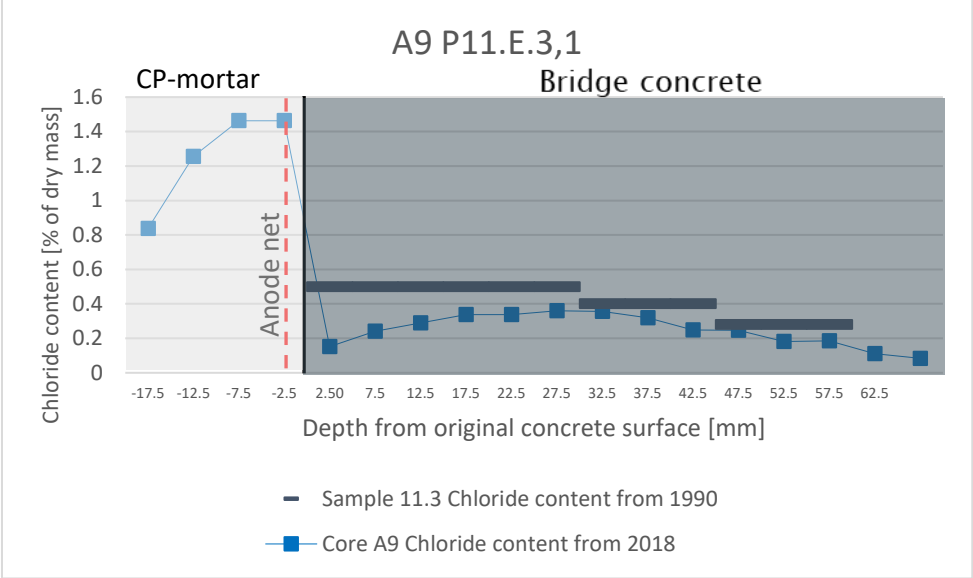
Figure 5-14 Chloride content core A9

The graph for core A9 is shown in Figure 5-14. The drop of chloride content is big when going from the CP-mortar to the bridge concrete. A significant amount of chloride has moved from the bridge concrete to the CP-mortar. It seems there have been little movement from the area where the reinforcement should be.

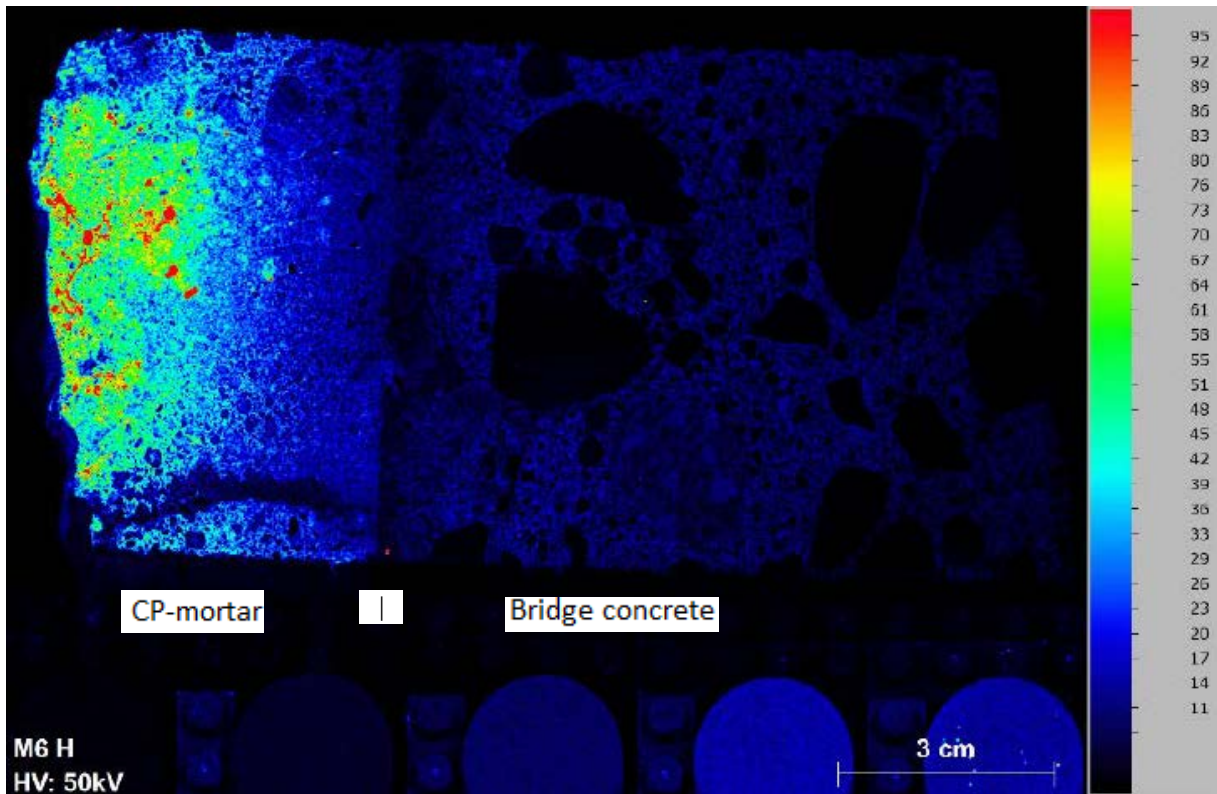
Figure 5-17 chloride mapping using μ -XRF scan on core M6

While studying the μ -XRF images from core M6, the crack discovered before cutting the core shown in Figure 4-15 became apparent and is clearly visible in Figure 5-17 in the bottom left corner. In the crack there was small amounts of chlorides compared to the surroundings. The crack can also be observed in the silica (Appendix E) and sulphur scans (Figure 5-27 d)), but all the other elements that was mapped show no signs of a crack.

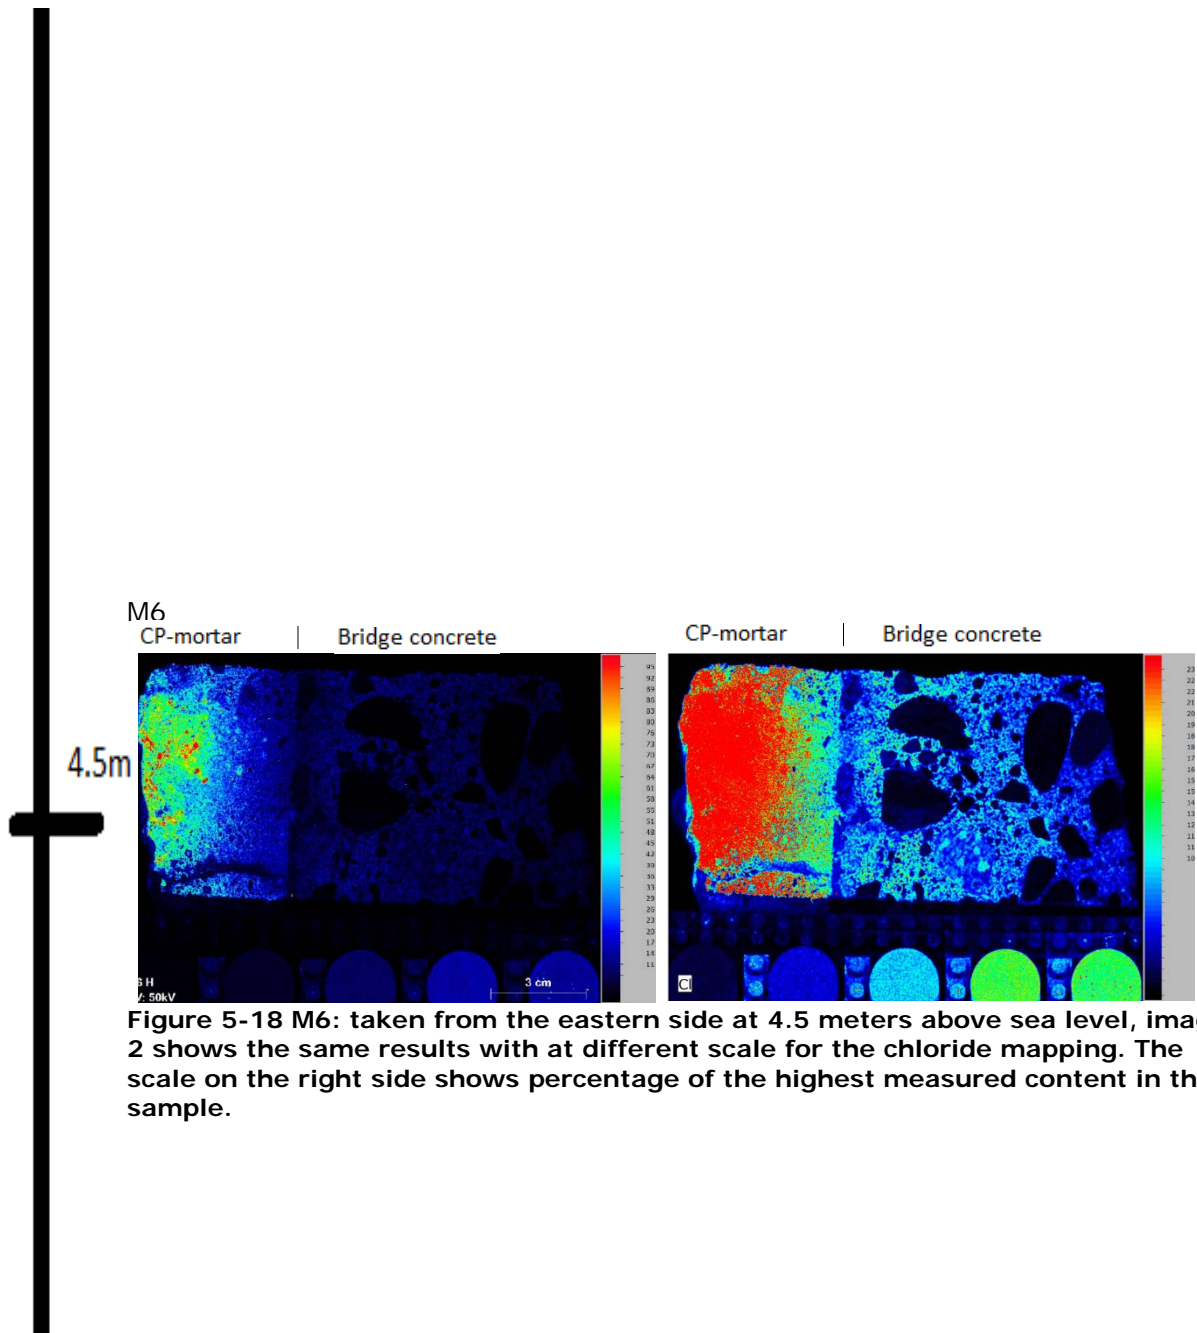
Figure 5-18 M6: taken from the eastern side at 4.5 meters above sea level, image 2 shows the same results with at different scale for the chloride mapping. The scale on the right side shows percentage of the highest measured content in the sample.

Several of the μ -XRF scans show similar tendencies as the grinded chloride profiles. This is easiest to see in the rescaled version of M6 (Figure 5-18). Where the area adjacent to the CP-mortar has low chloride content, while the levels increase further into the concrete before decreasing again.

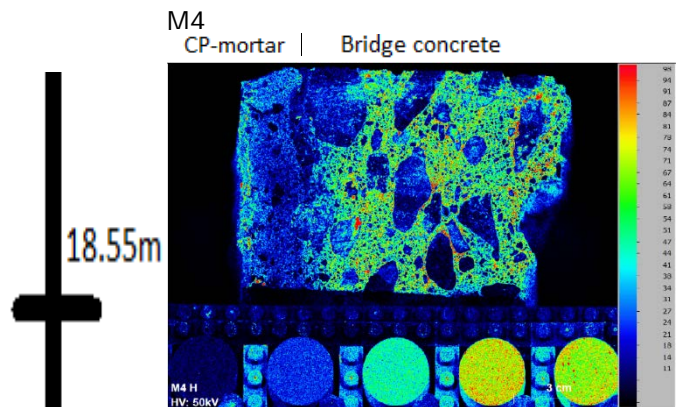
Figure 5-19 M4 taken from the Northern side at 18.55 Meters above sea level

M4 (Figure 5-19), which hadn't any current passing through it, does not show the same accumulation of chlorides in the CP-mortar as other cores and chloride profiles. There has been some penetration of the surface protection, but the inner part of the CP-mortar has almost no chlorides in it compared to the bridge mortar. This also indicates that the other cores have had migration as major contributor to the changed chloride levels since diffusion have been working on the chlorides in this core, and there have not been much movement due to it.

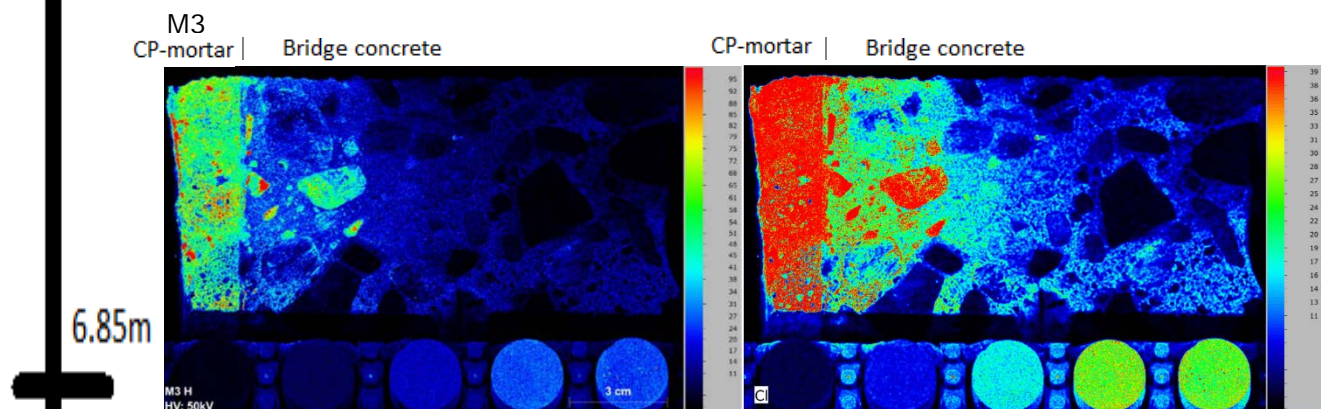
Figure 5-20 M3: taken form the northern side at 6,85 Meters above sea level, Image 2 shows the same results with at different scale for the chloride mapping. The scale on the right side shows percentage of the highest measured content in the sample.

M3 (Figure 5-20) shows high levels of chlorides on some aggregates inside the core and is possibly contamination from the cutting process (Danner 2018). There are three similar aggregates at about the same depth made out of the same material, two without chlorides and one with high concentrations of chlorides. This increases the possibility that the sample is contaminated in this area.

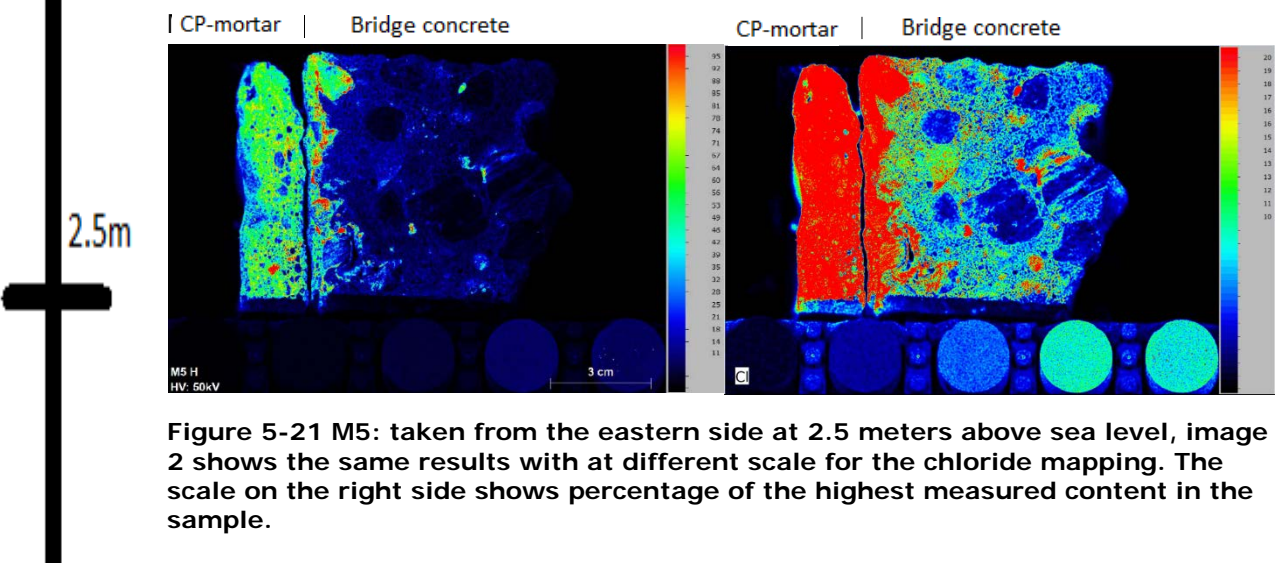
Figure 5-21 M5: taken from the eastern side at 2.5 meters above sea level, image 2 shows the same results with at different scale for the chloride mapping. The scale on the right side shows percentage of the highest measured content in the sample.

The μ -XRF scan for chlorides of M5 (Figure 5-21) show different results than the rest of the scans and the chloride profiles. There are accumulated chlorides in the outer part of the bridge concrete and in the CP-mortar, the concentration is somewhat higher in parts of the bridge concrete. This ingress into the bridge concrete is likely due to the delamination of the CP-mortar and sea water saturating the gap. The core is from an area 2.5 meters above sea level, so waves and spray should easily have reached the area providing chloride rich moisture. When the water dries up the chlorides remain, and the concentration increases. However, the part of the bridge concrete where the concentration is highest is also the part that is carbonated. And since the carbonated concrete can't contain many bound chlorides it is puzzling that the chlorides haven't moved out of this strip as suggested earlier. There is a possibility that there has been some sort of electric contact between the bridge concrete and the CP-mortar. This could have caused some migration countering the diffusion wanting to move the chlorides further into the concrete. Since there haven't been direct connection between the bridge concrete and the CP-mortar the chlorides haven't moved into the CP-mortar from the carbonated concrete.

There is a probability that there are areas with delamination that was not discovered during these investigations. One of the sampled cores (M5 Figure 5-21) has delamination, it was not certain that the area had been delaminated before the thin section investigation observed carbonatization at the bottom of the mortar. This proves that detecting all the delaminated areas can be difficult without destructive investigations and there can be more areas where the mortar has delaminated that was not discovered.

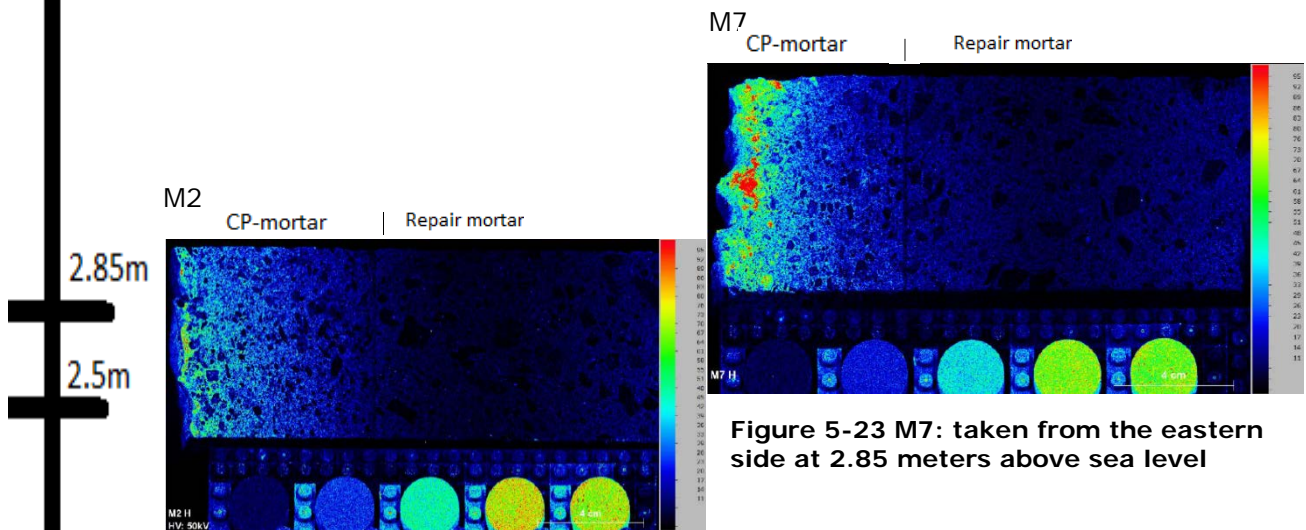
Studying the chloride ingressions makes it apparent that core M2 and M7 (Figure 5-23 and Figure 5-24) both consists of repair mortar and not original bridge concrete. It could also have been assessed by the size of the aggregates, but it was not expected that the repair would had gone as deep as the cores, as they were 210mm and 180mm long respectively. The scans show that there is not much chlorides in the middle of the extracted cores. There is a lot of penetrated chlorides in the front of the CP-mortar, but towards the right side the amount starts to increase again. This must be chlorides from the original bridge concrete that has diffused into the repair mortar. The low levels of chloride are puzzling, as this core is taken from the eastern side of the pillar, it should not have been subjected to much rainwater or other effects to wash out chlorides, the surface protection may still be intact.

Figure 5-24 M2: taken from the eastern side

Figure 5-23 M7: taken from the eastern side at 2.85 meters above sea level

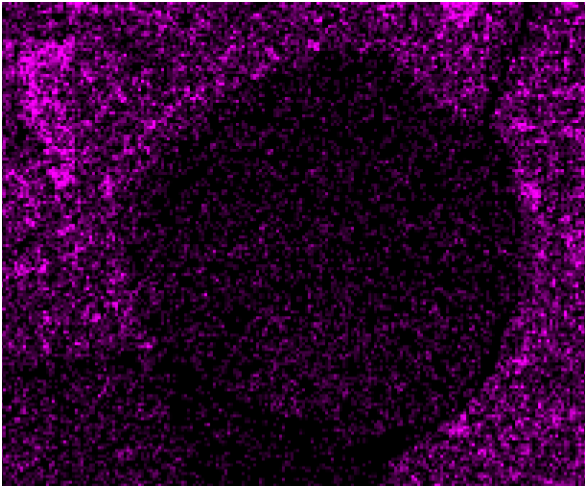
Figure 5-26 closeup of rebar imprint M8, shows a slight accumulation of sodium at the front of the rebar.

the rebar facing the anode net when scanning for sodium. These dots do not seem consistent with the spread of sodium through the rest of the core. There are aggregates with higher concentration of sodium throughout the core, but not much in the cement paste. If there has been any migration of sodium it is expected small amounts as they need to be dissolved in water to migrate (Andrade 1993). The accumulation of sodium can be an additional sign that migration is taking place even though there has been a low current working over time.

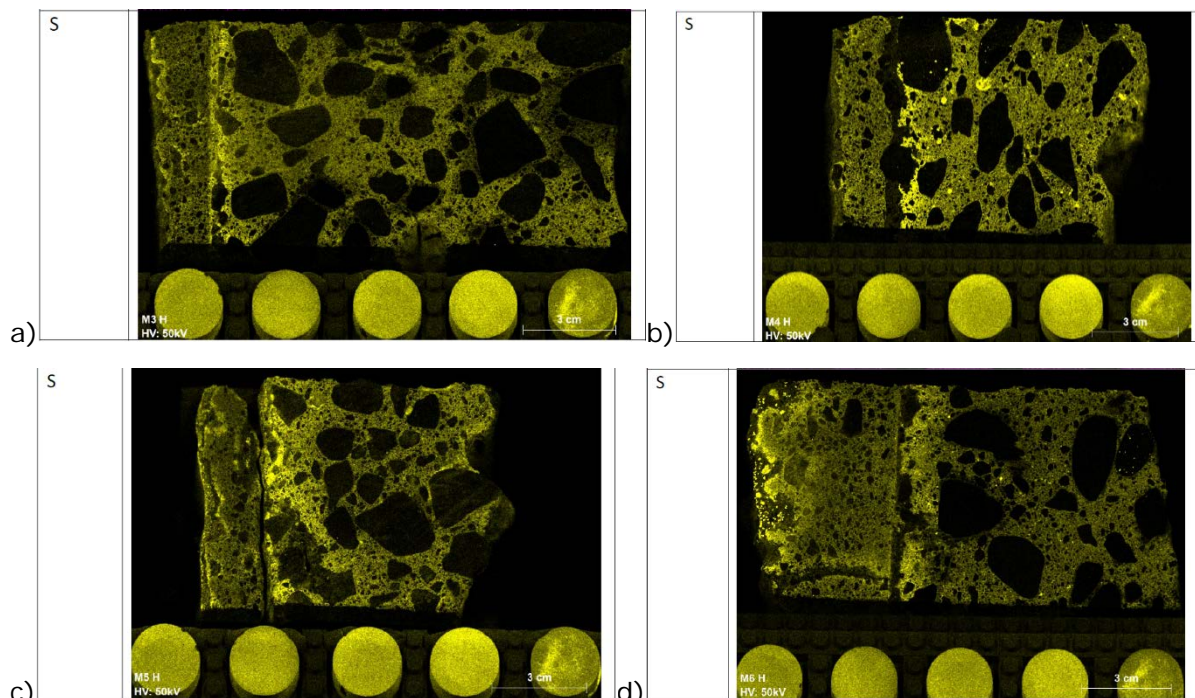
Figure 5-27 Sulphur scans of cores. a)M3 b)M4 c)M5 d)M6

There is sulphur present in all the cores, especially in cores M3, M4, M5 and M6 Figure 5-27. As sulphates are present in sea water it is likely that the accumulations are from sea water since both the original concrete surface and the surface of the CP mortar has accumulation. The cores with sulphur accumulation do not have repair-mortar, the roughness of the sulphur in M4 Figure 5-27 b) may be a result of hydro demolishing of the surface for better bond for the CP-mortar.

There is sulphur present in all the samples, with high concentration towards the interface between CP-mortar and bridge concrete for many of them (Figure 5-27). Due to the conditions there is a possibility of thaumasite formation in the interface between the CP-mortar and the bridge concrete. Though there is silicon and calcium in thaumasite the amount of these elements is expected to appear at the same rate as the rest of the concrete. However, there is not discovered thaumasite in the air voids from the thin section investigations. To identify thaumasite in the paste different investigations have to be made, such as SEM-EDX (Jakobsen 2019).

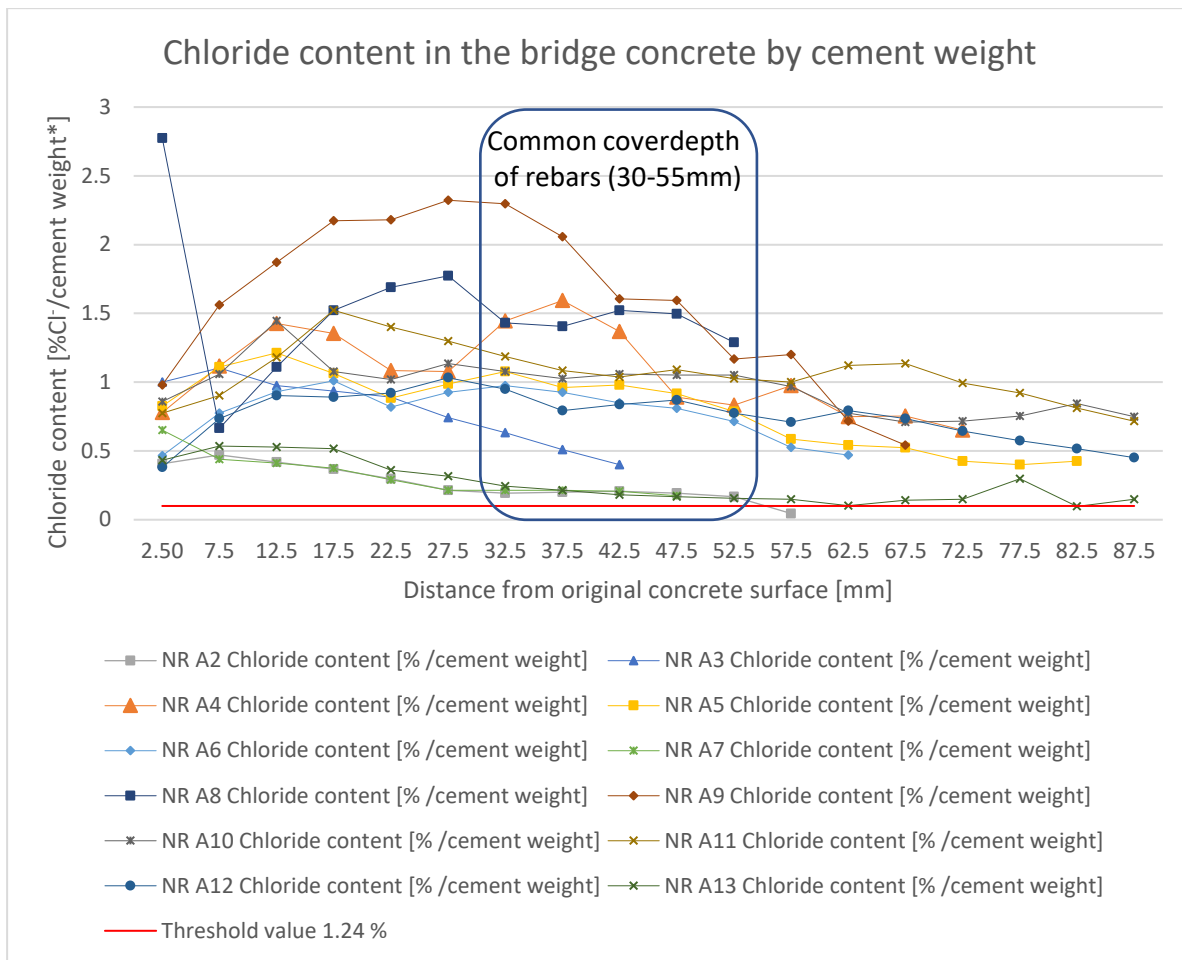
Figure 6-2 Chloride levels by cement weight compared to threshold value for steady corrosion.

Even though the chloride levels are lowered at the reinforcement it is not lowered to a point where it is certain that corrosion will stop propagation 0.1% (Figure 2-8) (Bertolini 2013) for any of the rebars. For the values below the red line in Figure 6-2 corrosion will stop without CP. However, local concentrations might be higher as there can be variations within the layer grinded for each point in the graph (5.3.2). The chloride levels have seemingly not been lowered to a point where the concrete can be considered healed.

The observed reduction in chlorides content is not enough to be able to turn off the current as suspected in chapter 3.3. To be able to turn off the current, all the chloride levels must be below common threshold level depicted in Figure 6-2 and Figure 2-8. It is recommended to further monitor the installation and reduce the current if the criteria given in 4.1.5 for CP can be met with then new current. This allows for less stress on the anodes and can possible prolong the lifetime of the installation.

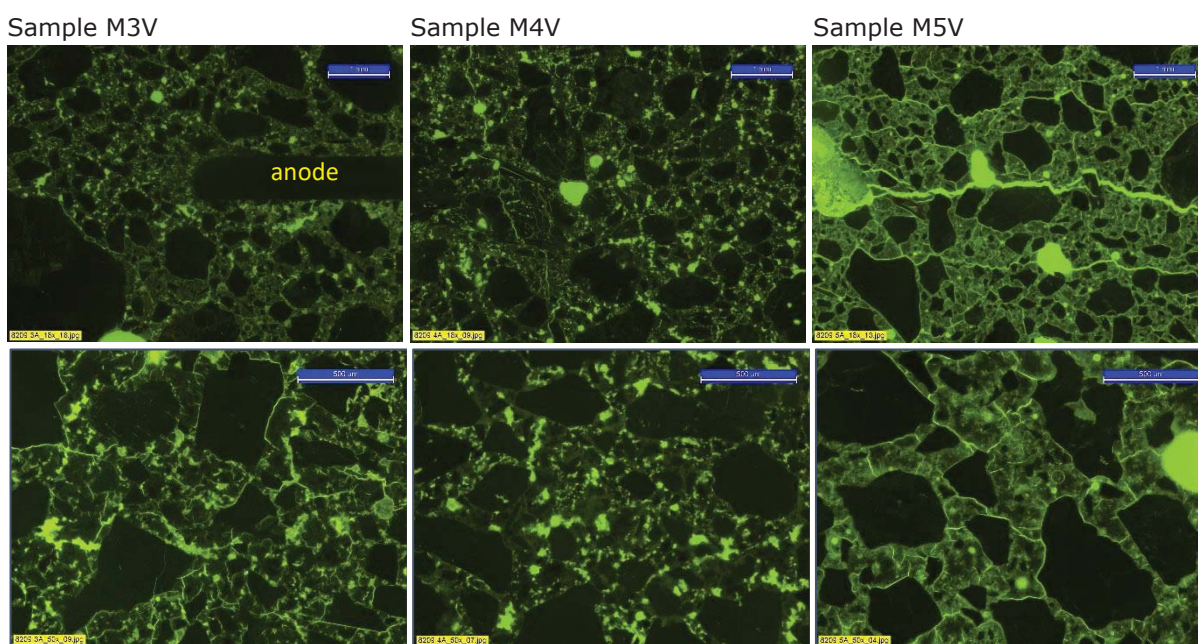
The microstructure of the KB mortar is not similar in the 3 samples (Figure 1). In samples M3V and M4V the paste appears with a very dark green color in fluorescent light mode, indicating that the apparent capillary porosity is very low. Contrary the capillary porosity is distinctly higher in sample M5V. In this sample also, the air content of the KB mortar is different from the two other samples; it is low and only few rounded voids are present. In sample M3V and M4V a high number of small irregular shaped voids are present in the KB mortar. Micro-cracks are abundant in sample M5V and to a certain extent also in sample M3V. Almost none of these cracks are observed in sample M4V, the sample where the anode net was disrupted (Figure 1). Vertical fine cracks are seen traversing through the KB mortar in all samples.

Figure 1: Typical appearance of the KB mortar seen in 16x and 50x in fluorescent light. The paste in M3V and M4V appears rather dark green with a high number of irregular shaped voids. Contrary the paste in sample M5V is lighter green and with only few, and rounded voids. A high number of micro-cracks are present in sample M3V and M5V; almost none in sample M4V.

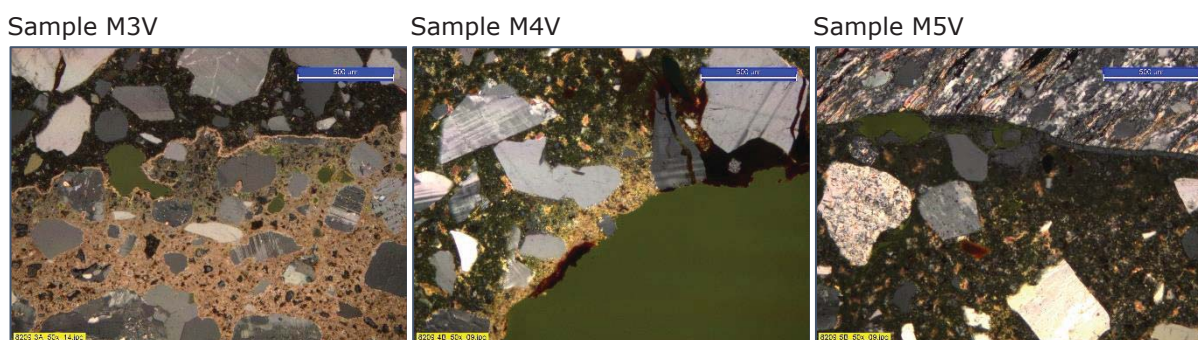
The cracks close to the rebar imprint form M5 are filled with alkali silica gel, this is the only spot with observed ASR from all the cores examined by thin section. There was not discovered ASR in the imprint of the rebar from M4 (Jakobsen 2019).

Figure 3: Observations in the bridge concrete. De-carbonation of the carbonated surface is observed in sample M3V. Carbonated paste as well as rusty material is observed in the imprint of sample M4V, and alkali silica gel is present in cracks around the area of a rebar in sample M5V.

In sample M4V, the paste around the rebar and the paste of the bottom of the section (bottom of core) was carbonated. Rusty material was observed lining the imprint and in several cracks related to the corroded rebar (Figure 3).

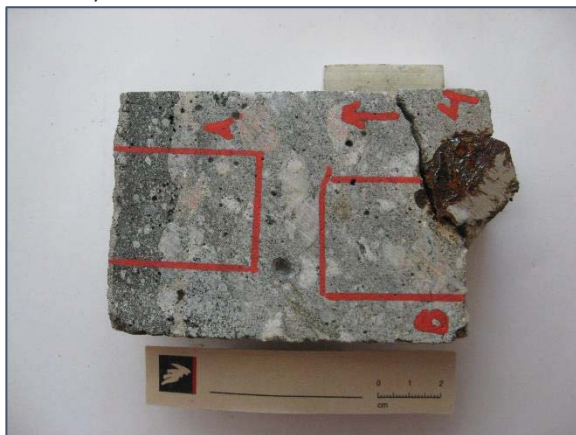
Core M4: No power on anode. Highly corroded rebar is seen in the bottom of the core. Cracks with rust is present around the rebar.

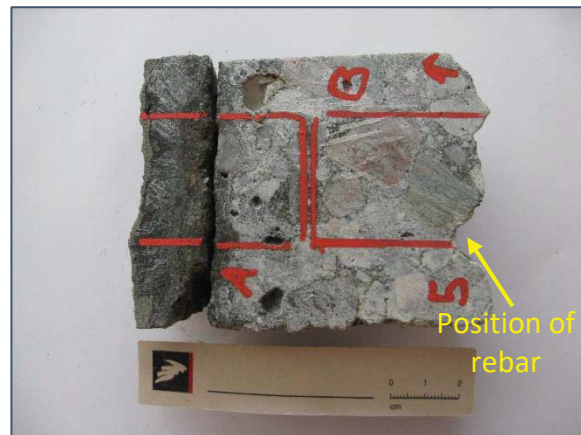
Core M5: Powered anode. Core is fractured between KB mortar and concrete.

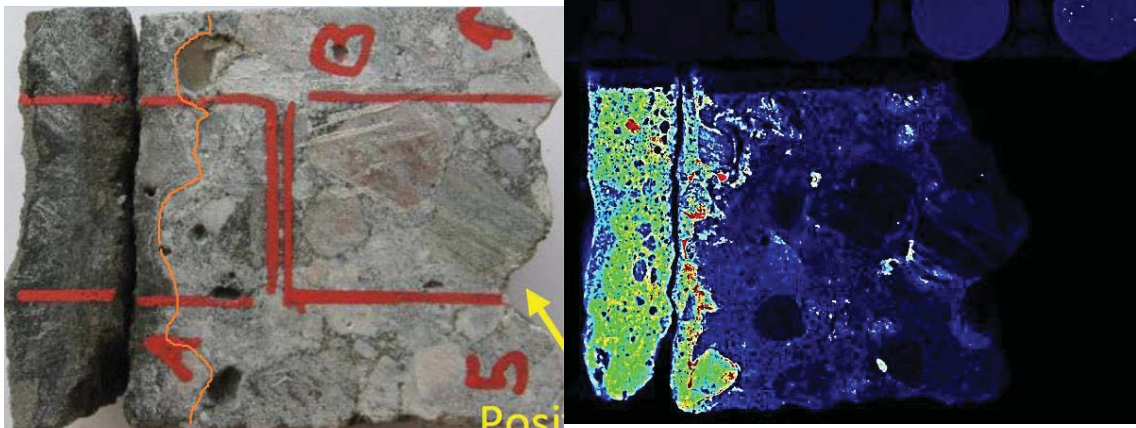
Figur 3 Front i M5 kan sees i μ -xrf skannen for klorider.

2. Det er en front med en hvit linje i betongen i M5, denne linjen ligner på μ -xrf skanningen for klorider. Det er antageligvis trukket klorider inn i dette laget fra utsiden, muligens som følge av at sprekken kan ha vært fylt opp av vann. Kan det være at det er reparasjons betong eller KB-mørtel i laget innenfor sprekken? **Nei, det er betong, dog ses ganske lidt mørtel rester på betonoverfladen, men dette kan ikke forklare dit profil. Din revne er hovedsaglit et vedhæftningsslip mellem mørtel og betong. Tror defektet er af en vis alder, derfor nok det store kloridindhold.** Med tanke på mengden klorider er det annerledes enn slik brubetongen er utsatt enn i de andre kjernene.

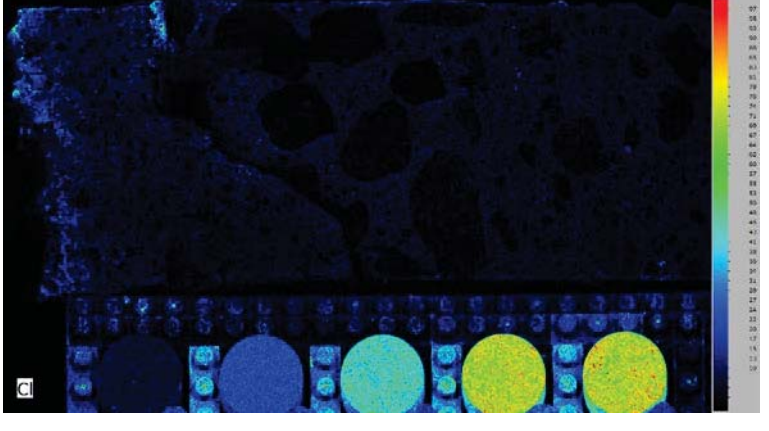
Core	Comment	Chloride ingress, normalized intensities
M1_V	<p>Broken at depth of a spacer.</p> <p>Very little chloride ingress in outermost 3 mm</p>

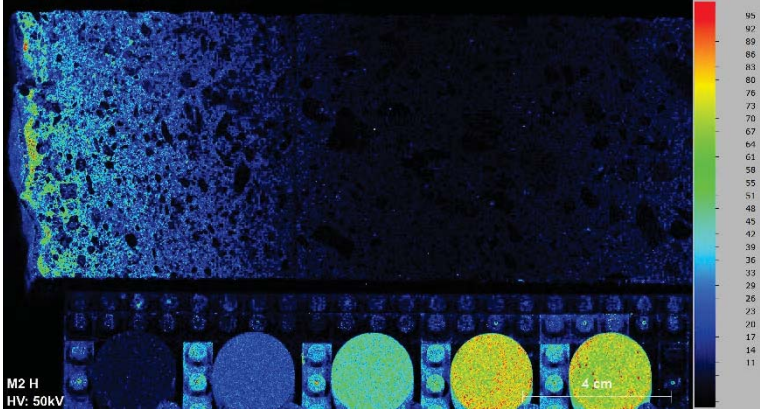
<p>Chloride ingress map for core M1_V. The image shows a cross-section of concrete with a color scale on the right ranging from 11 to 97. The outermost 3 mm shows very low chloride intensity (blue), indicating minimal ingress. A scale bar at the bottom indicates 3 cm.</p>
M2_H	<p>Some chloride ingress in the first 2 cm of the mortar on top of the concrete.</p>

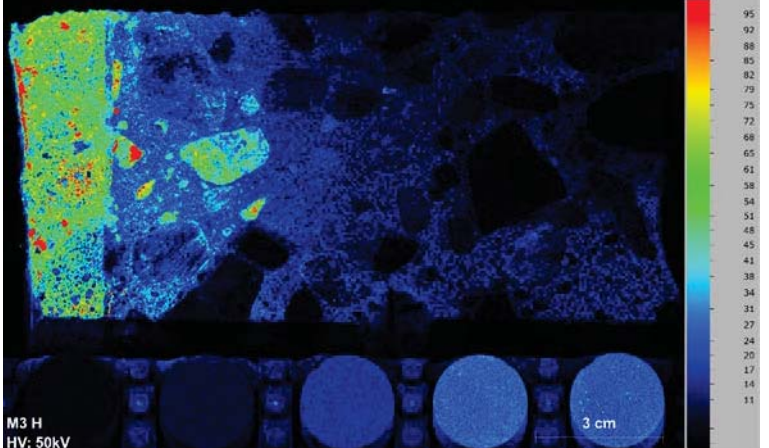
<p>Chloride ingress map for core M2_H. The image shows a cross-section of concrete with a color scale on the right ranging from 11 to 95. The first 2 cm of the mortar shows some chloride intensity (green/yellow), indicating ingress. A scale bar at the bottom indicates 4 cm. Technical details: M2 H HV: 50kV.</p>
M3_H	<p>Apparently high chloride ingress in the mortar on top of the concrete.</p> <p>Chloride contamination on aggregates, maybe from cutting process</p>

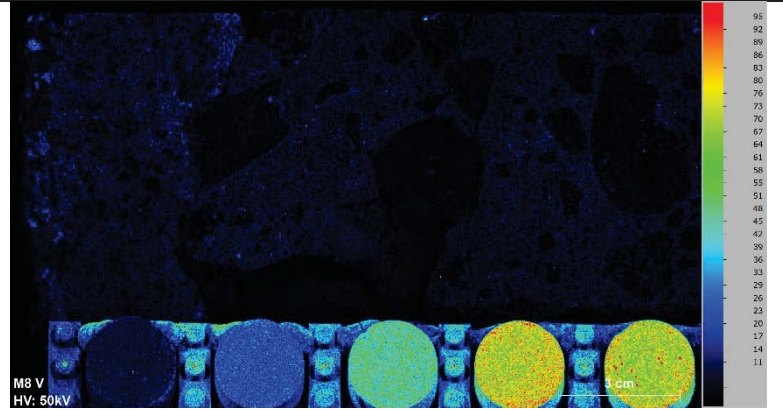
M8_V	Broken in several parts. Apparantly very low chloride ingress.
