Long-term performance of cathodic protection (CP) of marine bridge, inspection of Sortlandsbrua 27 years after CP installation

An investigation of performance and damages on the installation.

Master's thesis in Experience-based Part-time Master
programme Road and Railway Engineering
Supervisor: Mette Rica Geiker
May 2019

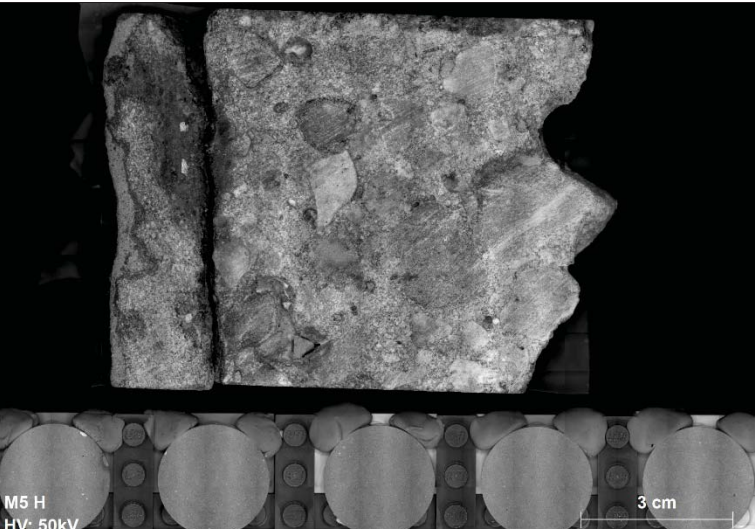
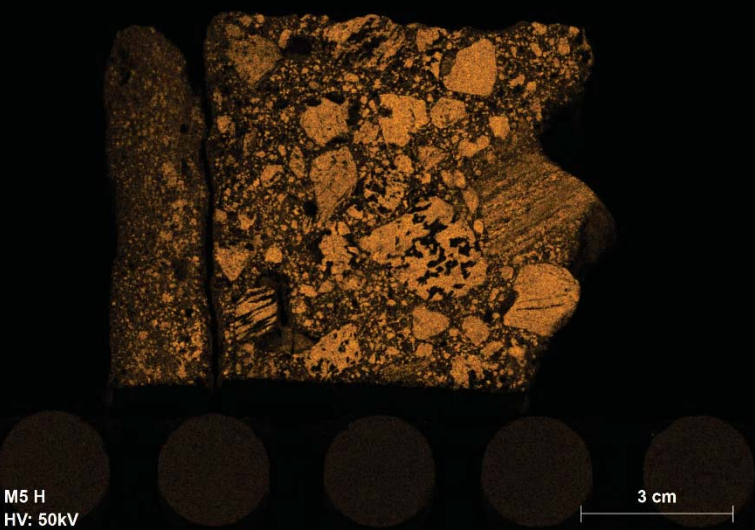
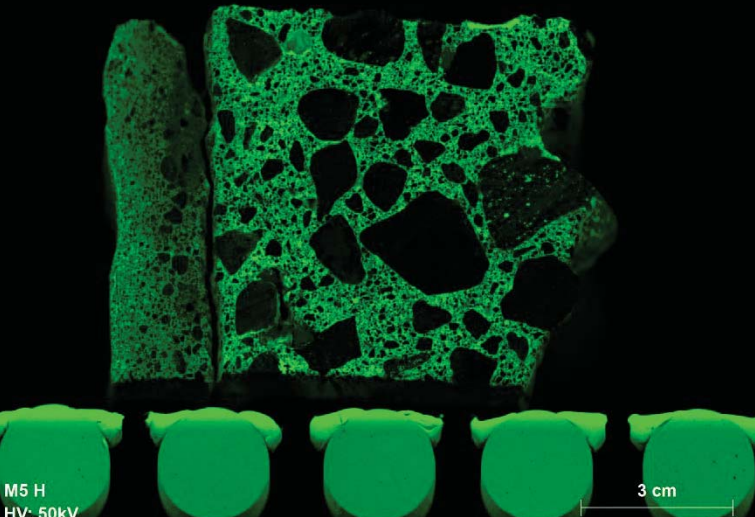
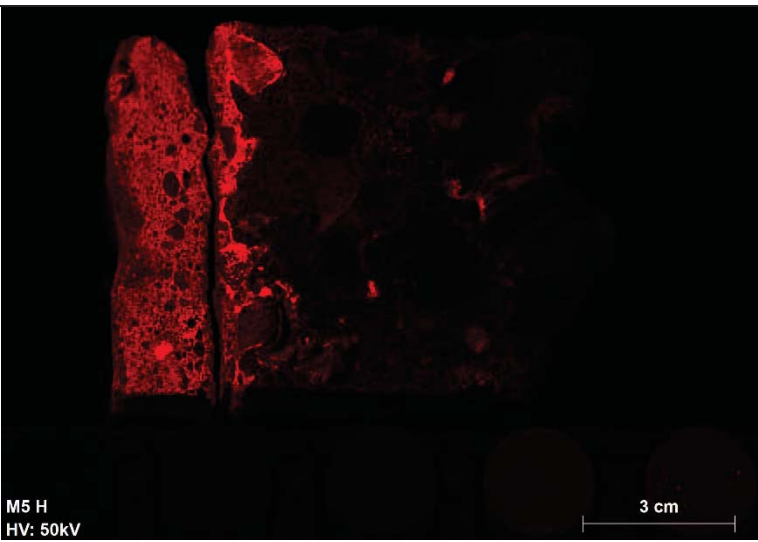
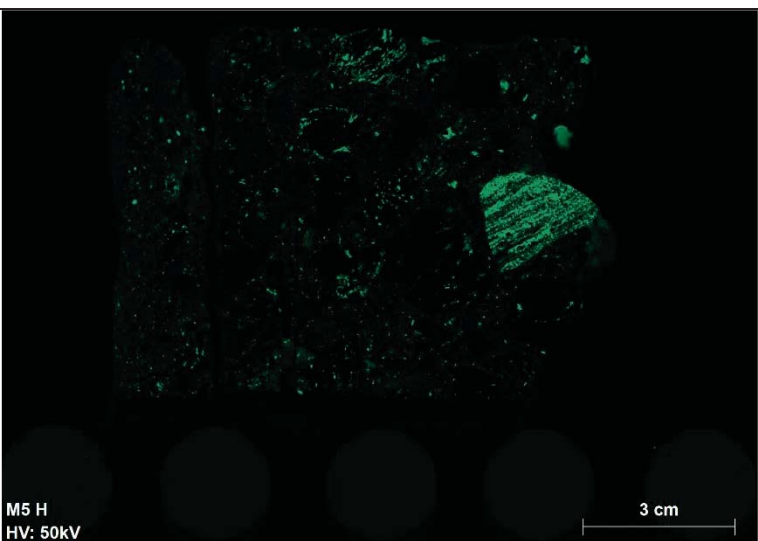
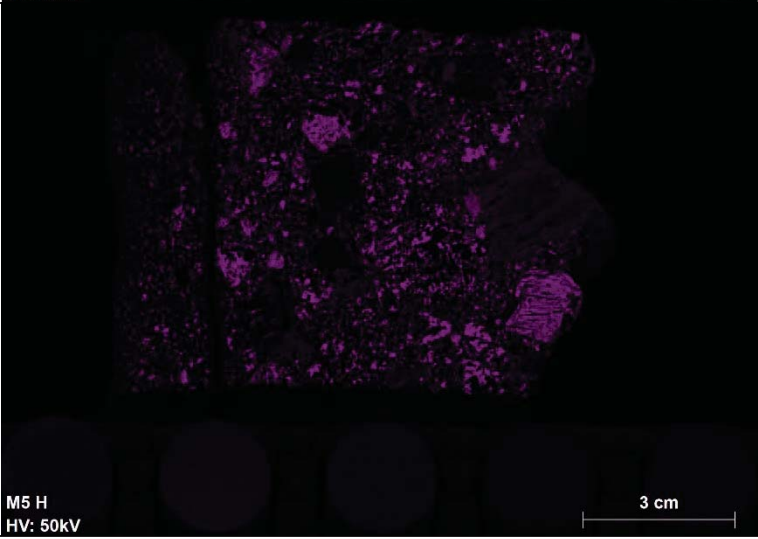
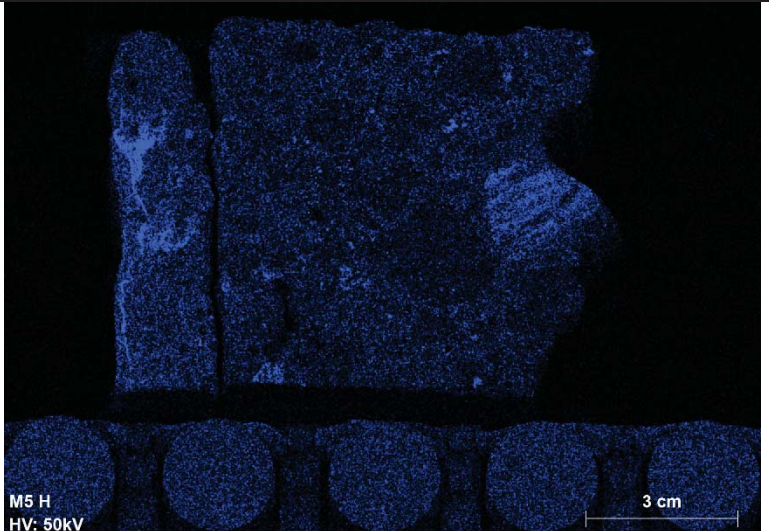
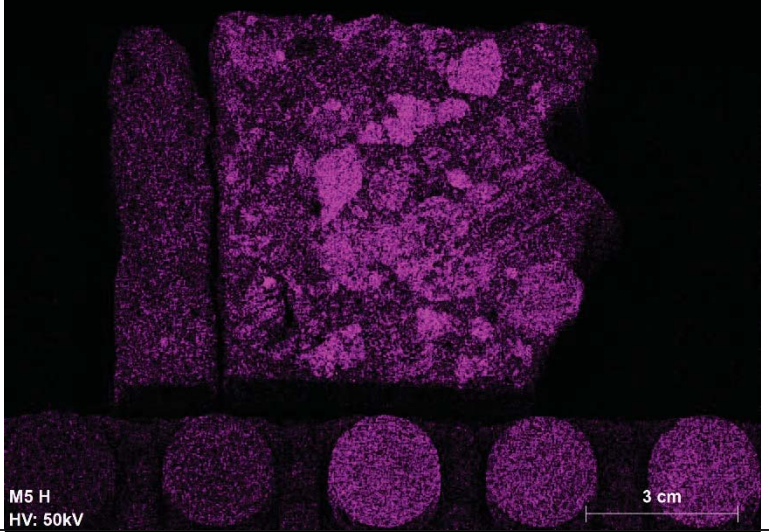
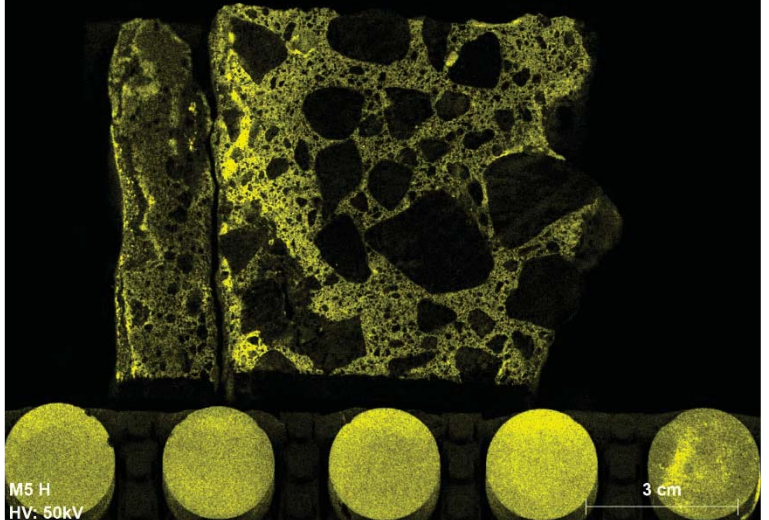
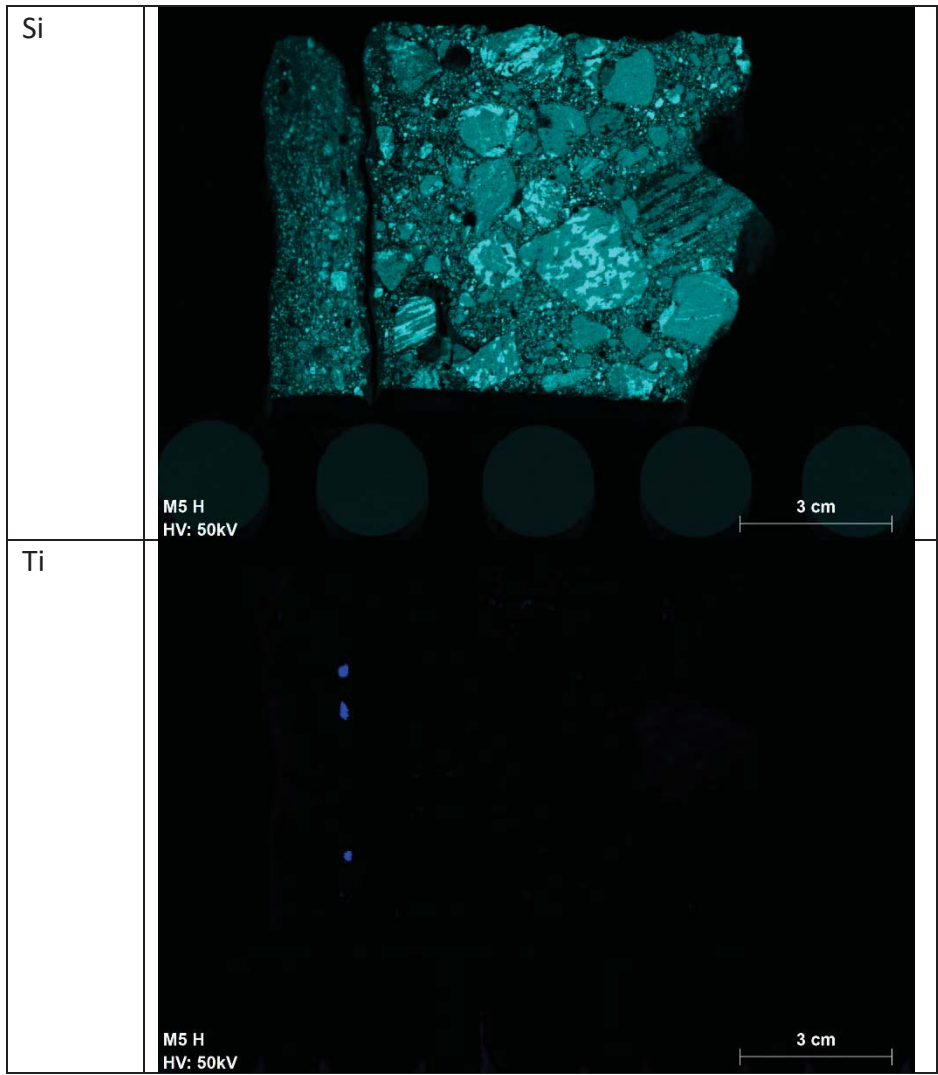
M5	
Element	Scanned Area

<p>M5_H</p>	<p>Broken at the mortar-concrete interface.</p> <p>High chloride ingress in the mortar and first cm of the underlying concrete</p>

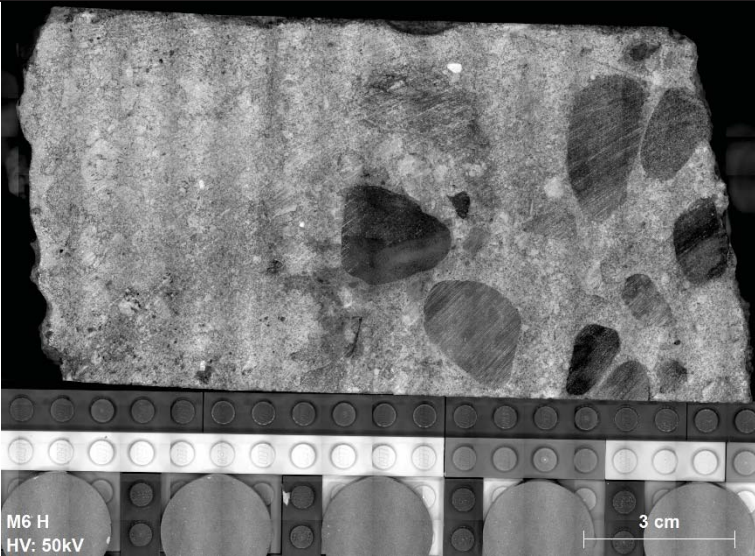
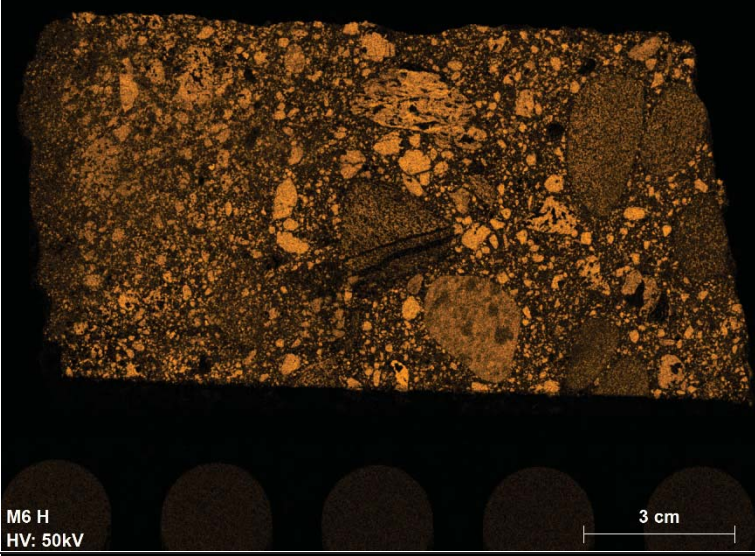
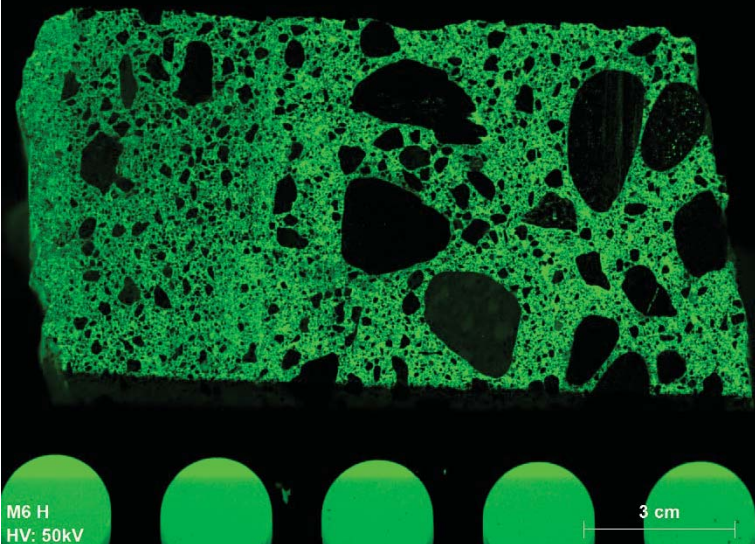
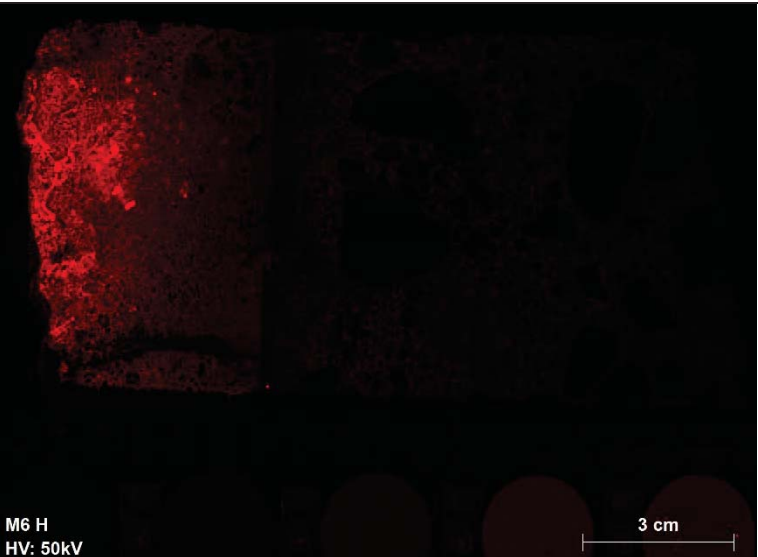
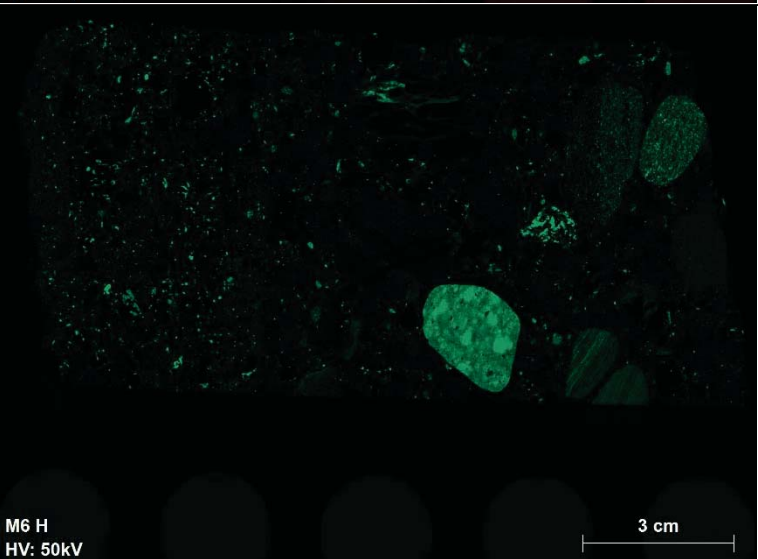
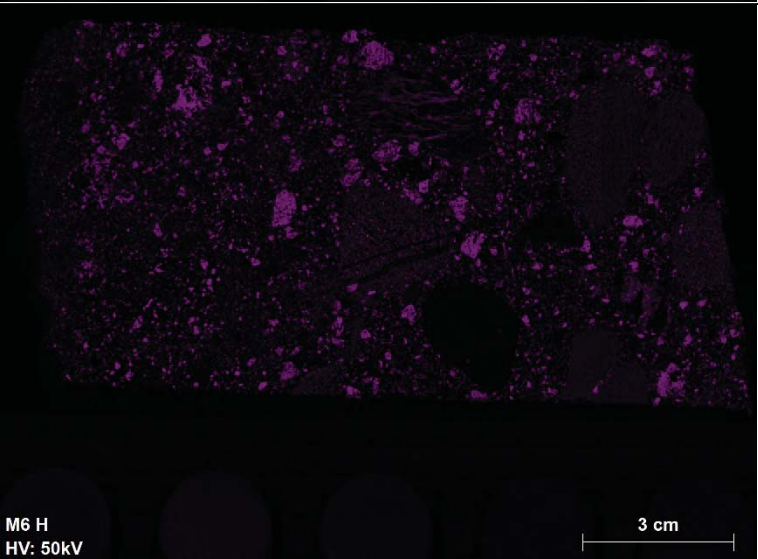
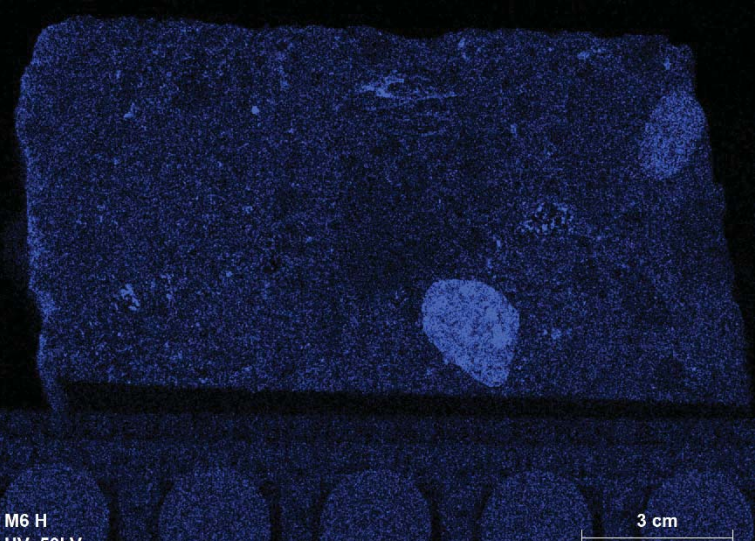
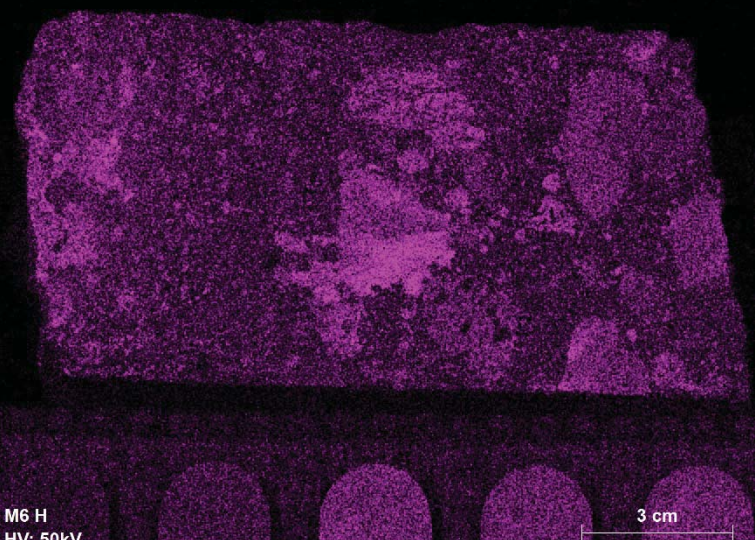
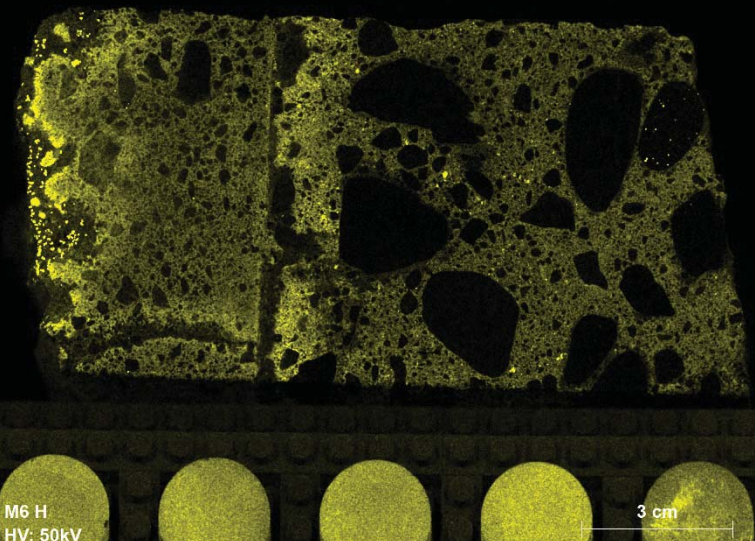
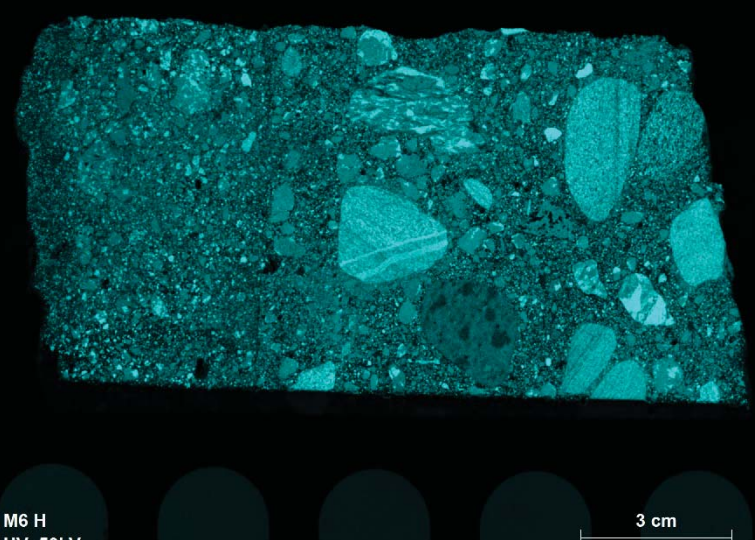
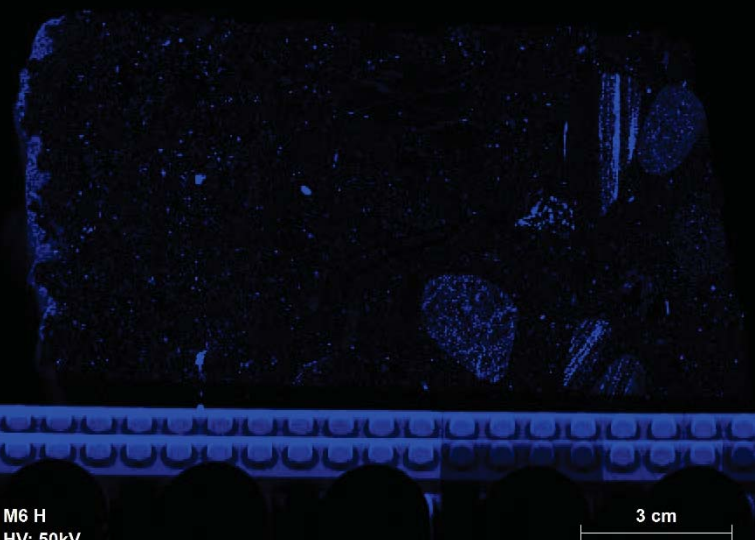
M6	
Element	Scanned Area

<p>M6_H</p>	<p>Broken at the mortar-concrete interface.</p> <p>High chloride ingress in the centre of the mortar.</p>

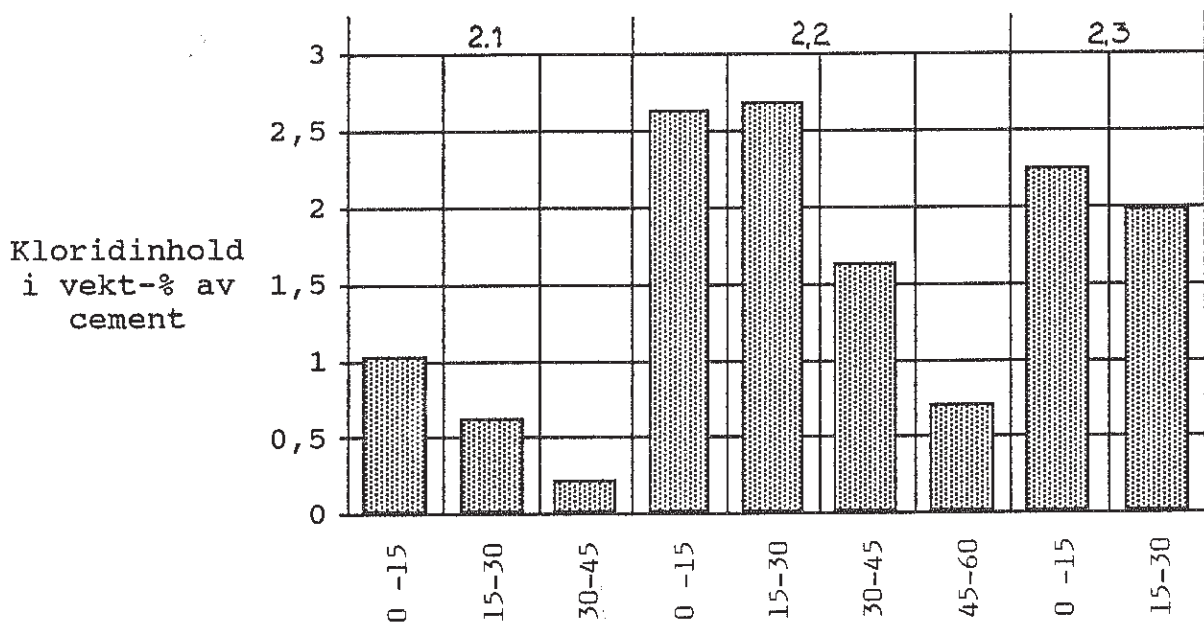
Kloridprofil pilar 2 vest og øst

RCT- MÅLINGER			Pilar nr. 2				
Nivå mm	Prøve	Dybde mm	mV	Cl-innh vekt% bet	Faktor	Cl-innh i vekt-% av sement	
360	2,1	0-15	24	0,16	6,40	1,024	Vest vegg
		15-30	36	0,098	6,4	0,6272	
		30-45	61	0,035	6,4	0,224	
380	2,2	0-15	2	0,41	6,4	2,624	Østre vegg
		15-30	1	0,42	6,4	2,688	
		30-45	13	0,255	6,4	1,632	
		45-60	33	0,11	6,4	0,704	
1300	2,3	0-15	6	0,35	6,4	2,24	Østre vegg
	2,3	15-30	8	0,31	6,4	1,984

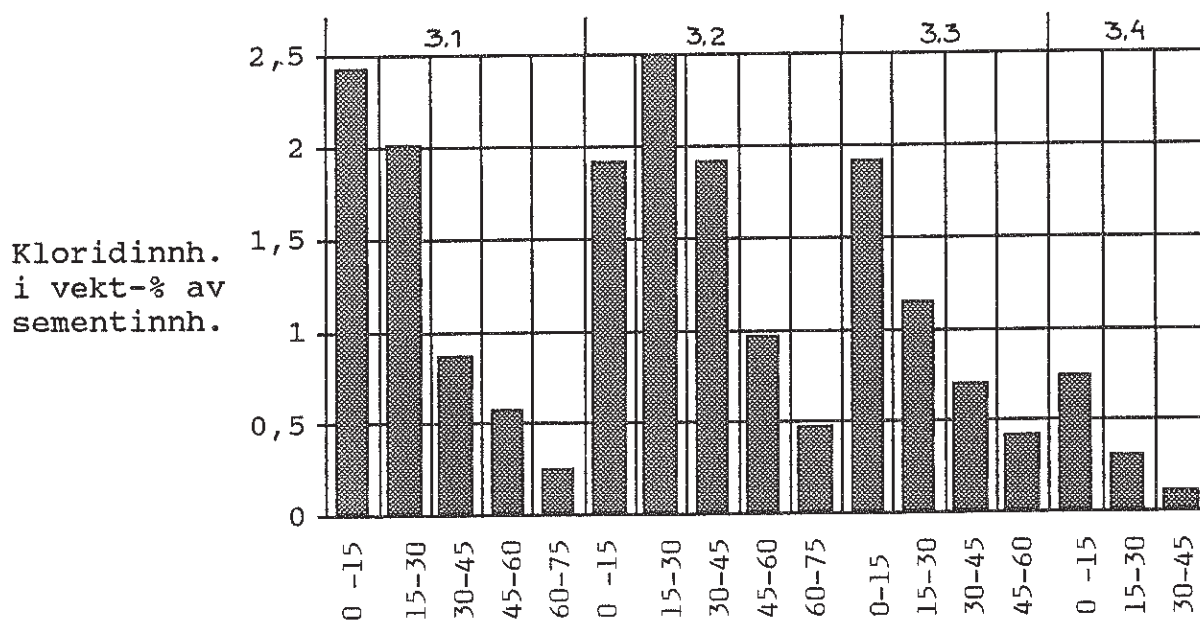
Kloridprofil pilar 3 vest

RCT- MÅLINGER		Pilar nr. 3				
Nivå mm	Prøve	Dybde mm	mV	CL-innh vekt% bet	Faktor	Kloridinnhold i vekt-% av sement
350	3,1	0-15	4	0,38	6,4	2,432
	3,1	15-30	8	0,315	6,4	2,016
	3,1	30-45	28	0,135	6,4	0,864
	3,1	45-60	38	0,09	6,4	0,576
	3,1	60-75	57	0,04	6,4	0,256
1000	3,2	0-15	9	0,3	6,4	1,92
	3,2	15-30	3	0,39	6,4	2,496
	3,2	30-45	9	0,3	6,4	1,92
	3,2	45-60	26	0,15	6,4	0,96
	3,2	60-75	43	0,074	6,4	0,4736
1500	3,3	0-15	9	0,3	6,4	1,92
	3,3	15-30	22	0,18	6,4	1,152
	3,3	30-45	33	0,11	6,4	0,704
	3,3	45-60	46	0,066	6,4	0,4224
3750	3,4	0-15	32	0,115	6,4	0,736
	3,4	15-30	53	0,048	6,4	0,3072
	3,4	30-45	74	0,018	6,4	0,1152

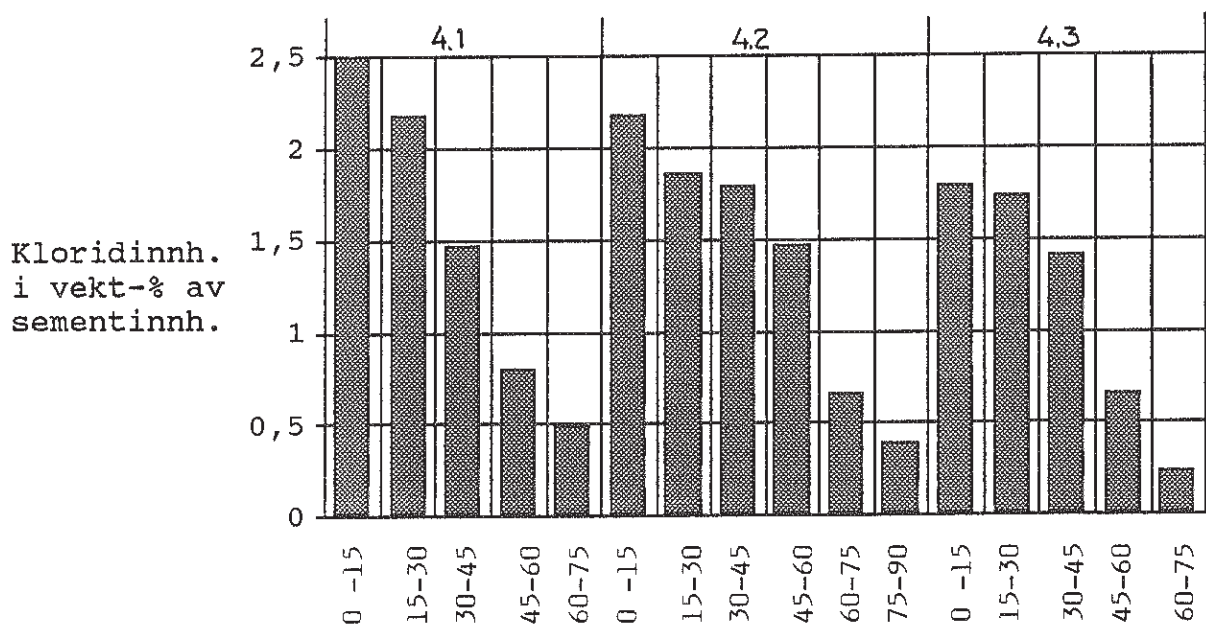
Kloridprofil pilar 4 öst

RCT- MÅLINGER		Pilar nr. 4					
	Pröve	Dybde	mV	CL-innh	Faktor	Kloridinnhold	
Nivå mm	mm	mm		vekt% bet		i vekt-% av sement	
550	4,1	0-15	3	0,39	6,4	2,496	Östre vegg
	4,1	15-30	6	0,34	6,4	2,176	
	4,1	30-45	16	0,23	6,4	1,472	
	4,1	45-60	30	0,125	6,4	0,8	
	4,1	60-75	42	0,076	6,4	0,4864	
1250	4,2	0-15	6	0,34	6,4	2,176	Östre vegg
	4,2	15-30	10	0,29	6,4	1,856	
	4,2	30-45	11	0,28	6,4	1,792	
	4,2	45-60	16	0,23	6,4	1,472	
	4,2	60-75	35	0,102	6,4	0,6528	
3000	4,3	0-15	11	0,28	6,4	1,792	Östre vegg
	4,3	15-30	12	0,27	6,4	1,728	
	4,3	30-45	17	0,22	6,4	1,408	
	4,3	45-60	35	0,102	6,4	0,6528	
	4,3	60-75	53	0,038	6,4	0,2432

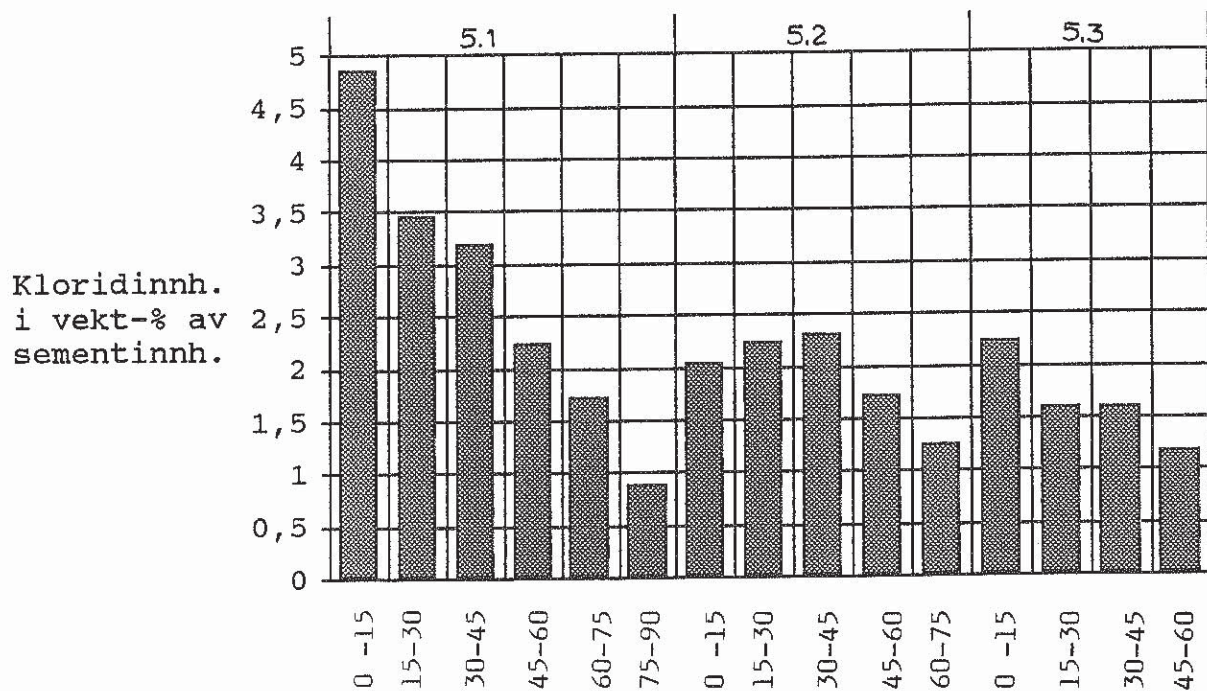
Kloridprofil pilar 5 öst

RCT- MÅLINGER		Pilar nr. 5					
	Pröve	Dybde	mV	CL-innh	Faktor	Kloridinnhold	
Nivå mm		mm		vekt% bet		i vekt-% av sement	
500	5,1	0-15	-13	0,76	6,4	4,864	Östre vegg
	5,1	15-30	-5	0,54	6,4	3,456	
	5,1	30-45	-3	0,5	6,4	3,2	
	5,1	45-60	6	0,35	6,4	2,24	
	5,1	60-75	12	0,27	6,4	1,728	
	5,1	75-90	28	0,138	6,4	0,8832	
1500	5,2	0-15	7	0,32	6,4	2,048	Östre vegg
	5,2	15-30	6	0,35	6,4	2,24	
	5,2	30-45	5	0,36	6,4	2,304	
	5,2	45-60	12	0,27	6,4	1,728	
	5,2	60-75	20	0,195	6,4	1,248	
	5,2	75-90	20	0,195	6,4	1,248	
3100	5,3	0-15	6	0,35	6,4	2,24	Östre vegg
	5,3	15-30	15	0,25	6,4	1,6	
	5,3	30-45	15	0,25	6,4	1,6	
	5,3	45-60	20	0,186	6,4	1,1904

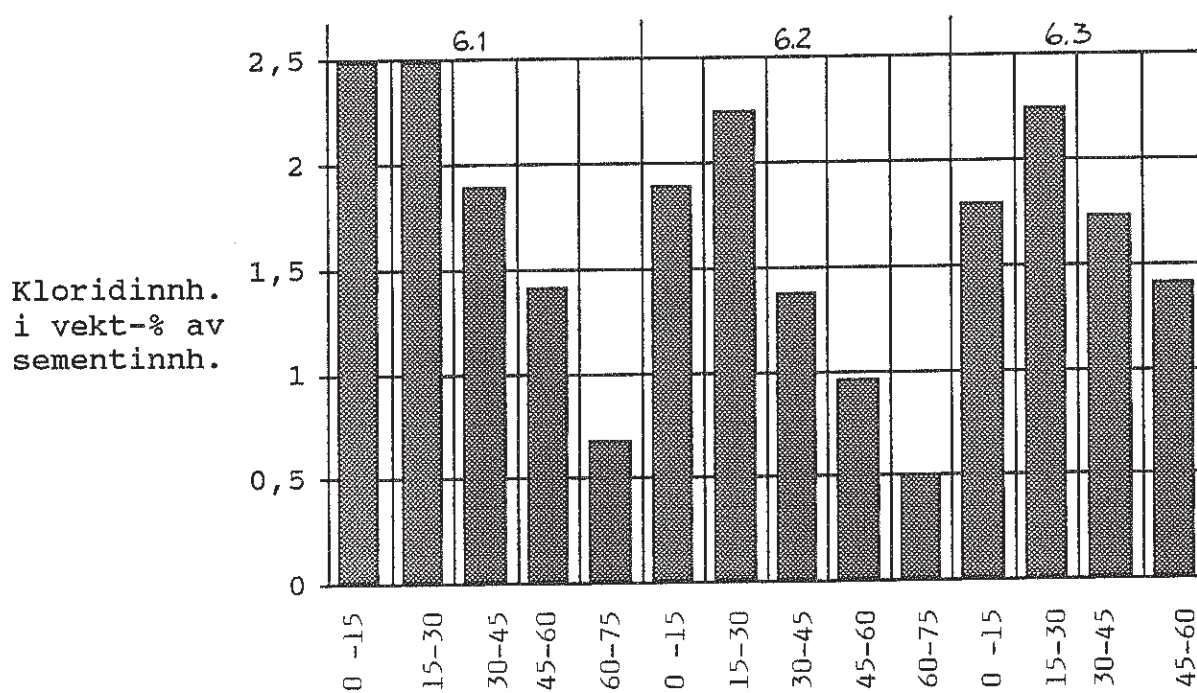
Kloridprofil pilar 6 öst

RCT- MÅLINGER			Pilar nr. 6				
	Pröve	Dybde	mV	CL-innh	Faktor	Kloridinnhold	
Nivå mm		mm		vekt% bet		i vekt-% av sement	
500	6,1	0-15	4	0,39	6,4	2,496	Östre vegg
	6,1	15-30	4	0,39	6,4	2,496	
	6,1	30-45	10	0,295	6,4	1,888	
	6,1	45-60	17	0,22	6,4	1,408	
	6,1	60-75	34	0,105	6,4	0,672	
1500	6,2	0-15	10	0,295	6,4	1,888	Östre vegg
	6,2	15-30	5	0,35	6,4	2,24	
	6,2	30-45	17	0,215	6,4	1,376	
	6,2	45-60	26	0,15	6,4	0,96	
	6,2	60-75	42	0,078	6,4	0,4992	
3600	6,3	0-15	11	0,28	6,4	1,792	Östre vegg
	6,3	15-30	6	0,35	6,4	2,24	
	6,3	30-45	12	0,27	6,4	1,728	
	6,3	45-60	17	0,22	6,4	1,408

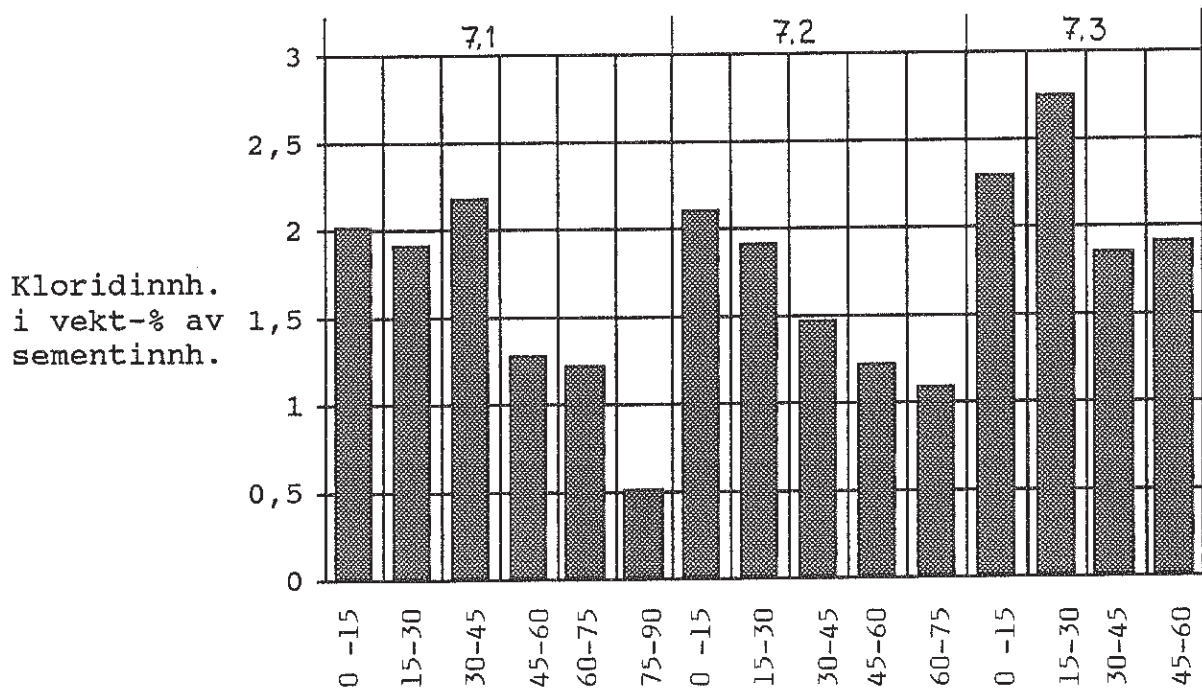
Kloridprofil pilar 7 öst

RCT- MÅLINGER		Pilar nr. 7					
	Pröve	Dybde	mV	CL-innh	Faktor	Kloridinnhold	
Nivå mm	mm	mm		vekt% bet		i vekt-% av sement	
1200	7,1	0-15	8	0,315	6,4	2,016	
	7,1	15-30	9	0,3	6,4	1,92	
	7,1	30-45	6	0,34	6,4	2,176	
	7,1	45-60	19	0,2	6,4	1,28	
	7,1	60-75	20	0,19	6,4	1,216	
	7,1	75-90	41	0,08	6,4	0,512	
2000	7,2	0-15	7	0,33	6,4	2,112	Östre vegg
	7,2	15-30	9	0,3	6,4	1,92	
	7,2	30-45	15	0,23	6,4	1,472	
	7,2	45-60	20	0,19	6,4	1,216	
	7,2	60-75	23	0,17	6,4	1,088	
3600	7,3	0-15	5	0,36	6,4	2,304	
	7,3	15-30	1	0,43	6,4	2,752	
	7,3	30-45	10	0,29	6,4	1,856	
	7,3	45-60	9	0,3	6,4	1,92

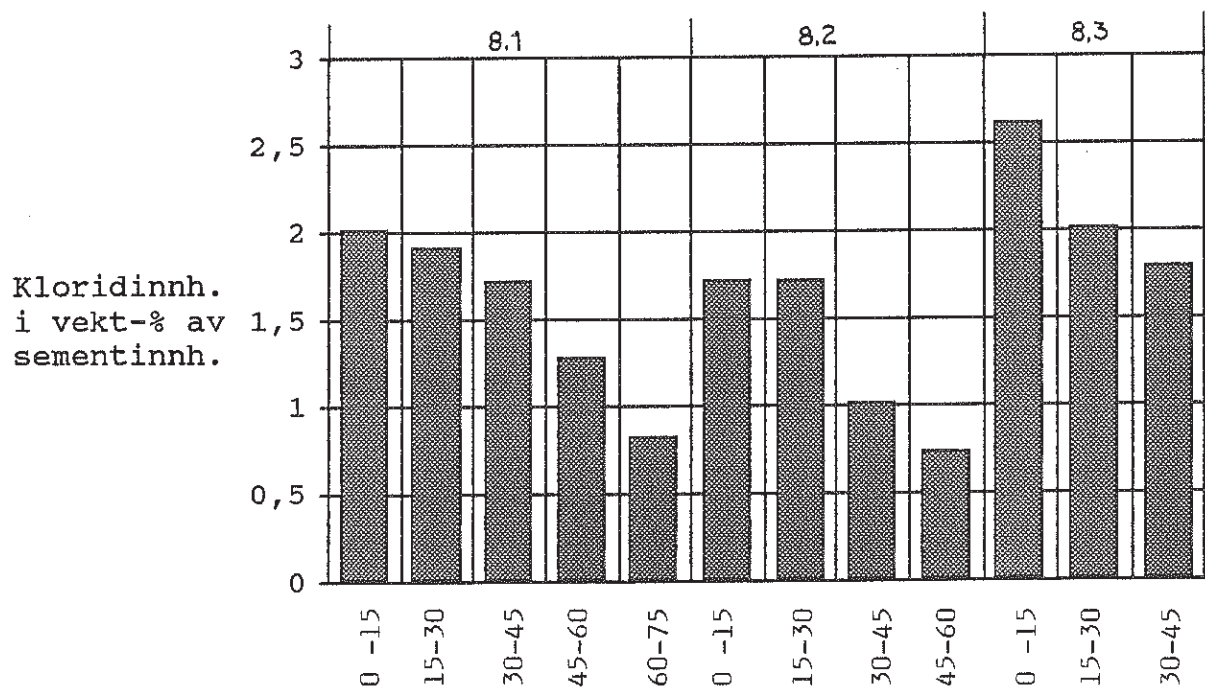
Kloridprofil pilar 8 öst

RCT- MÅLINGER		Pilar nr. 8						
	Pröve	Dybde	mV	CL-innh	Faktor	Kloridinnhold		
Nivå mm		mm		vekt% bet		i vekt-% av sement		
500	8,1	0-15	8	0,315	6,4	2,016	Östre vegg	
	8,1	15-30	9	0,3	6,4	1,92		
	8,1	30-45	12	0,27	6,4	1,728		
	8,1	45-60	19	0,2	6,4	1,28		
	8,1	60-75	29	0,13	6,4	0,832		
1500	8,2	0-15	12	0,27	6,4	1,728	Östre vegg	
	8,2	15-30	12	0,27	6,4	1,728		
	8,2	30-45	24	0,16	6,4	1,024		
	8,2	45-60	32	0,115	6,4	0,736		
2500	8,3	0-15	2	0,41	6,4	2,624	Östre vegg	
	8,3	15-30	8	0,315	6,4	2,016		
	8,3	30-45	11	0,28	6,4	1,792

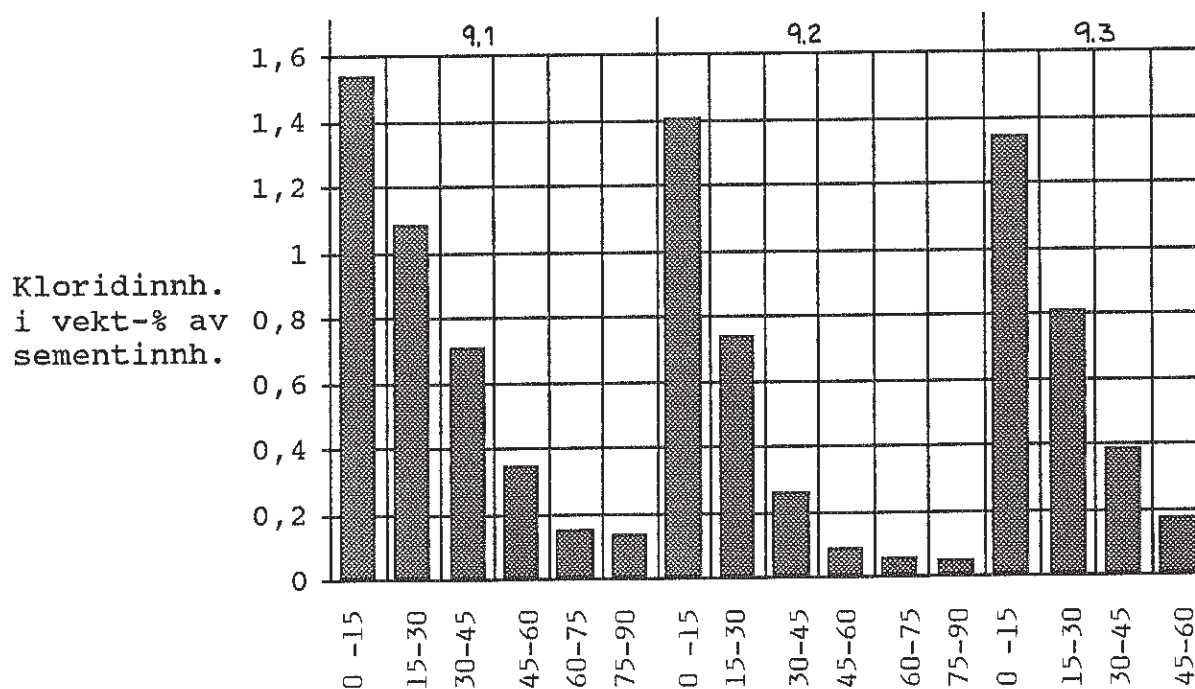
Kloridprofil pilar 9 nord

RCT- MÅLINGER		Pilar nr. 9				
Nivå mm	Prøve	Dybde mm	mV	CL-innh vekt% bet	Faktor	Kloridinnhold i vekt-% av sement
500	9,1	0-15	15	0,24	6,4	1,536
	9,1	15-30	23	0,17	6,4	1,088
	9,1	30-45	33	0,11	6,4	0,704
	9,1	45-60	50	0,054	6,4	0,3456
	9,1	60-75	68	0,024	6,4	0,1536
	9,1	75-90	71	0,021	6,4	0,1344
1000	9,2	0-15	17	0,22	6,4	1,408
	9,2	15-30	32	0,115	6,4	0,736
	9,2	30-45	57	0,04	6,4	0,256
	9,2	45-60	79	0,014	6,4	0,0896
	9,2	60-75	86	0,0086	6,4	0,05504
	9,2	75-90	87	0,008	6,4	0,0512
3000	9,3	0-15	18	0,21	6,4	1,344
	9,3	15-30	30	0,126	6,4	0,8064
	9,3	30-45	48	0,06	6,4	0,384
	9,3	45-60	67	0,027	6,4	0,1728

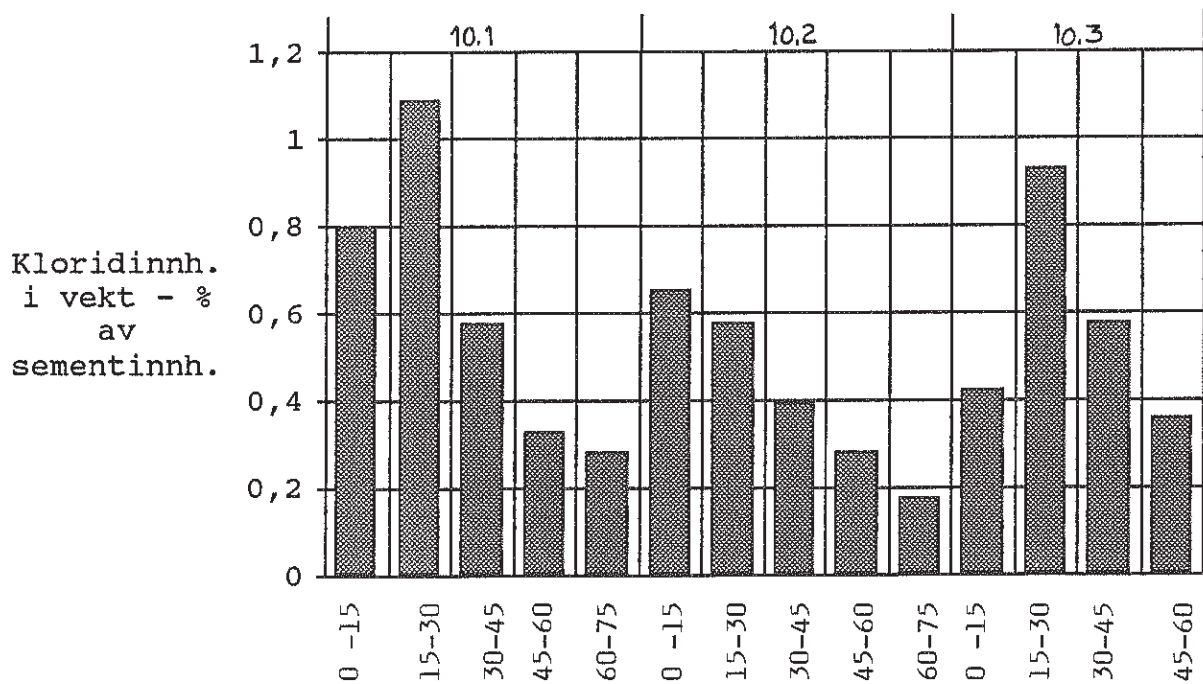
Kloridprofil pilar 10 nord

RCT- MÅLINGER		Pilar nr. 10						
	Prøve	Dybde	mV	CL-innh	Faktor	Kloridinnhold		
Nivå mm		mm		vekt% bet		i vekt-% av sement		
500	10,1	0-15	30	0,125	6,4	0,8	Nordre vegg	
	10,1	15-30	23	0,17	6,4	1,088		
	10,1	30-45	38	0,09	6,4	0,576		
	10,1	45-60	51	0,052	6,4	0,3328		
	10,1	60-75	55	0,044	6,4	0,2816		
1500	10,2	0-15	35	0,102	6,4	0,6528	Nordre vegg	
	10,2	15-30	38	0,09	6,4	0,576		
	10,2	30-45	47	0,062	6,4	0,3968		
	10,2	45-60	55	0,044	6,4	0,2816		
	10,2	60-75	65	0,028	6,4	0,1792		
3000	10,3	0-15	46	0,066	6,4	0,4224	Nordre vegg	
	10,3	15-30	27	0,145	6,4	0,928		
	10,3	30-45	38	0,09	6,4	0,576		
	10,3	45-60	50	0,056	6,4	0,3584

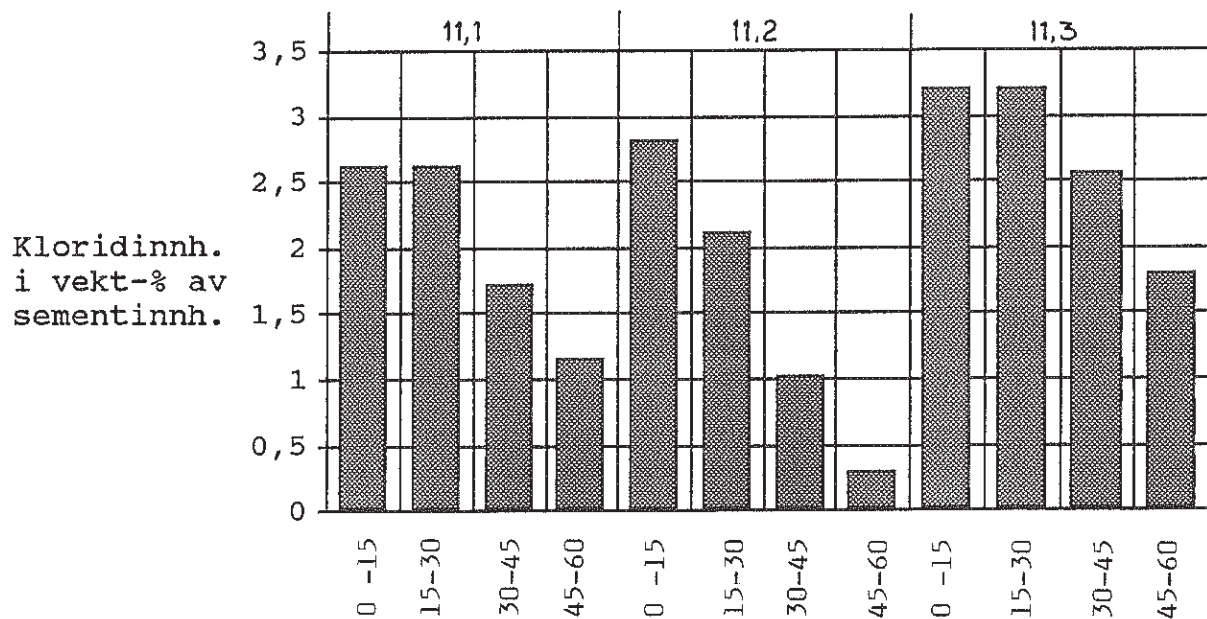
Kloridprofil pilar 11 öst 1-3

RCT- MÅLINGER		Pilar nr. 11 öst					
	Pröve	Dybde	mV	CL-innh	Faktor	Kloridinnhold	
Nivå mm		mm		vekt% bet		i vekt-% av sement	
400	11,1	0-15	3	0,41	6,4	2,624	Östre vegg
	11,1	15-30	3	0,41	6,4	2,624	
	11,1	30-45	12	0,27	6,4	1,728	
	11,1	45-60	20	0,18	6,4	1,152	
1000	11,2	0-15	0	0,44	6,4	2,816	Östre vegg
	11,2	15-30	7	0,33	6,4	2,112	
	11,2	30-45	24	0,16	6,4	1,024	
	11,2	45-60	54	0,046	6,4	0,2944	
1800	11,3	0-15	-3	0,5	6,4	3,2	Östre vegg
	11,3	15-30	-3	0,5	6,4	3,2	
	11,3	30-45	2	0,4	6,4	2,56	
	11,3	45-60	11	0,28	6,4	1,792

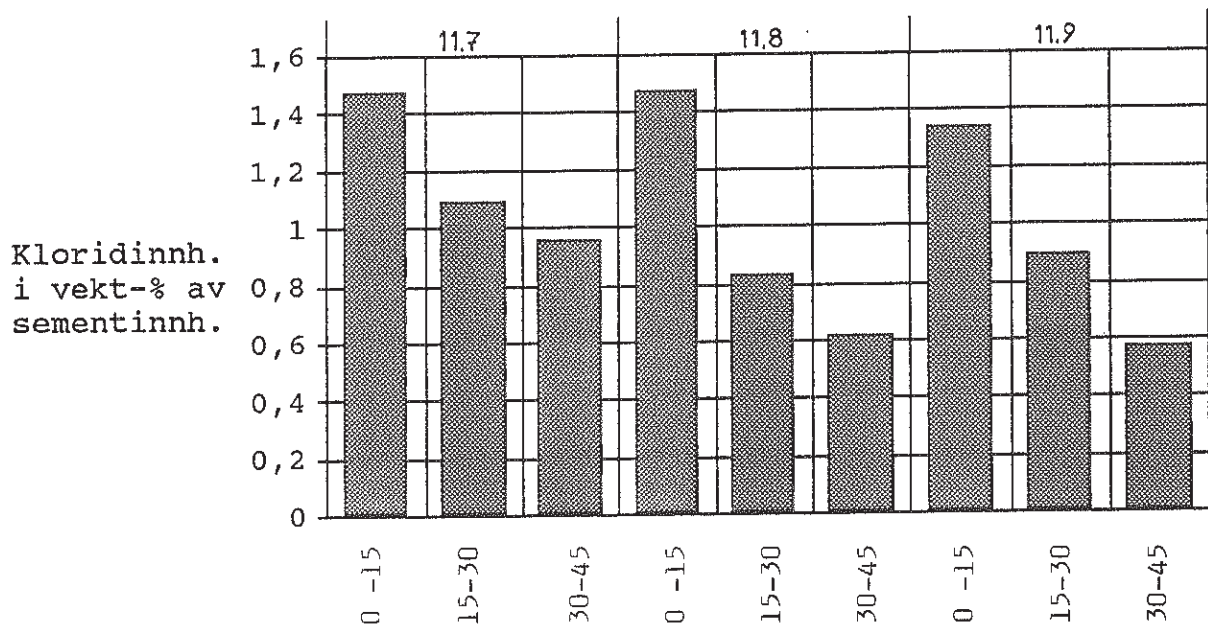
Kloridprofil pilar 11 sør 7-9

RCT- MÅLINGER			Pilar nr. 11 sør				
	Pröve	Dybde	mV	CL-innh	Faktor	Kloridinnhold	
Nivå mm	mm	mm		vekt% bet		i vekt-% av sement	
400	11,7	0-15	16	0,23	6,4	1,472	Søndre vegg
	11,7	15-30	20	0,17	6,4	1,088	
	11,7	30-45	26	0,15	6,4	0,96	
1000	11,8	0-15	16	0,23	6,4	1,472	Søndre vegg
	11,8	15-30	29	0,13	6,4	0,832	
	11,8	30-45	37	0,096	6,4	0,6144	
1800	11,9	0-15	18	0,21	6,4	1,344	Søndre vegg
	11,9	15-30	27	0,14	6,4	0,896	
	11,9	30-45	38	0,09	6,4	0,576

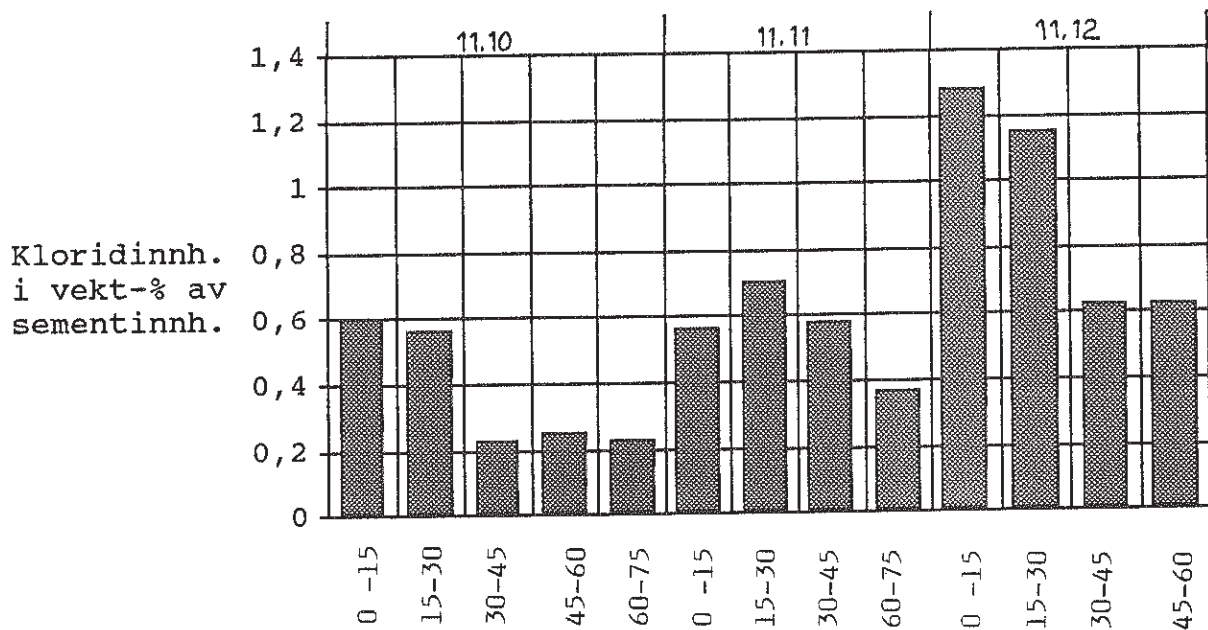
Kloridprofil pilar 11 vest 10-12

RCT- MÅLINGER			Pilar nr. 11 vest			
Nivå mm	Prøve	Dybde mm	mV	CL-innh vekt% bet	Faktor	Kloridinnhold i vekt-% av sement
4000	11;10	0-15	37	0,094	6,4	0,6016
	11;10	15-30	39	0,088	6,4	0,5632
	11;10	30-45	60	0,036	6,4	0,2304
	11;10	45-60	58	0,039	6,4	0,2496
	11;10	60-75	60	0,036	6,4	0,2304
2000	11,11	0-15	39	0,088	6,4	0,5632
	11,11	15-30	34	0,11	6,4	0,704
	11,11	30-45	38	0,09	6,4	0,576
	11,11	60-75	48	0,058	6,4	0,3712
1000	11,12	0-15	18	0,2	6,4	1,28
	11,12	15-30	22	0,18	6,4	1,152
	11,12	30-45	36	0,098	6,4	0,6272
	11,12	45-60	36	0,098	6,4	0,6272

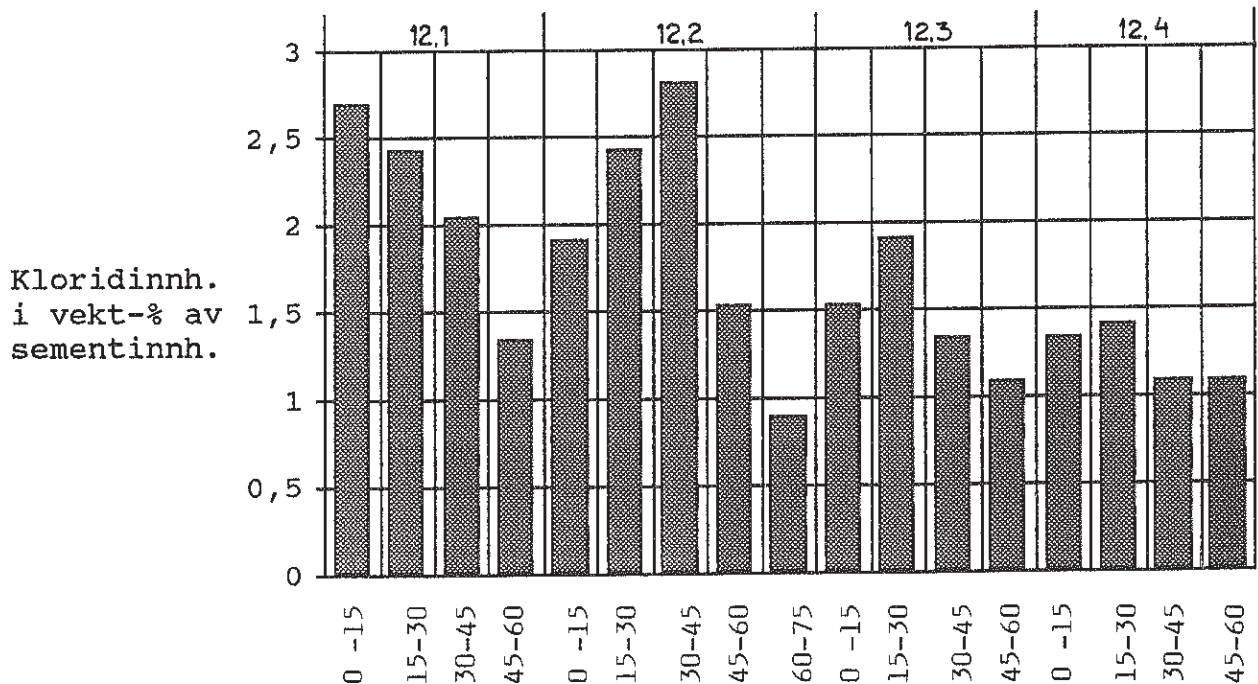
Kloridprofil pilar 12 öst og sør 1-4

RCT- MÅLINGER		Pilar nr. 12					
Nivå mm	Pröve	Dybde mm	mV	CL-innh vekt% bet	Faktor	Kloridinnhold i vekt-% av sement	
450	12,1	0-15	-1	0,42	6,4	2,688	Östre vegg
	12,1	15-30	1	0,38	6,4	2,432	
	12,1	30-45	5	0,32	6,4	2,048	
	12,1	45-60	15	0,21	6,4	1,344	
1050	12,2	0-15	7	0,3	6,4	1,92	Östre vegg
	12,2	15-30	1	0,38	6,4	2,432	
	12,2	30-45	2	0,44	6,4	2,816	
	12,2	45-60	12	0,24	6,4	1,536	
	12,2	60-75	25	0,14	6,4	0,896	
1800	12,3	0-15	12	0,24	6,4	1,536	Östre vegg
	12,3	15-30	7	0,3	6,4	1,92	
	12,3	30-45	15	0,21	6,4	1,344	
	12,3	45-60	20	0,17	6,4	1,088	
500	12,4	0-15	18	0,21	6,4	1,344	Søndre vegg
	12,4	15-30	17	0,22	6,4	1,408	
	12,4	30-45	20	0,17	6,4	1,088	
	12,4	45-60	20	0,17	6,4	1,088

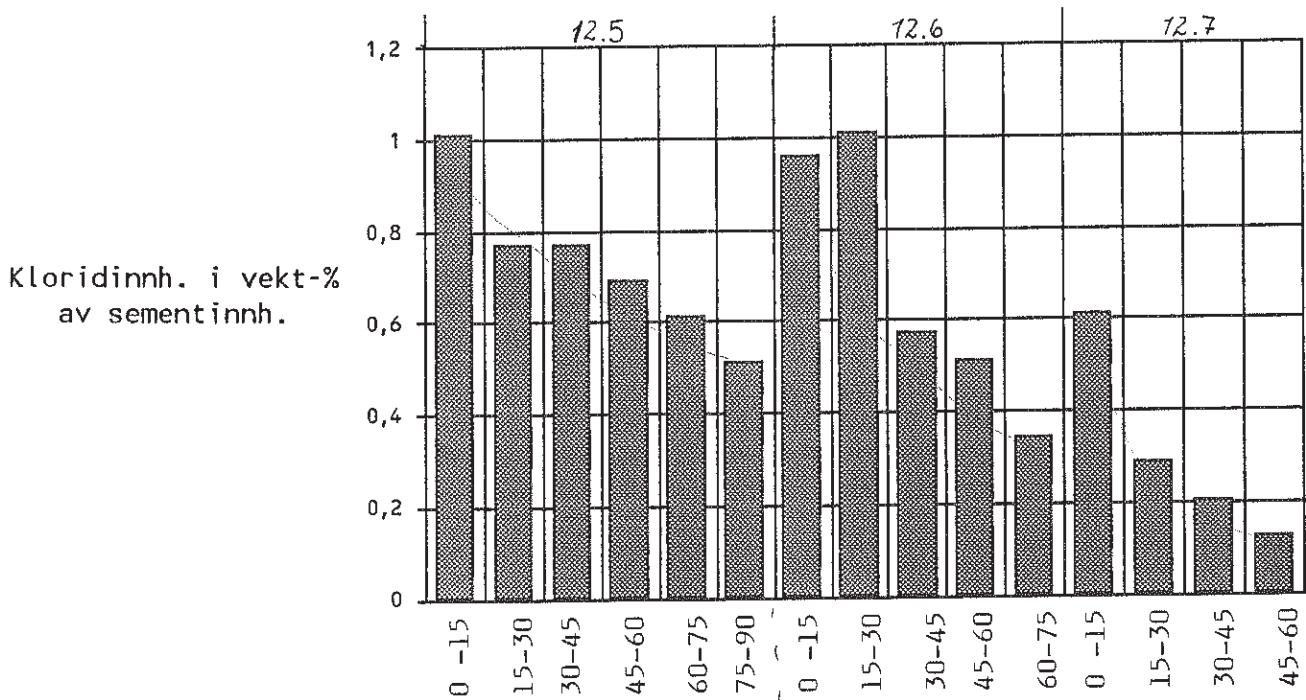
Kloridprofil pilar 12 vest 5-7

RCT- MÅLINGER			Pilar nr. 12				
Nivå mm	Prøve mm	Dybde mm	mV	CL-innh vekt% bet	Faktor	Kloridinnhold i vekt-% av sement	
1000	12,5	0-15	26	0,158	6,4	1,0112	Vestre vegg
	12,5	15-30	31	0,12	6,4	0,768	
	12,5	30-45	31	0,12	6,4	0,768	
	12,5	45-60	34	0,108	6,4	0,6912	
	12,5	60-75	37	0,096	6,4	0,6144	
	12,5	75-90	41	0,08	6,4	0,512	
3000	12,6	0-15	25	0,15	6,4	0,96	Vestre vegg
	12,6	15-30	26	0,158	6,4	1,0112	
	12,6	30-45	38	0,09	6,4	0,576	
	12,6	45-60	41	0,08	6,4	0,512	
	12,6	60-75	51	0,054	6,4	0,3456	
4000	12,7	0-15	37	0,096	6,4	0,6144	Vestre vegg
	12,7	15-30	55	0,045	6,4	0,288	
	12,7	30-45	63	0,032	6,4	0,2048	
	12,7	45-60	73	0,02	6,4	0,128
