Long-term performance of cathodic protection (CP) of marine bridge, inspection of Sortlandsbrua 27 years after CP installation

An investigation of performance and damages on the installation.

Master's thesis in Experience-based Part-time Master
programme Road and Railway Engineering
Supervisor: Mette Rica Geiker
May 2019

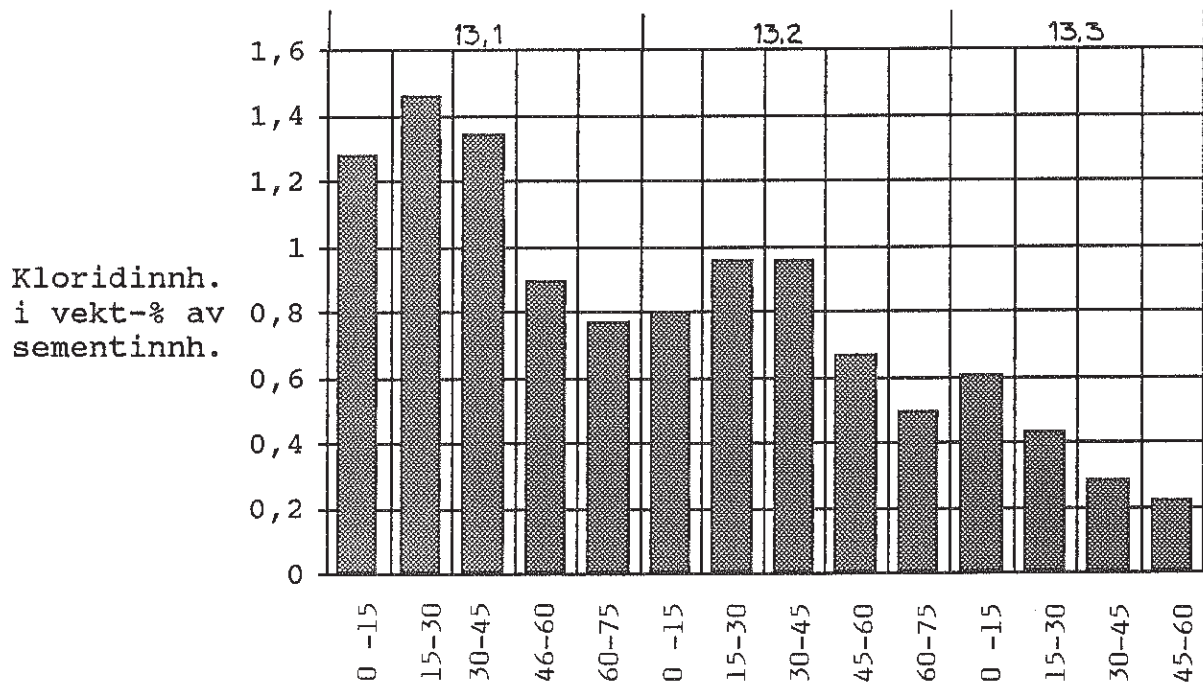
Kloridprofil pilar 13

RCT- MÅLINGER		Pilar nr. 13					
Nivå mm	Prøve	Dybde mm	mV	CL-innh vekt% bet	Faktor	Kloridinnhold i vekt-% av sement	
500	13,1	0-15	19	0,2	6,4	1,28	Vestre vegg
	13,1	15-30	16	0,228	6,4	1,4592	
	13,1	30-45	18	0,21	6,4	1,344	
	13,1	46-60	28	0,14	6,4	0,896	
	13,1	60-75	31	0,12	6,4	0,768	
1500	13,2	0-15	30	0,125	6,4	0,8	Vestre vegg
	13,2	15-30	26	0,15	6,4	0,96	
	13,2	30-45	26	0,15	6,4	0,96	
	13,2	45-60	35	0,104	6,4	0,6656	
	13,2	60-75	42	0,078	6,4	0,4992	
3500	13,3	0-15	37	0,095	6,4	0,608	Vestre vegg
	13,3	15-30	45	0,068	6,4	0,4352	
	13,3	30-45	55	0,044	6,4	0,2816	
	13,3	45-60	60	0,035	6,4	0,224

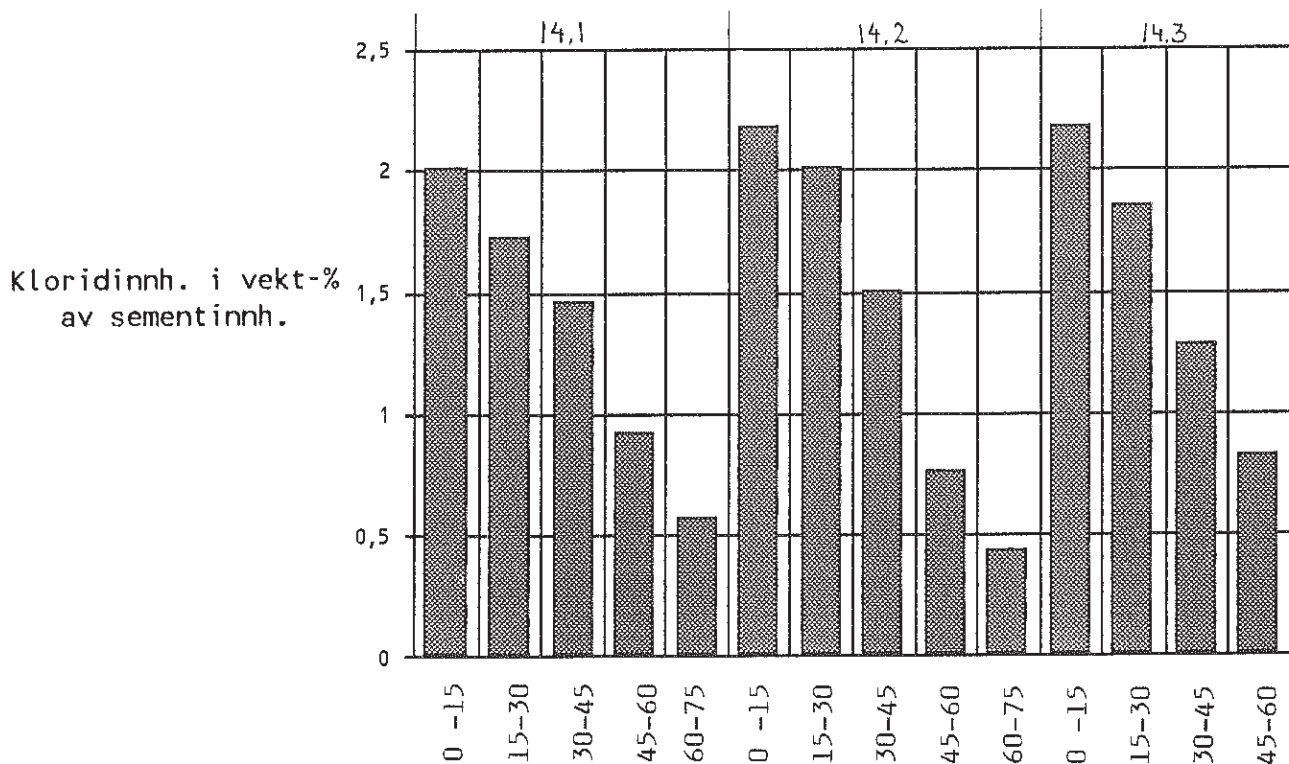
Kloridprofil pilar 14

RCT- MÄLINGER		Pilar nr. 14					
	Pröve	Dybde	mV	CL-innh	Faktor	Kloridinnhold	
Nivå mm	mm	mm		vekt% bet		i vekt-% av sement	
500	14,1	0-15	8	0,315	6,4	2,016	Östre vegg
	14,1	15-30	12	0,27	6,4	1,728	
	14,1	30-45	16	0,228	6,4	1,4592	
	14,1	45-60	27	0,145	6,4	0,928	
	14,1	60-75	37	0,09	6,4	0,576	
2000	14,2	0-15	6	0,34	6,4	2,176	Östre vegg
	14,2	15-30	8	0,315	6,4	2,016	
	14,2	30-45	15	0,235	6,4	1,504	
	14,2	45-60	31	0,12	6,4	0,768	
	14,2	60-75	45	0,068	6,4	0,4352	
3600	14,3	0-15	6	0,34	6,4	2,176	Östre vegg
	14,3	15-30	10	0,29	6,4	1,856	
	14,3	30-45	19	0,2	6,4	1,28	
	14,3	45-60	29	0,13	6,4	0,832

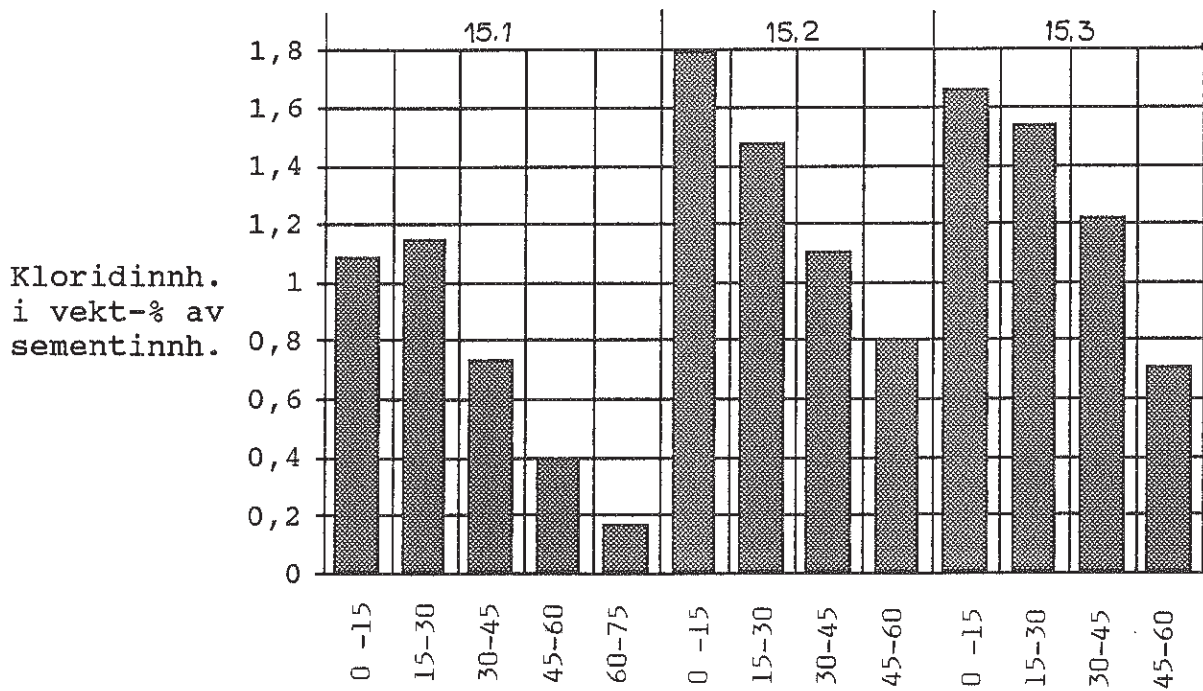
Kloridprofil pilar 15

RCT- MÅLINGER		Pilar nr. 15					
	Prøve	Dybde	mV	CL-innh	Faktor	Kloridinnhold	
Nivå mm	mm	mm		vekt% bet		i vekt-% av sement	
1000	15,1	0-15	23	0,17	6,4	1,088	Østre vegg
	15,1	15-30	24	0,18	6,4	1,152	
	15,1	30-45	34	0,115	6,4	0,736	
	15,1	45-60	48	0,062	6,4	0,3968	
	15,1	60-75	68	0,026	6,4	0,1664	
2000	15,2	0-15	11	0,28	6,4	1,792	Østre vegg
	15,2	15-30	16	0,23	6,4	1,472	
	15,2	30-45	26	0,172	6,4	1,1008	
	15,2	45-60	31	0,126	6,4	0,8064	
3400	15,3	0-15	13	0,26	6,4	1,664	Østre vegg
	15,3	15-30	15	0,24	6,4	1,536	
	15,3	30-45	21	0,19	6,4	1,216	
	15,3	45-60	36	0,11	6,4	0,704

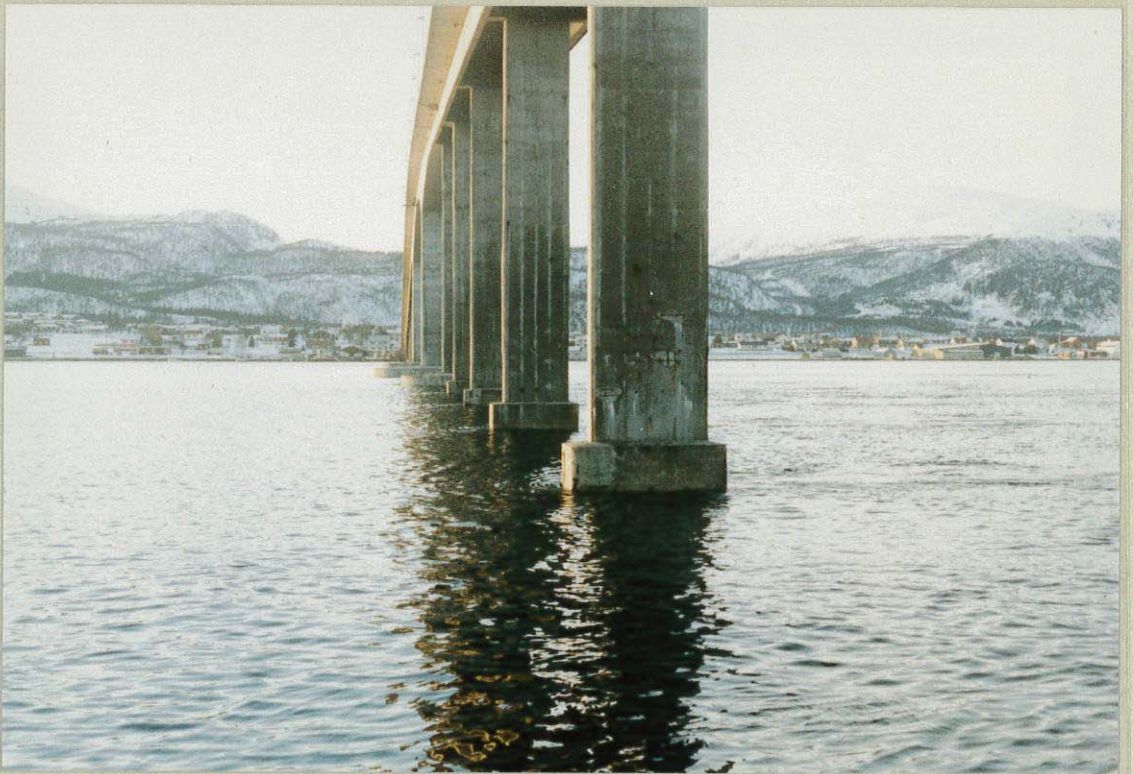
1.

Østre side av pilarene - fargenyanser

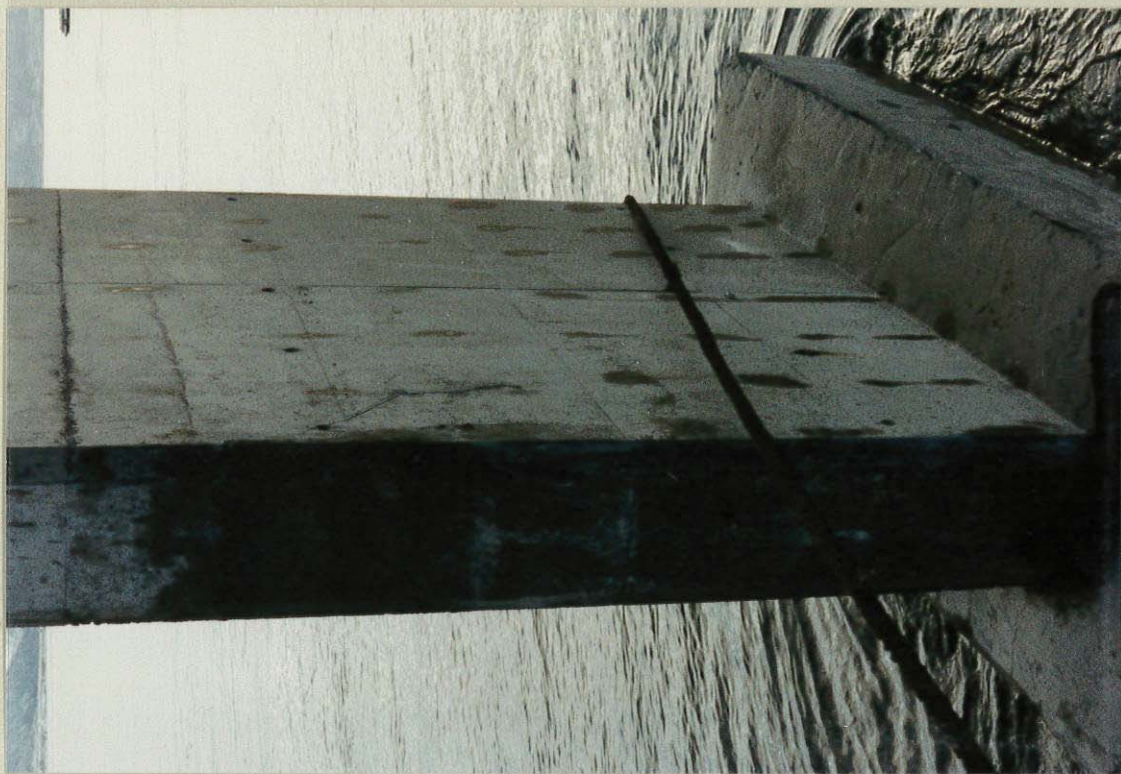
3.

Pilar 2 vestre og nordre side - de mørke
fletene er fra EKP-målingene

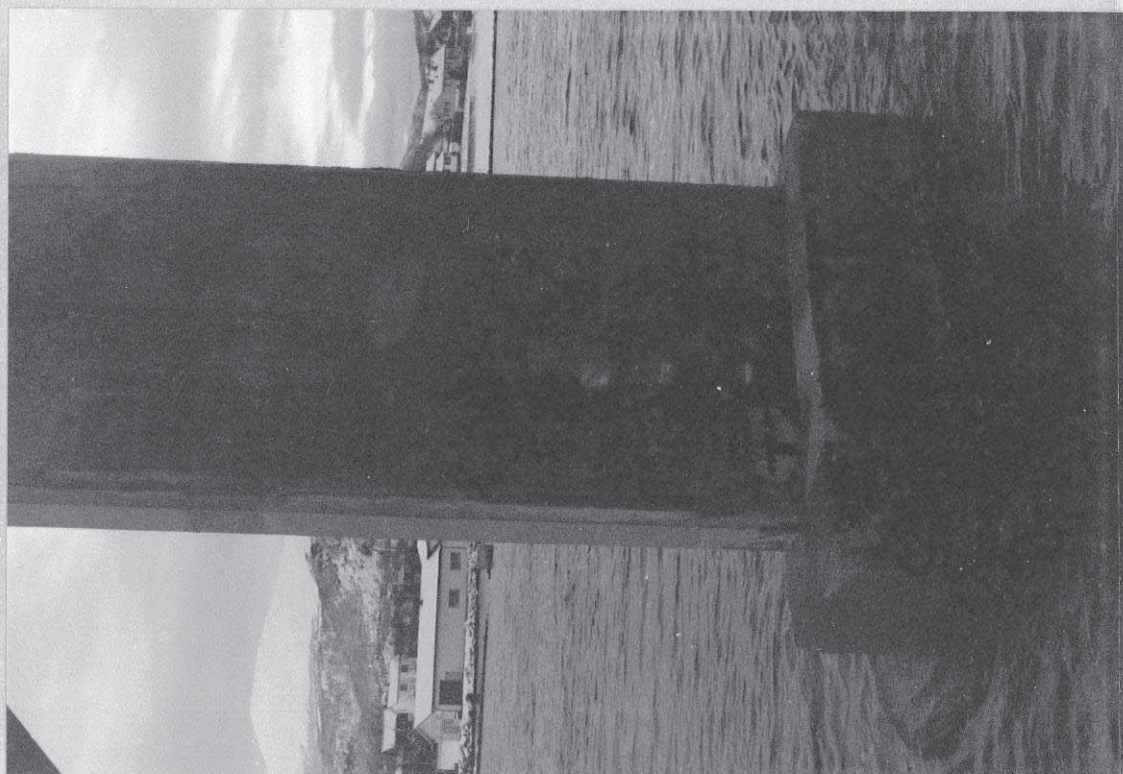
5.

Pilar 3 nordre og vestre vegg

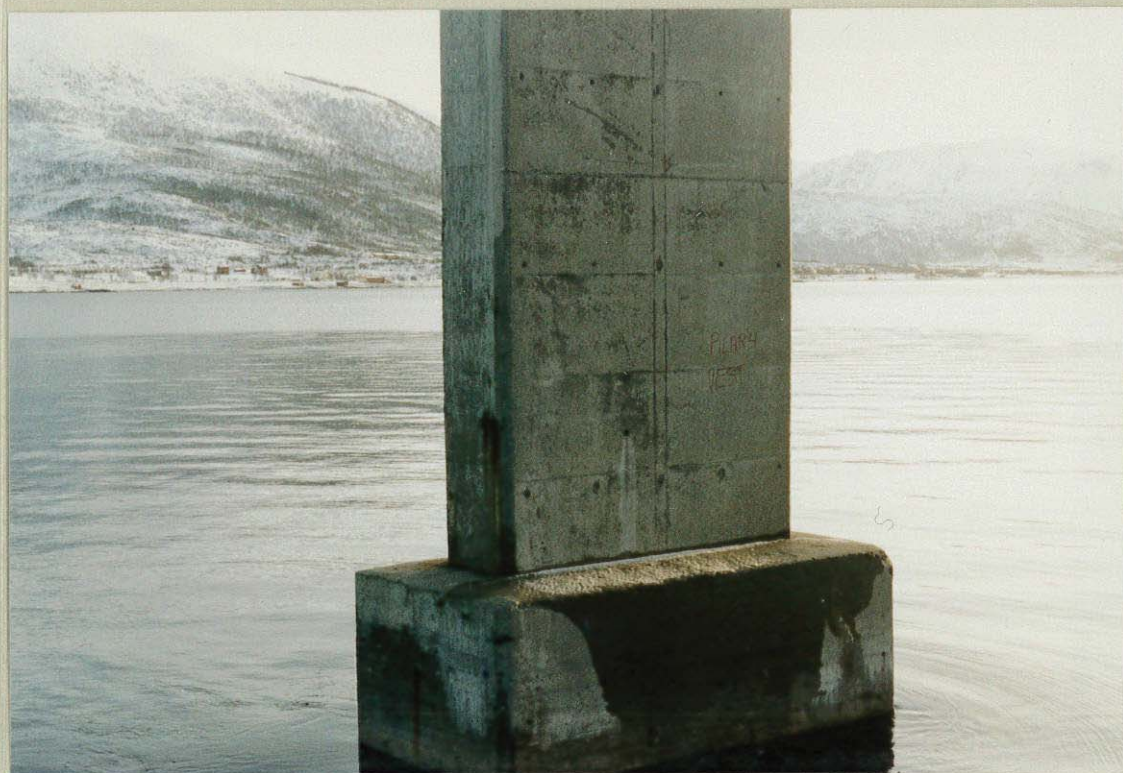
7.

Pilar 4 nordre og vestre vegg

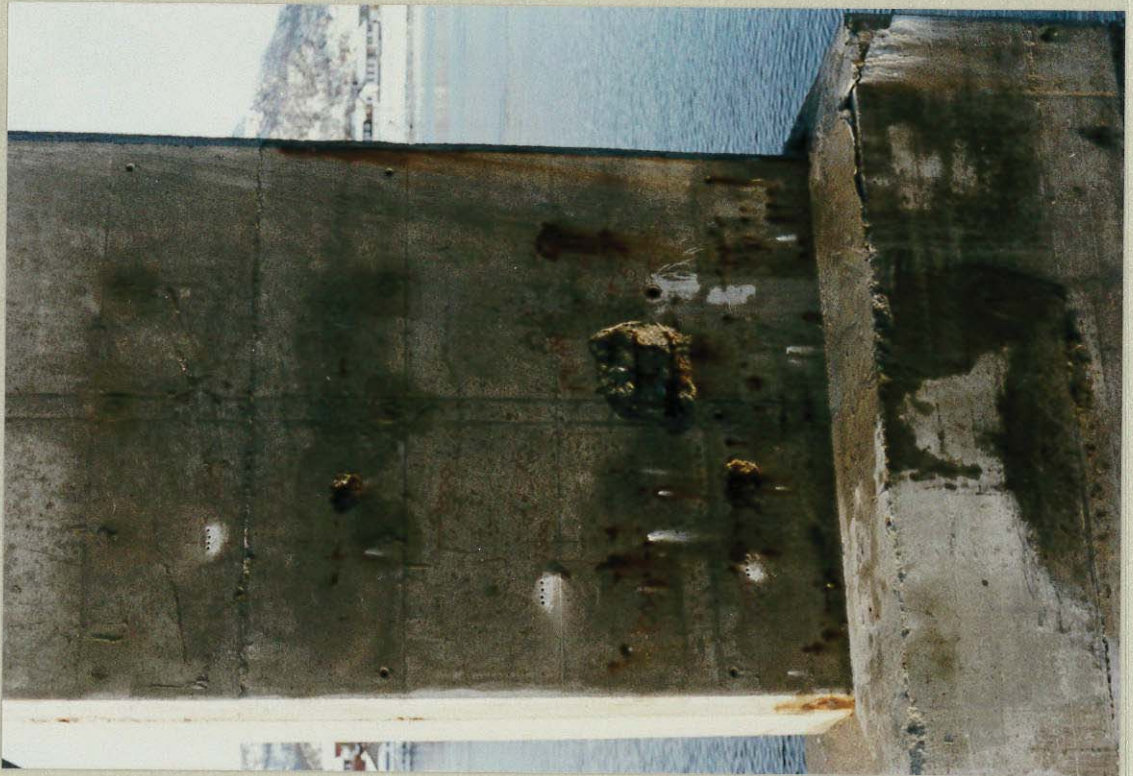
9.

Pilar 5 østre og søndre vegg

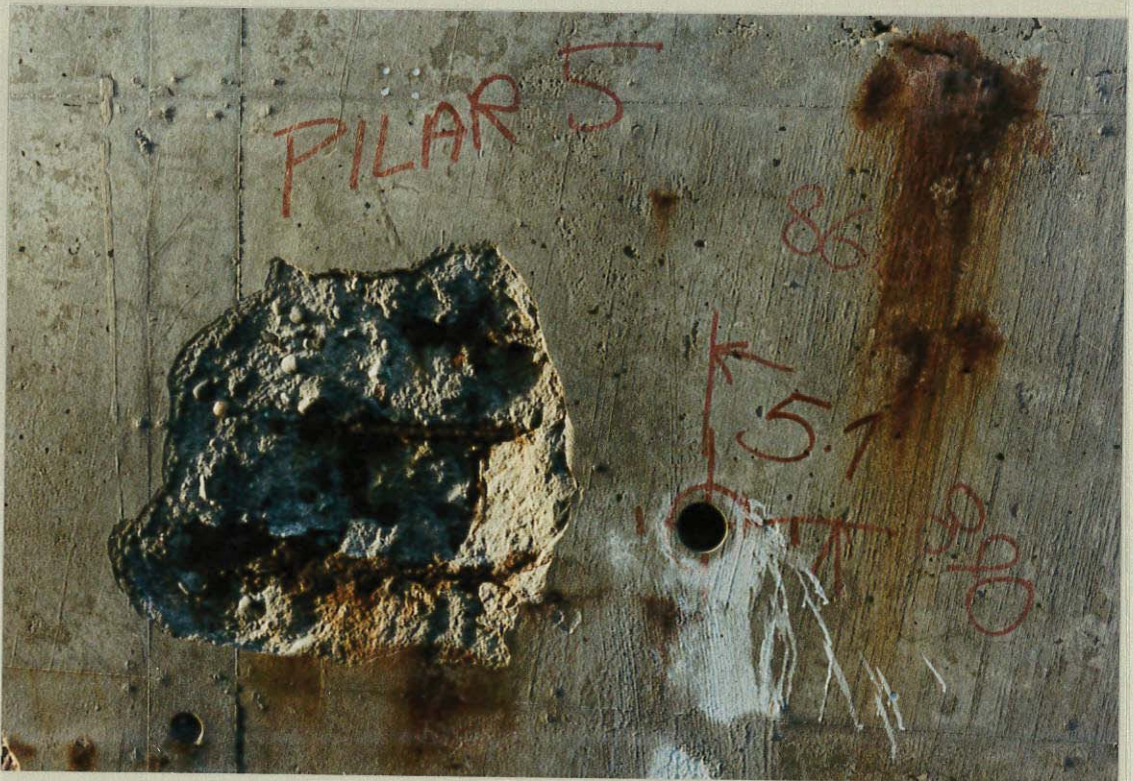
Kjerneprøve merket 5.1 er boret 860 mm sør for nordre hjørne og 890 mm over ok fundament. Prøven er boret inn 300 mm. Det er boret i en vertikalarmering \emptyset 25. Denne ligger ca. 53 mm innenfor betongoverflaten. Armeringen har sitt passiviserende belegg i behold og den viser ingen tegn på korrosjon. Kjernen viser jevn kornfordeling og porefordeling. Den utborede prøven viser en vertikal laminering 8 - 12 mm bak overflaten.

10. Pilar 5

Avskalling, kjerneboring hull 5.1.

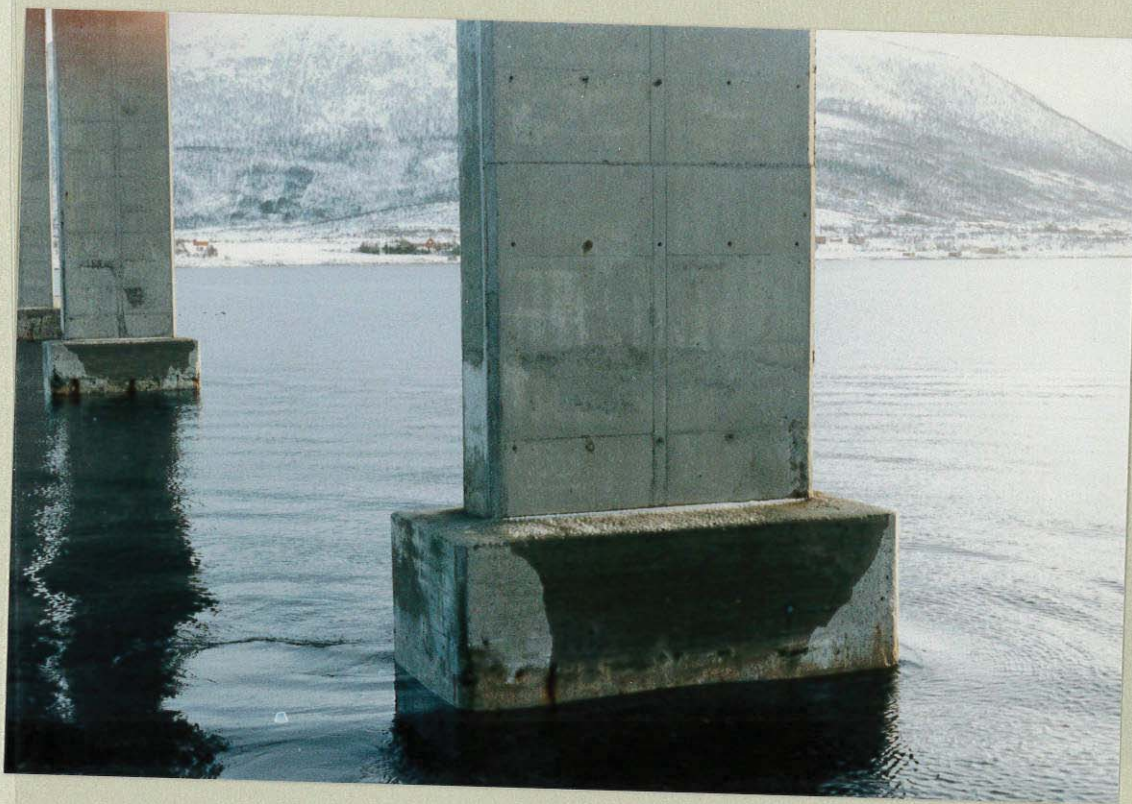
11.

Pilar 5, vestre og nordre vegg

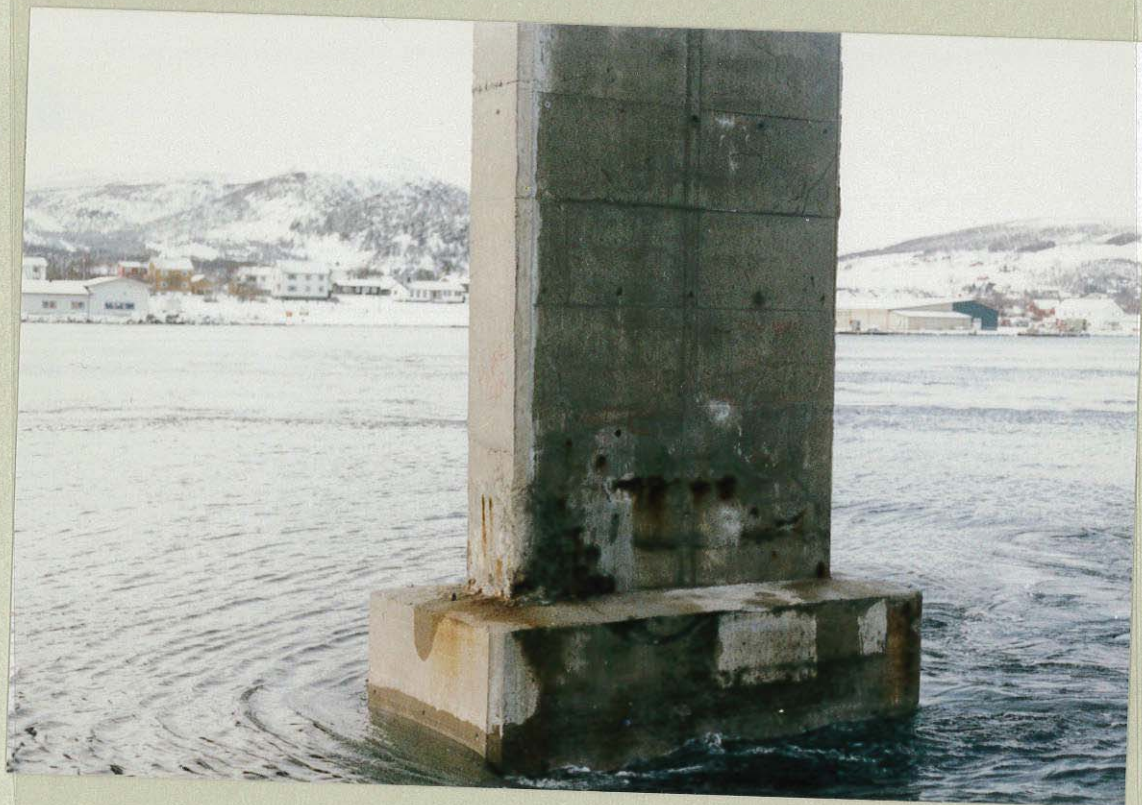
12.

Kjerneprøve, merket 6.1 er boret inn 295 mm. Prøven er boret på østre vegg 1400 mm over ok fundament og 890 mm nord for søndre hjørne. Den utborede prøven viser dårlig betong i en dybde av 120 mm. Det er boret gjennom en del av horisontalarmeringen. Denne har ikke det passiviserende belegg og er i en korrosiv tilstand. De ytre delene av betongkjernen er så dårlige at kjernen ikke holdes sammen. Dette kan indikere at betongen er frostskaadet. Dette bør undersøkes nærmere.

Pilar 6 østre vegg, kjerneløring 6.1. vises

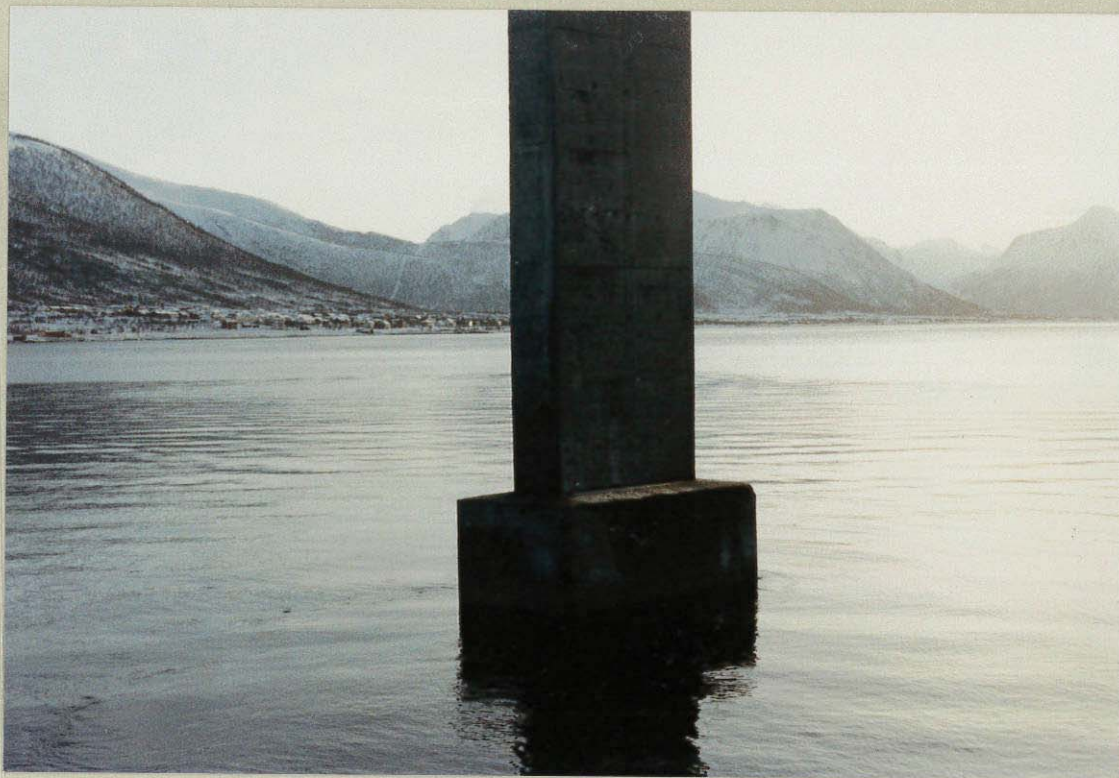
13.

Pilar 6 nordre og vestre vegg

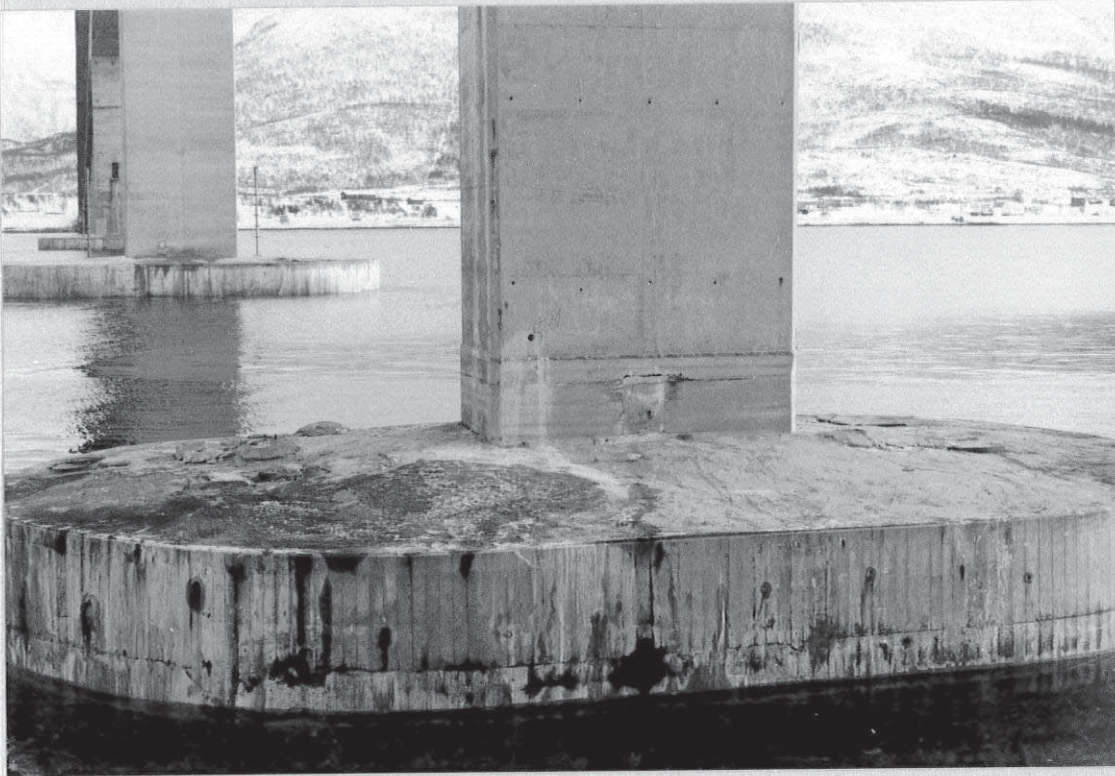
19.

Pilar 9 - nordre og vestre vegg. Til venstre sees kjerneboringssted, kabelforankringene er frilagt.

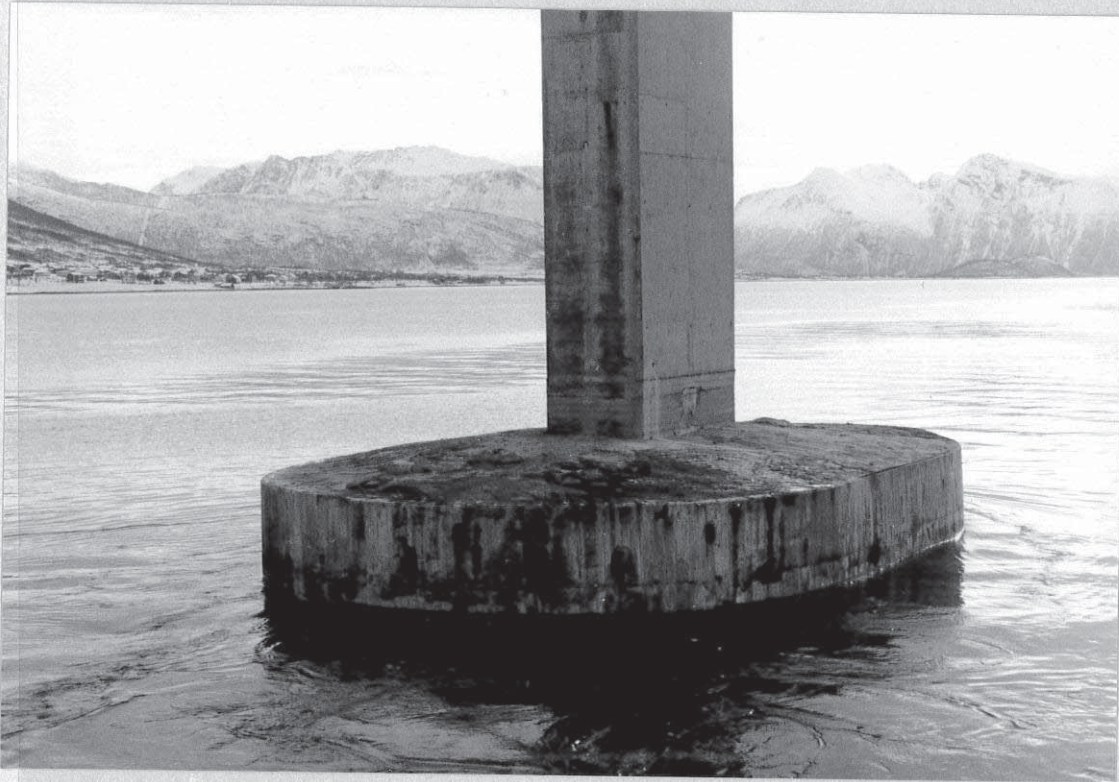
20.

Pilar 9, nordvestre hjørne - restutslag

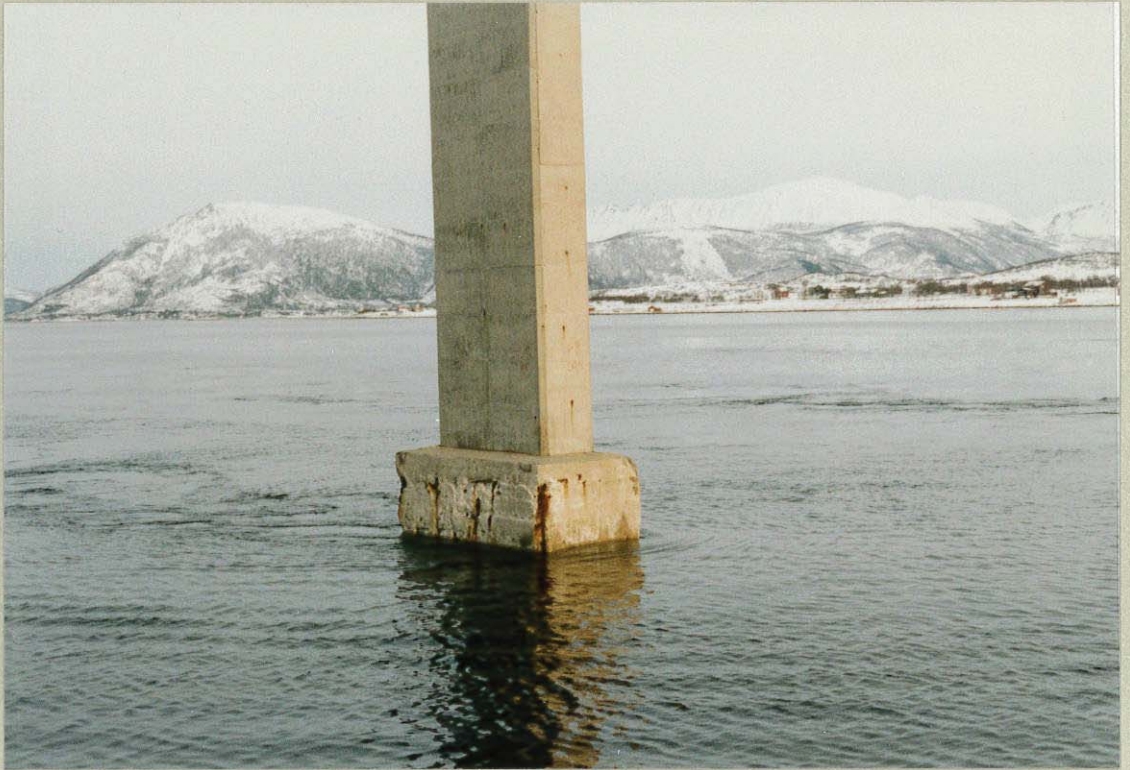
17.

Pilar nr. 8 - søndre og vestre side

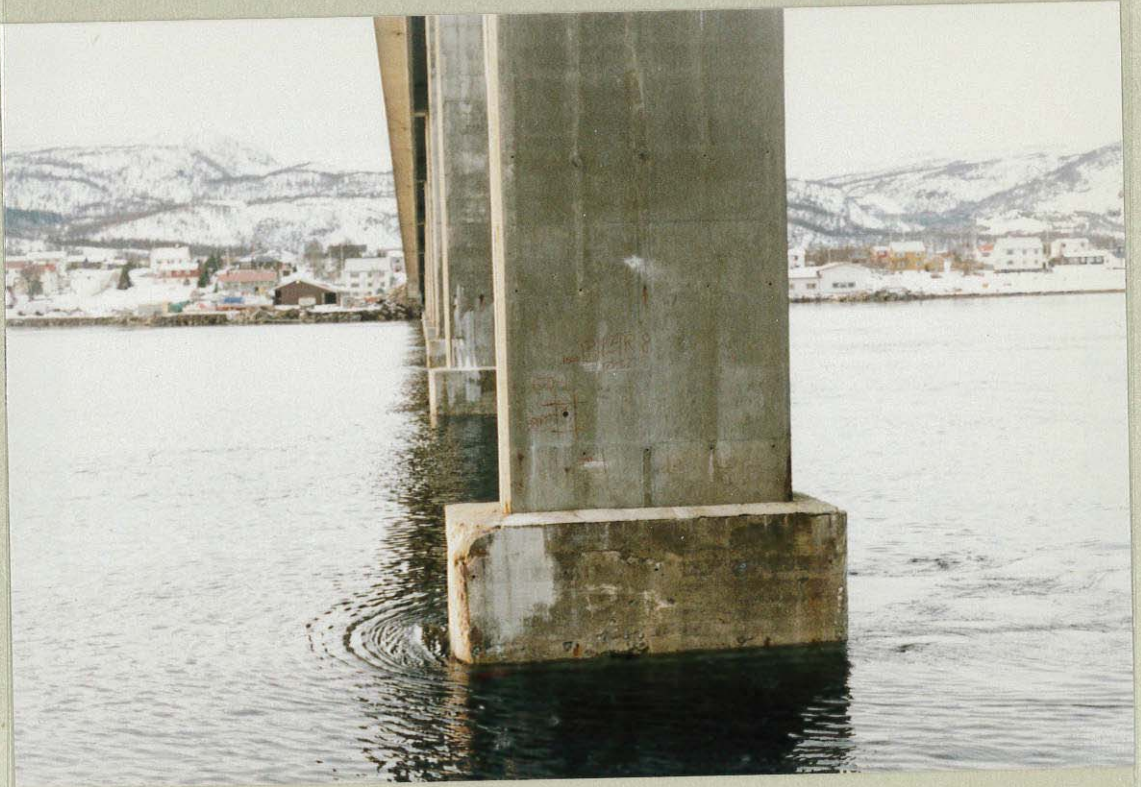
18.

Pilar 8 - østre vegg

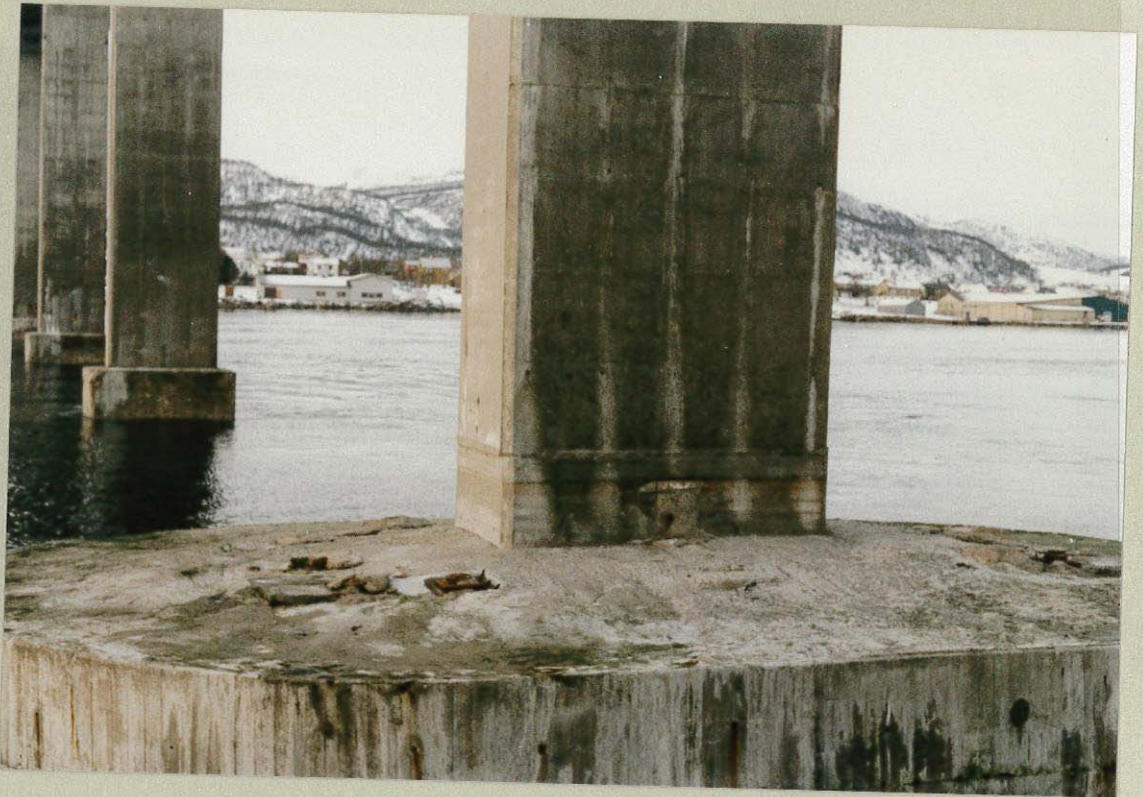
21.

Pilar 9 søndre og østre vegg - Kabel-
forankringene er frilagt og korrodert.

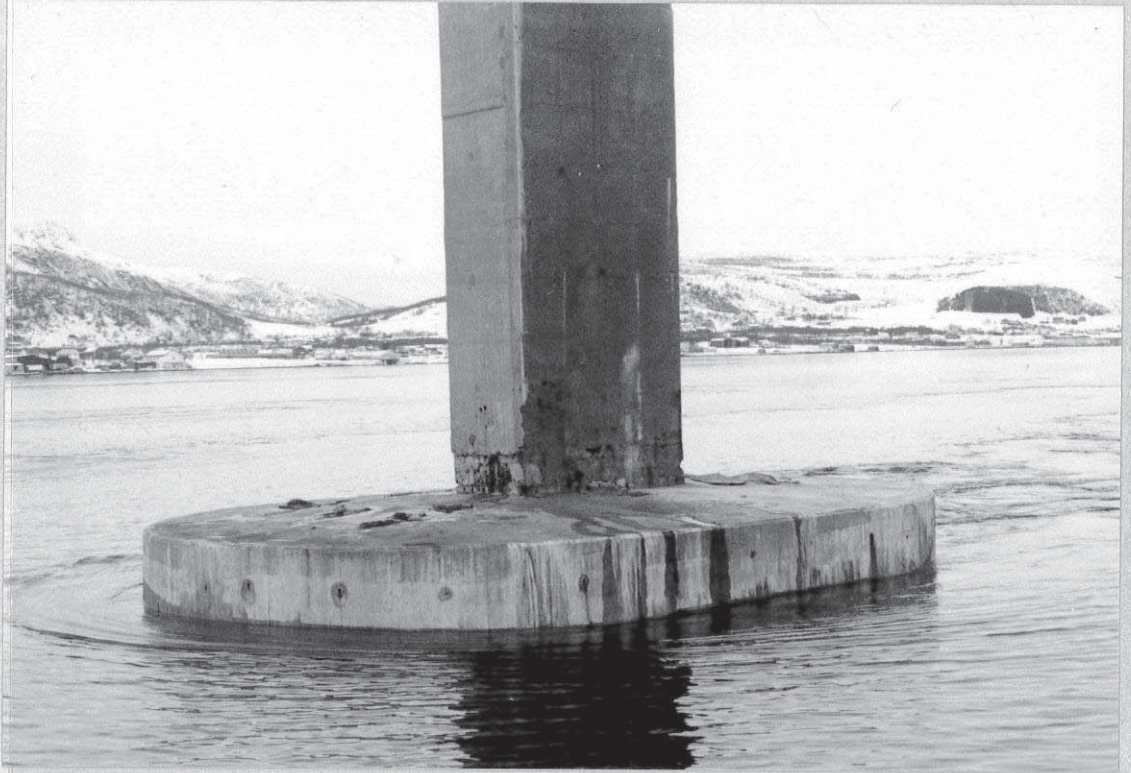
Bilde nr. 29.

Pilar 12 søndre og østre vegg.

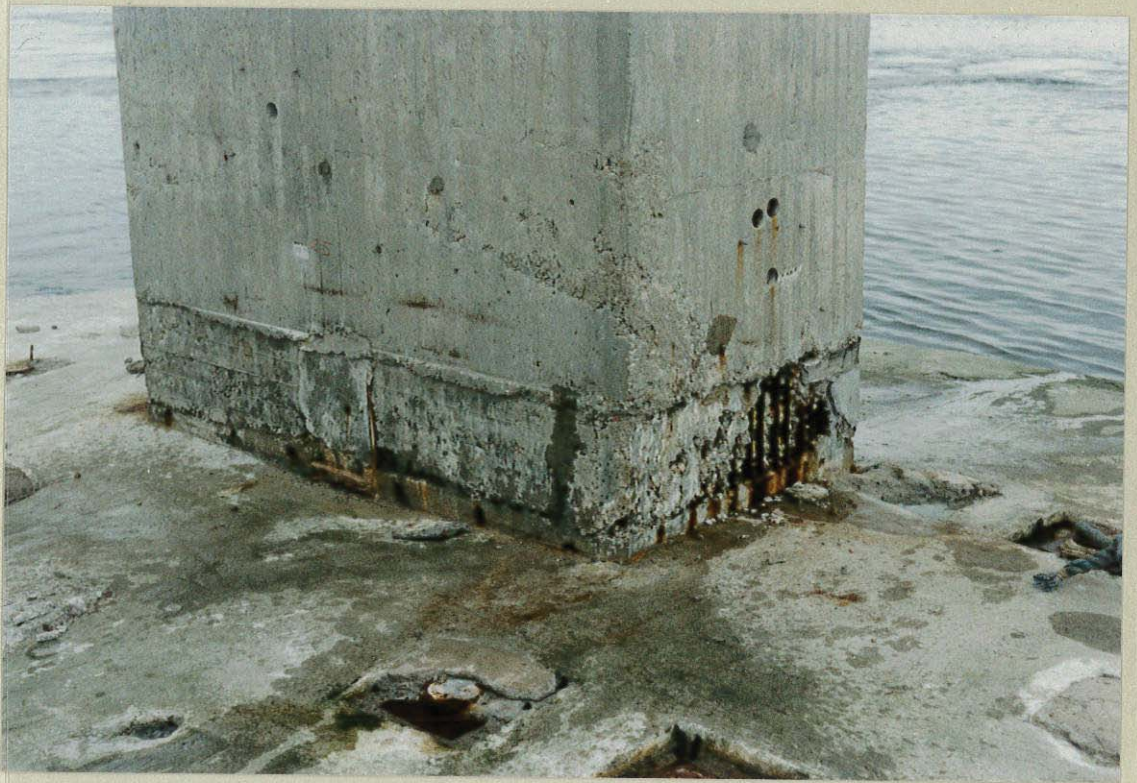
33.

Pilar 12 vestre og søndre vegg.

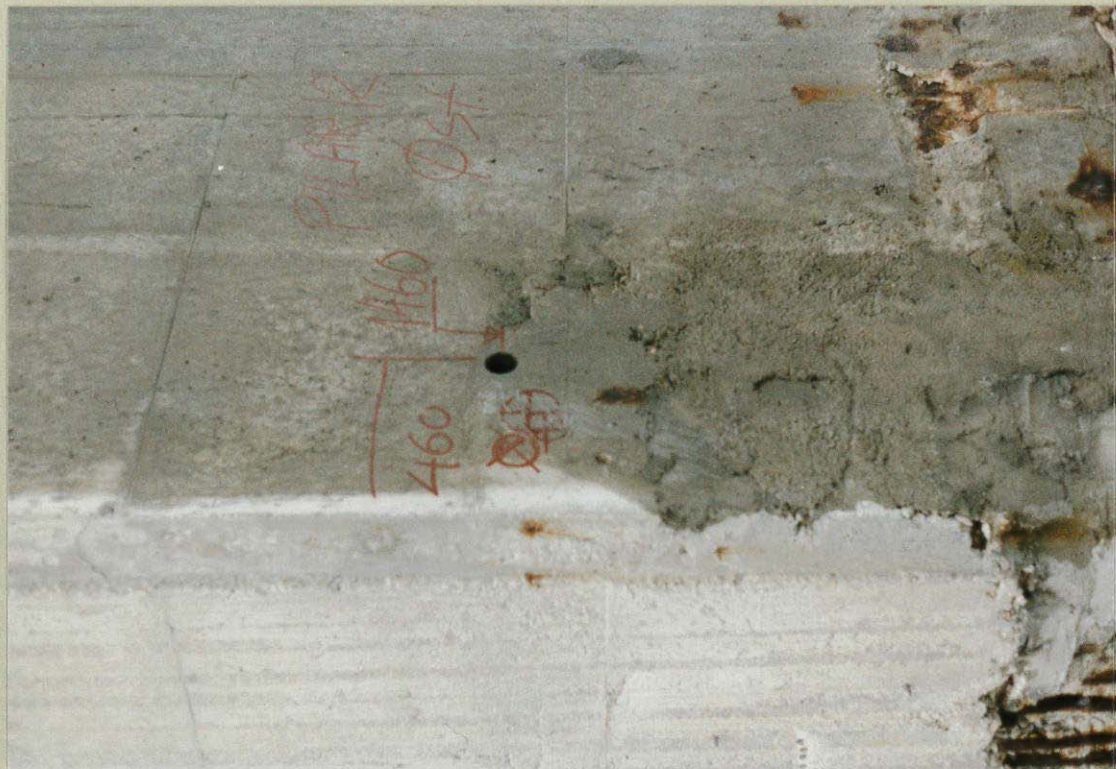
35.

Pilar 12 sørøstre hjørne i en høyde av
300 til 2000 mm.

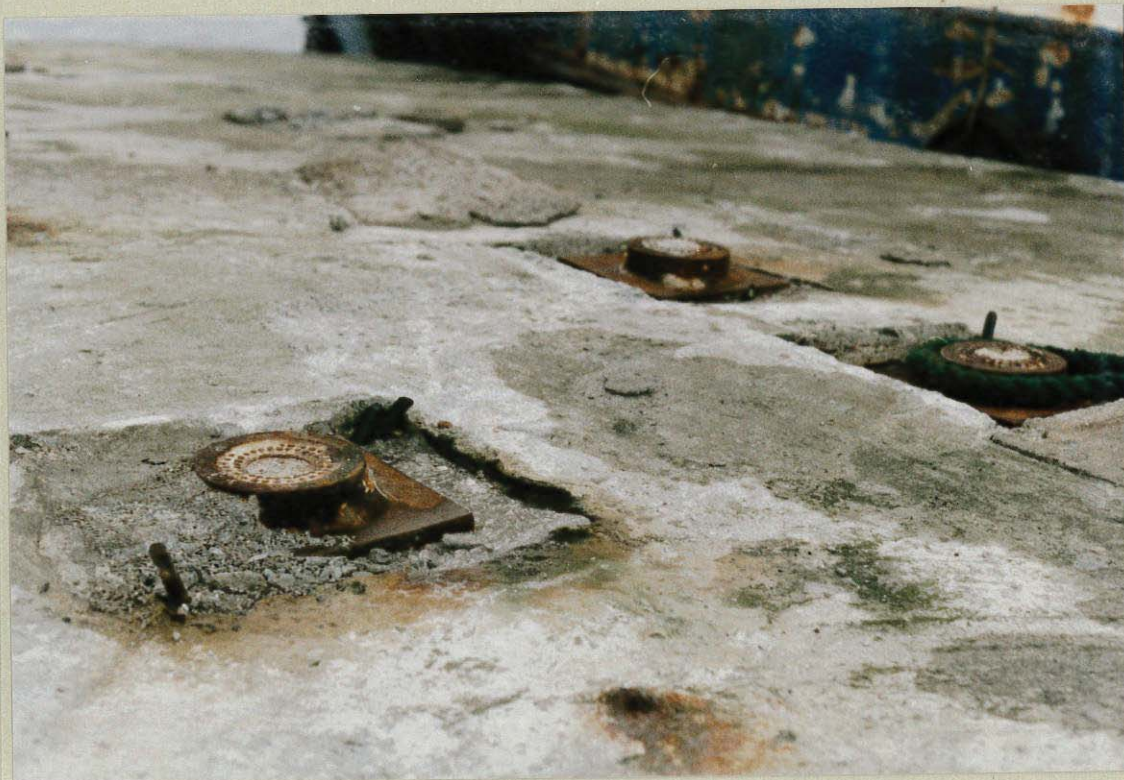
37.

Pilar 12 kabelforankringer er frilagt
sydvestre side

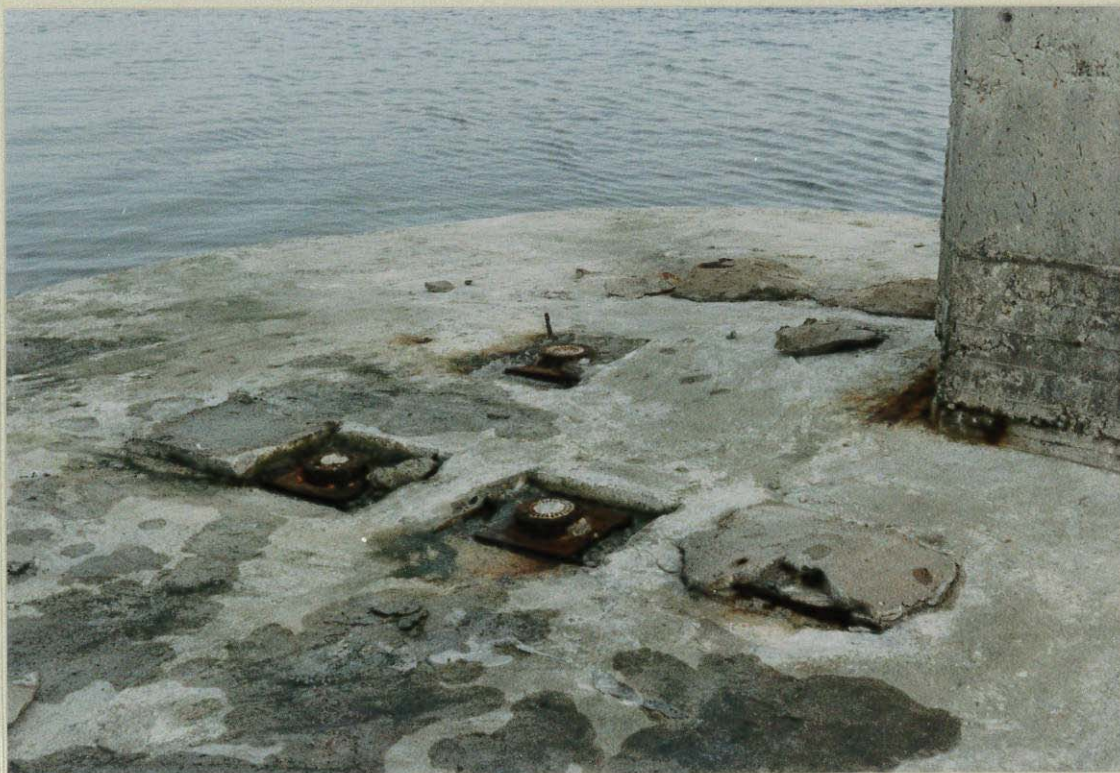
38.

Pilar 12, Frilagte kabelforankringer

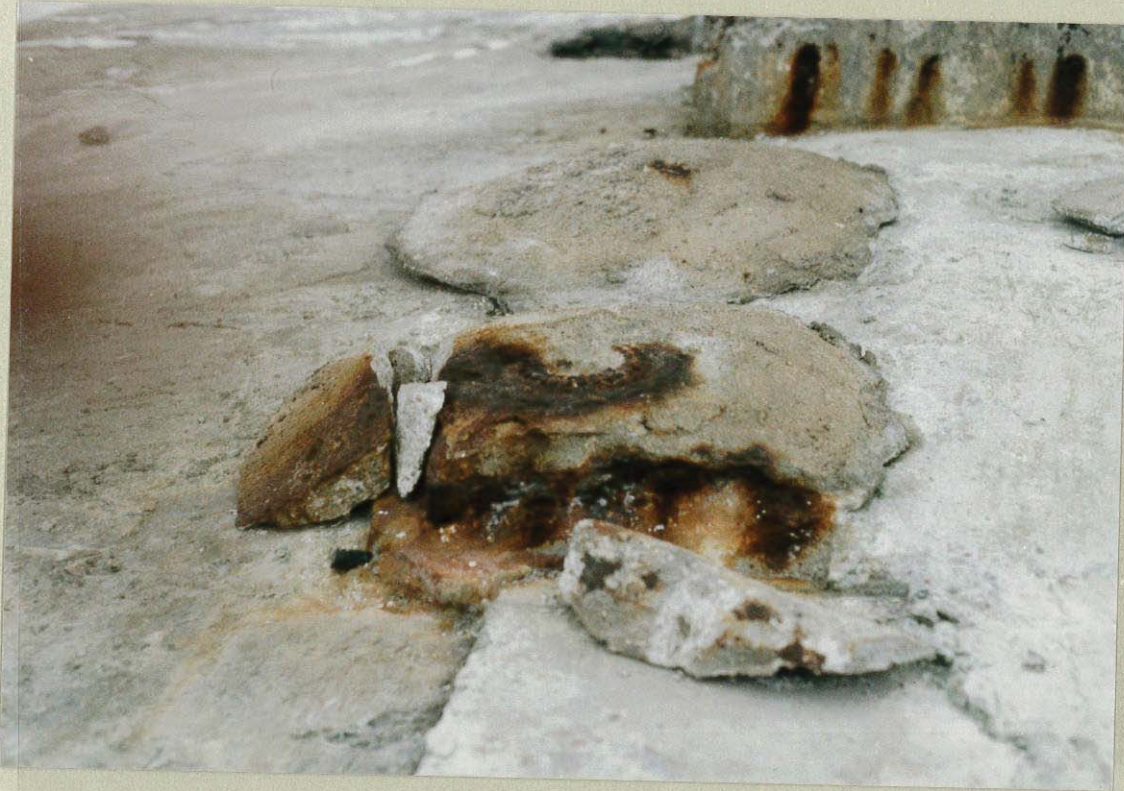
39.

Pilar 12, Betongen er rundt en kabelforankring er sterkt misfarget og er i ferd med å ødelyses

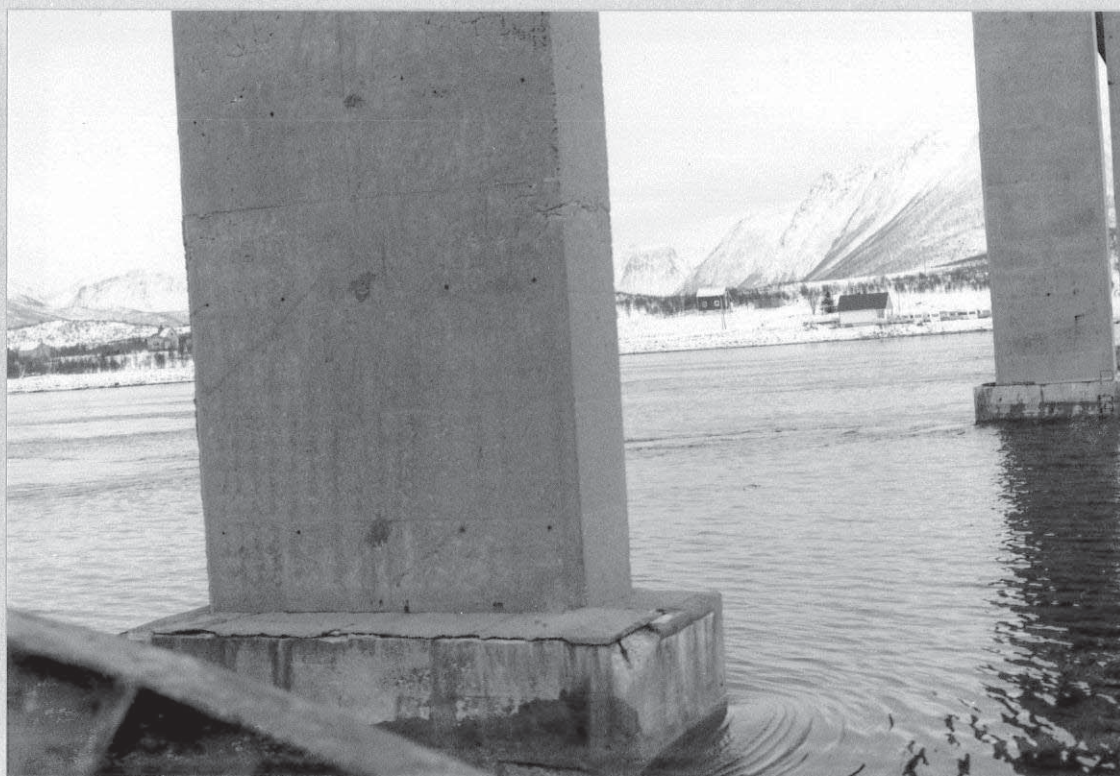
Pilaren ser meget bra ut. Det er ikke registrert skader av betydning. På vestre vegg ca. 4,0 m over fundament-toppen er det påvist et mindre steinreir, se bilde nr. 42.

Pilar 13 søndre og vestre vegg

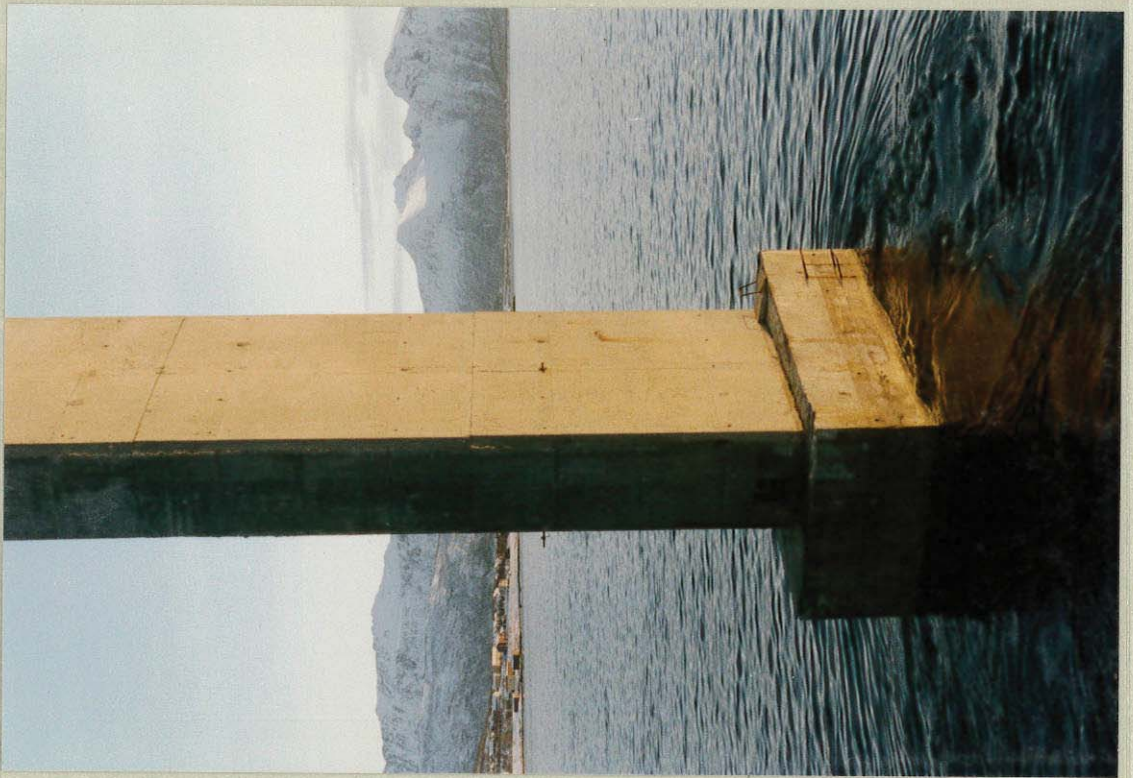
På det nordøstre hjørne er det funnet et vertikalt riss i en høyde av 2000 mm over fundamenttoppen. Det er ikke påvist rustutslag i risset. På nordre vegg ca. 200 mm over ok fundament er det rustutslag, se bilde nr. 45. Overdekningen er målt med Covermeter og er funnet å være 25 - 40 mm på østre vegg og 30 - 50 mm på vestre vegg. På pilarens østre side står det to AZ stag ut av veggen. Disse ligger 2000 mm over fundamentet, se bilde nr. 44.

Pilar 14 østre og søndre vegg
