Long-term performance of cathodic protection (CP) of marine bridge, inspection of Sortlandsbrua 27 years after CP installation

An investigation of performance and damages on the installation.

Master's thesis in Experience-based Part-time Master
programme Road and Railway Engineering
Supervisor: Mette Rica Geiker
May 2019

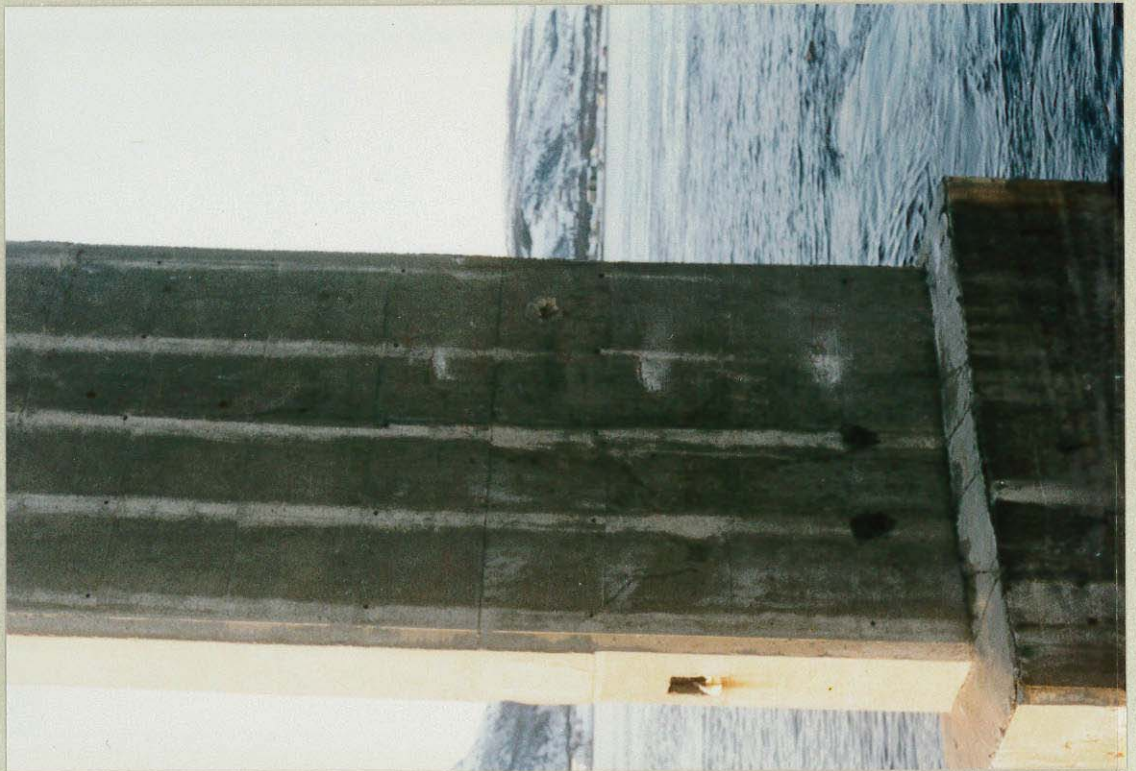
På det nordøstre hjørne er det funnet et vertikalt riss i en høyde av 2000 mm over fundamenttoppen. Det er ikke påvist rustutslag i risset. På nordre vegg ca. 200 mm over ok fundament er det rustutslag, se bilde nr. 45. Overdekningen er målt med Covermeter og er funnet å være 25 - 40 mm på østre vegg og 30 - 50 mm på vestre vegg. På pilarens østre side står det to AZ stag ut av veggen. Disse ligger 2000 mm over fundamentet, se bilde nr. 44.

Pilar 14, vestre og nordre side.

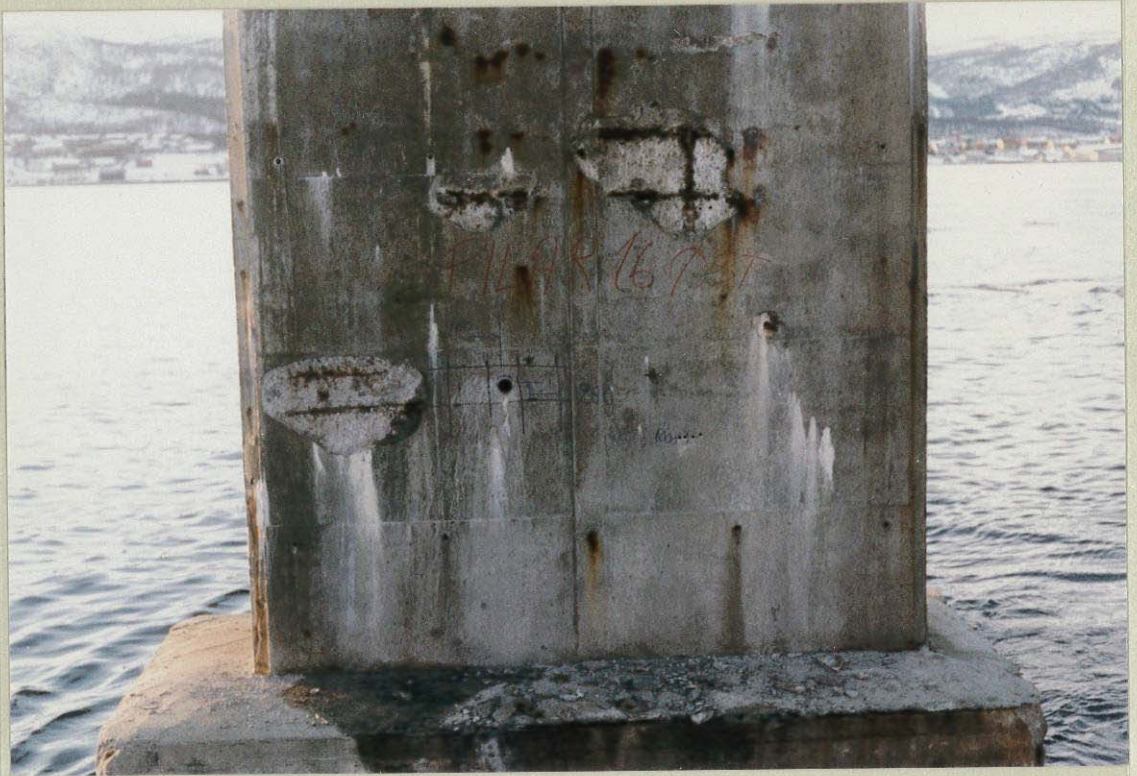
50.

På østre vegg er det i området fra ok fundament og 4 - 5 m opp registrert flere rustutslag, avskallinger og riss. I rissene er det påvist fellingsprodukter, se bildene 50 og 51. På kote + 3,0 m er avskallet betong hugget bort. Denne er 700 mm bred 400 mm høy og går inn til armeringen. Frilagt armering er meget sterkt angrepet av korrosjon, se bildene 53 og 54. Overdekningen er målt til 20 mm i dette området.

Armeringen på pilarens østre side synes å være i en korrosiv tilstand i en høyde av 4 - 5 m. Ved nedslåing av avskallet betong ble det konstatert sterkt forvitret betong bak et 10 - 15 mm hardt sjikt. Dette kan indikere at betongen i denne pilaren er frostskaadet. Dette bør undersøkes nærmere.

Pilar 16 østre side

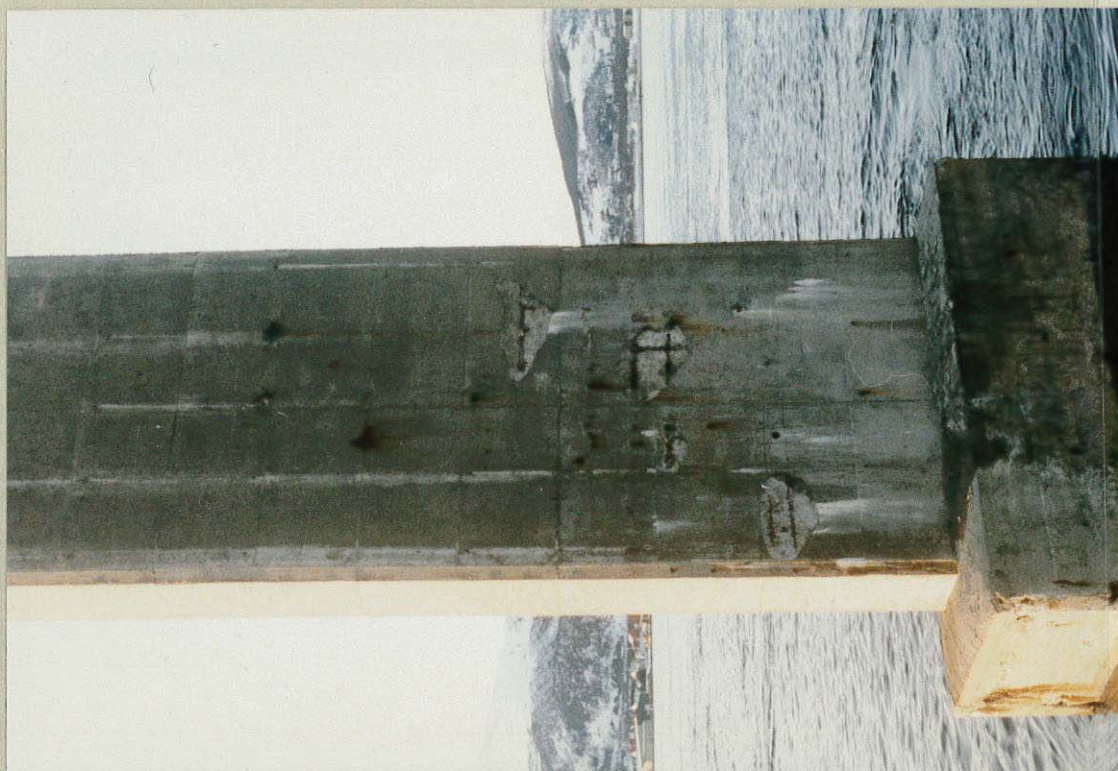
51.

Pilar 16 østre og søndre side

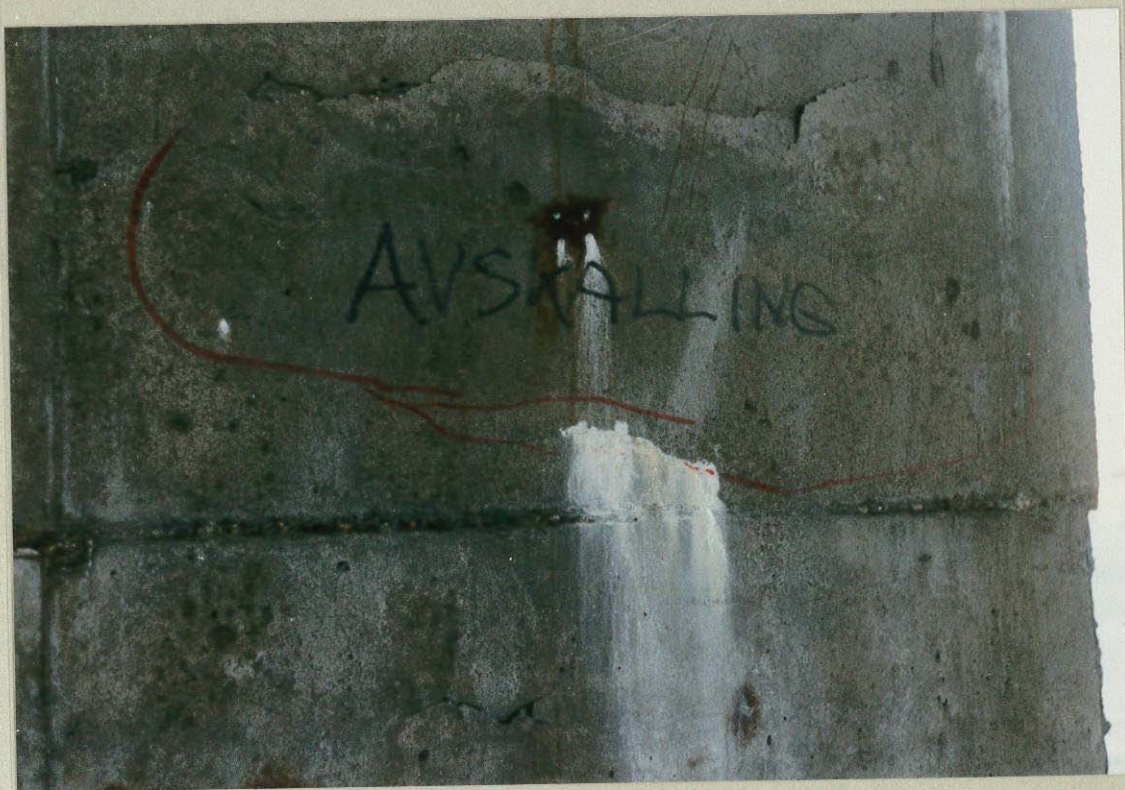
52.

Pilar 16 øst avskalling på kote +3000

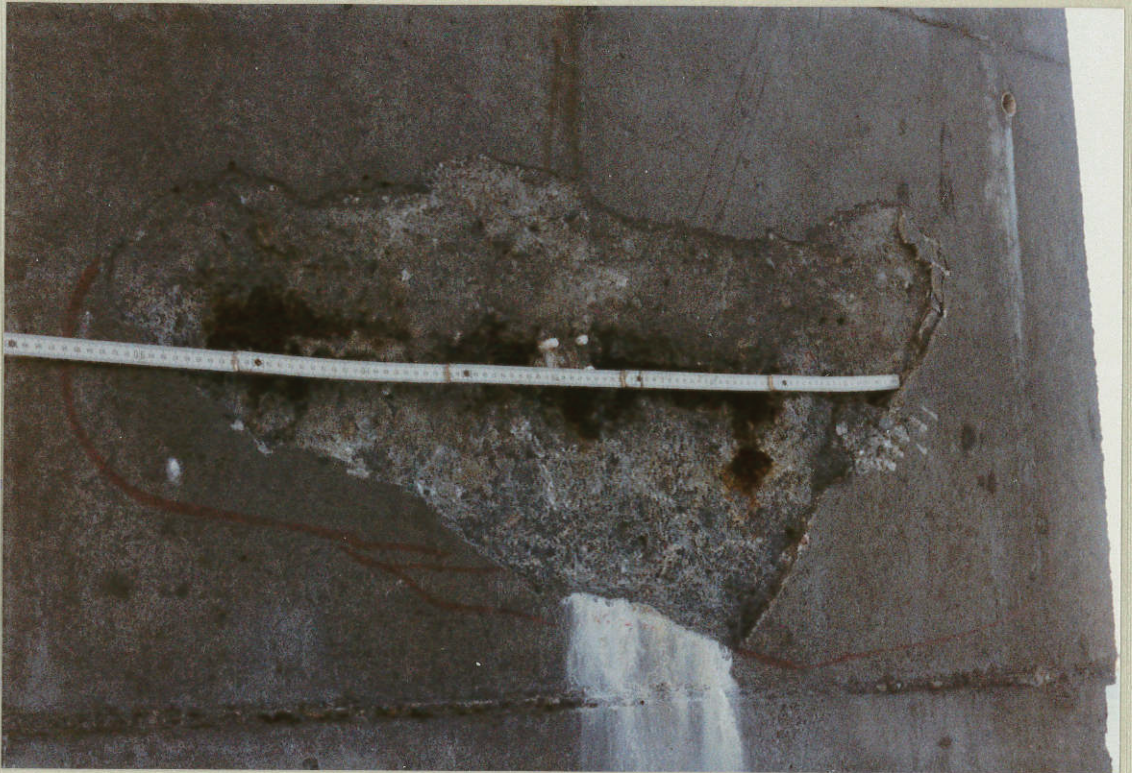
53.

Pilar 16 øst - samme som foregående, men
etter nedslåing av avstalling.

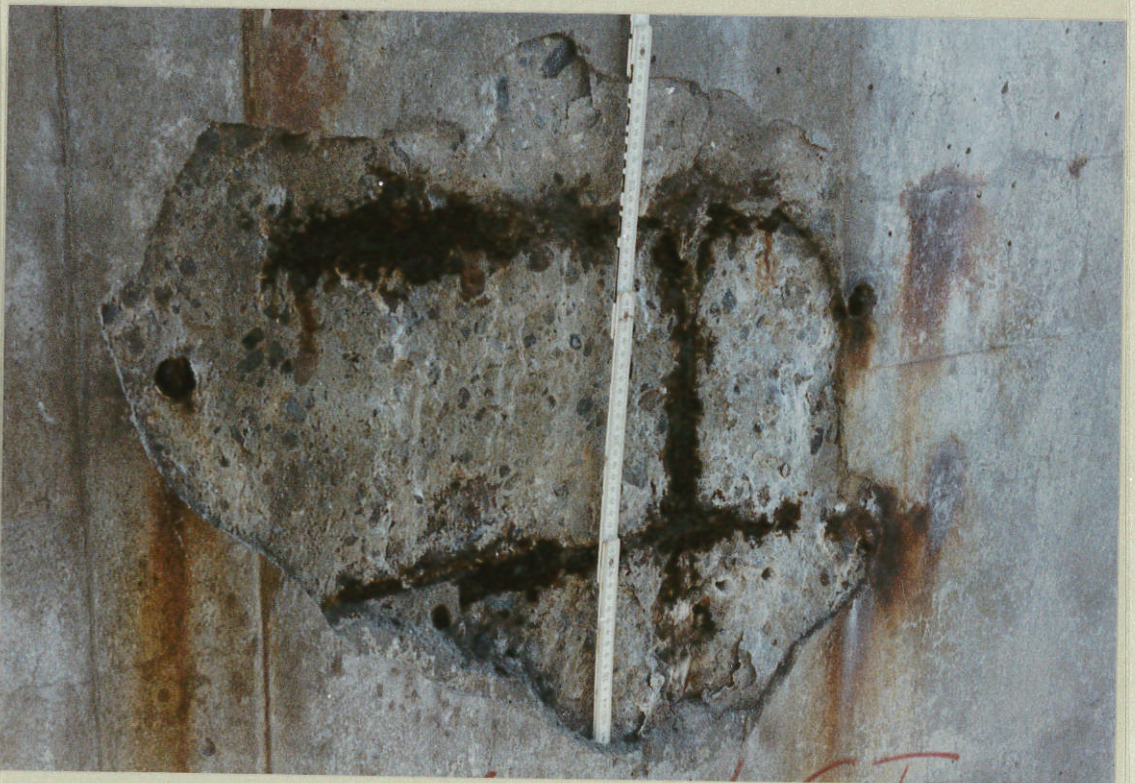
54.

Pilar 16 øst - heftig korrosjon på nivå +2000
