Korrosjonsforsøk på bolter i Vardøtunnelen

Etatsprogrammet Varige konstruksjoner 2012-2015

Nr. 464

Corrosion test on rock bolts in the Vardø tunnel

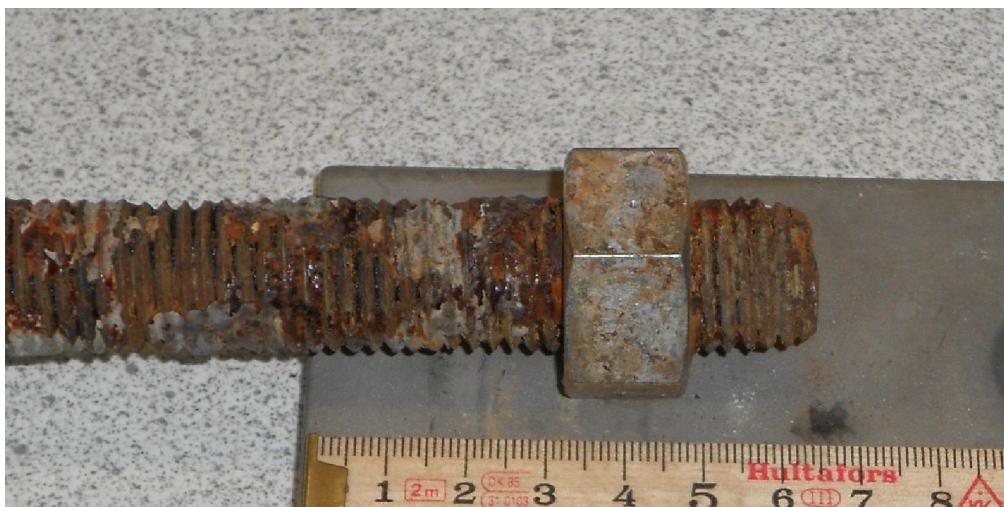
Figure 4. Bolt nr. 5. Identification mark.

After the inspection the bolt was identified, for future reference, with one indent dot in every other face of the stainless steel nut, see Figure 4.

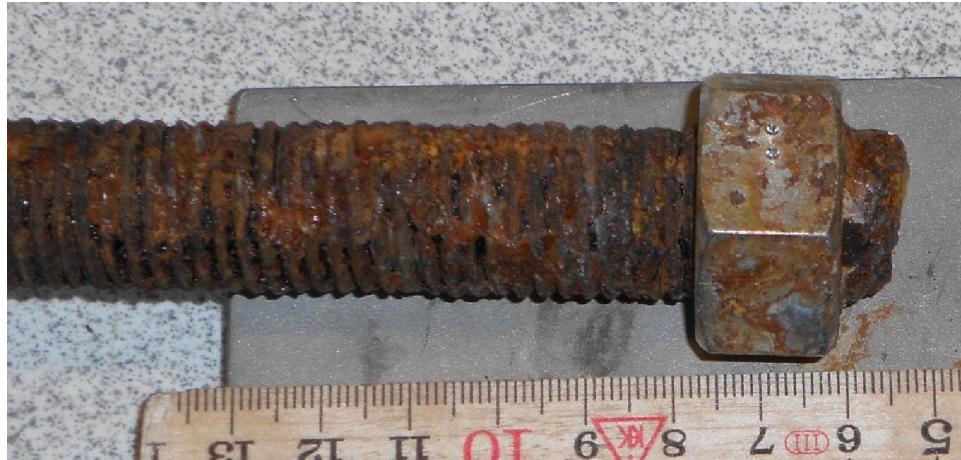
Figure 6. Bolt nr. 6. Identification marks.

The measured thickness of the galvanized coating is slightly higher on this bolt than the 70 microns estimated as the original thickness in Report 1608. The average thickness of the grey epoxy coating is about 100 microns which can be considered normal for a single layer epoxy coat.

After the inspection the bolt was identified, for future reference, with two indent dots in every other face of the stainless steel nut, see Figure 6.

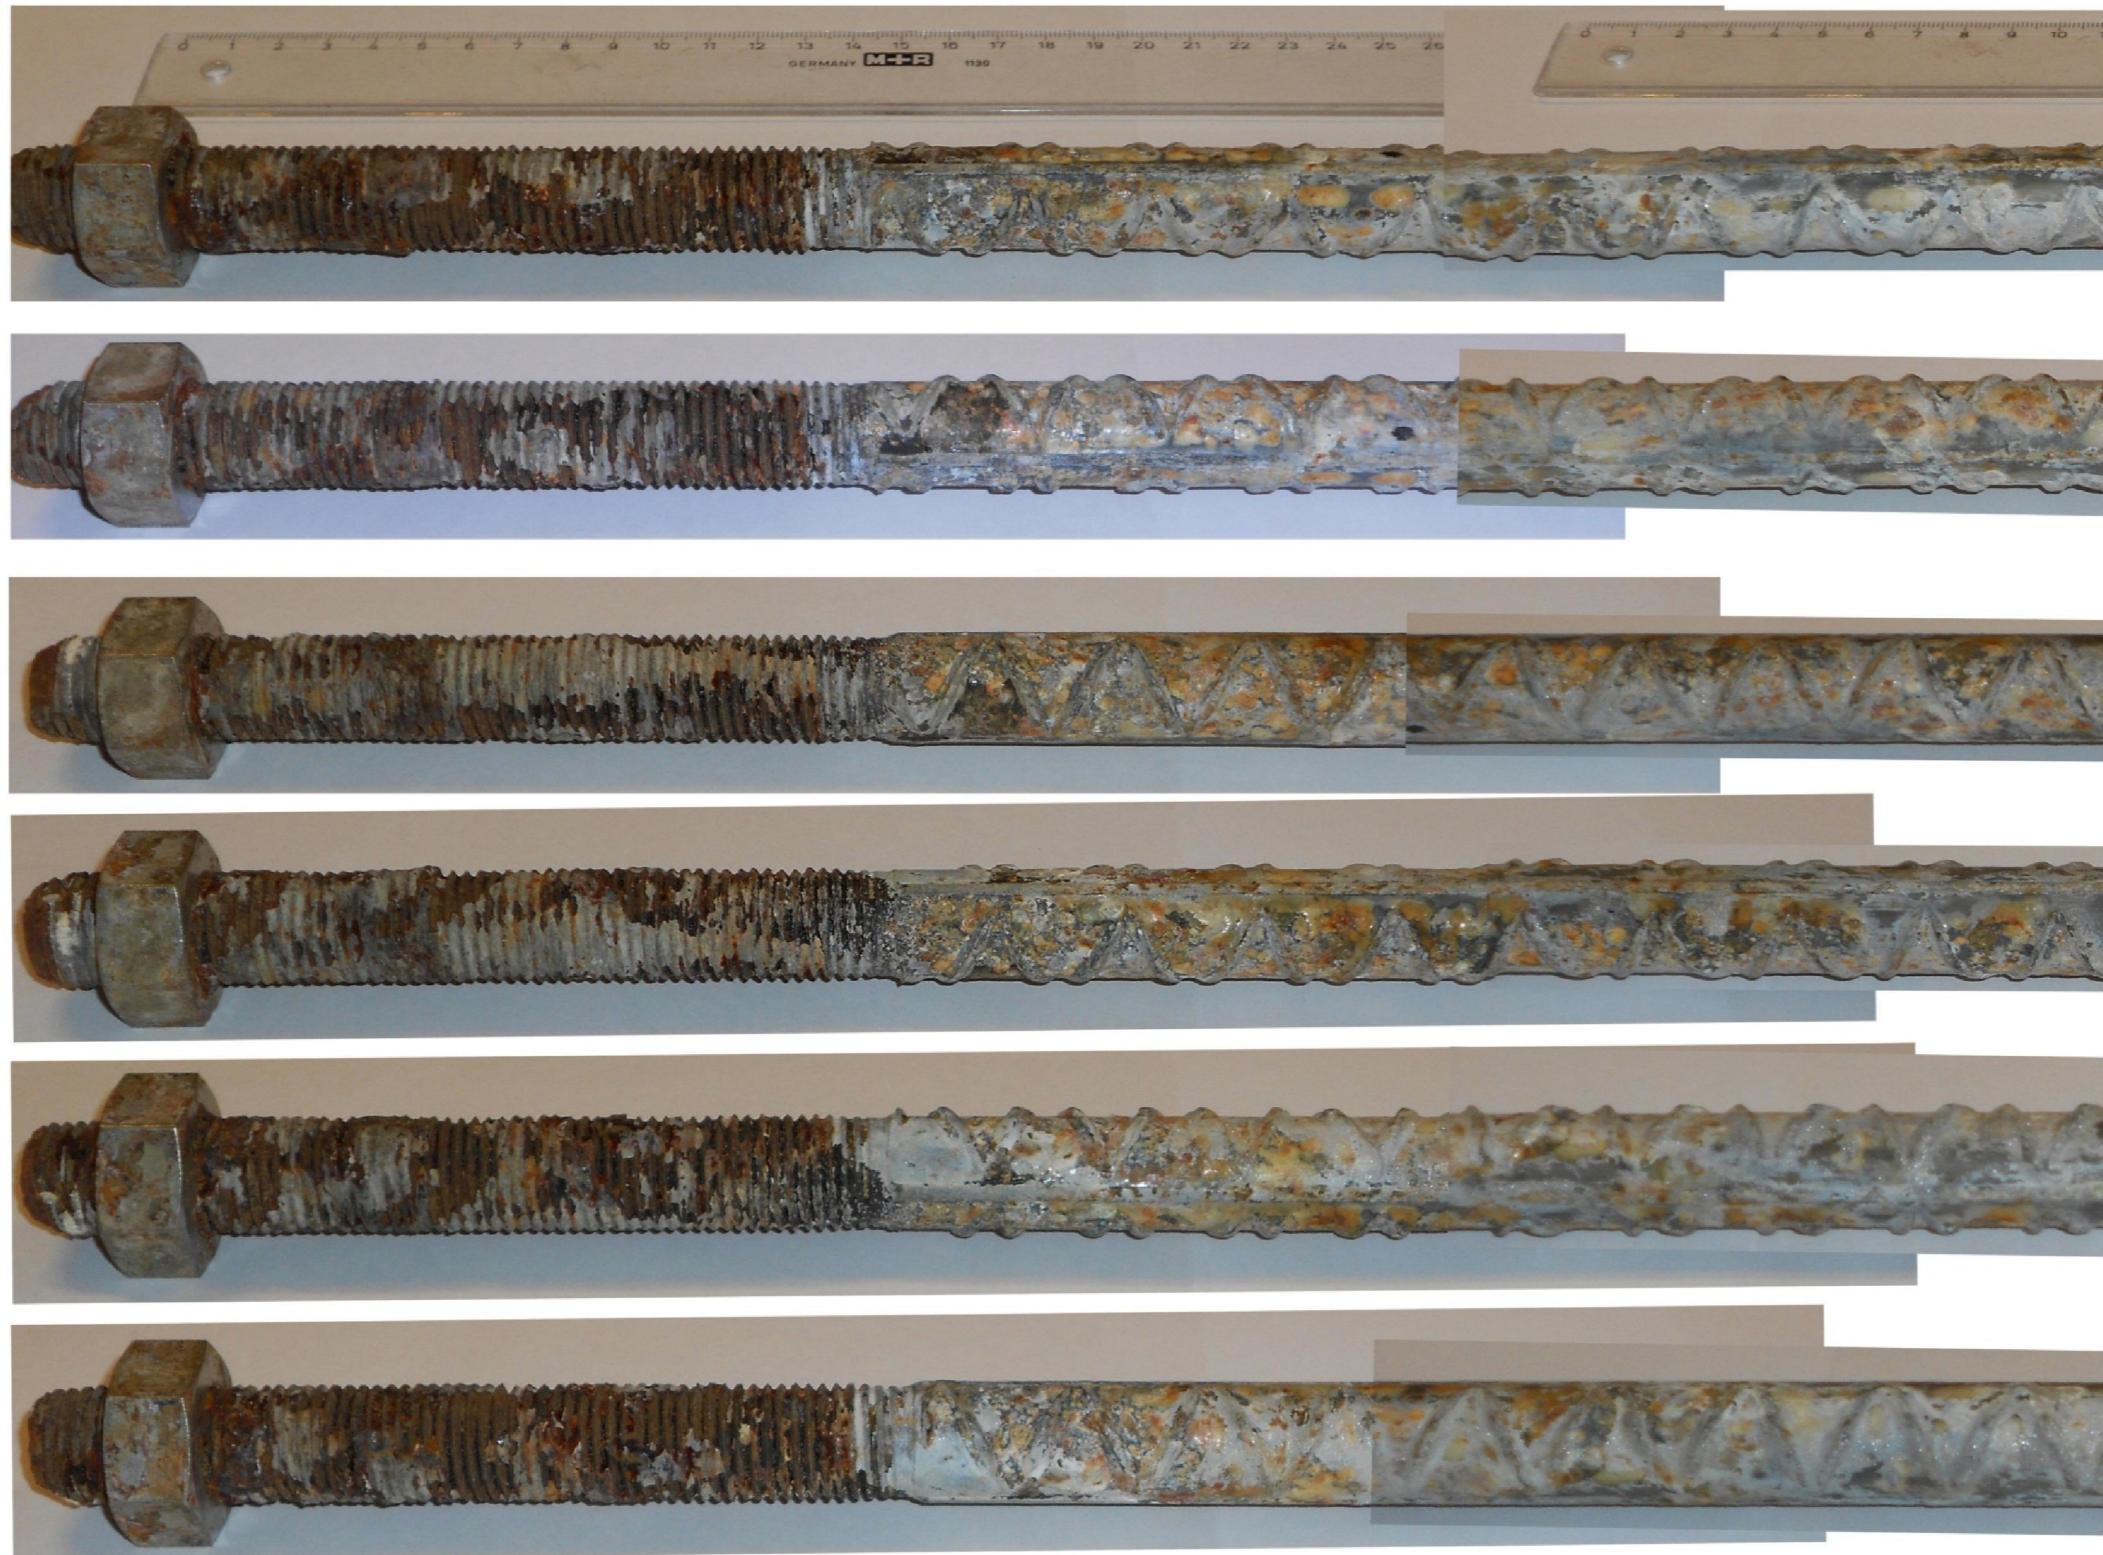
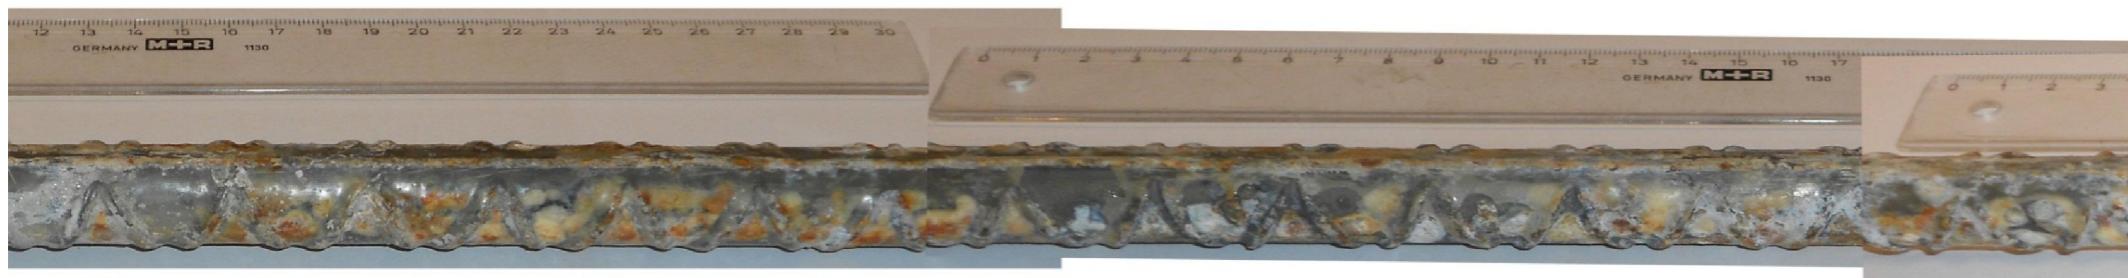
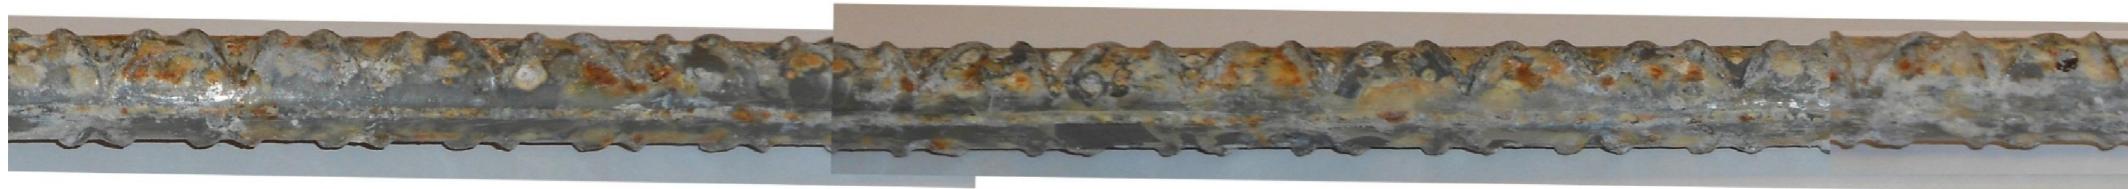
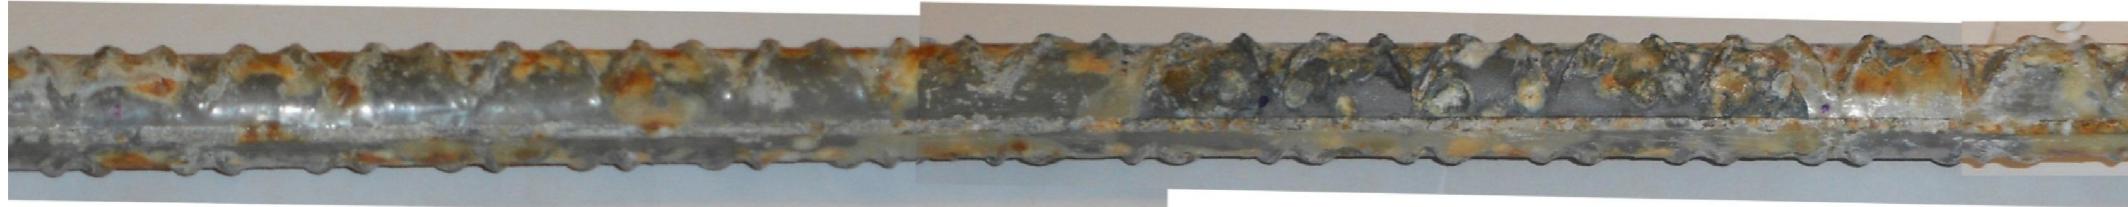
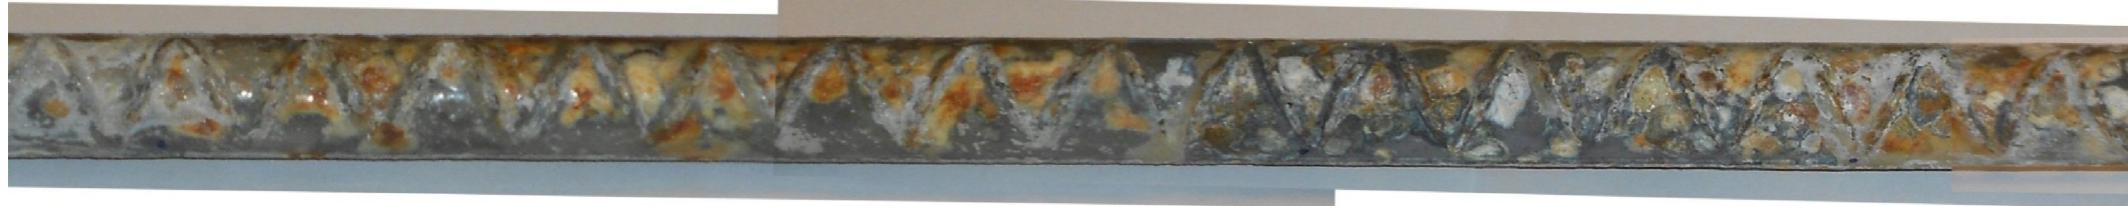
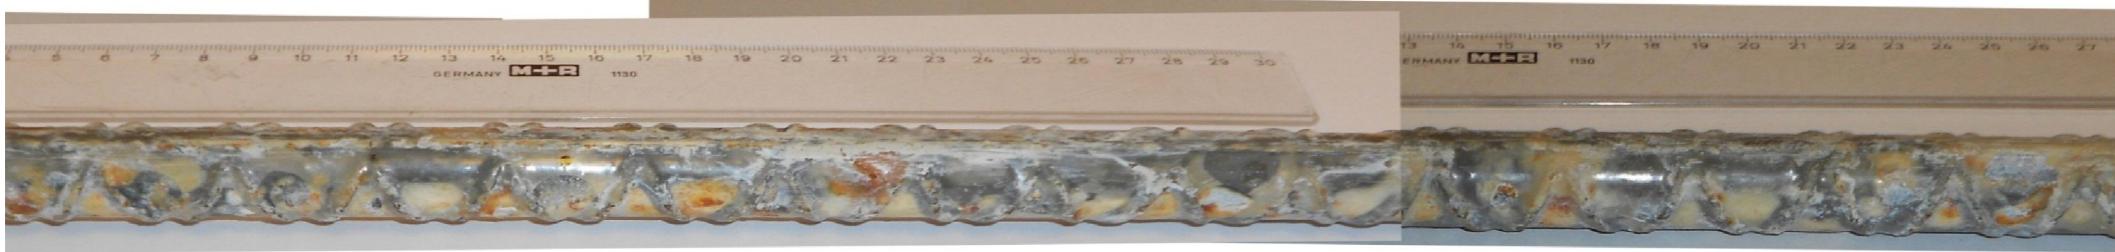
Figure 10. Bolt nr. 5 Galvanized with one layer of clear epoxy after cleaning.

Photos were taken along the entire length of the bolts all around with 60 ° rotation. The photos were assembled in Photoshop, each 60 ° rotation is shown in Figure 10 and Figure 11. The original .psb and .jpg files are copied on a memory stick, which is attached to this report.

The description of one side of the bolt is given in Table 8. Each area between V-shaped ribs was described for one side of the bolt, a total of 113 areas. The V-shaped ribs which were described are seen in line 2, 3 and 4 (counted from top) in Figure 10.
