Antonia Menga
Terje Kanstad
Daniel Cantero

Corrosion induced failures of post-tensioned bridges

Trondheim – May – 2022

Report

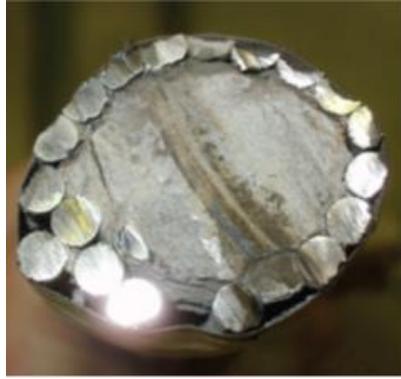
Figure 2.3.2. Sorell Bridge (ID-3). Cross sectional view of one of the most severely corroded tendons. The tape just visible around the outside was applied during recovery to keep the tendon together at the cross sectional cut. There is no tendon duct (Papè and Melchers, 2011).

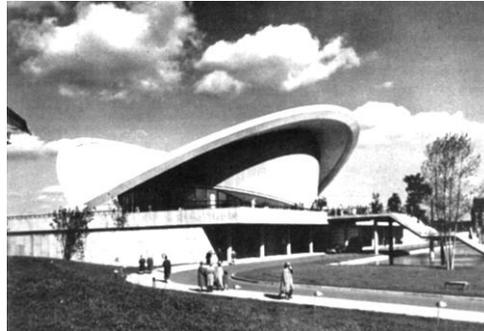
ID-19 was a structure covered by a double curved roof (Figure 3.1.4) erected on only two bearings (Figure 3.1.5). The roof consisted of two prestressed parts (inner- and outer-roof, respectively) resting on a concrete ring beam. It suddenly collapsed (Figure 3.1.6) due to corrosion-induced fractures in the tendons. The collapse occurred without early indications (Helmerich and Zunkel, 2014).

Figure 3.1.4. Original structure of Berlin Congress Hall (ID-19) before sudden collapse (Helmerich and Zunkel, 2014).

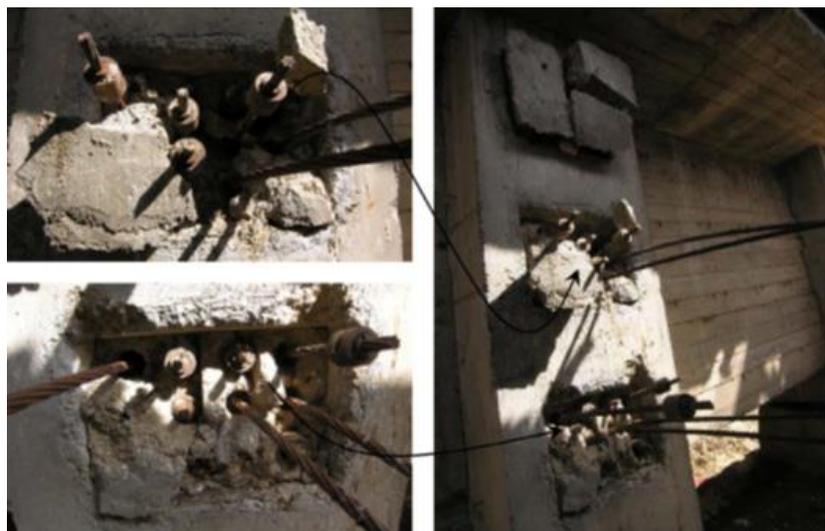
In the Petrulla Viaduct (ID-4) the collapse was determined by the breakage of the tendons, with subsequent expulsion of the anchorages (Figure 3.1.7) due to the release of stored elastic energy in the tendons. The breakage was followed by loss of prestress, hence loss of shear capacity, and consequent inward rotation of the lower flanges of the I-section beams. This mechanism ended by forming a plastic hinge (Figure 3.1.8) at mid span of one of the beams (Anania et al, 2018).

Figure 3.1.7. Petrulla Viaduct (ID-4). Expulsion of the anchorages. Global view of the expulsion at the end of the beam (Anania et al, 2018).

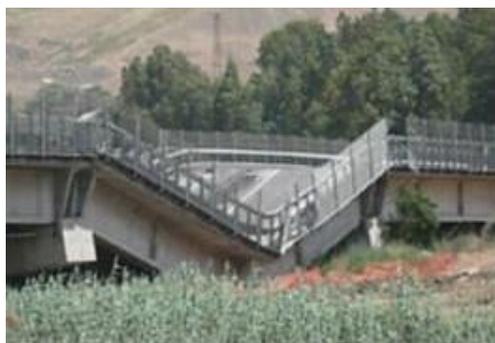
Figure 3.1.8. Collapse mechanism of Petrulla Viaduct (ID-4) (Anania et al, 2018).

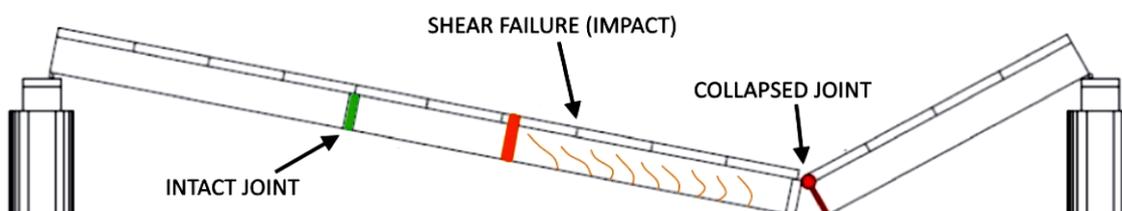
Another example of collapse mechanism (Figure 3.1.9) is the one that took place in Fossano Bridge (ID-5). The collapse was triggered by a shear failure in one of the joints, due to absence of the equilibrating action of the prestressing system (Bazzucchi et al, 2018).

Figure 3.1.9. Collapse mechanism of Fossano Bridge (ID-5) (Bazzucchi et al, 2018).

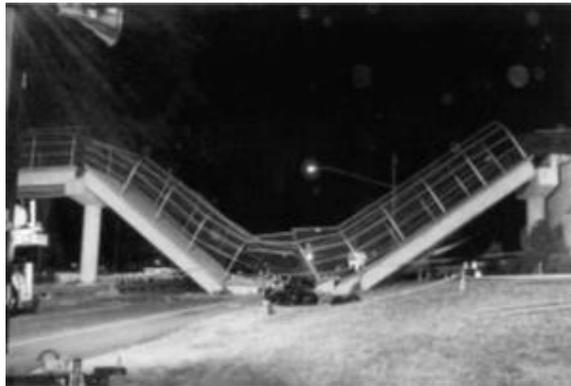
The collapse in Lowe’s Motor Speedway (ID-9) occurred while 107 people were passing over it (Poston and West, 2005), with the complete failure of one span (Figure 3.1.11). The collapse of Annone Viaduct (ID-21) was due to overloading, after the bridge suffered from numerous collisions and subsequent repairs over time (Di Prisco et al, 2018).

Figure 3.1.11. Collapsed span of Lowe’s Motor Speedway (ID-9) (Poston and West, 2005).

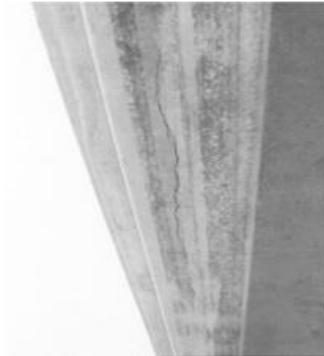
Poston and West (2005) estimated that the collapse of Lowe’s Motor Speedway (ID-9) could have been avoided if observed warning signs had been taken into consideration. These signs included:

- longitudinal cracks (Figure 3.1.17) along the stem soffit at mid span directly under the grout plug location;
- corrosion staining around the grout plugs in several beams.

It was evident that the grout plugs, used in the process to give the strands their profile in the beams, clearly represented a weakness for the bridge.

Figure 3.1.17. Lowe’s Motor Speedway (ID-9): longitudinal crack in double-T stem directly under the grout plug location (Poston and West, 2005).

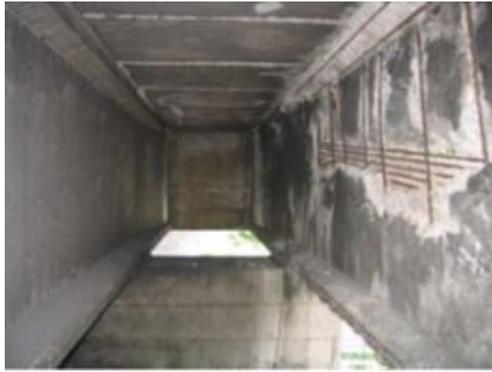
In Annone Overpass (ID-21) high levels of corrosion as well as concrete spalling were observed along the beams (Figure 3.1.19). However, the presence of a shear crack at the Gerber joint (Figure 3.1.20) was well known from more than 10 years before the collapse (Di Prisco et al, 2018).

Figure 3.1.19. Annone Overpass (ID-21). Damage observed on internal surfaces of the prefabricated beams in 2006 (Di Prisco et al, 2018).

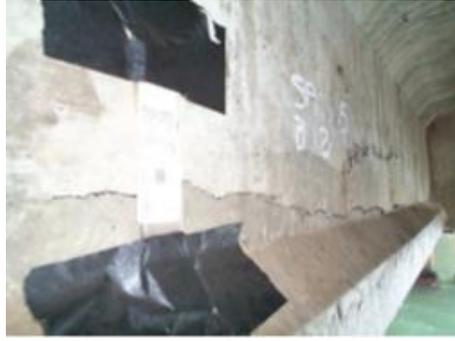
Sorell Bridge (ID-3) was demolished because of the appearance of cracking (Figure 3.1.21) along the web of 51 beams. The cracks followed the path of the post-tensioning tendons, leaving the tendons without concrete protection in some cases (Papè and Melchers, 2011).

The cracks raised concern especially because the tendons were encased directly in the concrete, without ducts. Hence, the tendons would have been directly exposed to the external environment (rich in chlorides since the bridge crossed a lagoon). Moreover, the damage was extended to several beams.

Figure 3.1.21. Typical longitudinal web cracking along a beam in Sorell Bridge (ID-3) (Papè and Melchers, 2011).

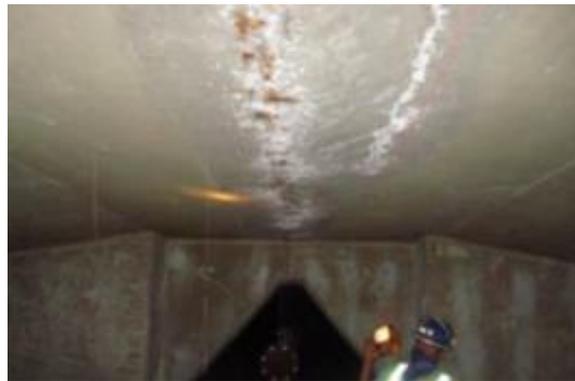
Figure 3.1.23. Bridge in the Midwest, USA (ID-13). Presence of efflorescence, delamination, and spalling observed on post-tensioned box girders (Venugopalan, 2008).

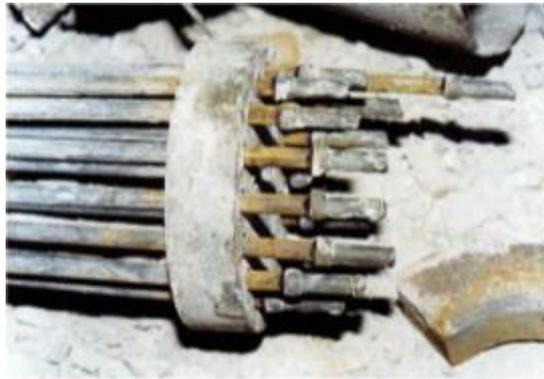
Figure 3.3.3. Corrosion of wires at anchorage plate in I-94 Bridge over US 81 (ID-30) (Dickson et al, 1993).

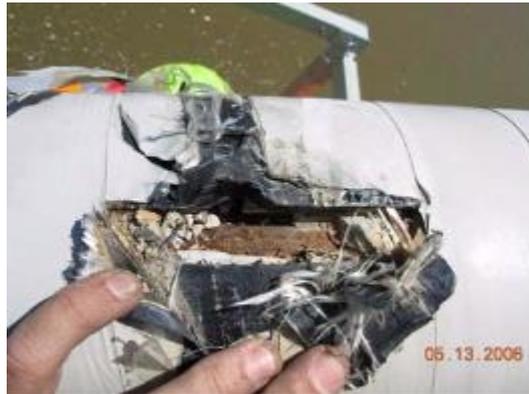
Failed tendons (either cables or prestressing tendons, externally or internally post-tensioned) usually appeared corroded, with longitudinal and transverse splits in the PE duct (Figure 3.3.6). There were also cases with completely ruptured tendons, lying on the bottom of the span (Figure 3.3.7) or tendon slippage from the ducts in the failed section of the structure (Figure 3.3.4).

Figure 3.3.6. Luling Bridge (ID-10). Corrosion of wires at PE split (Mehrabi, 2009).

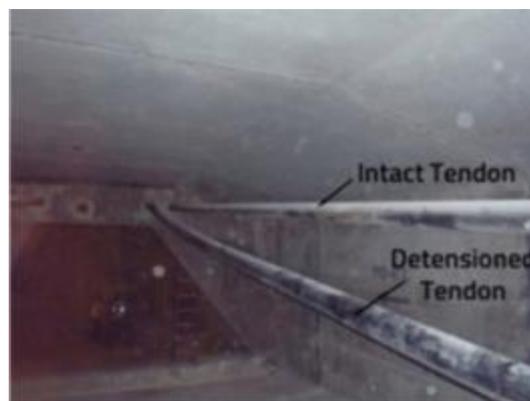
Figure 3.3.7. Ringling Causeway Bridge (ID-15). Detensioned tendon discovered in July 2011 (Ahern et al, 2018).

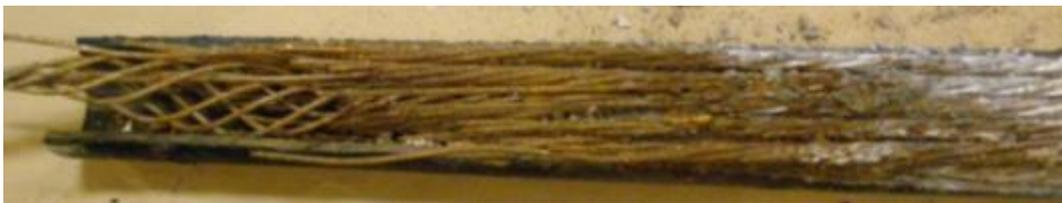
Figure 3.3.8. Corroded tendon in a Florida Bridge (ID-20) (Lau and Lasa, 2016).

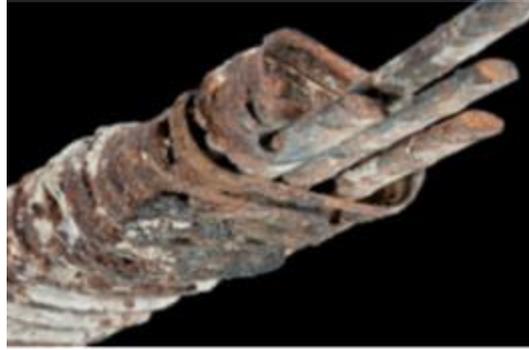
In Berlin Congress Hall (ID-19, described in Section 3.1) the roof failed next to the final groove of the ring beam (Helmerich and Zunkel, 2014). In that location, most of the tendons and the metallic ducts in which the tendons were encased appeared heavily corroded (Figure 3.3.11).

Figure 3.3.11. Remaining bituminized roofing on a completely failed, non-grouted and heavily corroded tendon in Berlin Congress Hall (ID-19) (Helmerich and Zunkel, 2014).

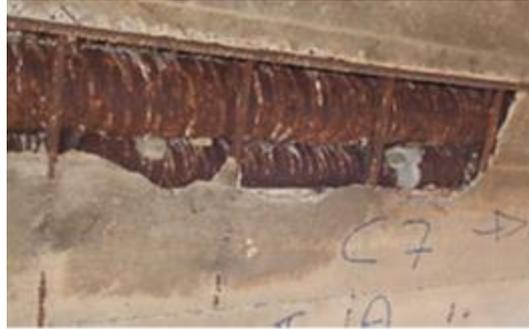
Figure 4.2.1.1. No gap among the tendons in Petrulla Viaduct (ID-4) (Anania et al, 2018).

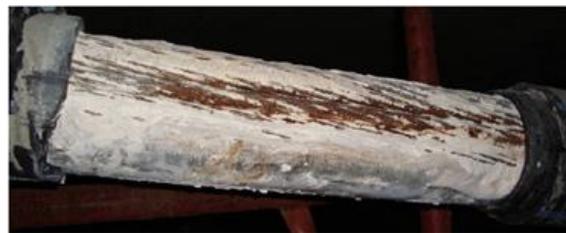
Corrosion, mostly in the form of pitting, took place in segments of the tendon that exhibited visible segregation of the grout or had partial or full depth voids (Ahern et al, 2018). In these locations the grout remained unhardened with a white, soft, and chalky appearance (Figures 4.2.2.1 and 4.2.2.2). The whitish grout had high pH, and contained only trace levels of chlorides, but high sulphate levels, even if the corrosion process occurred without infiltration of external chlorides or sulphates into the ducts. It is important to highlight that no corrosion attacks were found in the areas where the tendons were embedded in a regular hardened cement grout (Carsana and Bertolini, 2015).

Figure 4.2.2.2. Example of whitish segregated grout embedding corroding strands in an Italian bridge (ID-18) (Bertolini and Carsana, 2011).

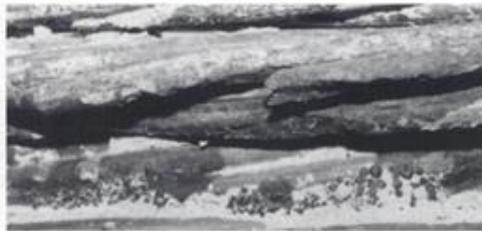
In Florida, concerns about grouting practices rose again in 2000, with the failure of external tendons (Figure 4.2.2.3) at the Mid-Bay Bridge (ID-7).

Figure 4.2.2.3. Broken wire in one of the strands of Mid-Bay Bridge (ID-7) (Venugopalan and Powers, 2003).

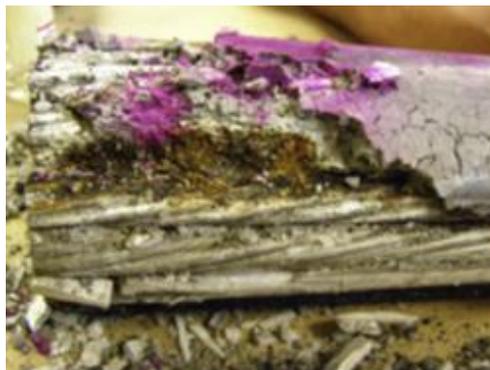
The post-tensioning industry in the United States responded with the adoption of more rigorous grout specifications (low permeability and little to no bleed) and execution programmes to ensure high-quality grouting operations. Thanks to the measures adopted, the number of tendon failures due to corrosion dropped. However from 2011 other bridges, constructed with the new measures adopted in 2000 (e.g., ID-15, Figure 4.2.2.4), reported tendon failures due to grout segregation.

Figure 4.2.2.4. Corrosion of a strand embedded in deficient grout in Ringling Causeway Bridge (ID-15). Pink colour shows the pH indicator (phenolphthalein) sprayed on the grout surface (Lau and Lasa, 2016).

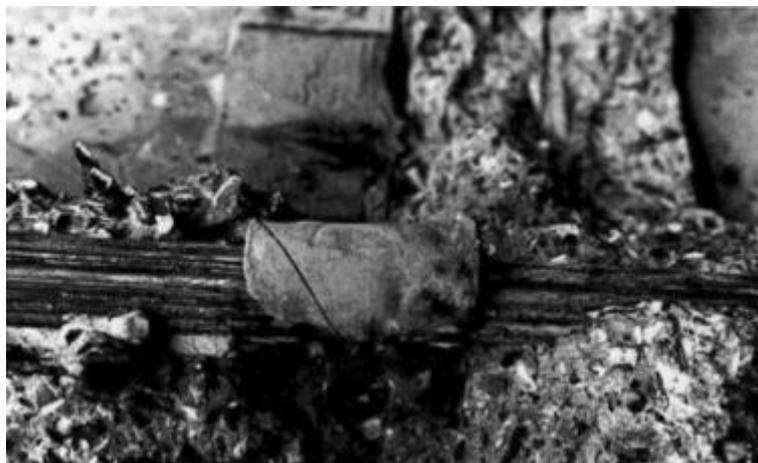
ID-1.3. Cardboard tube across transverse joint (Woodward and Williams, 1988).

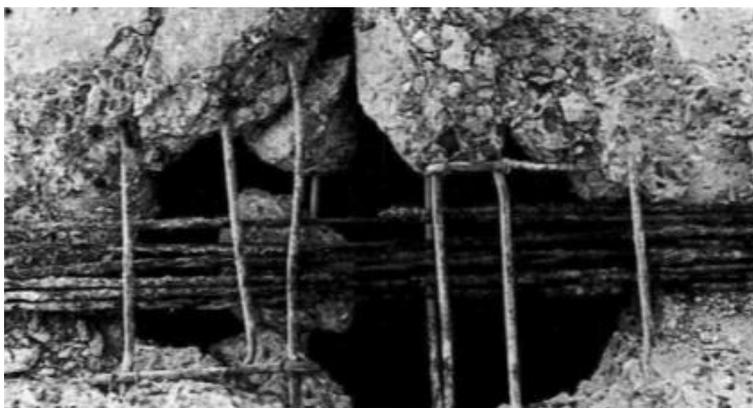
ID-1.6. Transverse tendon crossing a longitudinal joint: duct poorly grouted and corrosion on wires within segments (Woodward and Williams, 1988).

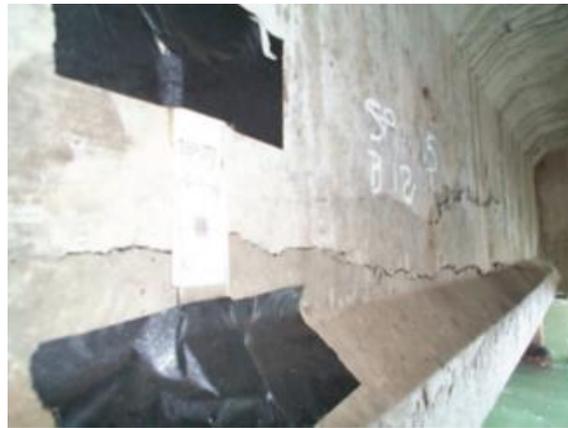
ID-3.2. Typical longitudinal web cracking along a beam (Papè and Melchers, 2011).

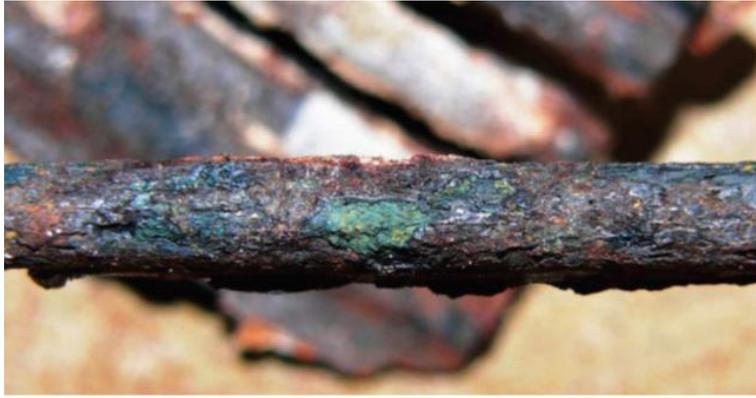
ID-3.4. Prestressing strand with corrosion products including dark-green-coloured rust (Papè and Melchers, 2011).

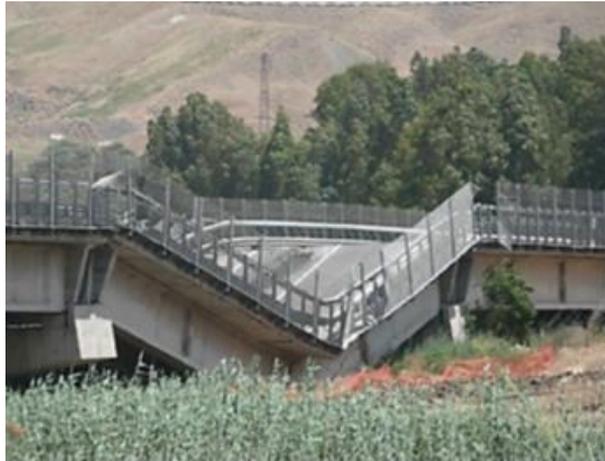
ID-4.1. Collapse mechanism of the bridge (Anania et al, 2018).

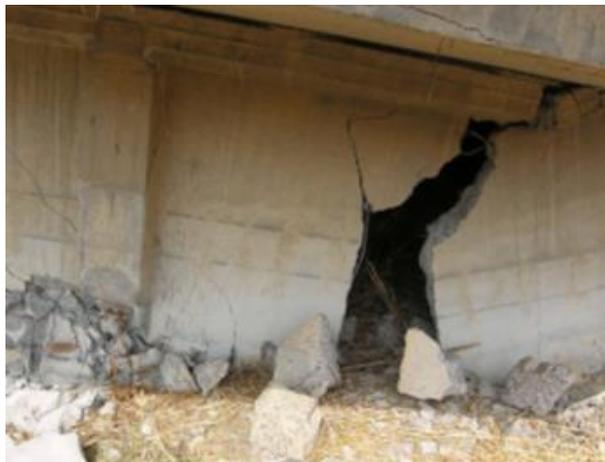
ID-4.2 Bridge beam: mid span fracture (Anania et al, 2018).

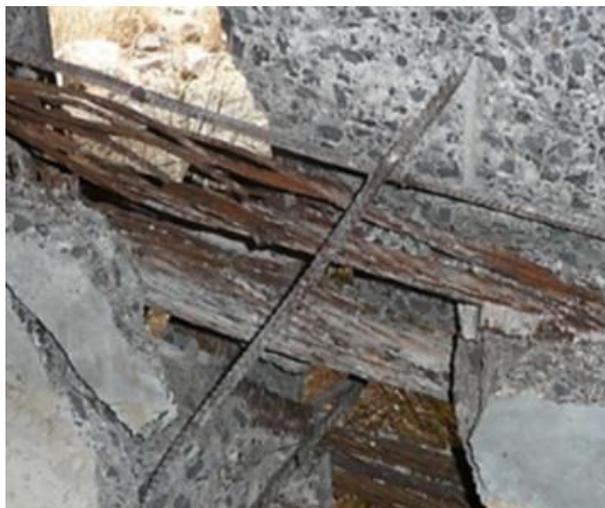
ID-4.3. Tendons in the bridge after collapse (Anania et al, 2018).

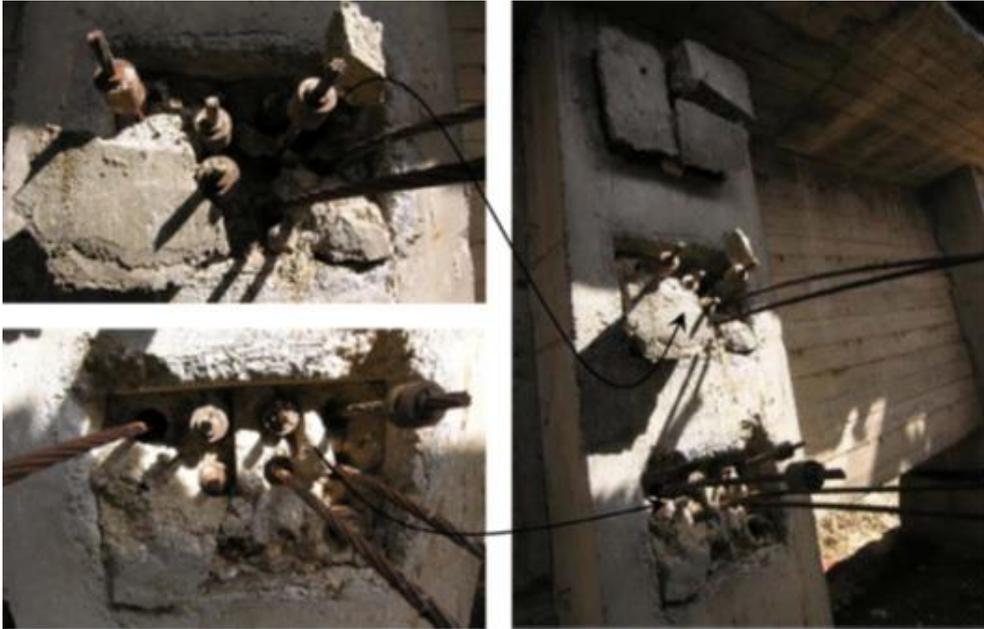
ID-4.4. Expulsion of the ducts head anchorages. Global view of the expulsion at the head of the girder beam (Anania et al, 2018).

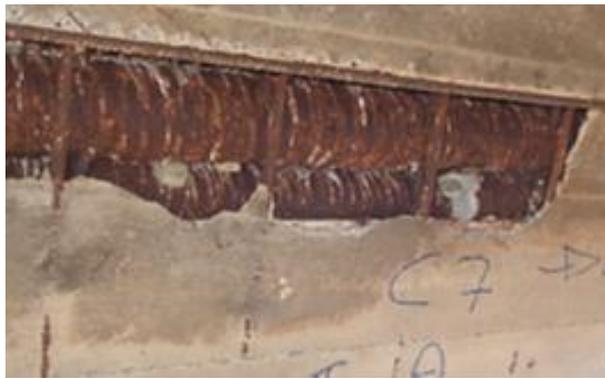
ID-4.5. No gap among the tendons (Anania et al, 2018).

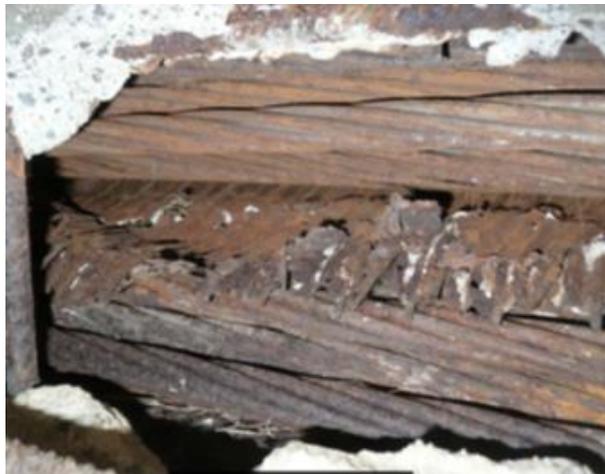
ID-4.6. Congestion of strands in the mid span of the bridge beams (Anania et al, 2018).

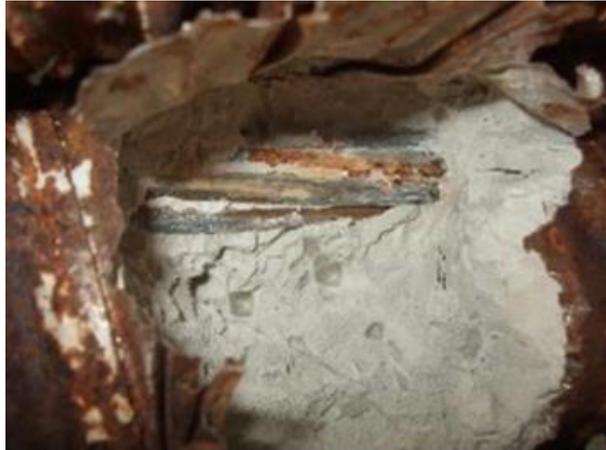
ID-4.7. View of the non-Portland cement grout for the bonding of tendons and advanced corrosion of both duct and strands (Anania et al, 2018).

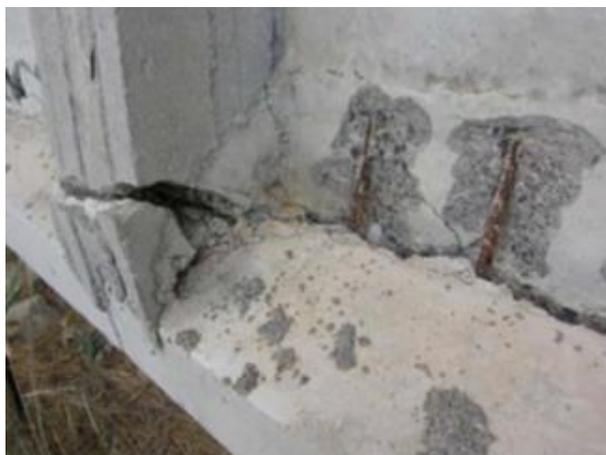
ID-4.9. Detailed view of vertical mild reinforcement expelled by the rotation of the lower flange (Anania et al, 2018).

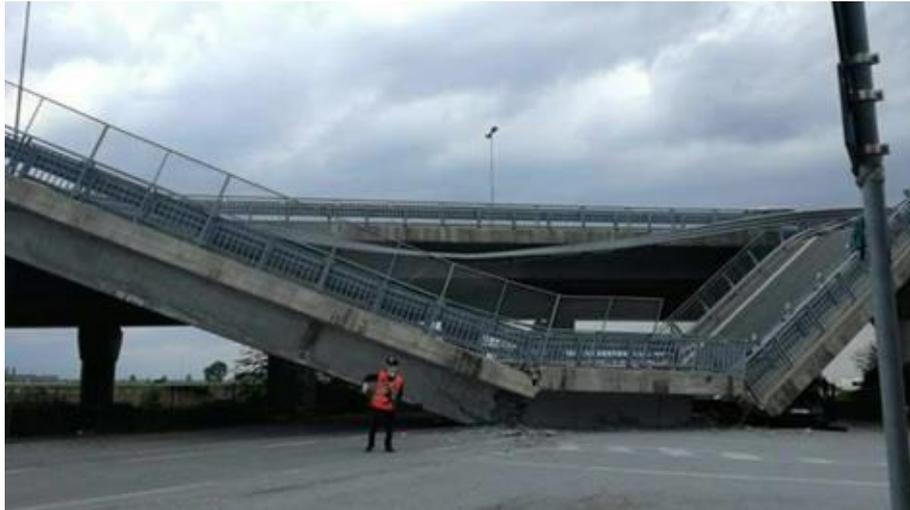
ID-5.1. Collapse mechanism of the bridge

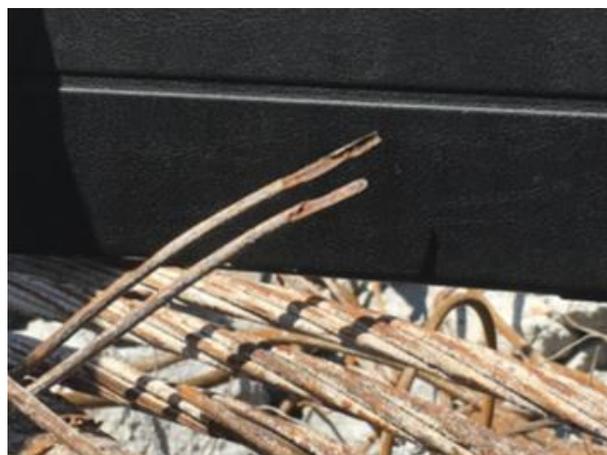
ID-6.8. Pit corrosion in the debris after failure (Nutti et al, 2020).

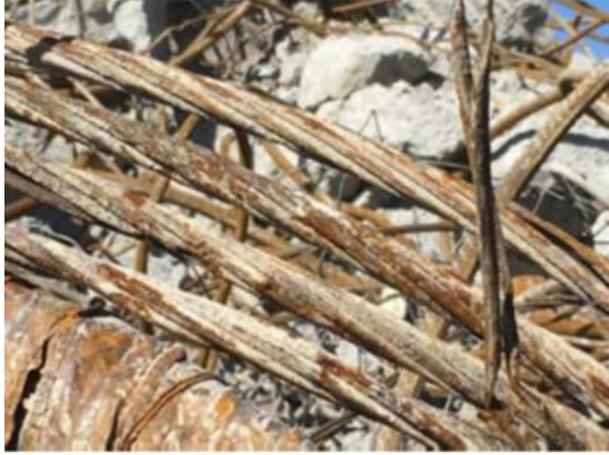
ID-6.9. Pitting corrosion of prestressing tendons (Morgese et al, 2020).

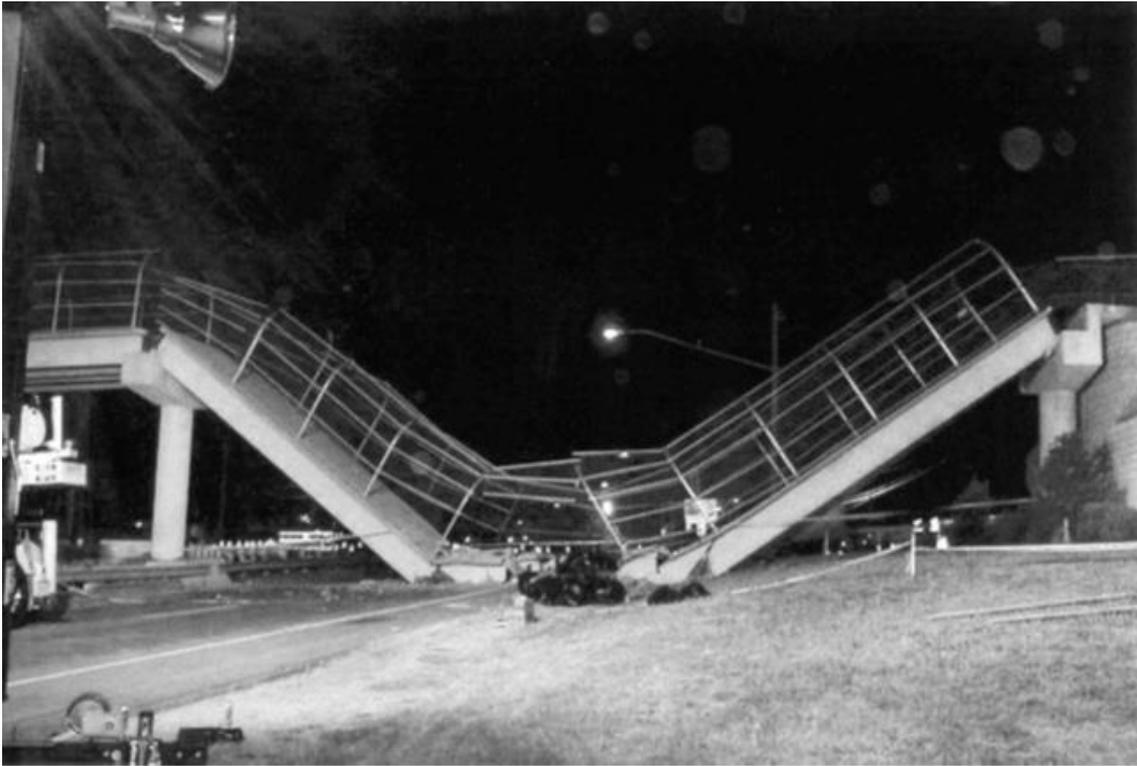
ID-9.1. Collapsed span of pedestrian bridge (Poston and West, 2005).

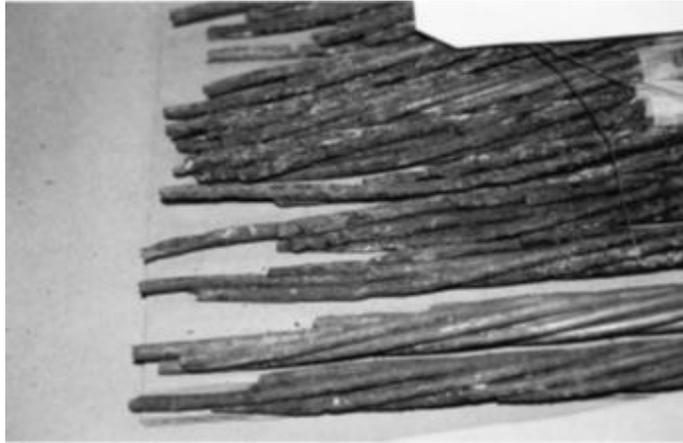
ID-9.3. Strand from one of the collapsed double-T's beams (Poston and West, 2005).

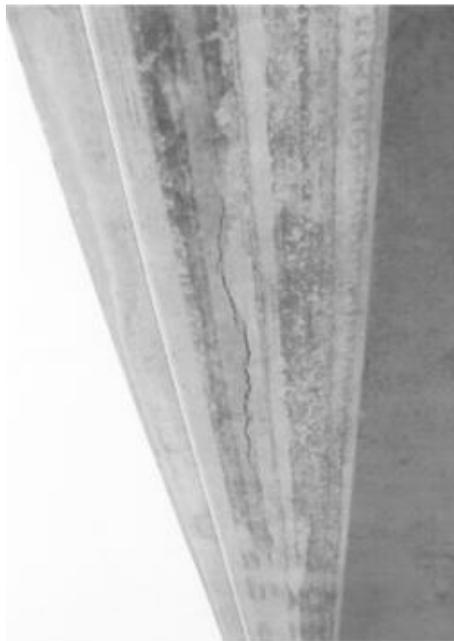
ID-9.5. Longitudinal crack in double-T beams stem directly under the grout plug location (Poston and West, 2005).

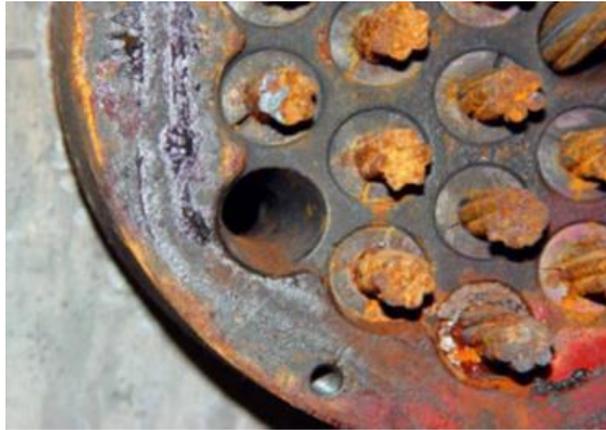
ID-14.1. Close-up view of an anchorage head at tendon location E3E-CO4S (continuity tendon) showing signs of corrosion from water collecting at the anchorage (Reis, 2007).

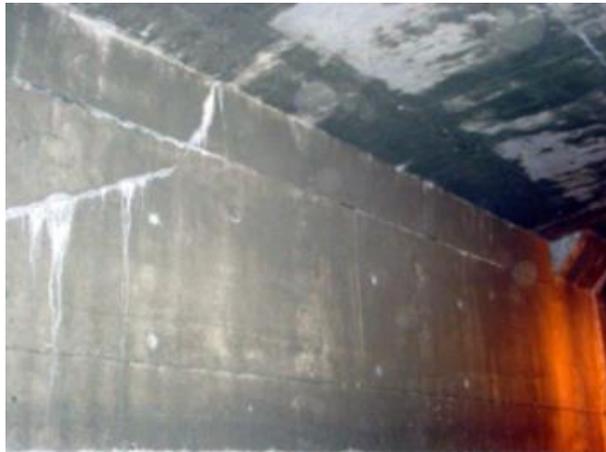
ID-14.2. View of interior web wall showing a crack and effervescence (Reis, 2007).

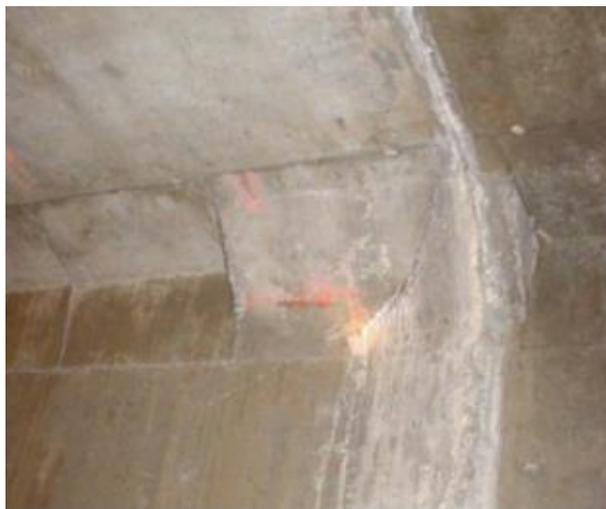
ID-14.3. View of a crack showing effervescence (Reis, 2007).

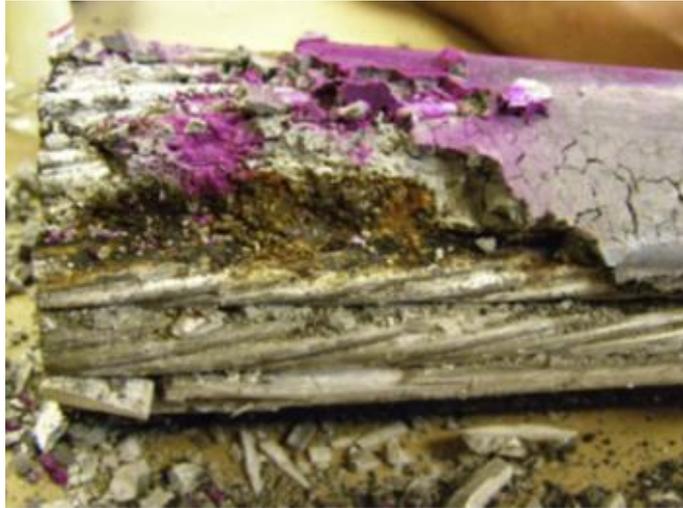
ID-15.6. Corrosion of a strand embedded in deficient grout. Pink colour shows the Ph indicator (phenolphthalein) sprayed on the grout surface (Lau and Lasa, 2016).

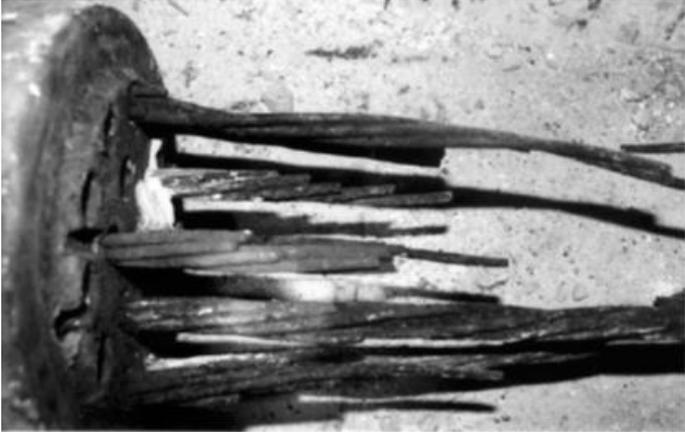
ID-17.1. Failed tendon of Niles Channel Bridge. June 1999 (Powers et al, 2002).

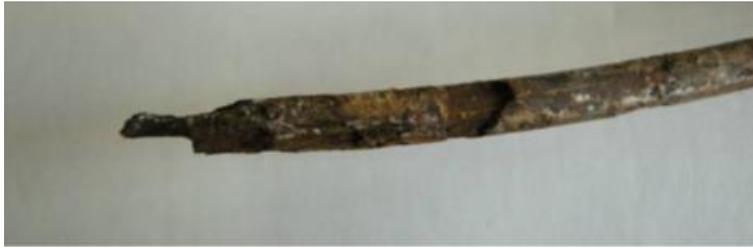
ID-18.1. Example of penetrating corrosion attacks observed on a wire of the failed cable (Bertolini and Carsana, 2011).

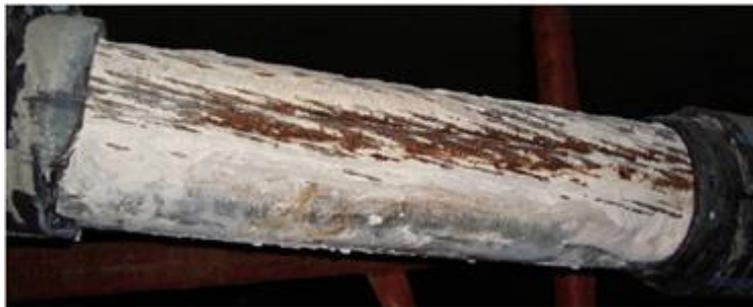
ID-18.2. Example of whitish segregated grout embedding corroding strands (Bertolini and Carsana, 2011).

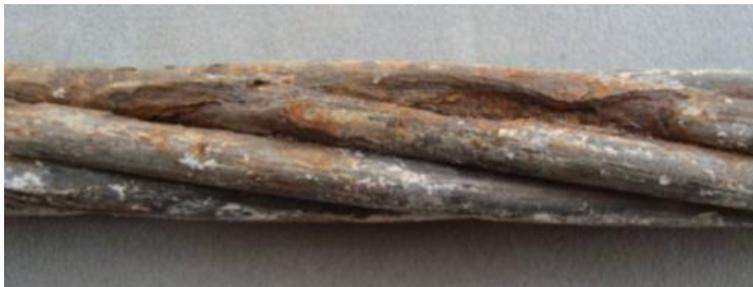
ID-18.3. Example of corrosion attacks on a prestressing strand in contact with the whitish segregated grout (Bertolini and Carsana, 2011).

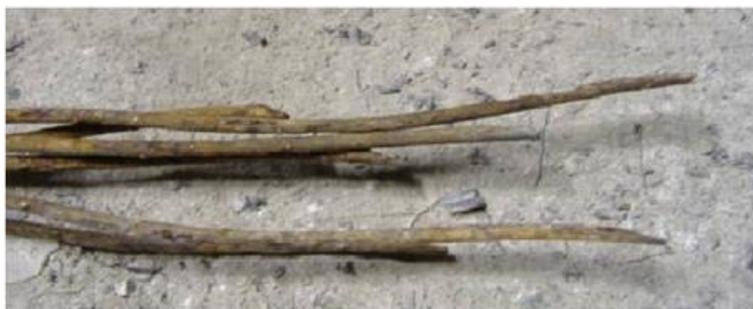
ID-18.4. Example of failed wires in a prestressing strand in contact with the whitish segregated grout (Bertolini and Carsana, 2011).

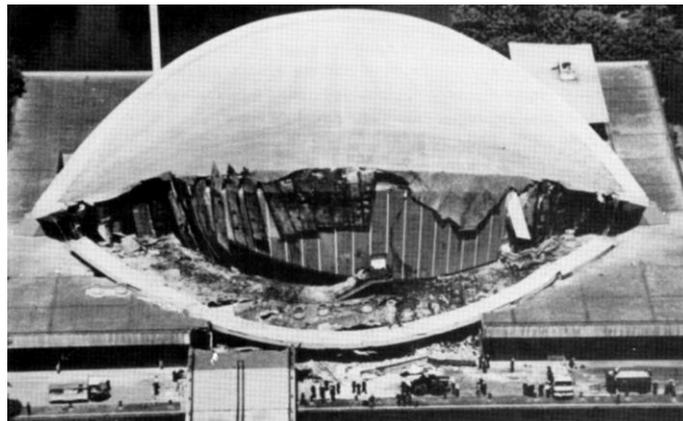
ID-19.5. View from the South on the collapsed roof overhang in 1980 (Helmerich and Zunkel, 2014).

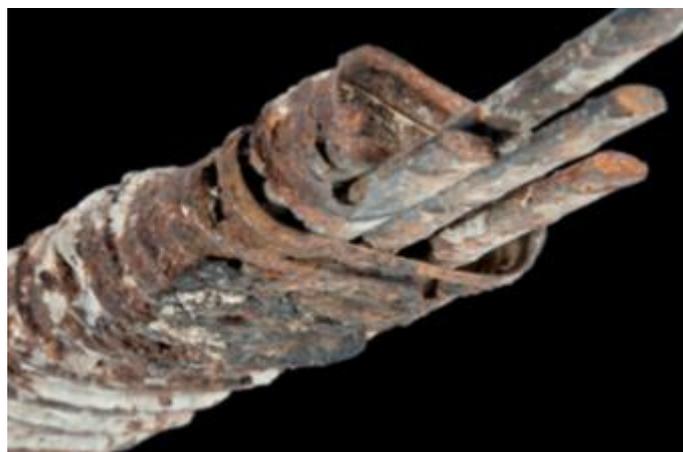
ID-19.6. Remaining bituminized roofing on a completely failed, non-grouted and heavily corroded tendon (Helmerich and Zunkel, 2014).

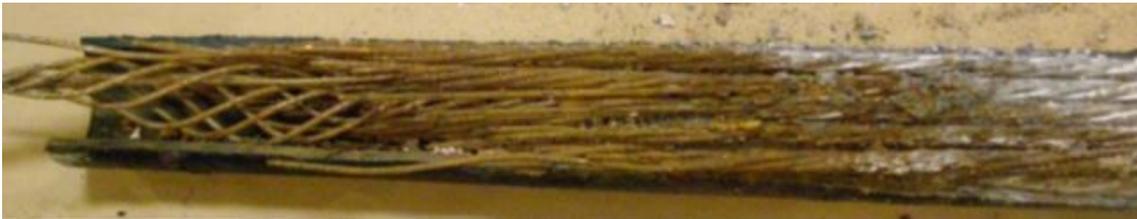
ID-20.2. Corroded tendon (Lau and Lasa, 2016).

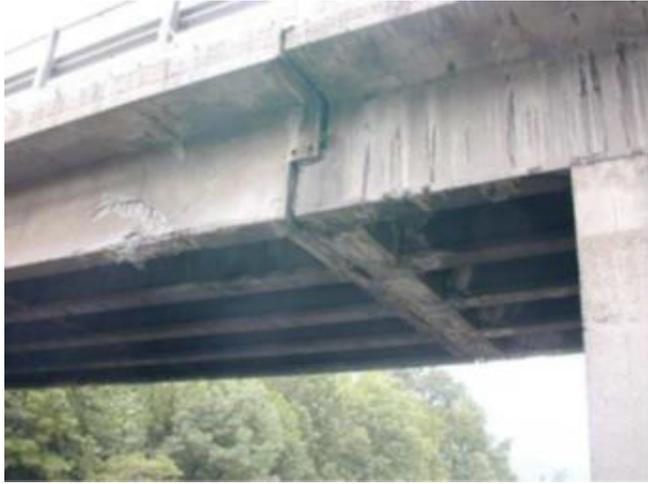
ID-21.4. Lateral impacts occurred in 2006 due to trucks circulating on SS.36 towards Lecco: location(Di Prisco et al, 2018).

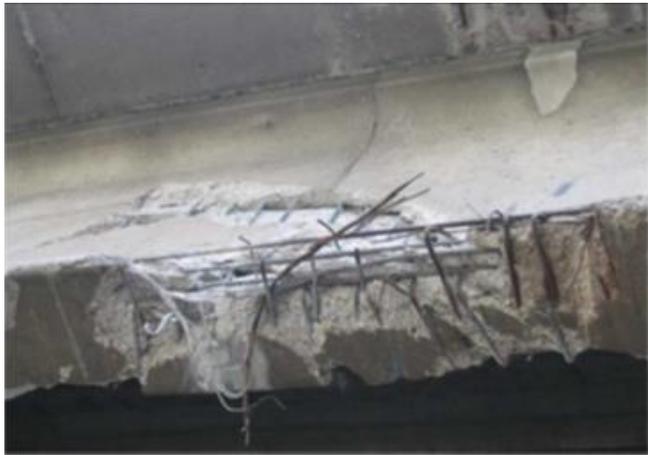
ID-21.5. Lateral impacts occurred in 2006 due to trucks circulating on SS.36 towards Lecco: particular of the damaged zone (Di Prisco et al, 2018).

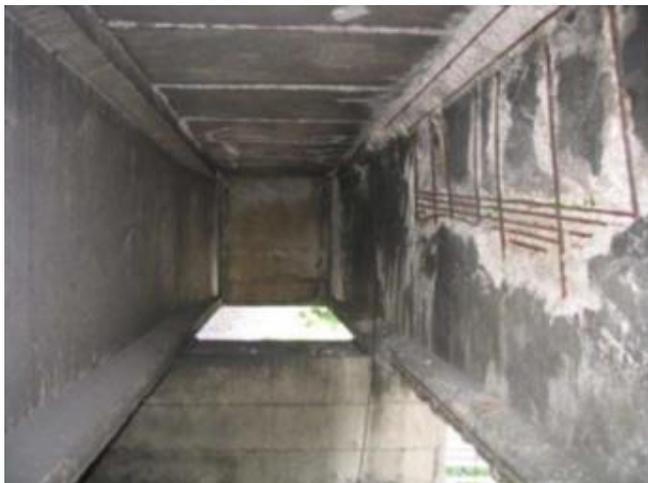
ID-21.6. Damage observed on internal surfaces of the prefabricated beams in 2006 (Di Prisco et al, 2018).

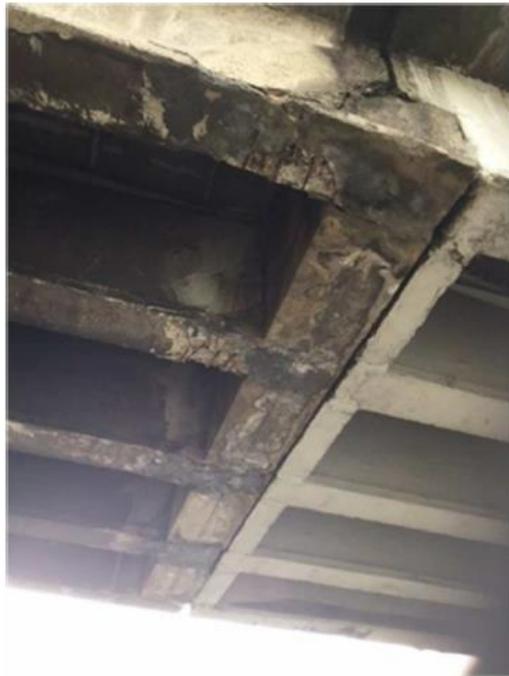
ID-21.8. Critical dapped-end joint view before the collapse: bottom view (Di Prisco et al, 2018).

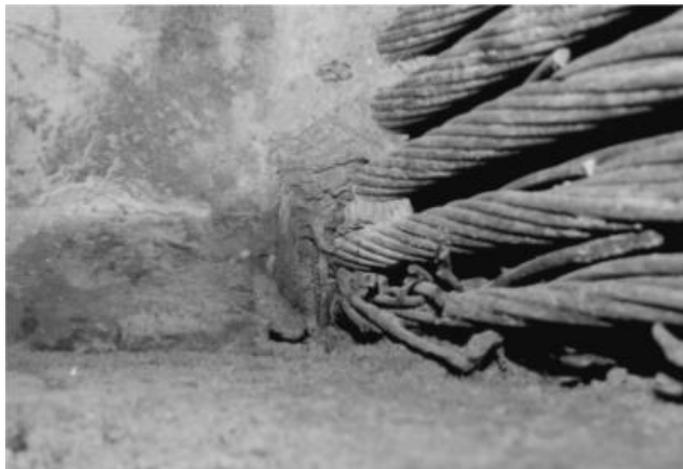
ID-28.1. Corrosion of external tendons that had been encased in concrete (Tilly, 2002).

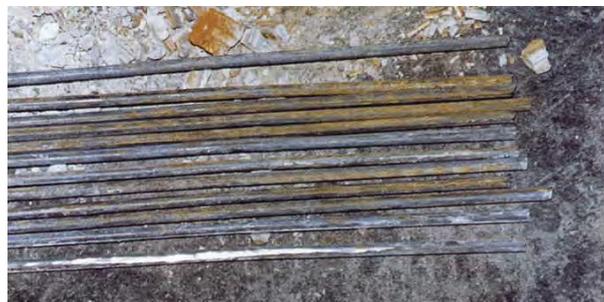
ID-30.2. Typical minor surface corrosion seen on post-tensioning wires removed from duct. No pitting or fractures were noted (Dickson et al, 1993).

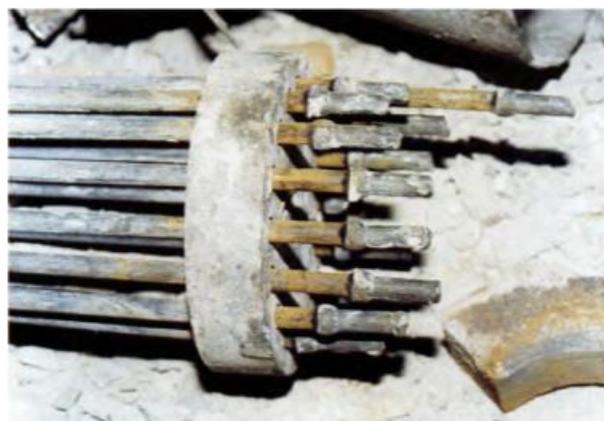
ID-30.3. Corrosion of wires at anchorage plate is greater than that exhibited inside ducts. (Dickson et al, 1993).

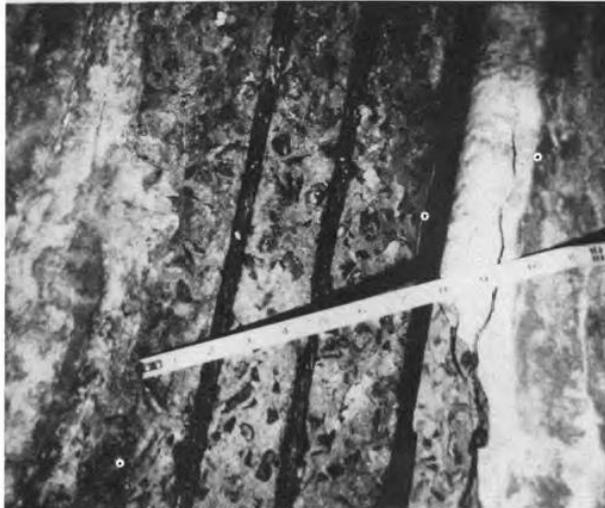
ID-31.4. Spalled concrete and exposed strands in beam 2 (Murray and Frantz, 1992).

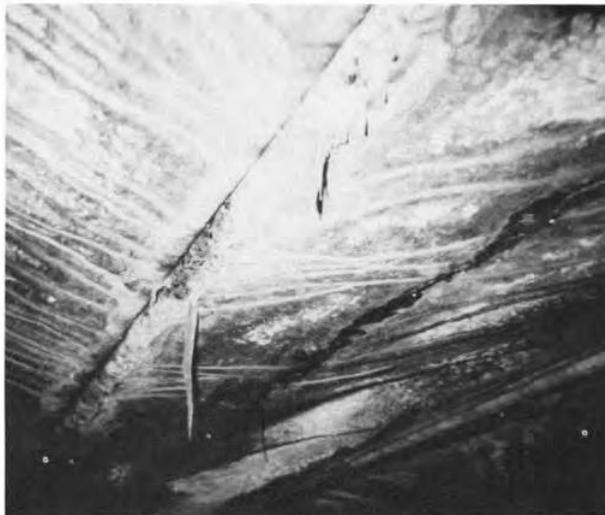
ID-31.5. Stains on beams (Murray and Frantz, 1992).
